# **THE INFLUENCE OF DAM FAILURES ON DAM SAFETY LAWS IN PENNSYLVANIA**

*Andrew T. Rose, Ph.D., P.E.*

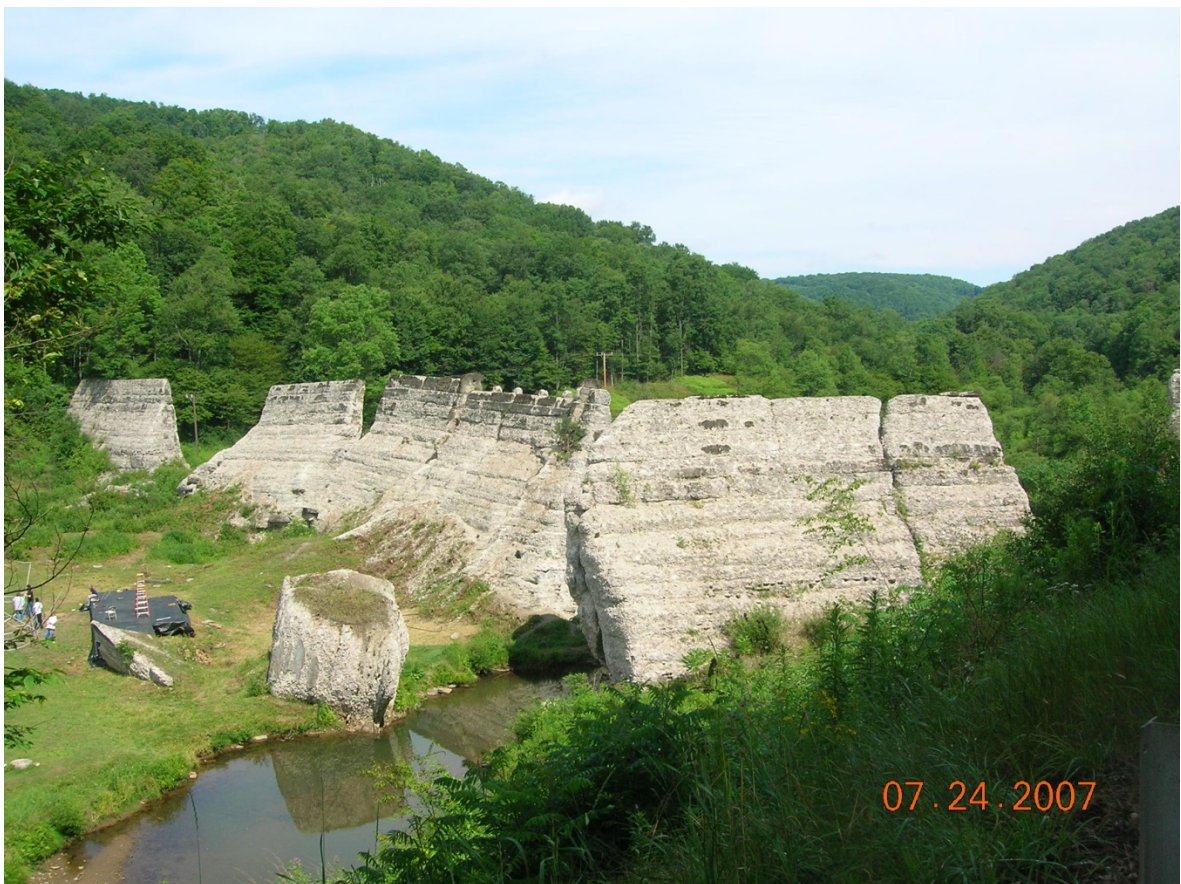
**Figure 6.** The remnants of Austin Dam as of 2007. (Andrew T. Rose).

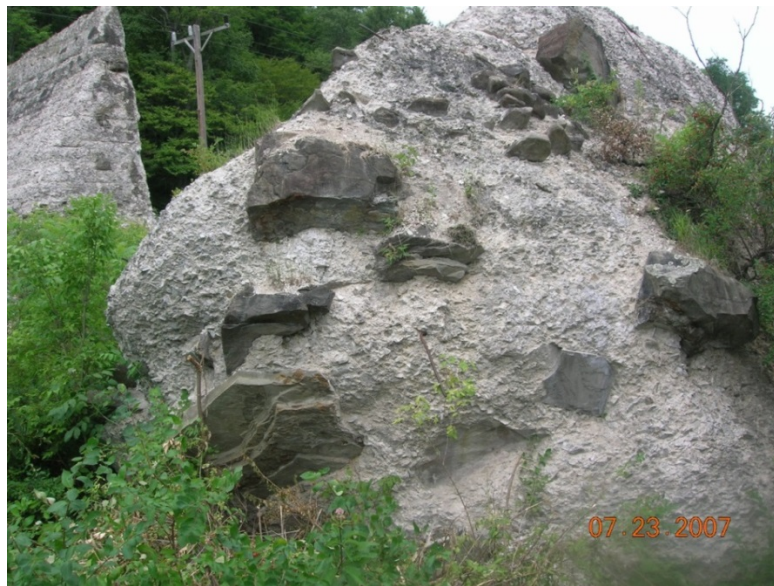
According to Delatte<sup>11</sup> the dam was constructed of cyclopean concrete, with large rock inclusions in the matrix. In addition, some of the work was performed under cold weather conditions with concrete being placed under freezing conditions. Horizontal and vertical construction joints were present in the structure and it is not certain of the efforts taken to keep these joints from forming planes of weakness and seepage paths within the structure. Although a minimal amount of twisted iron rods were used to anchor the dam to rock and in the thinner upper portion of the dam near the crest, no record exists of rods being used across cold joints in the concrete structure. Figure 8 shows the cyclopean nature of the concrete in a remnant of the dam. Figure 9 shows a portion of the dam after years of weathering with vertical and horizontal joints apparent. Figure 10 shows one of the rods used to anchor the dam to the underlying rock.

**Figure 8.** Dam remains in 2007 showing cyclopean concrete. (Andrew T. Rose)

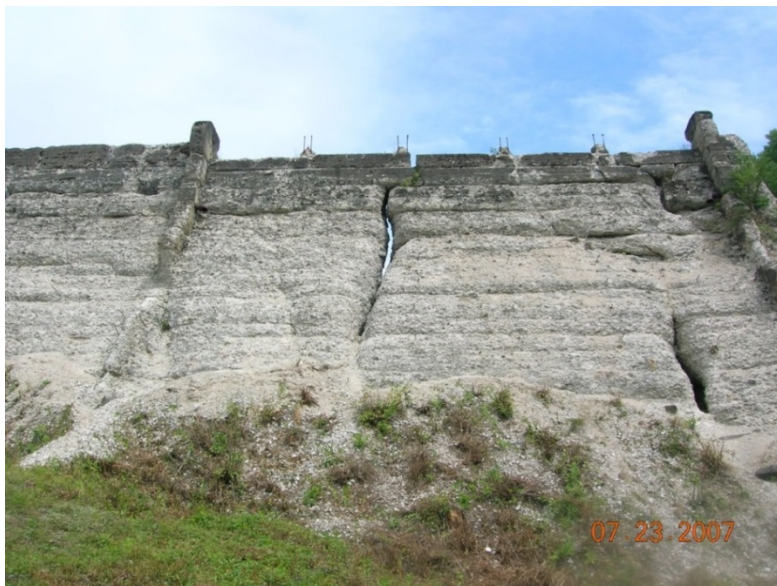
**Figure 9.** Spillway section of dam in 2007 showing vertical and horizontal joints after years of weathering. (Andrew T. Rose)

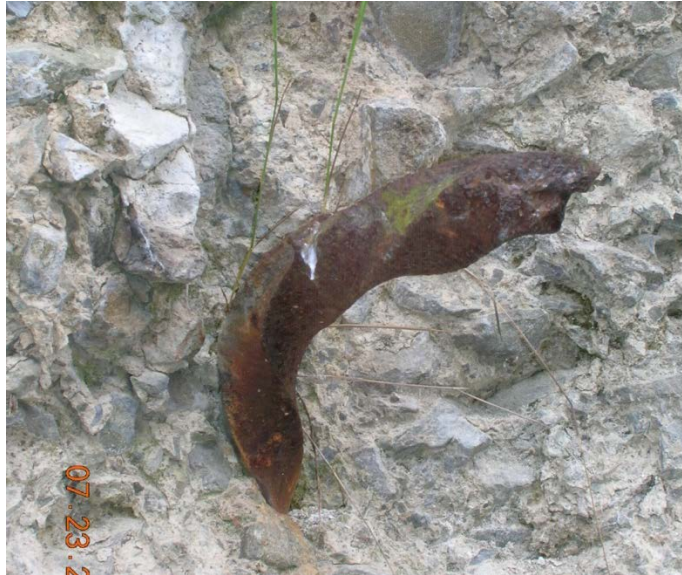
**Figure 10.** Rod used in construction of dam. (Andrew T. Rose)

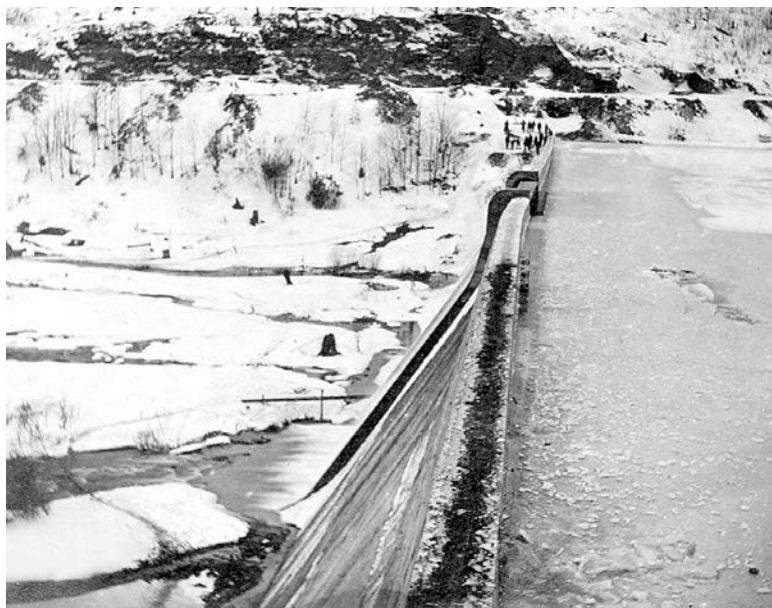
After the dam was completed and put into service in December 1909, a problem occurred which should have foretold of eventual failure. After snowmelt and heavy rains in January 1910, the dam was subject to a full reservoir and a portion of the dam east of the spillway slid downstream about 31 inches at the crest,<sup>12</sup> as shown in Figure 11. The movement was accompanied by the observation of vertical cracks and seepage on the downstream face and seepage in the channel 10 to 12 ft below the toe.<sup>10</sup> The photograph shown in Figure 12 indicates that with water going over the spillway, the newly completed dam had seepage at several locations on the downstream face, possibly originating from construction joints in the concrete structure.

**Figure 11.** Bulging of dam crest east of spillway observed in January 1910 (Courtesy of the Potter County Historical Society).

Comparing Figures 11, 12, and 13, the hole blasted in the crest was located near the point where the sliding of the dam appeared greatest. No indication is provided as to whether the opening of the hole in the dam crest followed by water pouring through the new opening lead to erosion at the toe in this region where the stability of the dam appears to be worst.

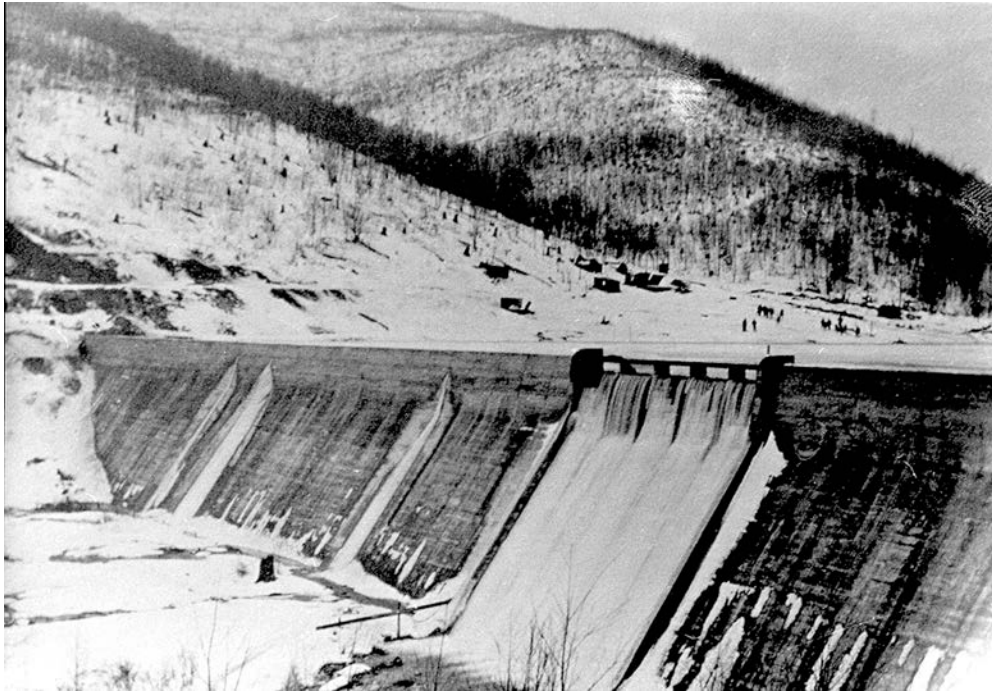
**Figure 12.** Seepage on downstream face of dam in January 1910 (Courtesy of the Potter County Historical Society).

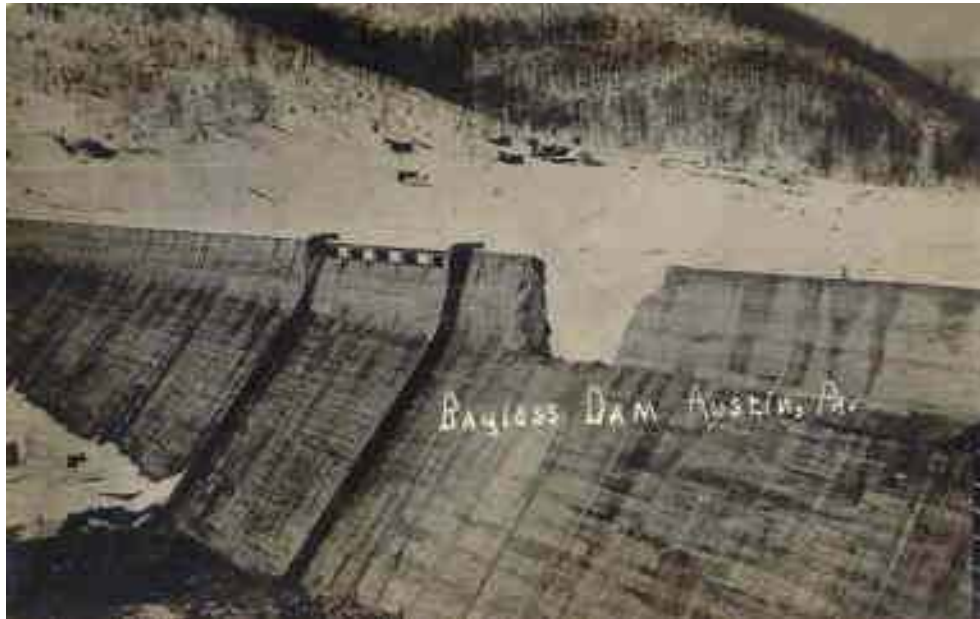
This initial movement of the dam by sliding caused concern and the effort to relieve pressure behind the dam was hampered by the lack of a relief valve, which had been eliminated from the design by Hatton, at the owner's request, to save money. In addition, the cap on the outlet pipe was inaccessible due to the heavy flow, thus removing the cap was not possible.<sup>10</sup> Instead the Bayless company undertook a somewhat foolish measure and using dynamite, blasted out a small section of the crest about 6 to 8 ft wide and 4 ft below the crest. This lowered the head of water behind the dam to about 37 ft, as shown in Figure 13. Even with the lowering of the water level, concern remained, so a second charge was used to blow off the cap on the outlet pipe and the reservoir was drained.<sup>10</sup> At that time it was observed that part of the embankment on the upstream face had eroded away through the outlet pipe and possibly under the dam. It was further observed that a section of the dam had moved downstream relative to the inlet chamber wall through which the outlet pipe passed.<sup>10</sup>

**Figure 13.** Concrete removed by dynamite to relieve pressure behind dam, January 1910 (Courtesy of the Austin Dam Memorial Association, URL <http://austindam.net/>).

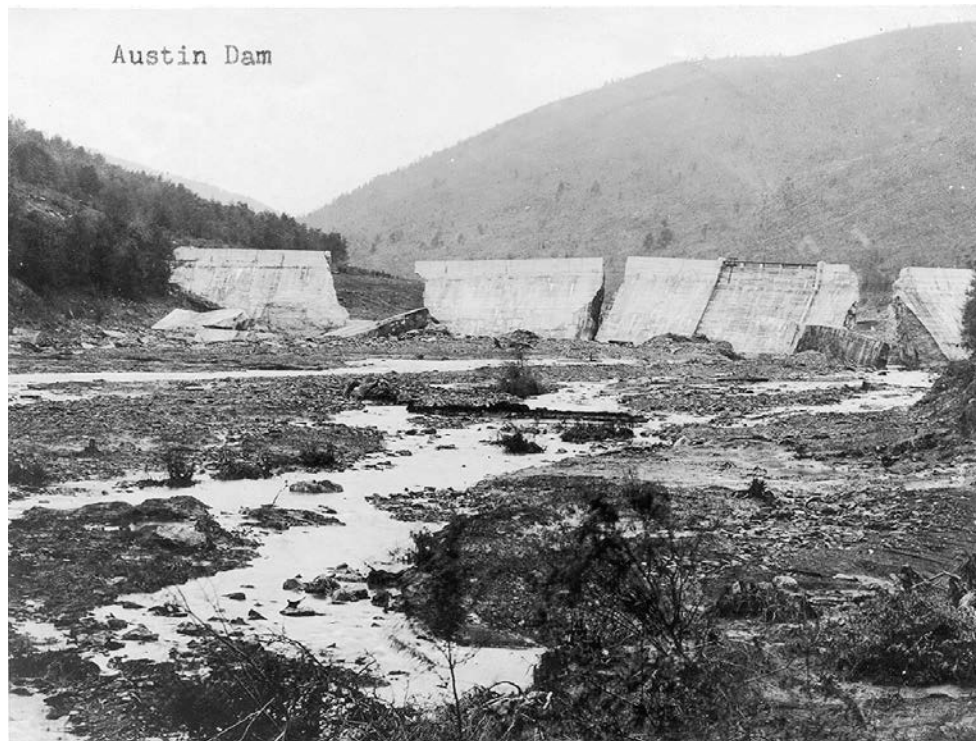
The dam appears to have functioned adequately until the final and complete failure on September 30, 1911. The dam essentially broke into pieces as the water pressure from the reservoir behind the dam pushed the massive concrete blocks downstream. Figure 15 shows a view of the dam blocks strewn across the valley. An observer living near the dam saw the impending dam failure and telephoned downstream to the town of Austin, giving warning of the inevitable flood. Records indicate at least 78 people died as a result of the flood, but more

**Figure 15.** Austin Dam after the failure of September 30, 1911 (Courtesy of the Potter County Historical Society).

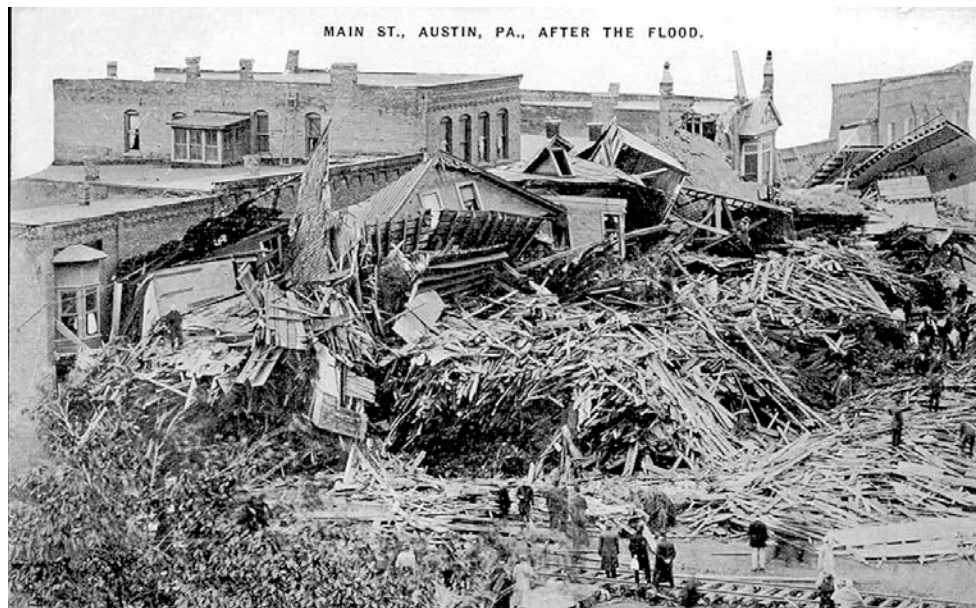
**Figure 16.** Main St., Austin, PA, after the flood (Courtesy of the Potter County Historical Society).

would have likely perished if the warning had not been provided. Most of the casualties were in Austin which was about 1½ miles below the dam, but there were also casualties further downstream in the smaller community of Costello. Figure 16 shows some of the destruction caused by the flood.

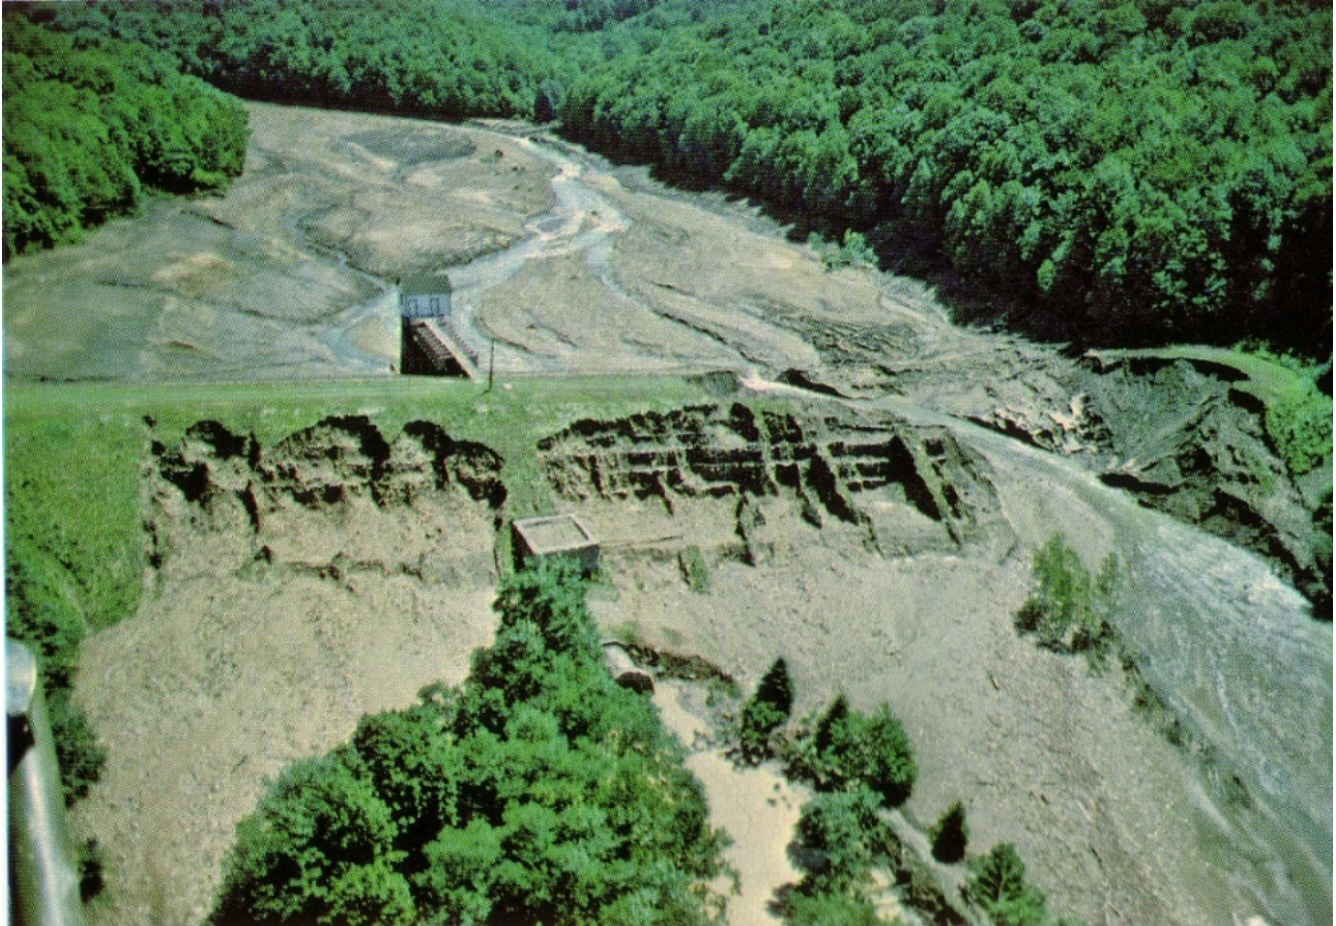
up to 11.8 inches of rain in 24 hours on the area.<sup>27</sup> Described as a 500-year storm,<sup>28</sup> the dam's spillway, which had been identified as inadequate in studies dating back to 1943, was greatly undersized leading to the overtopping failure. In addition, the embankment dam was constructed using hydraulic fill and had low resistance to erosion due to overtopping.<sup>29</sup> Figure 18 shows the remains of Laurel Run Dam following the failure.

**Figure 18.** View of Laurel Run Dam looking upstream after overtopping failure of July 20, 1977.<sup>30</sup>
