Do Yesterday's Earth-Cut Spillway Designs Meet Today's Standards? The Ins and Outs of Earth Spillway Design and Integrity Analysis

Wesley Hollenbach, EIT, Gannett Fleming, Inc.
Paul Schweiger, P.E., CFM, Gannett Fleming, Inc.
Kent R. Finemore, P.E., NHDES – Dam Bureau
Andy Deichert, P.E., West Virginia NRCS
Tim Ridley, P.E., West Virginia NRCS
Jeff McClure, West Virginia NRCS

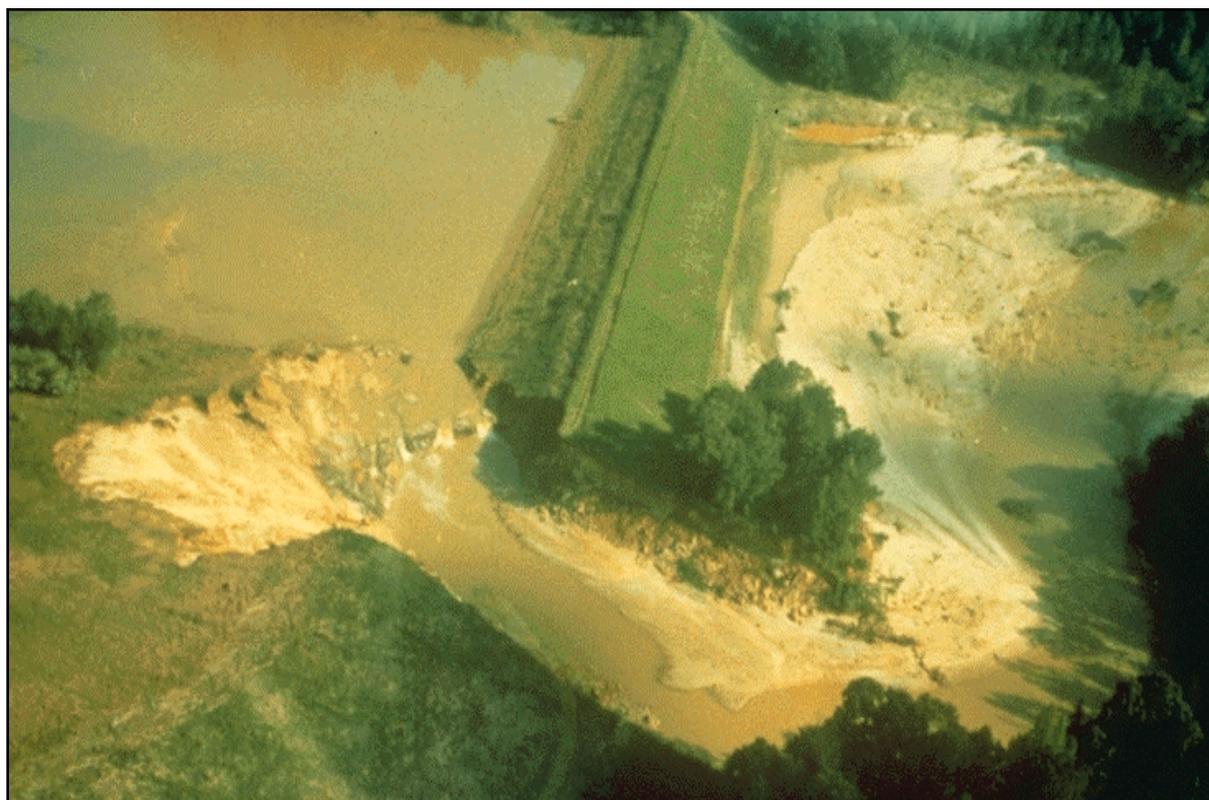
Figure 1. Failure of Black Creek Site 53 Auxiliary Spillway (Photo courtesy of Darrell Temple)

In May of 1983, the Black Creek watershed of the Yazoo basin in Mississippi endured severe flooding. This flooding activated the auxiliary spillway of Black Creek Site 53 and resulted in failure of the dam by erosion and breaching of the auxiliary spillway. The local landowner constructed a farm access road into the exit channel of the spillway perpendicular to the flow, creating a very steep drop in grade. Investigators determined that this drop was the point of primary attack by erosion and the location of the initial headcut formation. The final spillway breach measured 40 feet deep and 160 feet wide, and effectively drained the flood control pool. The constructed auxiliary spillway was

100 feet wide. Approximately 187,000 cubic yards of spillway material was eroded (Temple, 1989b). Figure 1 shows Black Creek Site 53 following complete breaching of the auxiliary spillway. This dam provides one of several examples where an earth-cut auxiliary spillway did not perform as originally intended.

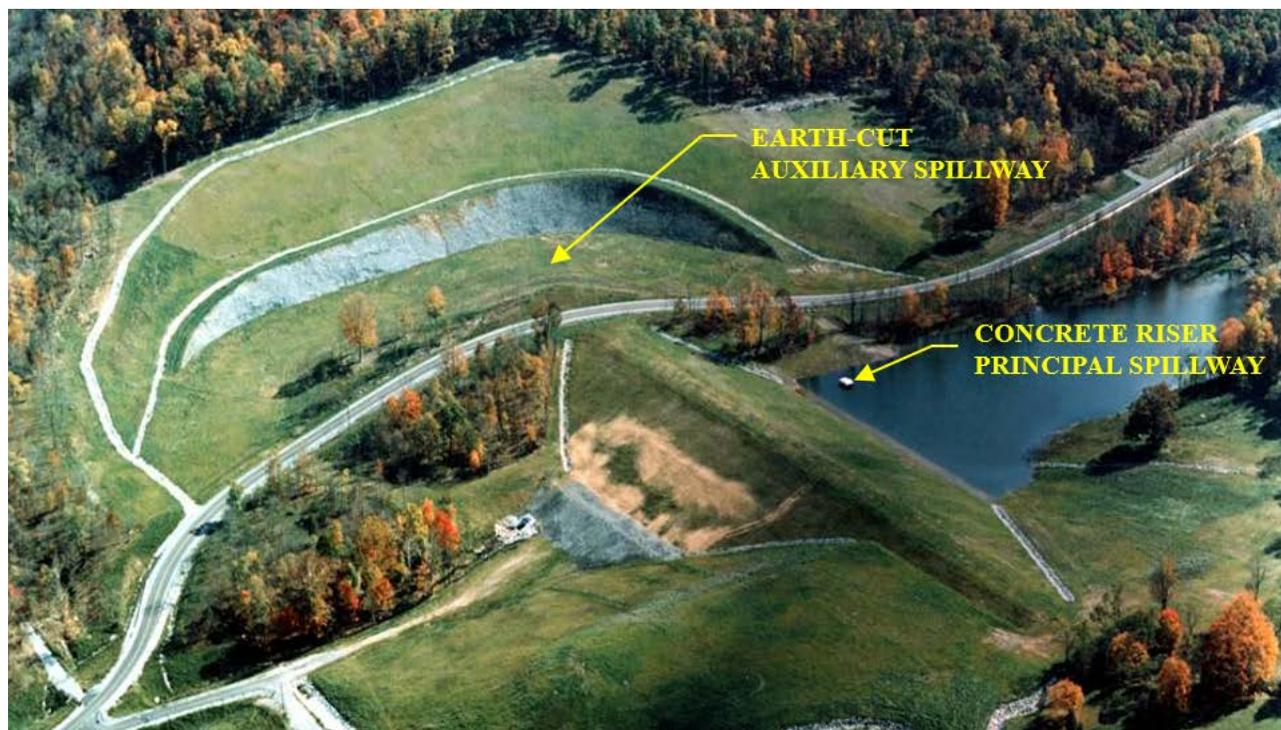
Figure 2. Typical NRCS Flood Control Dam with Auxiliary Spillway (Lost River Site 27, Hardy County, West Virginia)

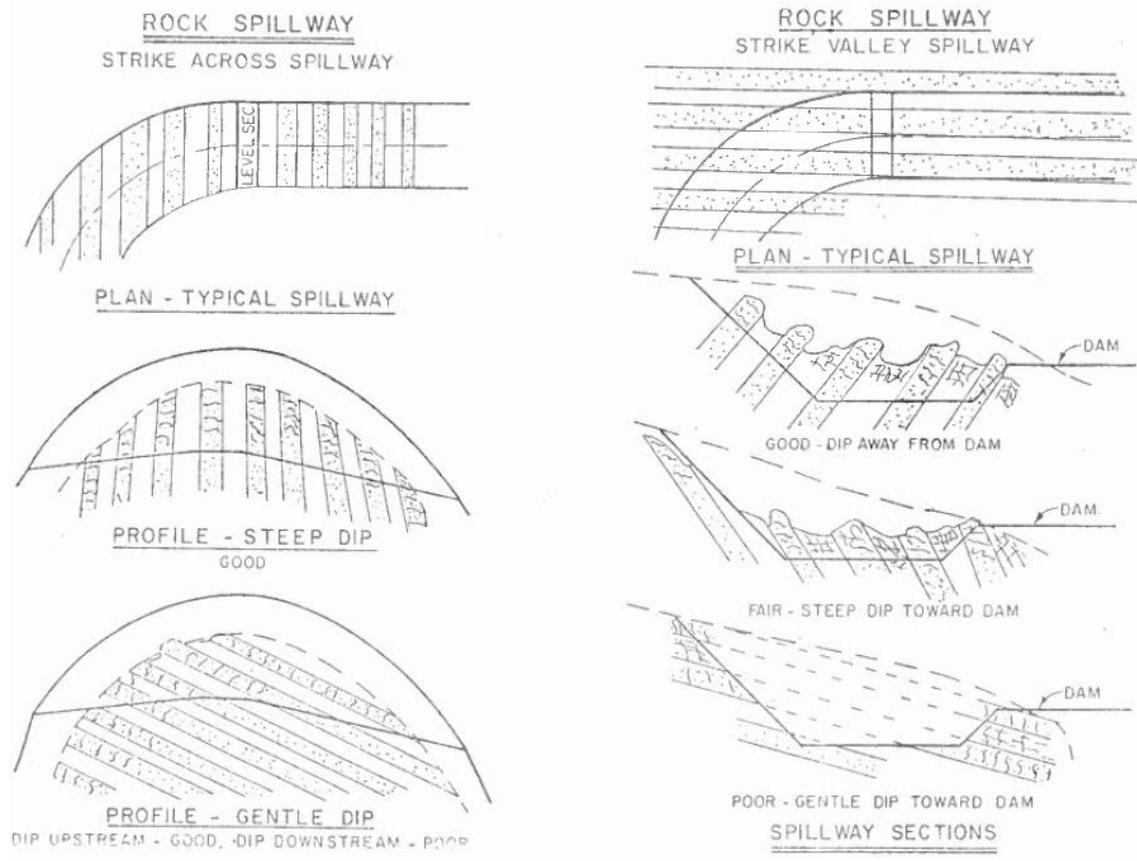
Figure 3. Example of NRCS guidance for the Strike and Dip of Rock within an Auxiliary Spillway (USDA SCS, 1980)

The NRCS also provided guidance for the preferred direction of the strike and dip of the rock within the auxiliary spillway. The design guidance preferred the strike and dip in the upstream direction or away from the dam so that any fractures within the rock would divert flow in that direction (USDA SCS, 1980). Figure 3 shows NRCS preferences of strike and dip within an auxiliary spillway; illustrating good, fair, and poor geologic orientations relative to the dam and auxiliary spillway alignment. This guidance improved upon older references; however, no quantitative way to analyze spillway erosion existed.

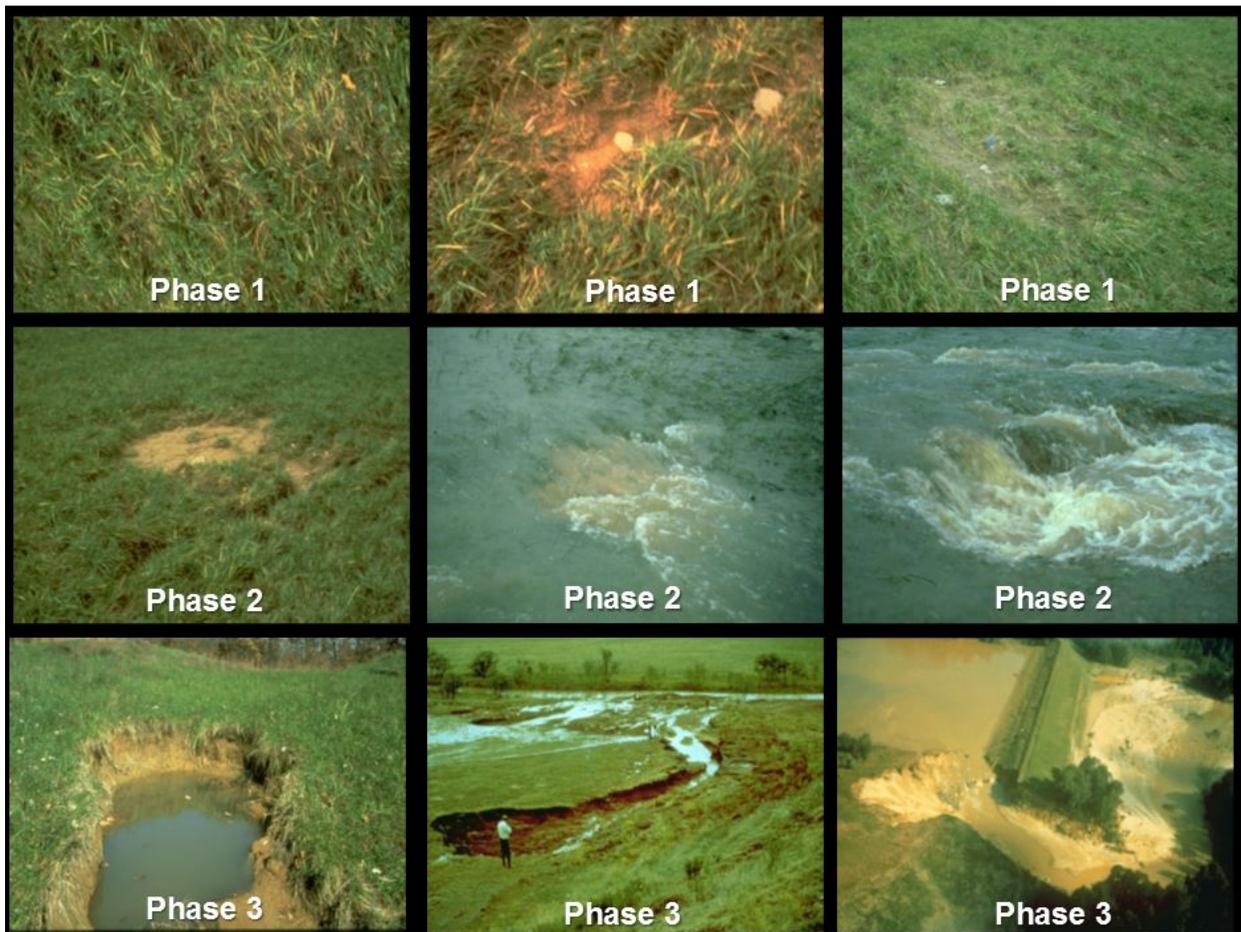
Figure 4. Summary Photos of 3 Phase Erosion Process (Photos courtesy of Darrell Temple)

The spillway integrity analysis portion of the model calculates erosion damage to earth-cut spillways in three separate phases. The first phase is erosion resulting in the local failure and removal of the vegetal cover, if any, and the development of concentrated flow. The second phase is the downward and downstream erosion resulting from the flow and stress concentration leading to the formation of a vertical or near vertical headcut. The third phase of the erosion process is the upstream advance of the headcut, which may also be accompanied by further widening and deepening (Temple and Hanson, 1994). The model calculates these three phases in time steps over the passage of the hydrograph through the spillway based on user inputs of the spillway including surficial dimensions and vegetal cover conditions as well as subsurface profiles of both soil and/or rock and their physical properties. Sections A, B, and C

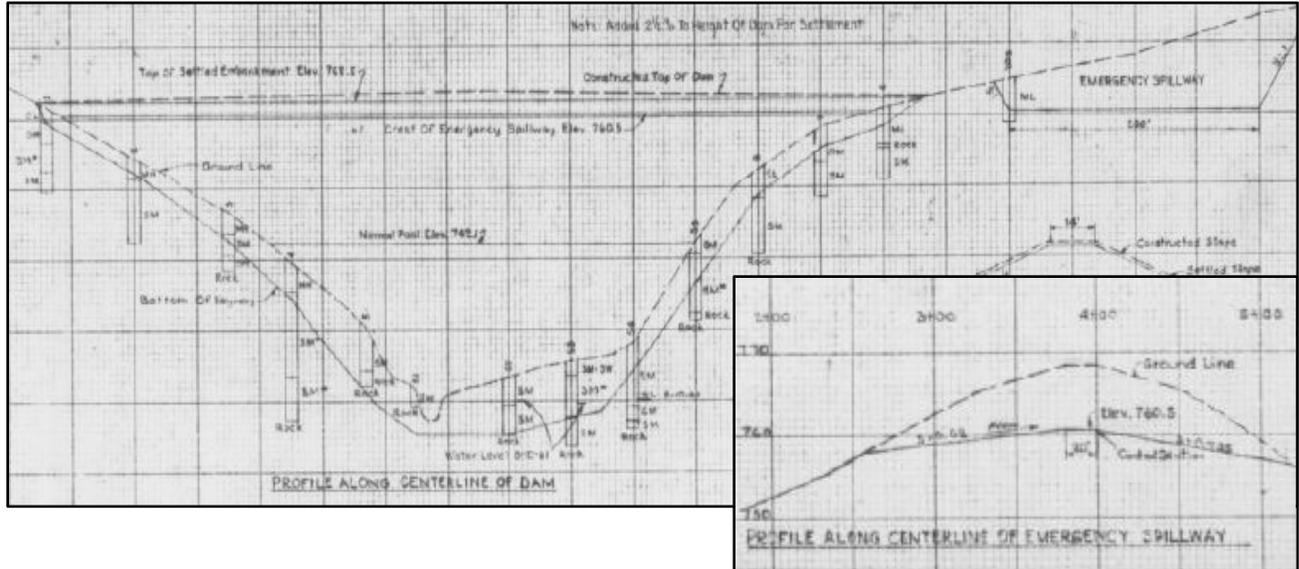
Figure 5. As-Built Drawing Profiles of Huff Creek Site 5B (As Built Drawings courtesy of NRCS)

Huff Creek Site 5B Dam provides a good example of performing a limited detail integrity analysis of a spillway with very little information available. Huff Creek Site 5B is an NRCS flood control dam constructed in Greenville County, SC in 1961. Figure 5 shows the only available subsurface information relevant to the auxiliary spillway, profiles from the As-Built drawings. The reviewers developed the auxiliary spillway surface profile for input into SITES from the 'profile along centerline of emergency spillway' shown in Figure 5 and then projected that profile to the inside edge of the spillway based on the plan view of the dam. **It is important to note that the profile entered in SITES should be the most erodible profile within the spillway.** If it is not clear where the most erodible profile is located within the spillway, the user should evaluate multiple profiles to determine which one presents the worst-

case scenario. For most spillways, the most erodible profile is located along inside edge of the auxiliary spillway (edge closest to the dam); however, situations exist where most erodible profile is located on the outside edge of the auxiliary spillway or somewhere in the middle. The geologic profile along the inside edge of the spillway generally has the most weathered and weakest material, due to its relative location and depth to the original ground surface, and experiences the greatest erosion. In extreme cases, like the one shown in Figure 6, the terrain at the dam abutment was so steep that the designer(s) elected to construct the spillway with no natural bulk between the dam embankment and the spillway. In this case, the geologic profile along inside edge of the spillway consists of highly erodible fill material.

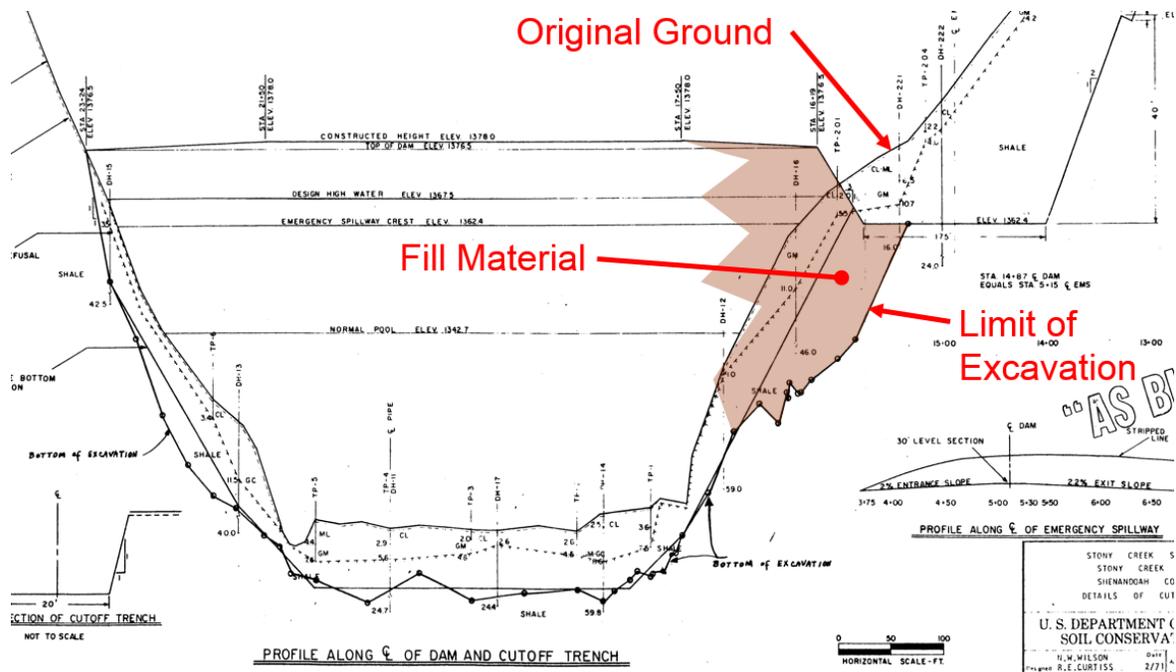
Figure 6. Example of an Auxiliary Spillway Constructed on Dam Embankment Fill (As Built Drawings courtesy of NRCS)

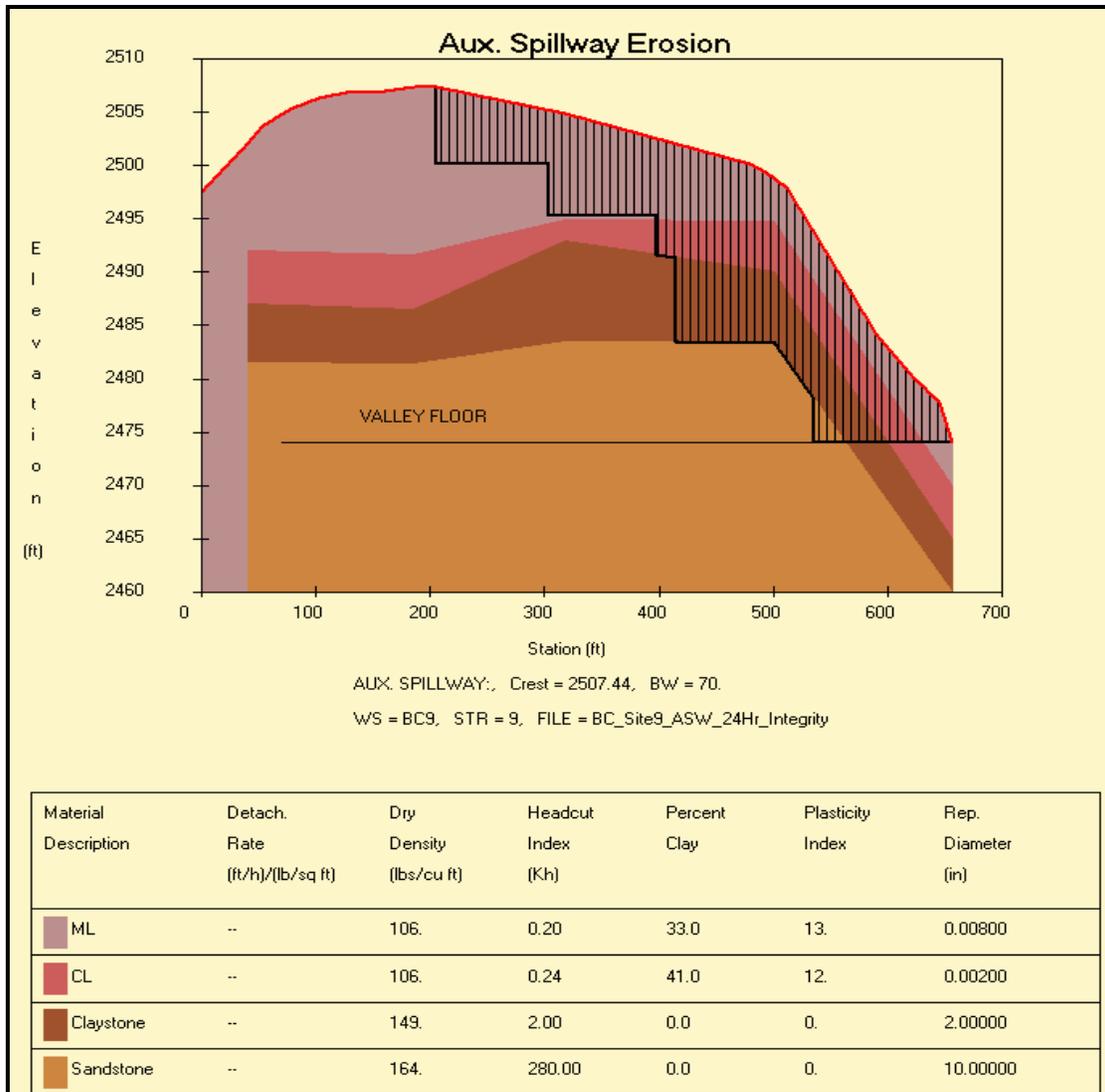
Figure 7. Plot of Auxiliary Spillway Profile and Extent of Erosion from Integrity Analysis for 24-hour Class C Freeboard Hydrograph (PMF) Obtained from SITES Model Output

The planners created a full profile of the spillway once the strata breaks were established in both of the bore-holes in the spillway of Brush Creek Site 9. This process also involved review of the original design files and As-Built drawings to extrapolate beyond the limits of the two bore-holes. The material properties were calculated based on the laboratory testing results of soil and rock samples. The soil sample testing included particle size, dry unit weight, and plasticity index. The rock core testing included unconfined compressive strength and slake durability which measures weathering resistance. The values obtained from the lab testing were used to calculate K_h values for each material. The calculated values were then compared to the K_h photo reference within SITES. The photo reference provides additional guidance in identifying common ranges in index values for similar materials and an empirical means of back checking the calculated values. Figure 7 shows the SITES output profile for Brush Creek Site 9 including the material properties. The integrity analysis of Brush Creek Site 9 showed erosion of the downstream end of the auxiliary spillway but no breaching of the spillway crest during passage of the 24-hour FBH.

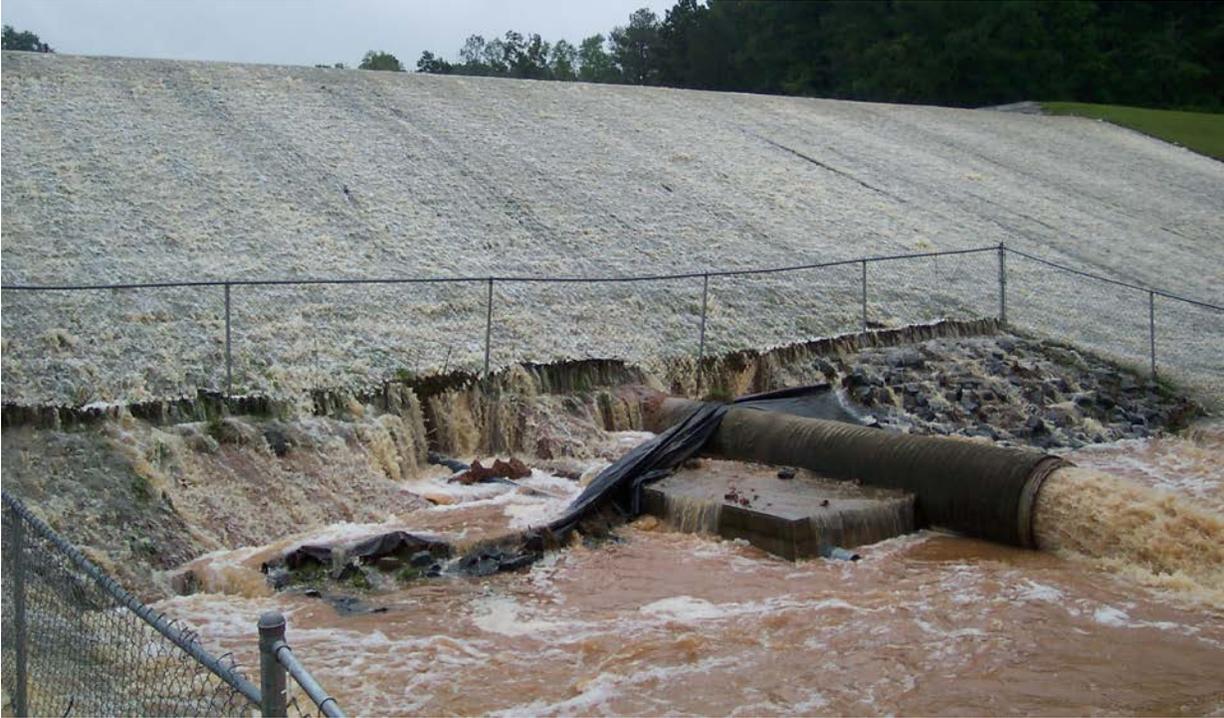
Figure 8. Effect of Non-Uniformities (Photo courtesy of Gregg Huddock, Golder Associates)

When inspecting, evaluating or designing an earth-cut auxiliary spillway, there are many factors to keep in mind that can have a major impact on spillway integrity evaluation results. A few common mistakes to look for include poor maintenance conditions, non-uniform vegetative cover; not extending the straight section of the spillway exit channel beyond the toe of the dam; failing to account for what takes place downstream of the constructed auxiliary spillway; and modifications made to the spillway after construction. The importance of a uniform vegetative cover cannot be overstated. Non-uniformities within the spillway can lead to rapid Phase 1 failure. These non-uniformities can include sparse vegetation, tire ruts, fences, signs, roads and road drainage ditches, trails, rodent borrows, etc. Figure 8 shows an example of how a fence can initiate the headcut process. Note the uniform cover and uniform flow on the downstream slope prior to flow reaching the fence. The photo in Figure 8 depicts a dam overtopping event; however, the same principal applies to an auxiliary spillway.

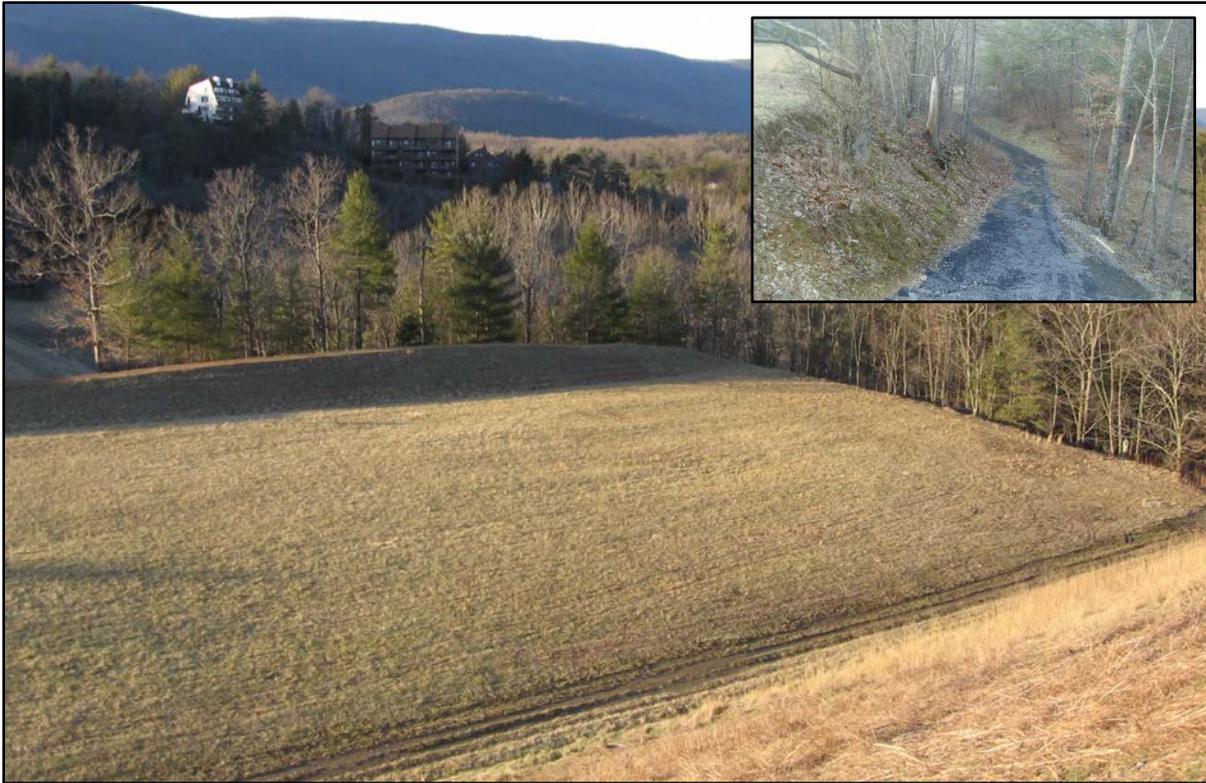
Figure 9. Well maintained auxiliary spillway with steep drop (road cut) beyond constructed section

It is essential that designers orient auxiliary spillways in a manner that does not direct flows towards the dam embankment. In most cases this can be avoided if the exit channel is straight, perpendicular to the level control section, extends beyond the toe of the dam, and has an unobstructed outlet. Obstructions should be avoided that could direct flow back towards the dam embankment. Designers should evaluate spillways down to the valley floor elevation. The valley floor is defined as the elevation below which the spillway will not erode because of downstream control. Headcutting can develop downstream of the constructed portion of the auxiliary spillway exit channel and progress upstream into the spillway crest, resulting in a breach. Figure 9 shows an example of a well-maintained auxiliary spillway with a sharp drop in grade and an access road beyond the constructed portion of the spillway. Figure 10 shows a similar spillway flowing. Note how flow is plunging downward and initiating the formation of a headcut whereas the flow within the constructed section above the drop is smooth and uniform.

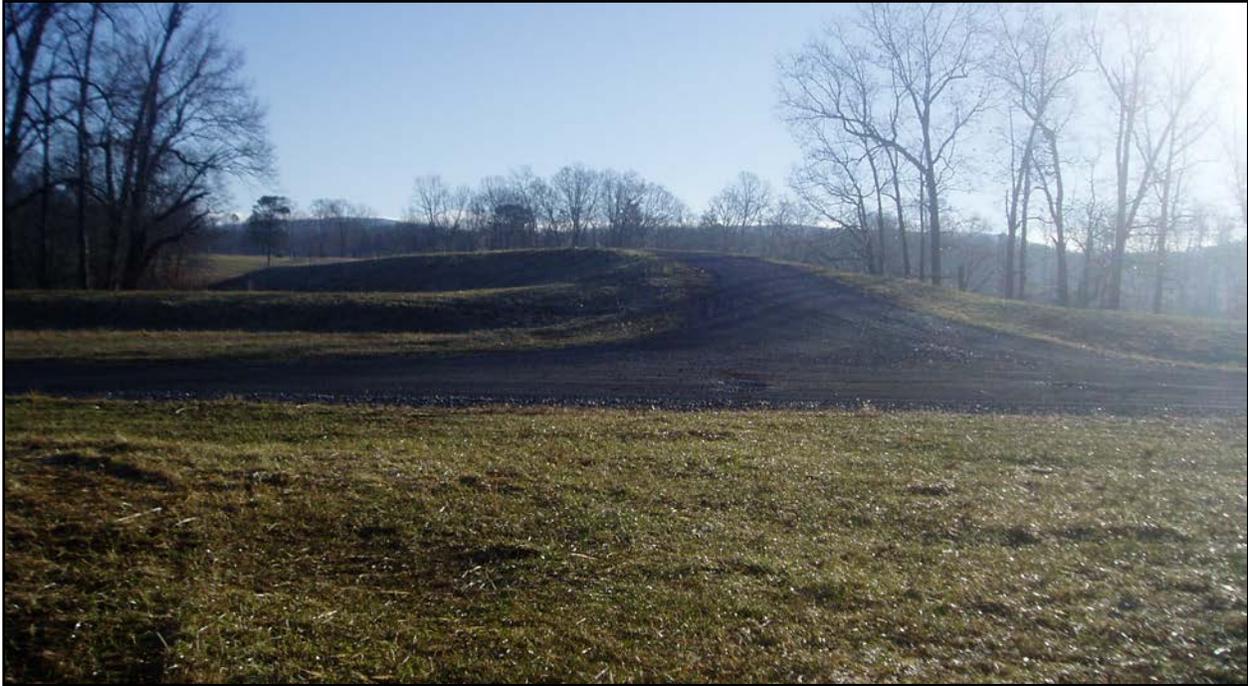
Figure 11. Ramp to Top of Dam across Auxiliary Spillway Control Section

Sometimes an auxiliary spillway is modified from its original design; this modification can adversely impact its performance. Figure 11 illustrates an example of a spillway modification by a local farmer who placed fill within the level control section of the spillway to construct an access ramp to transport his farm equipment over the dam. By flattening the spillway bank slope at the crest and adding fill material within the spillway cross section, the farmer reduced the spillway discharge capacity and created a non-uniform flow condition.

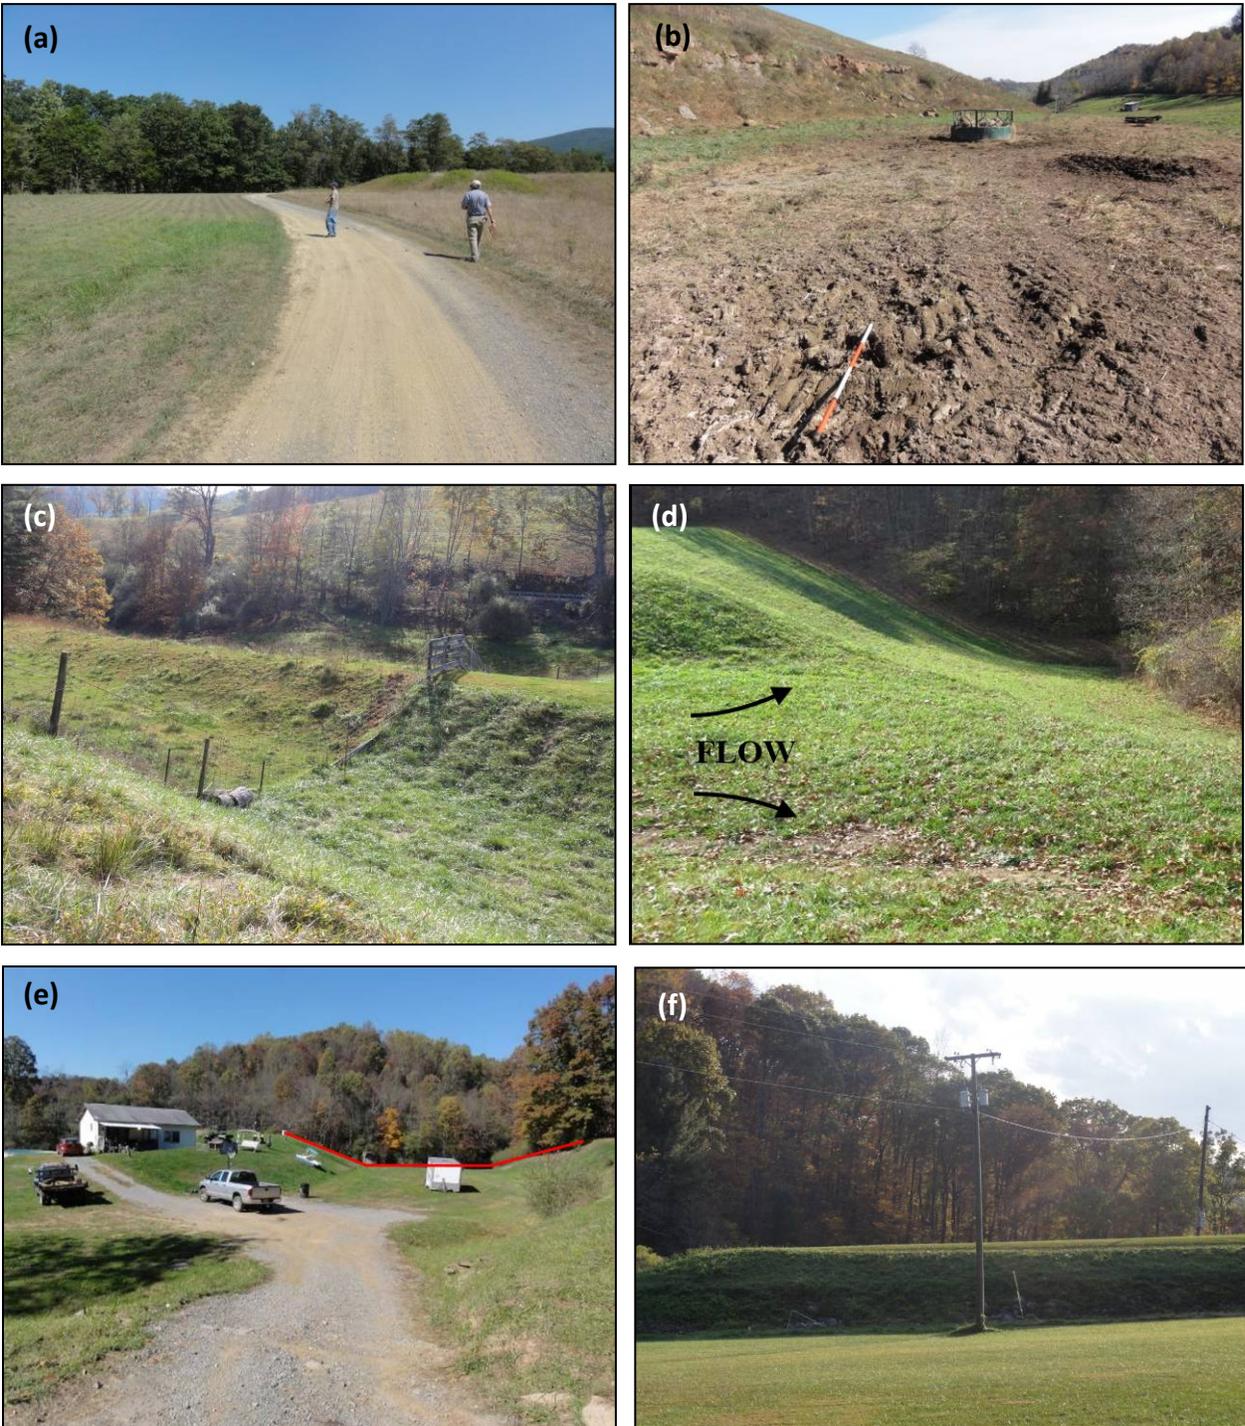
Figure 12. Photos Showing Typical Examples of Observed Deviations From Recommended Auxiliary Spillway Practice; (a) Dirt Road Parallel to Flow, (b) Sparse Grass Cover Due to Livestock, (c) Fence Across Spillway, (d) Spillway Exit Channel Along Toe of Dam, (e) Road Across Spillway and Obstructions In Spillway, (f) Utility Pole In Spillway.

Deviations from the established spillway layout guidelines often include: (1) not extending the exit channel of the auxiliary spillway far enough downstream from the dam to preclude damage to the dam, (2) locating a portion of the auxiliary spillway directly on embankment fill (see Figure 6), (3) allowing unpaved roads and drainage ditches through the spillway parallel to the flow, (4) incorporating abrupt changes and very steep slopes in exit channel and outlet, and (5) including obstructions and irregularities within the spillways. Figure 12 shows examples of some of the aforementioned deviations.

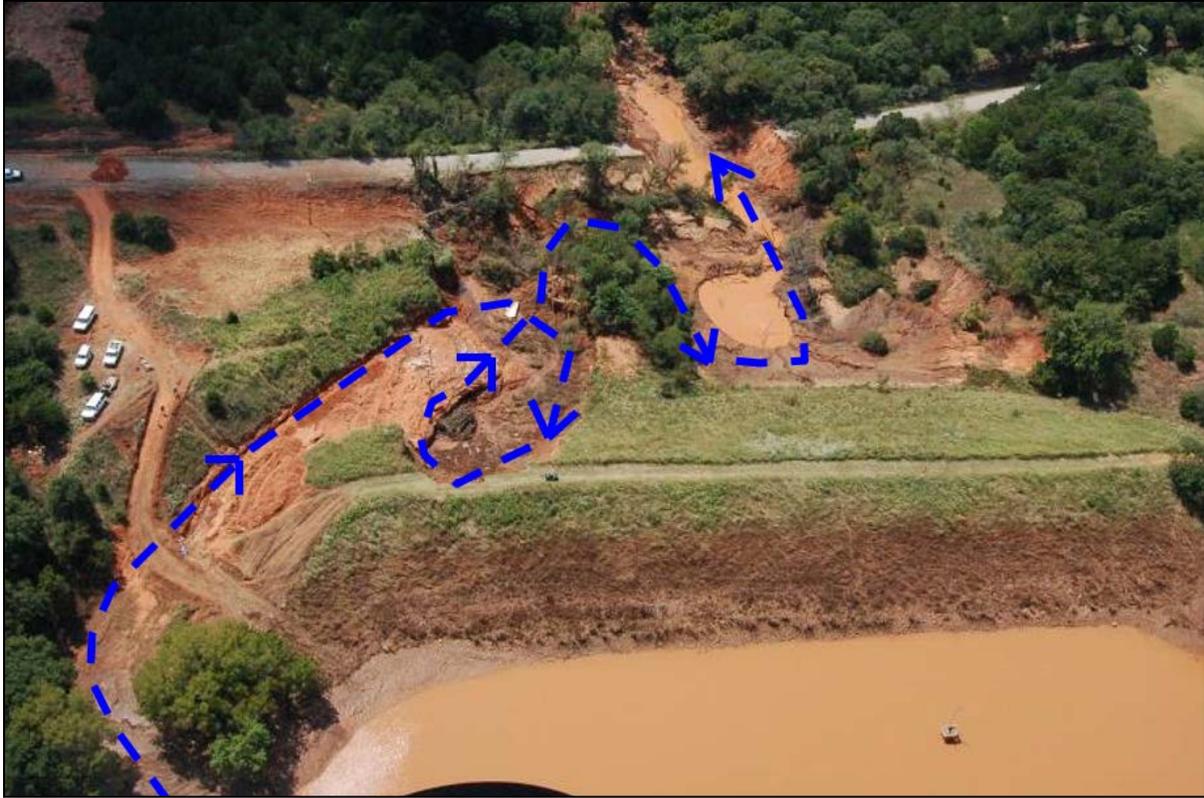
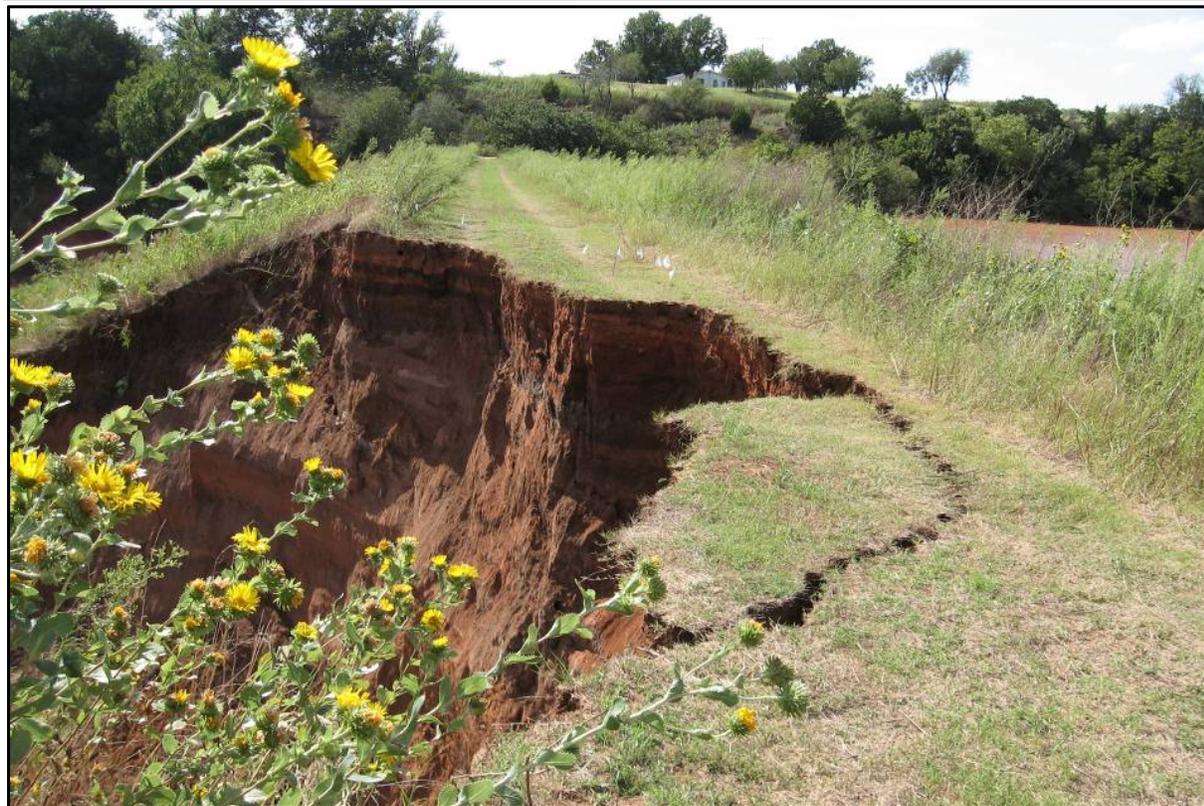
Figure 13. Photographs showing the flow path and erosion in the downstream slope of Sugar Creek Dam L-44 located in Caddo County, Oklahoma following Tropical Depression Erin on August 19, 2007.

When designing the downstream exit channel and negotiating related landrights/flowage easements, it is important to consider possible unusual flow conditions that could cause the spillway flow to meander, change direction, and return to erode the dam embankment. This condition is not always evident as the subsurface geologic features that can cause this condition can be complex and not well defined. In some cases man-made features, such as a new highway crossing downstream of the dam constructed many years after the dam, obstruct and redirect the flow towards the dam. Sugar Creek Dam L-44 in Oklahoma, shown in Figure 13, is an example of an auxiliary spillway exit channel condition that nearly breached the dam embankment. In this case the higher ground beyond the constructed portion of the exit channel directed the flow back towards the dam embankment causing erosion of the downstream slope.
