# EXTREME EVENTS: GRAPHS, PHOTOS, VIDEOS

John Harrison, P.E.  
Schnabel Engineering

**Abstract:** This paper presents a few extreme storm events that have served as the basis for the development of PMP estimates for the Eastern United States (HMR 51). Other extreme storm events that have approached PMP magnitudes will also be presented. These rainfall depths are graphed with world record rainfalls, PMP rainfall, and 100-year rainfall as a basis of comparison. Photos and testimonies of these extreme events have been presented to provide expanded discussion of limited experiences that in various ways affect all of us in the dam safety community. Videos of two floods are presented at the conference.

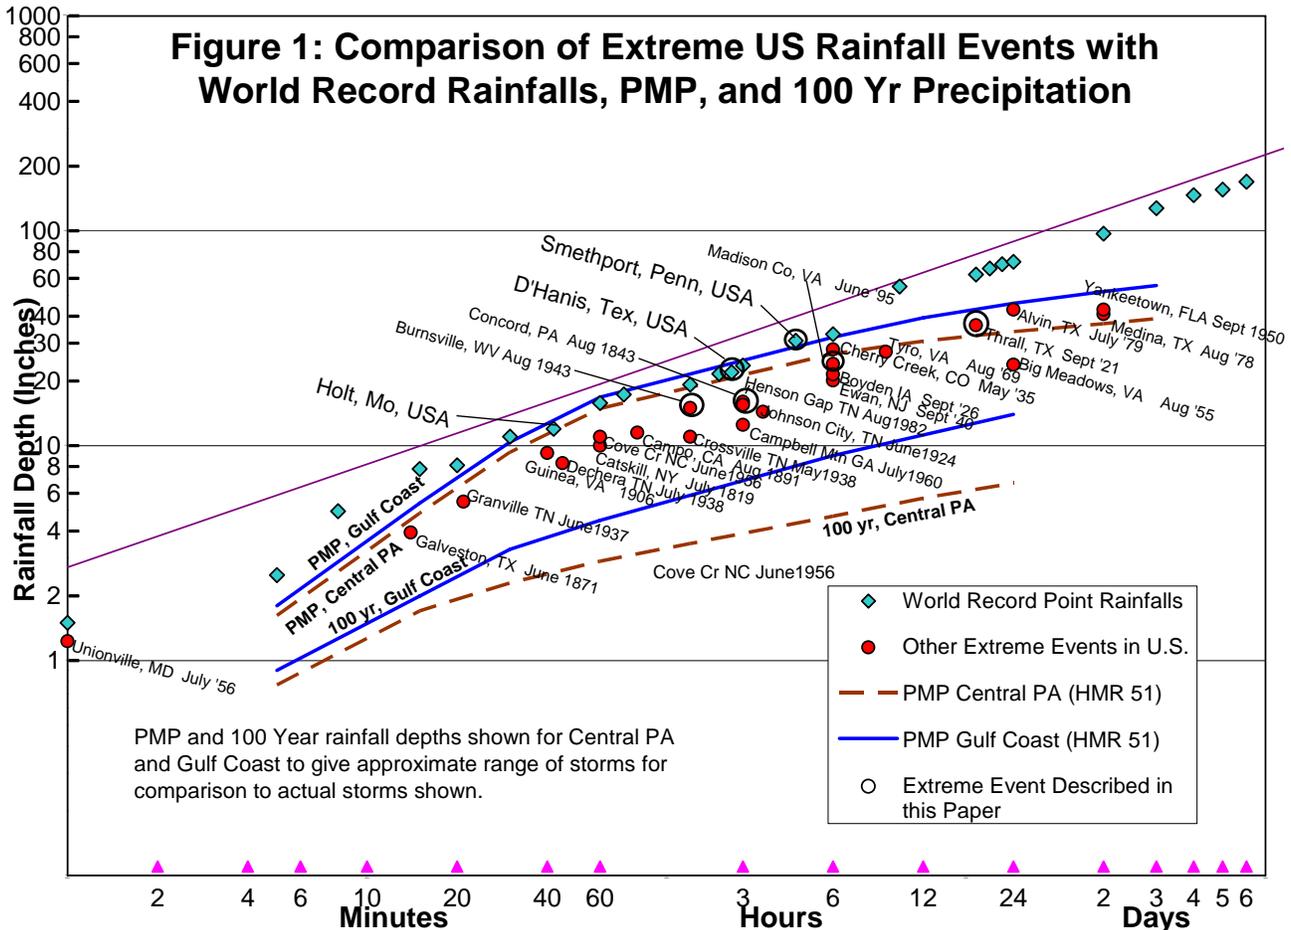
Figure 1 is a graph showing world record rainfalls, PMP estimates (10 sq.mi., per HMR 51), and miscellaneous extreme events in the United States (primarily eastern US). Several of the extreme rainfalls presented in this paper are highlighted in the figure.

This storm was a world record event for its duration. Approximately 22 inches of rain fell in 2.75 hours (see Figure 1). The peak discharge of Seco Creek measured at the Rothe ranch (11 mi above D’Hanis) was 230,000 cfs for a drainage area of 142 square miles. This discharge is one of the highest ever measured for a basin of this size. Average rainfall over the basin was about 9 inches.<sup>1</sup> The entire town of D’Hanis was under water, 17 homes were washed away, and more than a mile of Southern Pacific railway was totally destroyed. Five people were killed, and the death toll would have been much higher had the storm occurred at night.

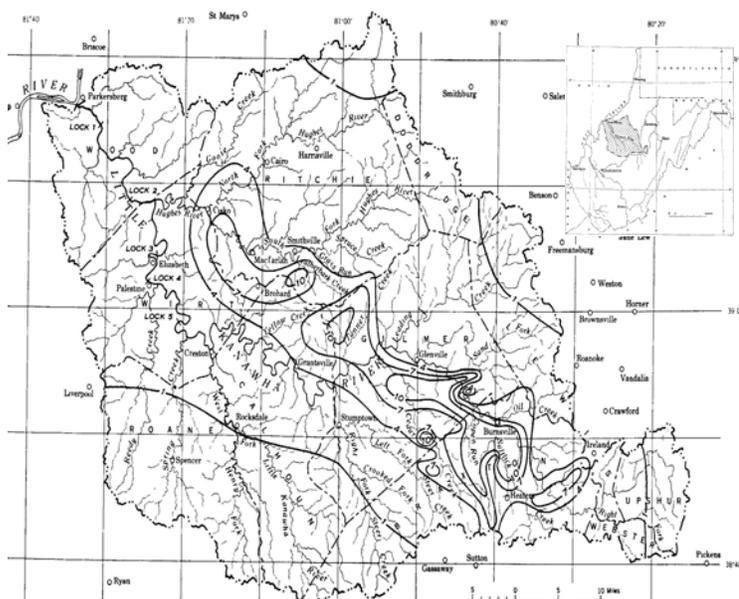
Figure 2: Isohyetal map of Little Kanawha River Basin (Source: USGS WSP 1134A)

A notable flood of short duration and high intensity occurred during the night of August 4-5, 1943 in Central West Virginia. The affected area was about 50 miles long and 10 miles wide in the diamond-shaped Kanawha River Basin, with elevations generally ranging from about EL 600 to EL 1500 (Figure 2). Point rainfall amounted to as much as 15 inches in 2 hours. According to the U.S. Weather Bureau (1943), the record-breaking rains were accompanied by “one of the worst, if not the worst, electrical storms of record”. Twenty-three people perished in the flood, all of whom lived along relatively small tributaries.<sup>2</sup> Six precipitation gages

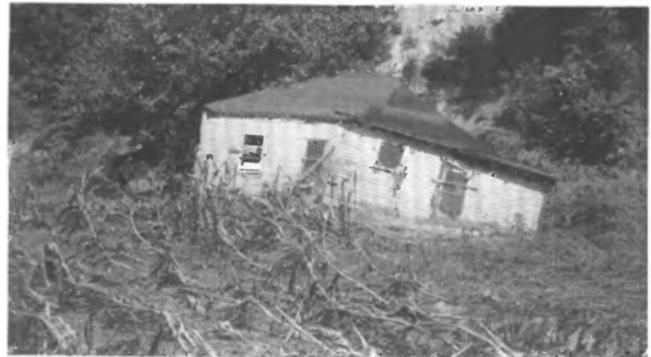
Figure 3: This home was swept ½ mile downstream and came to rest in the creek bed. All six inhabitants perished. (Source: USGS WSP 1134A)

The single largest property damaged from the flood was a 10-mile stretch of the B & O Railroad, where six railroad bridges and much track was destroyed. Heavy deposits of sand and gravel washed down many small runs. An example of the damage from the storm is shown in Figure 3. Some of the highest unit discharges were 4,700 cfs (3,100 cfs/mi<sup>2</sup>) for the North Fork Yellow Creek (1.51 mi<sup>2</sup>) and 7,400 cfs (3,060 cfs/mi<sup>2</sup>) for Laurel Fork above White Pine (2.42 mi<sup>2</sup>). Discharges were estimated by the slope-area method.<sup>4</sup>

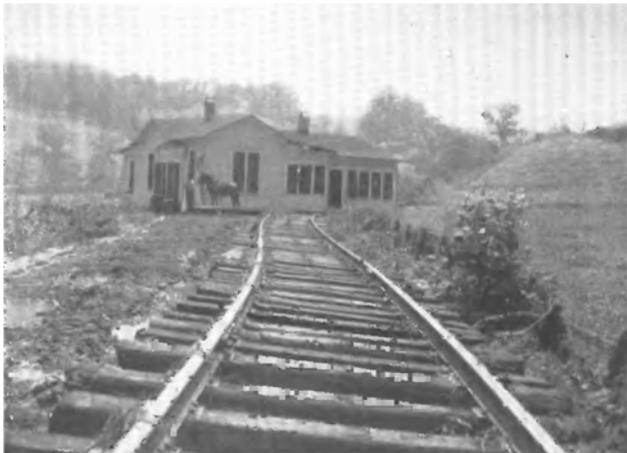
Figure 4: Residence near Heaters with its four occupants inside was washed one mile down O'Brien Fork of Saltlick Creek and lodged on a displaced section of railroad track (Source: USGS WSP 1134-B)

Genesee, tributary to the Saint Lawrence River. The distribution of rainfall over three basins explains the lesser severity of flooding on the main stems of these rivers, compared to the headwater streams and runs of each basin. Figures 4 and 5 show two examples of the flood damage.

The damage from the storm was extensive. The dikes at Emporium, PA were overtopped, flooding most of the town. Dams above Austin and Johnsonburg, PA overtopped and breached. Buildings were knocked off of foundations, and 75 miles of Pennsylvania Railroad track was severely damaged (Figures 4 & 5). Sections of the Coudersport and Port Allegany Railroad and the Baltimore & Ohio Railroad were so badly damage that they were never rebuilt. Fifteen people perished in the flood, and many were left homeless. The following is a record of various observations of residents regarding the storm as recorded by Eisenlohr:

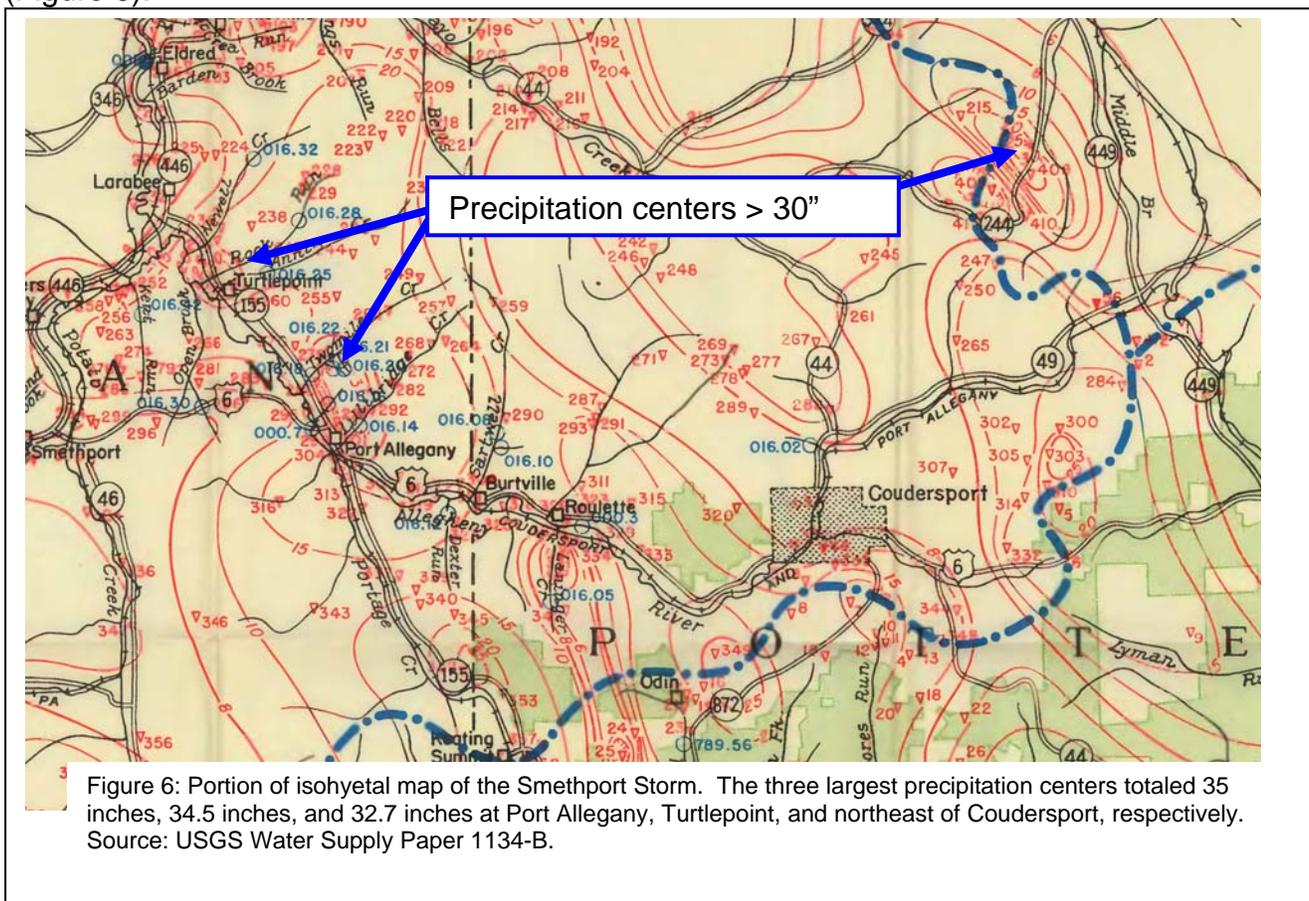
The maximum precipitation center received more than 35 inches at Port Allegany, with two additional centers of more than 30 inches at Turtle Point and northeast of Coudersport, PA (Figure 6).

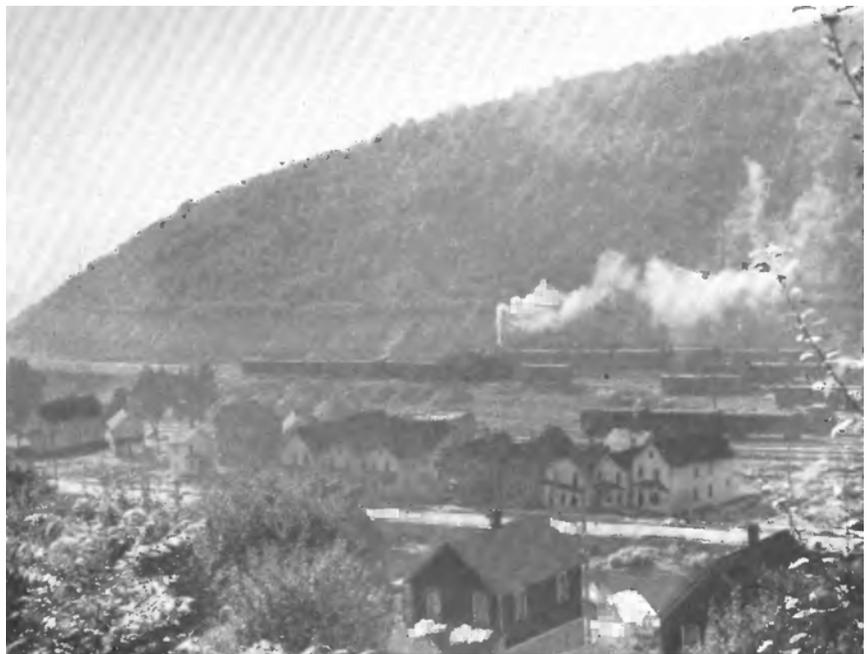
Figure 7: Houses knocked off their foundations and pushed together in Johnsonburg, PA (Source: USGS Water Supply Paper 1134-B)

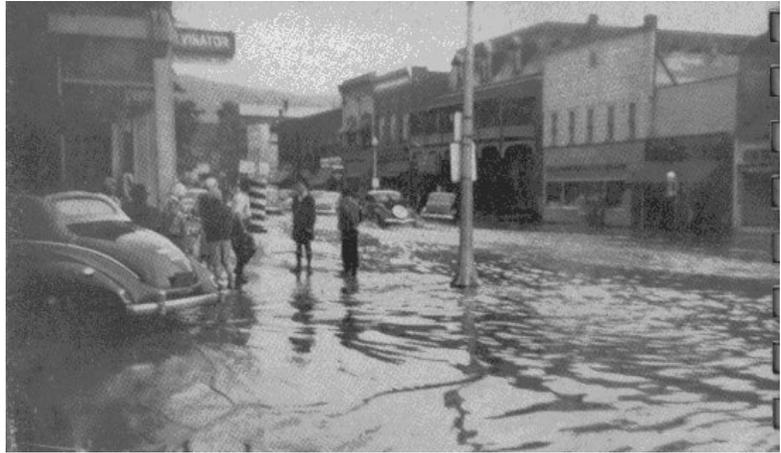
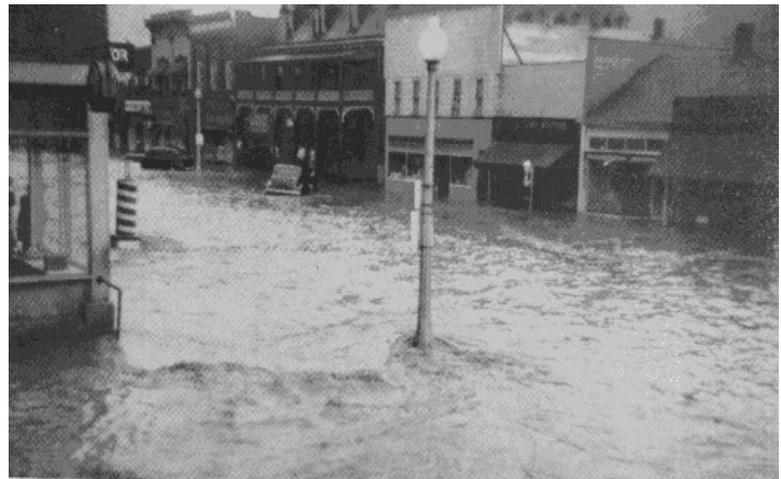
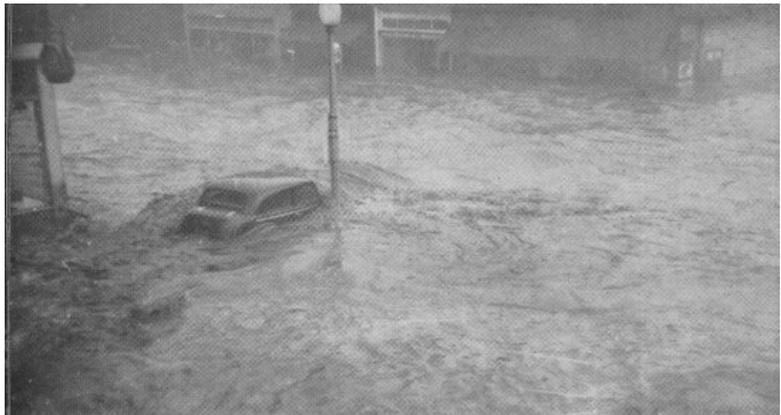
Figure 8: Flooding stages at half-hour increments in Emporium, PA July 1942 (Source: Ginny's Genealogy Page)

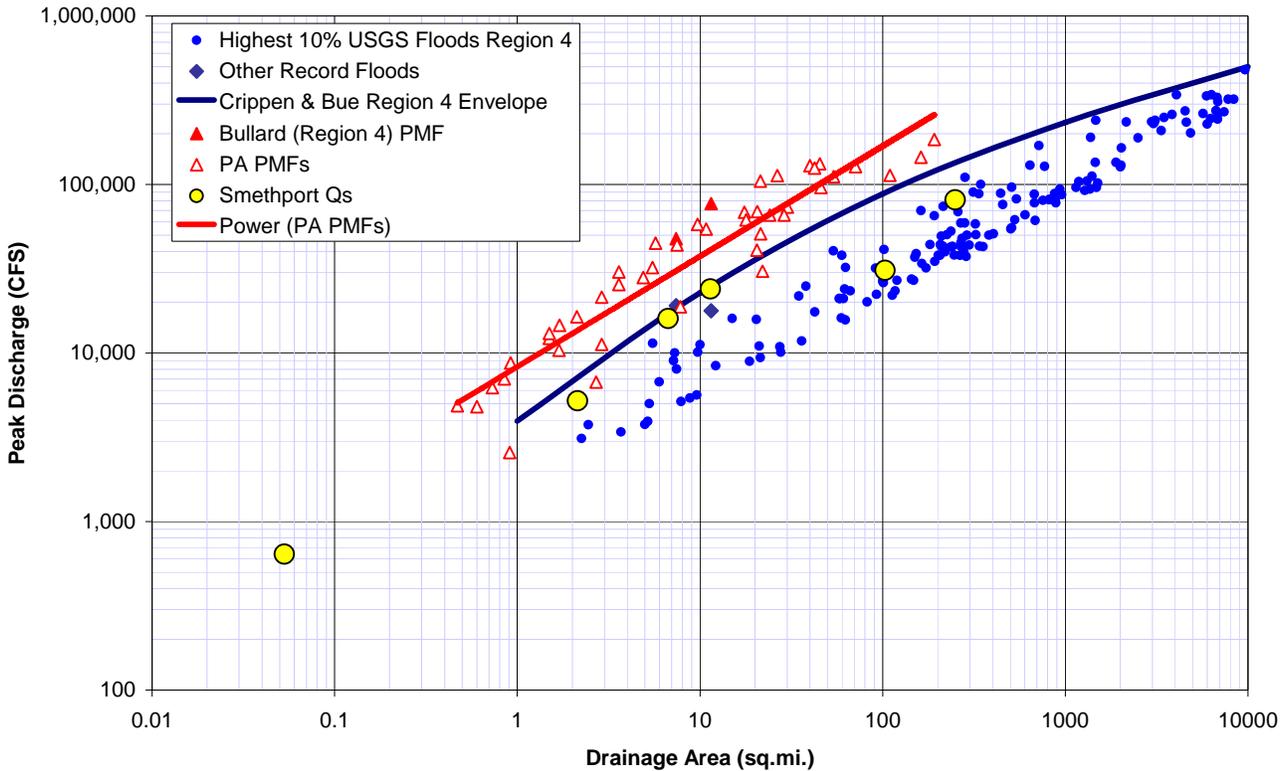
Figure 9 shows a comparison of some of the estimated flood discharges during the 1942 storm, compared with other historical observed floods in the region and PMFs for Pennsylvania.

Figure 9: Comparison of Peak Discharges Smethport, PA (July 1942) Storm with Other Observed Flows and Computed PMFs Northern Appalachian (Crippen & Bue Region 4)

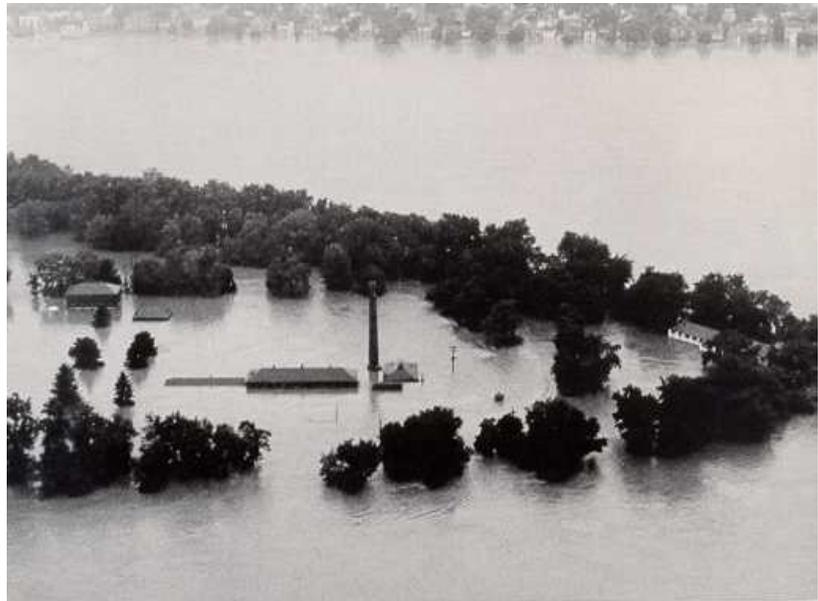
Figure 10: Susquehanna River at Harrisburg during Hurricane Agnes, June 1972 (Source USGS PP 924)

Rainfall was 84% of the PMP for a 50,000 square mile area centered near Zerbe, PA. Accordingly, the greatest flooding was on relatively large drainage basins. Figure 11 shows the peak flows at various locations throughout the Mid Atlantic region. Some of the damage at the largest drainage areas can be seen in Figure 10, Susquehanna River at Harrisburg, where the drainage area is approximately 24,000 square miles.

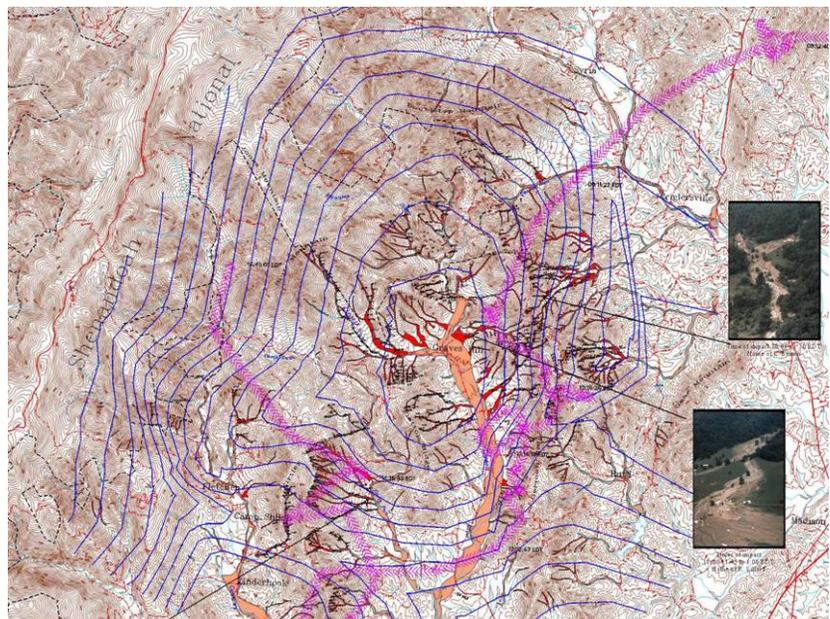
Figure 13: Map showing isohyets, storm track (purple), and debris flows (red) in Madison County, VA during June 1995 flooding. Source: USGS OFR 96-13

In late June 1995, intense rainfall and flooding struck portions of western Virginia along the eastern slope of the Blue Ridge. The flooding resulted in three fatalities and millions of dollars in damage. Although many convective storms occurred over this region during this three day period, one particular convective system that occurred on 27 June developed over Madison County, Virginia (eastern slopes of the Blue Ridge Mountains), and remained relatively stationary, producing up to 24 inches of rain in only 6 hours (see Figure 1). The flooding caused numerous debris flows along the Blue Ridge, as shown in Figure 13. One debris flow

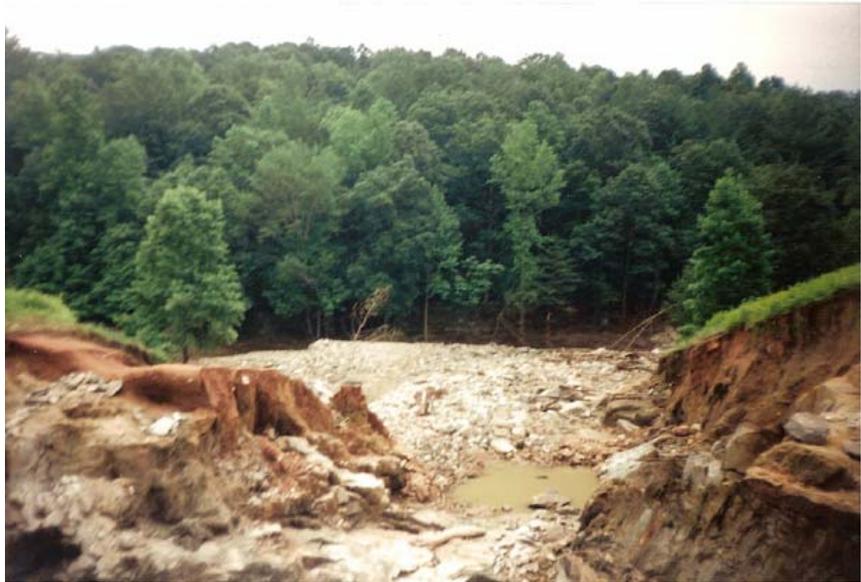
destroyed a house in its path and killed the resident. The stream gage at the Rapidan River at Ruckersville was destroyed, but not before recording a record stage of 31.3 feet, or approximately 106,000 cfs, which is about 350% of the next highest peak over a 64-year record period. Figure 14 shows White Oak Dam after the flood. Its earthen emergency spillway was severely eroded, but did not breach due to the control section which was excavated through a narrow rock ridge.

Figure 14: Damage to White Oak Dam emergency spillway, June 1995 (Photo courtesy of Rapidan Service Authority).
