IX. Environmental Effects

This section examines the environmental impacts associated with the breach of the Silver Lake fuse plug. Silver Lake is a storage reservoir and one component of the Dead River Project (FERC No. 10855) operated by Upper Peninsula Power Company (UPPCO), a subsidiary of Wisconsin Public Service Corporation. Downstream from the Dead River Project is the Marquette Project (FERC No. 2589) operated by Marquette Board of Light and Power (MBLP). Both projects are located on the Dead River in Marquette County, Michigan.

A. General Description of the Dead River Basin and Project Area¹

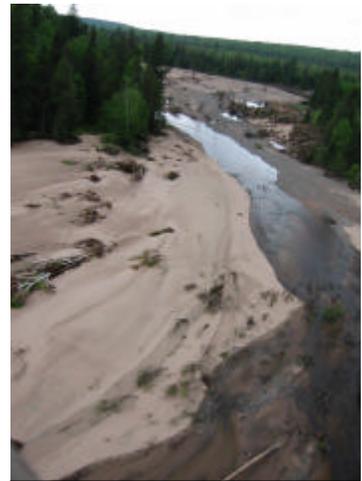
Photo 11. Sediment below Silver Lake. Source MDNR 6/9/03

occurred. It is estimated that approximately 800,000 to one million cubic yards of sediment was transported downstream from Silver Lake as a result of the breach. (Photo 1) Independently, the Michigan Department of Natural Resources estimated the total sediment released at one million cubic yards (Personal communication with J. Mistak, MDNR).

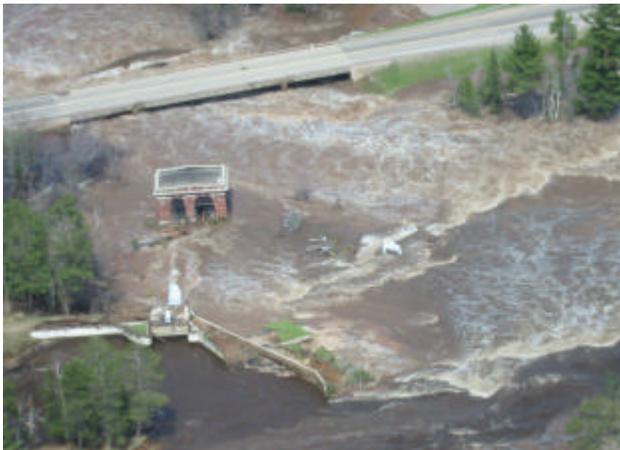
Photo 13. Tourist Park dam breach. Source MDNR 5/15/03

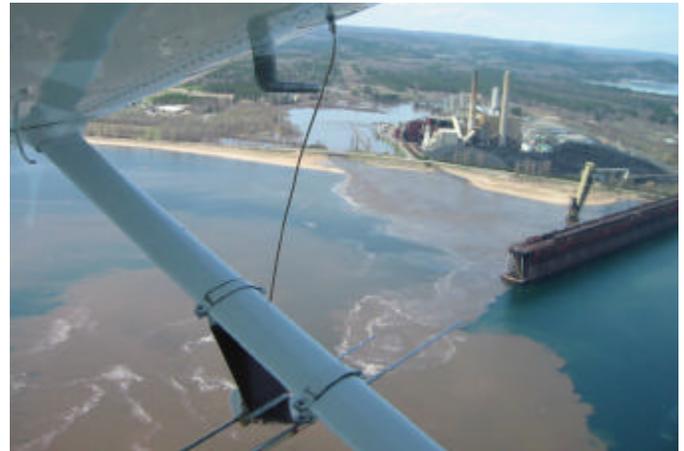
Photo 12. Sediment plume into L. Superior. Presque Isle Power Plant in background. Source MDNR 5/15/03

Further erosion occurred below each of the downstream dams as the river channel exceeded flood stage. Below Hoist, McClure and Forestville, the channel is more deeply incised than the river below Silver Lake. Continuing downstream, the breaching of the Tourist Park dam (Photo 2) resulted in substantial erosion and the release of accumulated sediment from behind the dam. Much of this sediment was deposited in Lake Superior. (Photo 3)

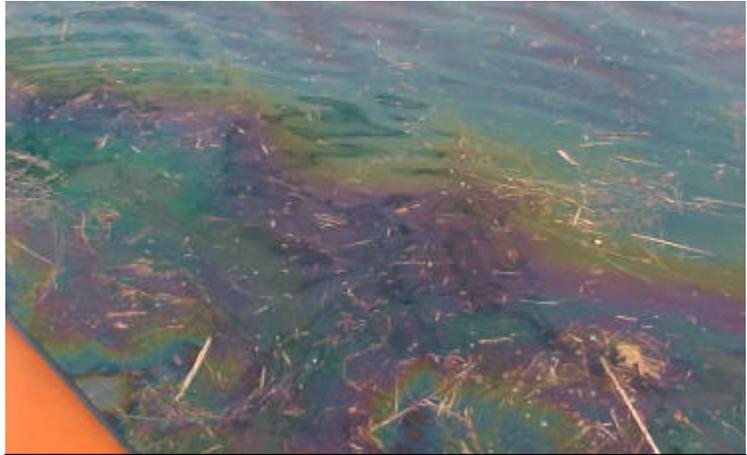
Photo 15. Oily sheen and debris in L. Superior. Source MDNR 5/15/03

Reports of the event (Environmental News Network web page, May 16, 2003) also state that when the Tourist Park dam failed, the flood waters swept through the Presque Isle Power Plant grounds washing coal piles out into Lake Superior. Aerial photographs of the mouth of the Dead River and Lake Superior, taken the day after the breach, show an oily sheen over the surface of the water. (Photo 5)

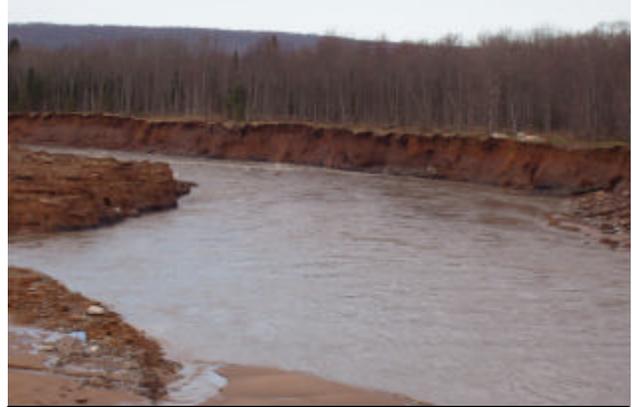
Photo 6. Erosion below Silver Lake. Source UPPCO 5/15/03

turbidity is an increase in downstream drift. Aquatic insects will dislodge from the substrate in response to decreased light. Prolonged levels of turbidity will result in the depletion of benthic macroinvertebrates and severe damage can result from heavy sediment deposits. (Photo 6).

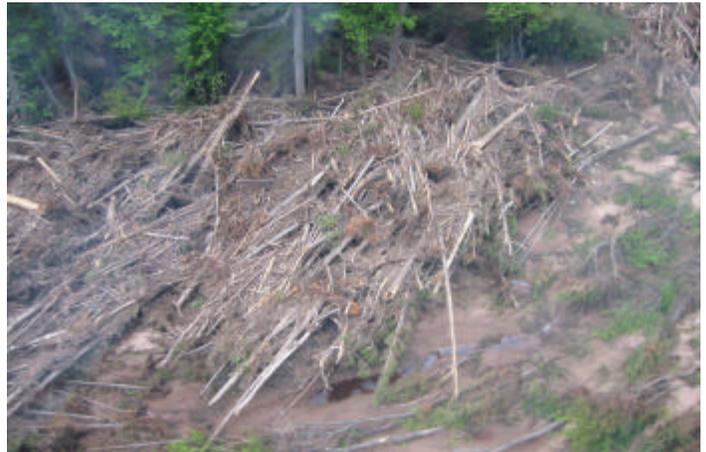
Photo 7. **Downed** trees and debris below Silver Lake.
Source MDNR 6/9/03

Below Silver Lake reservoir and each of the subsequent reservoirs downstream, hundreds of mature trees and shrubs were uprooted or knocked down as a result of the torrent flows (Photo 7). Others, along the stream banks below Silver Lake have sediment several feet thick piled over the roots that will prevent moisture from reaching the roots system and slowly cause the trees to die.

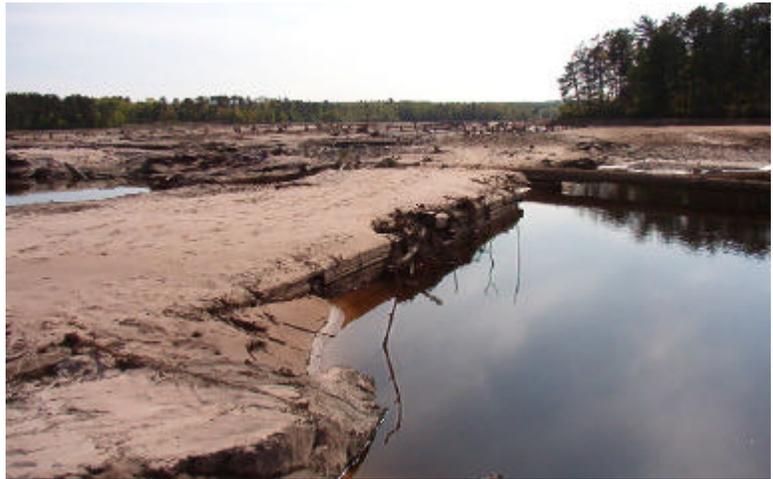
Photo 8. Timber dam near old gun powder factory (not shown) in Tourist Park reservoir. Source FERC 6/03/03

The EA states that there are no archaeological sites or historic resources in the areas of potential effect for the Dead River or Marquette Projects. However, an old gun powder factory site, from the late 1800's to early 1900's, was discovered in the Tourist Park reservoir. The site consists of bricks and mortar at the ground level. Nearby are the remains of timber dam (Photo 8). The flooding event did not impact the site other than to

expose an area that was previously submerged. The State Historic Preservation Office will need to be consulted regarding future activities that may affect the site.

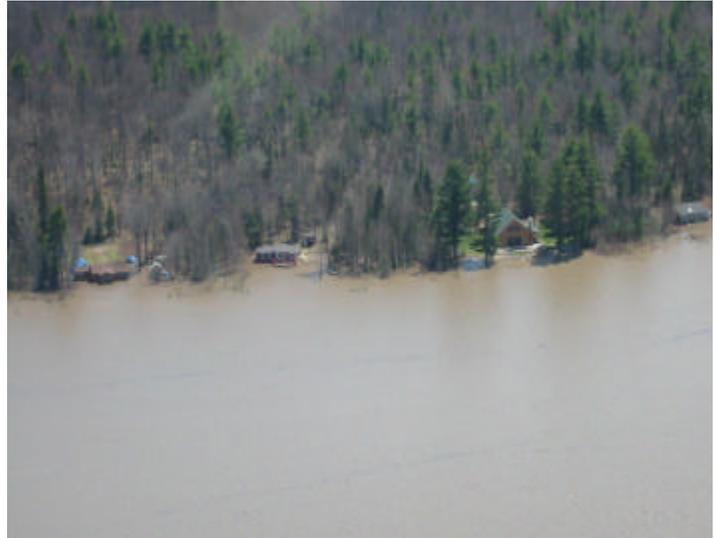
Photo 9. Homes flooded and turbid water in the Dead River Storage Basin. Source MDNR 5/15/03

The Milwaukee Journal Sentinel (May 15, 2003) reported that following the breach of the Silver Lake dike, authorities ordered the evacuation of a 485 acre area in the northern half of Marquette. The report stated that more than 1,800 people were evacuated from their homes on Thursday, May 15, 2003. Marquette County reported that residents were allowed to return to their homes on Friday afternoon. There were no injuries reported and no missing persons associated with the flood. The report also stated that 20 vacation and permanent homes were damaged along with three businesses sustaining structural damage (Photo 9).

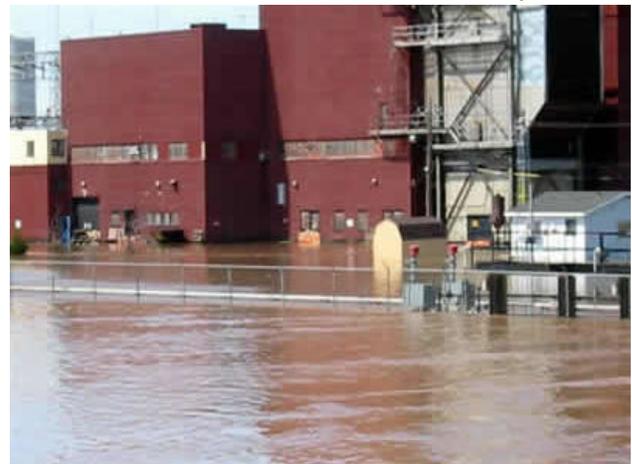
Photo 16. Flooded Presque Isle Power Plant 5/15/03. Source: Marquette County

The largest economic impact of the flooding event was the shutdown of the Presque Isle Power Plant located at the mouth of Dead River (and immediately below the Tourist Park development). The Marquette Mining Journal (May 29, 2003) reported that the combined waters from Silver Lake and Tourist Park reservoir inundated the plant damaging motors, gearboxes, switching equipment and transformers. The coal-fired plant has nine generating units that produce approximately 635 megawatts of power. Three hundred megawatts of the plants capacity is used to run the Marquette Iron Range mines that employ about 1,500 people. The Marquette Mining Journal (May 30, 2003) reported that shutdown of the power plant and subsequent shutdown of the mines resulted in approximately 1,100 miners being

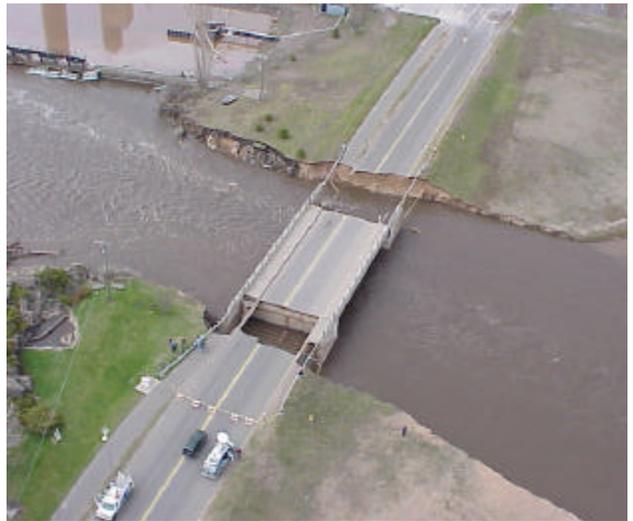
Photo 17. Damaged Lakeshore Blvd. bridge, 5/15/03.
Source: Marquette County

At the end of May 2003, the Marquette County web page, reported that in the City of Marquette, part of Granite Street, Tourist Park, bridges over County Road 550, and the bridge over the Dead River at Lakeshore are closed due to damage. (Photo 11) Further, County Roads AAO and AAT remain close as does Lakeshore Boulevard north of Hawley Street. Marquette County estimated that the cost of repairs to roads and bridges destroyed or damaged at \$3 million. Sections of railroad tracts were also damaged causing a disruption in service and operation of the LS&I Railroad.
