# REPORT

## FORENSIC INVESTIGATION AND ROOT CAUSE ANALYSIS DECEMBER 14, 2005 INCIDENT UPPER RESERVOIR DIKE TAUM SAUK PLANT FERC PROJECT NO. 2277

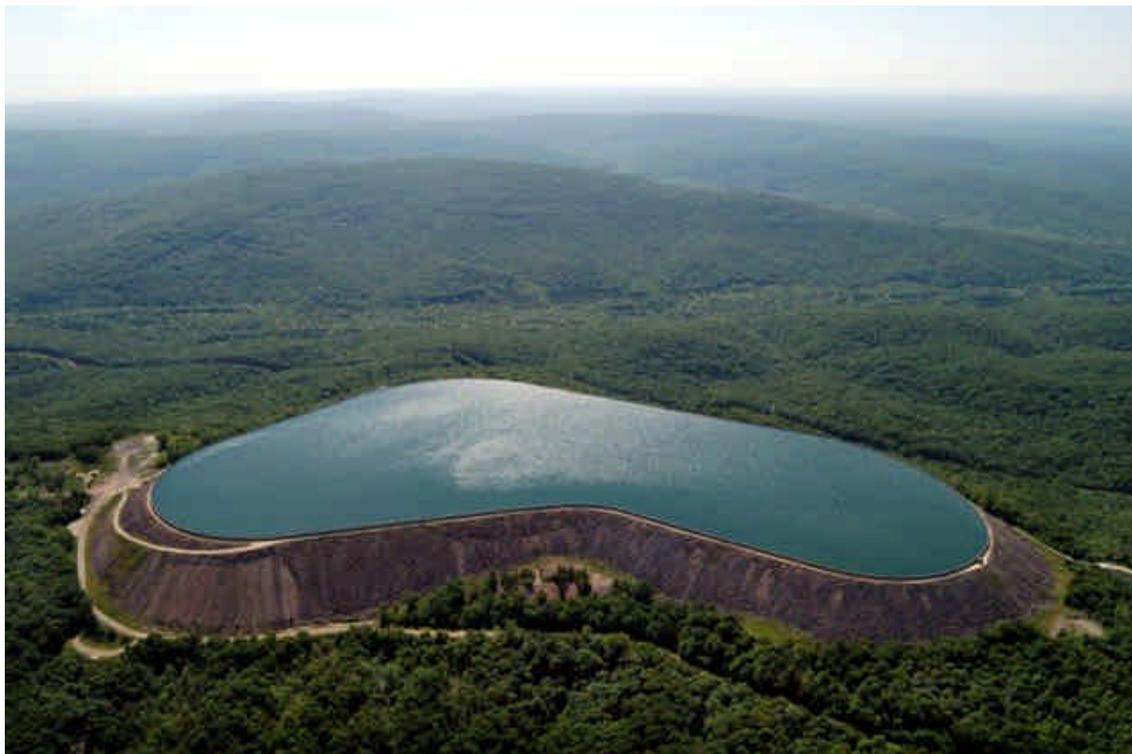
**FIGURE 2-2**

The Upper Reservoir Dike is 6,562-feet long and forms a kidney-shaped reservoir as illustrated on **Figure 2-2**. The Dike is a concrete-faced dumped rockfill dam (CFRD) with a maximum height in the range of 84 feet above the reservoir floor. The floor is generally at El. 1505 and the 12-foot wide crest of the Dike is at El. 1589. A 10-foot-high, 1-foot-thick reinforced concrete Parapet Wall on the crest of the Dike fill extends the maximum pool level to El. 1599. However, as the Dike has settled over time, the true top of the Parapet Wall is as much as two feet lower than the design level at El. 1599.

**VIEW OF UPPER RESERVOIR**

The pneumatically placed upstream concrete face slab has a design thickness of 10 inches, and is reinforced with No. 7 bars at 12 inches, both ways. In actual placement, the slab thickness averaged nearly 18 inches due to the unevenness of the rockfill. There are no horizontal joints except at the junctures with the Parapet Wall and the foundation cutoff-slab. The face slab was placed in panels, 60 feet wide at their widest dimension. Expansion joints between the slabs, to accommodate movement caused by settlement of the rockfill, used asphaltic expansion joint material and U-shaped copper water stops.

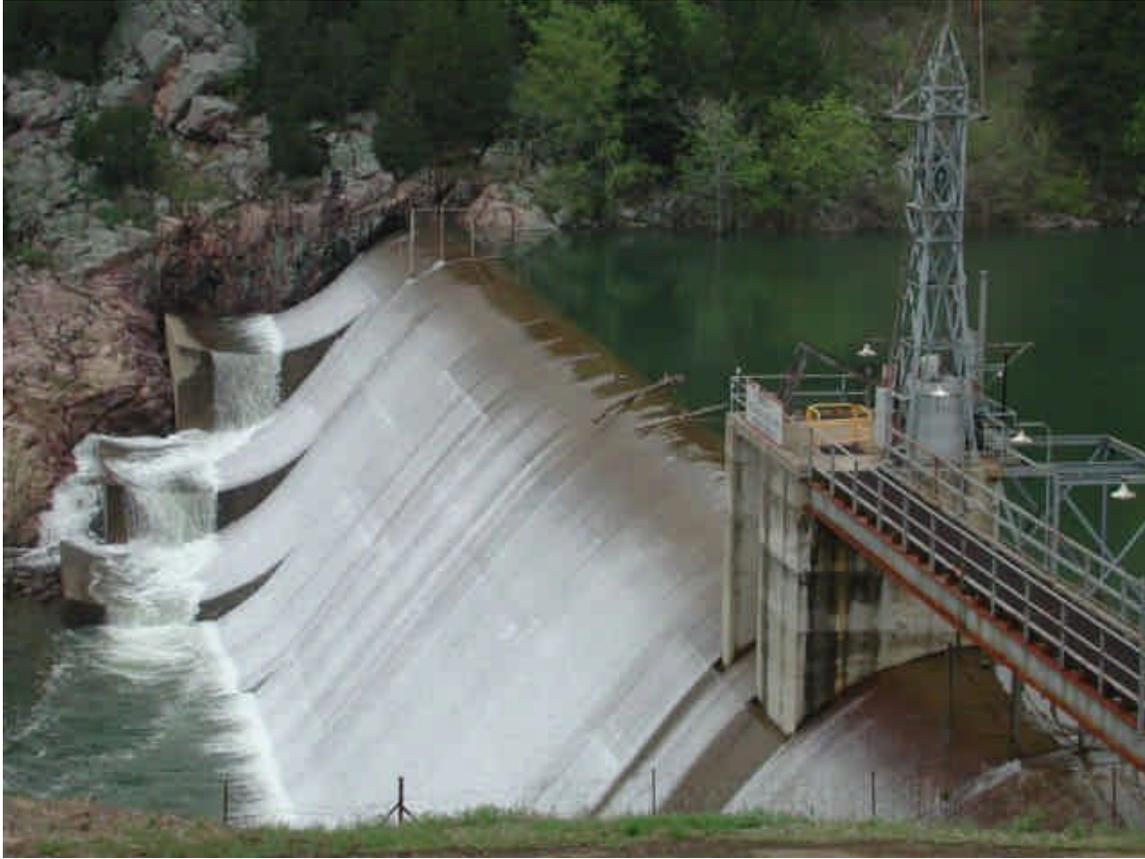
**FIGURE 2-3**

**VIEW OF LOWER RESERVOIR DAM**

The Lower Reservoir Dam is a concrete gravity dam founded on rock with a maximum height of 60 feet above bedrock. The entire 390-foot long Lower Reservoir Dam is an ungated overflow spillway except for two piers that support the operating deck. The spillway crest is at El. 750 and the operating deck is at El. 765. The Dam section has a base width at the maximum section equal to 1.25 times the height and a downstream slope equal to 0.83 Horizontal to 1 Vertical. The spillway discharges to a reinforced concrete flip bucket with a 28-foot radius. The elevations of the flip-buckets for the abutment blocks are higher than those for the center blocks as may be seen on *Figure 2-3*.

As shown on *Figure 2-3*, the Lower Reservoir Dam is located in a narrow steep-sided gorge just downstream of the junction of Taum Sauk Creek and the East Fork of the Black River. It forms the Lower Reservoir with a surface area of 395 acres and a water level at the spillway crest. The canyon at this location is in exposed hard blocky rhyolite rock of good quality. The Lower Reservoir design volume at the spillway crest is 6,350 acre-feet.

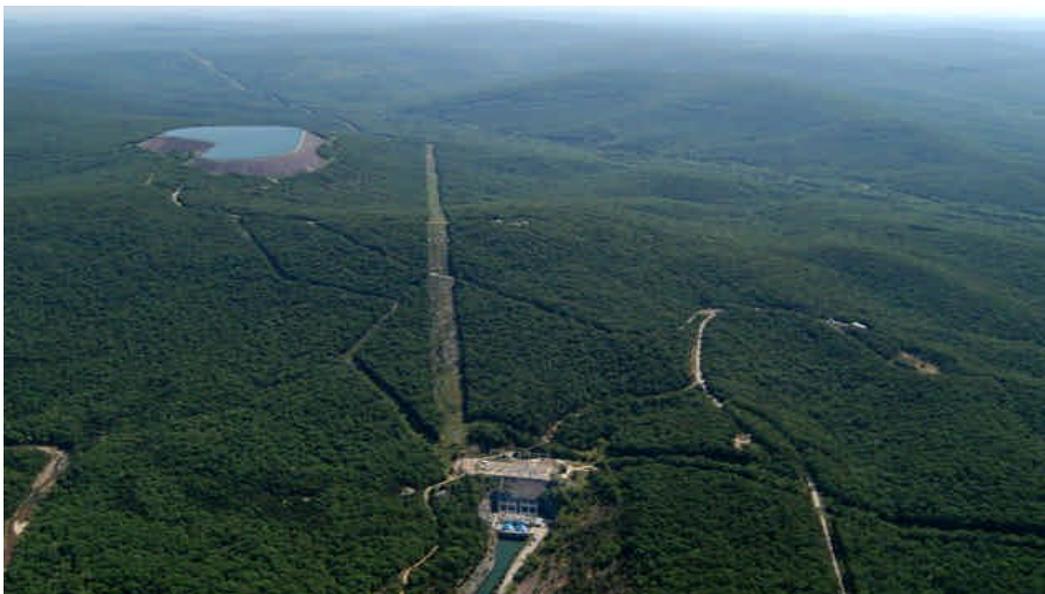
**FIGURE 2-4**

The Taum Sauk Plant Powerhouse is located at the upstream end of the Lower Reservoir about two-miles from the Upper Reservoir as illustrated on *Figure 2-4*. It is situated in a deep, narrow canyon through which a tailrace channel was excavated to connect to the East Fork of the Black River as shown on *Figure 2-5*. The Powerhouse is connected to the Upper Reservoir via a concrete and steel-lined Shaft and tunnel (not to be confused with the Access Tunnel mentioned previously). The initial reversible pump-turbine rating for each unit was 175 MW, but these have been upgraded such that the total plant capacity is now in the range of 450 MW. The tailrace that leads to the Lower Reservoir is about 65-feet wide and 2,000-feet long.

**VIEW OF POWERHOUSE IN RELATION TO UPPER RESERVOIR**

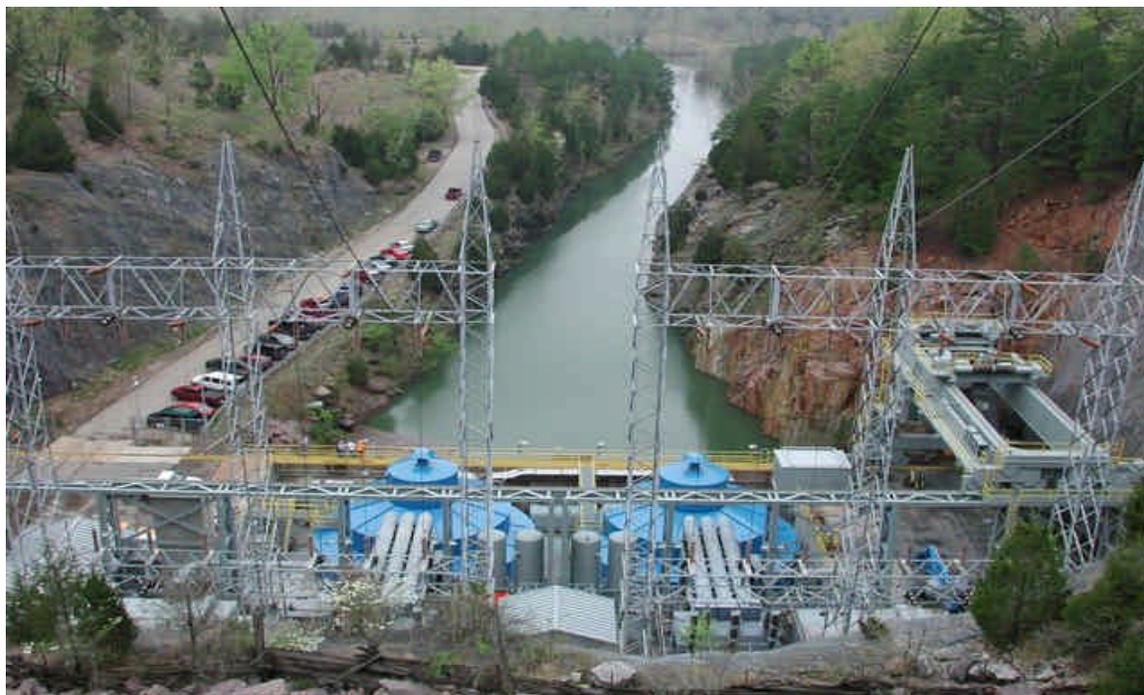
**FIGURE 2-5**

**VIEW OF POWERHOUSE**

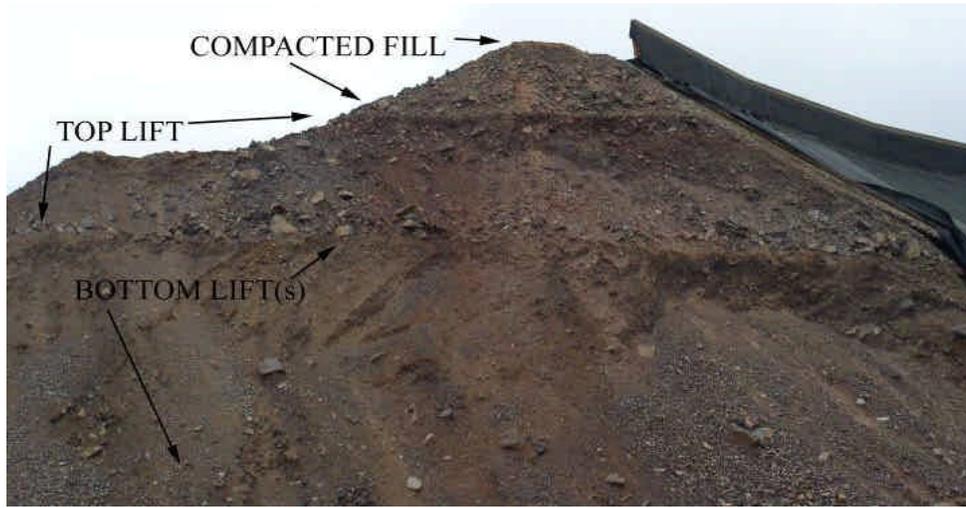
**FIGURE 2-7**

The fines content issue stands out on the slopes of the Breach Area as illustrated below on *Figure 2-7*, which is a photo of the north side of the Breach Area. This is supposed to be a rockfill, but it is apparent that fines were left in place and comprise a significant percentage of the overall embankment. We submit that this was not the original designer's intent and that the shear strength and drainage properties of this finer material acts negatively on the performance of this type of dam and dike construction.

**VIEW OF NORTH SIDE OF BREACH AREA**

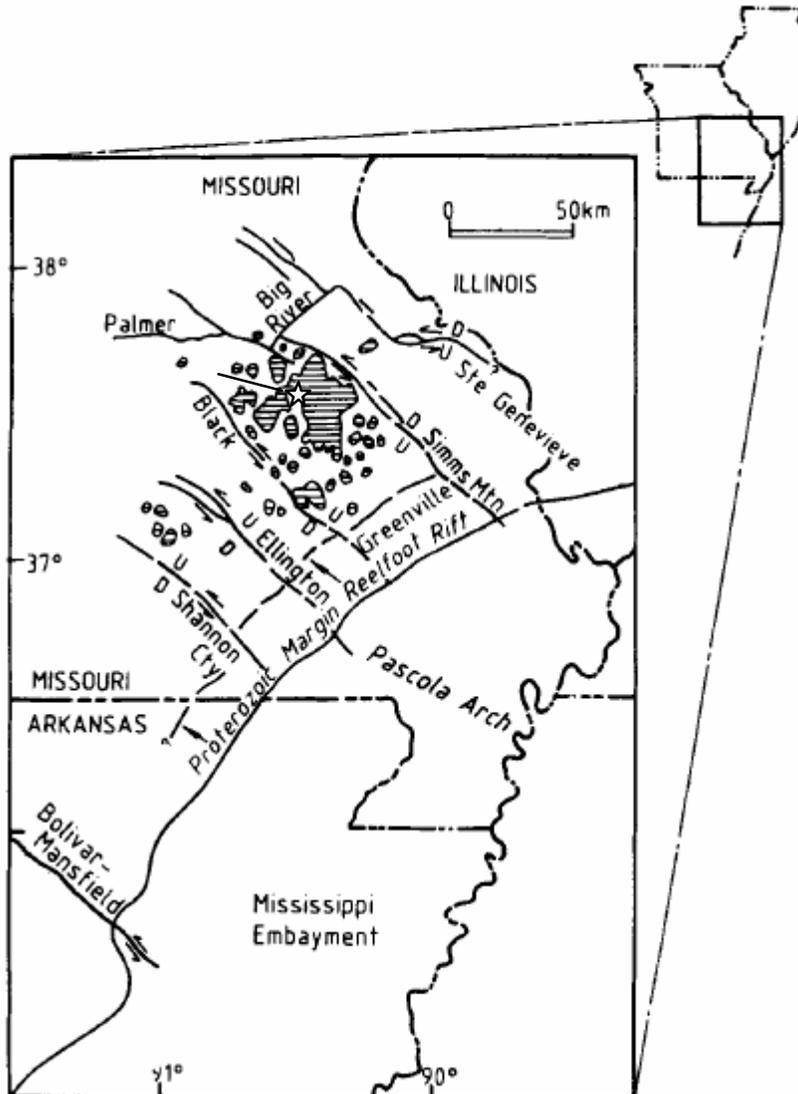
## FIGURE 3-1

As shown on *Figure 3-1* there are a number of northwest trending faults associated with the Reelfoot Rift.

(Regional map showing relations of major faults in southeast Missouri and northeast Arkansas to Proterozoic margin of Reelfoot rift, from Clendinen, et al., 1989)

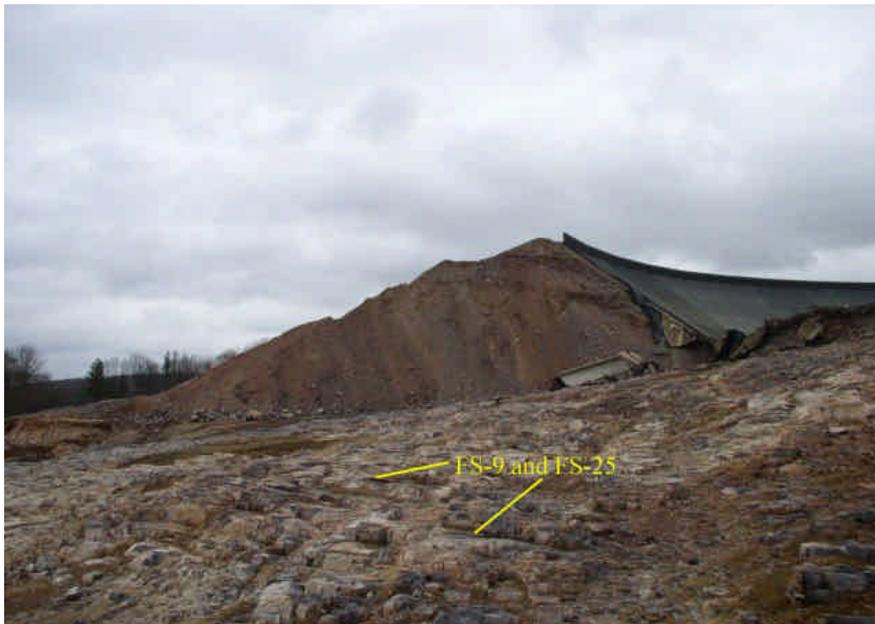
**FIGURE 3-5**  
**FRACTURE SETS FS-9 AND FS-25**

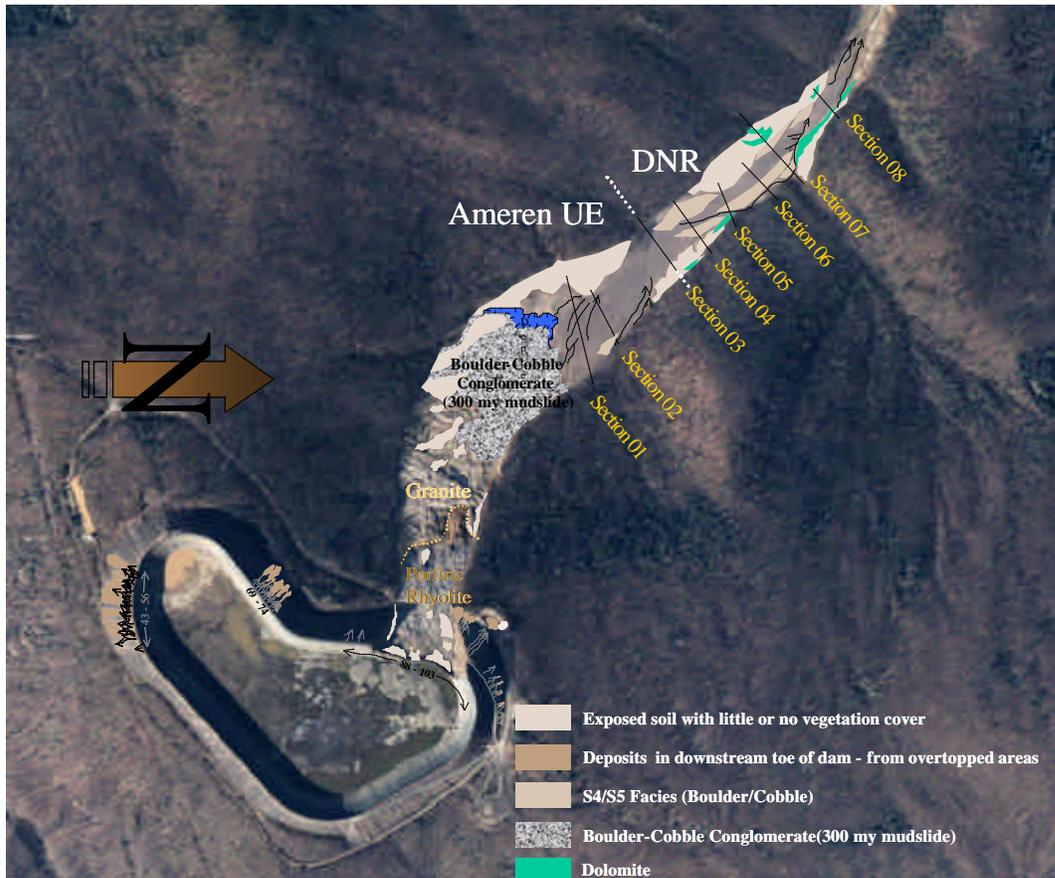
**FIGURE 3-14**

*Figure 3-14* shows the location of the sections developed as part of the overall mapping effort.

**GENERALIZED DISTRIBUTION OF DEPOSITS DERIVED FROM BREACH AREA AND SUBSEQUENT DEBRIS TORRENT**

Referring back to *Figure 3-14*, the deposits shown in Breach Area are those distinctive facies S4/S5, with larger particle sizes as shown on *Figure 3-18*. The facies at the other sections indicated on *Figure 3-14* are shown on *Figures 3-18 and 3-19*.

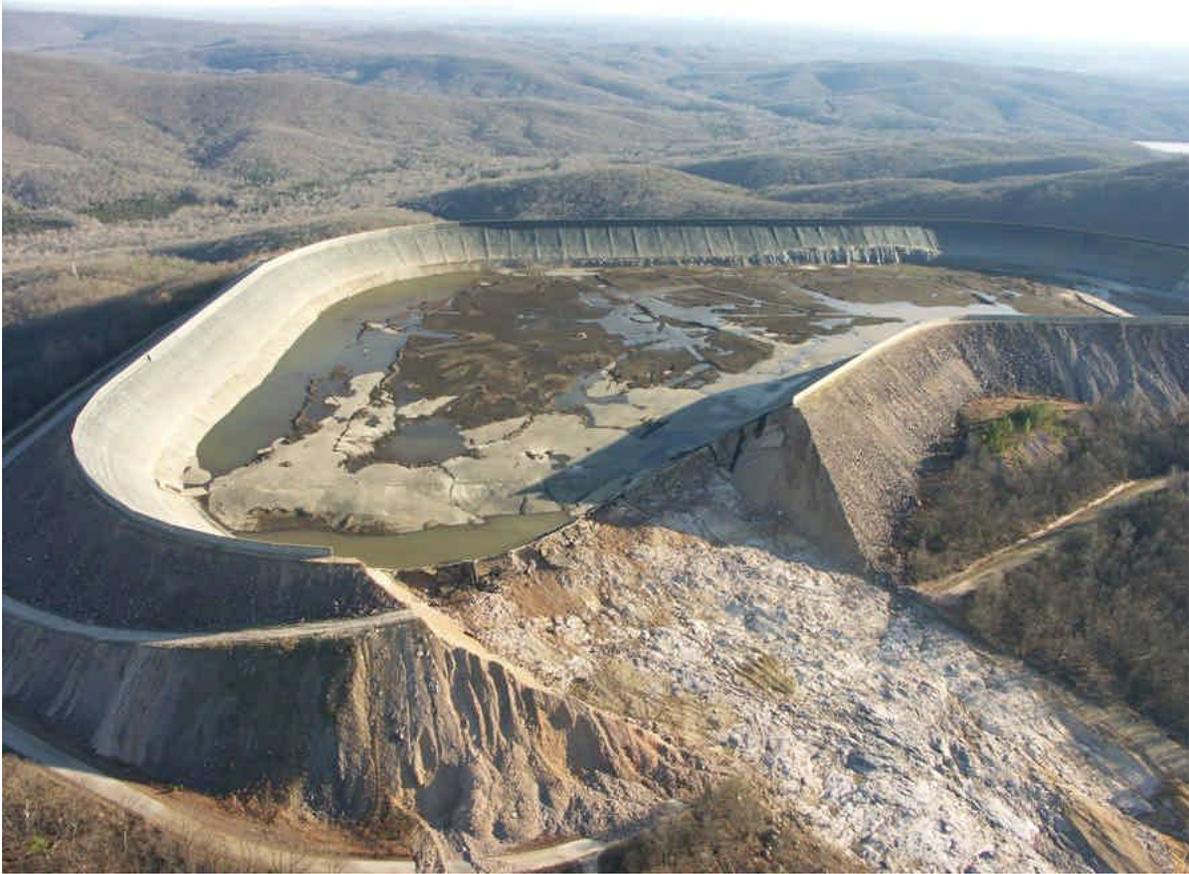
**FIGURE 4-1**

During the early morning hours, around 5:00 AM, the northwest corner of the Dike around the Upper Reservoir breached over a width of about 700 feet, causing an uncontrolled, rapid release of water down the west slope of Profitt Mountain and into the East Fork of the Black River. An overall aerial view of the flow path is shown on *Figure 2-1*. The following series Figures (*Figures 4-1 to 4-6*) provide a photographic description of the incident.

**OVERALL VIEW OF THE BREACHED DIKE**

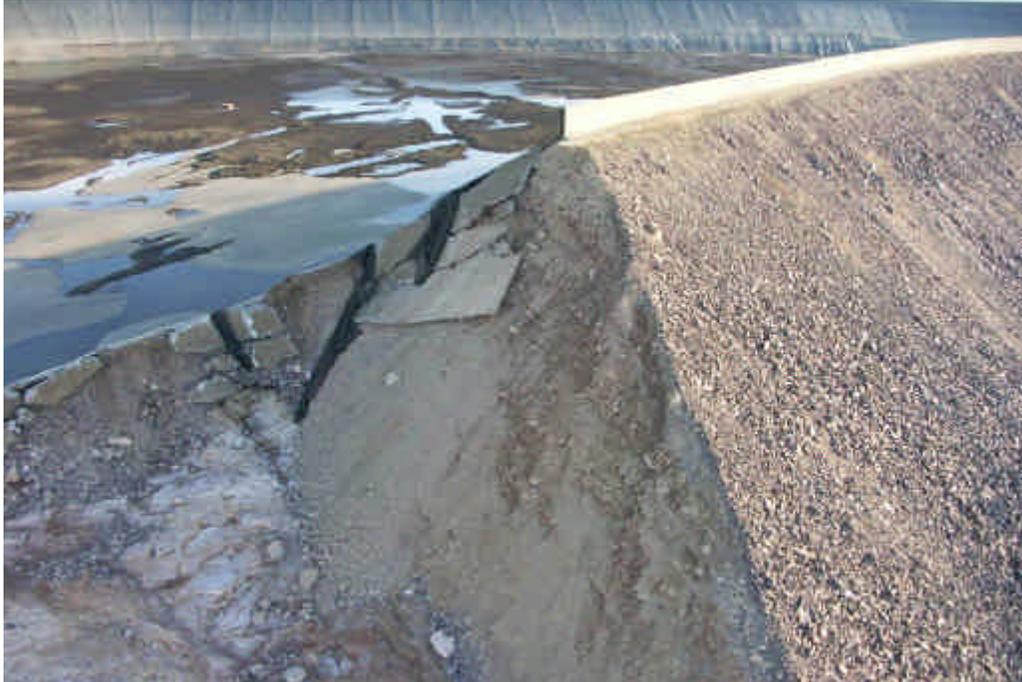
**FIGURE 4-2**  
**CLOSE UP VIEW OF WEST SIDE OF BREACH AREA**

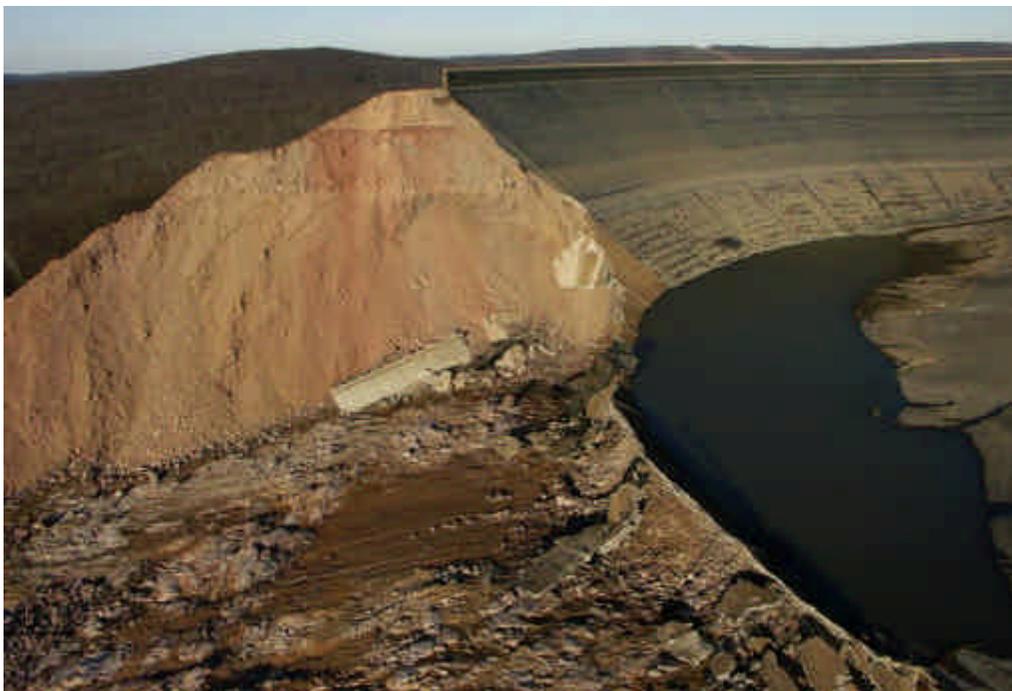
**FIGURE 4-3**  
**CLOSE UP VIEW OF EAST SIDE OF BREACH AREA**

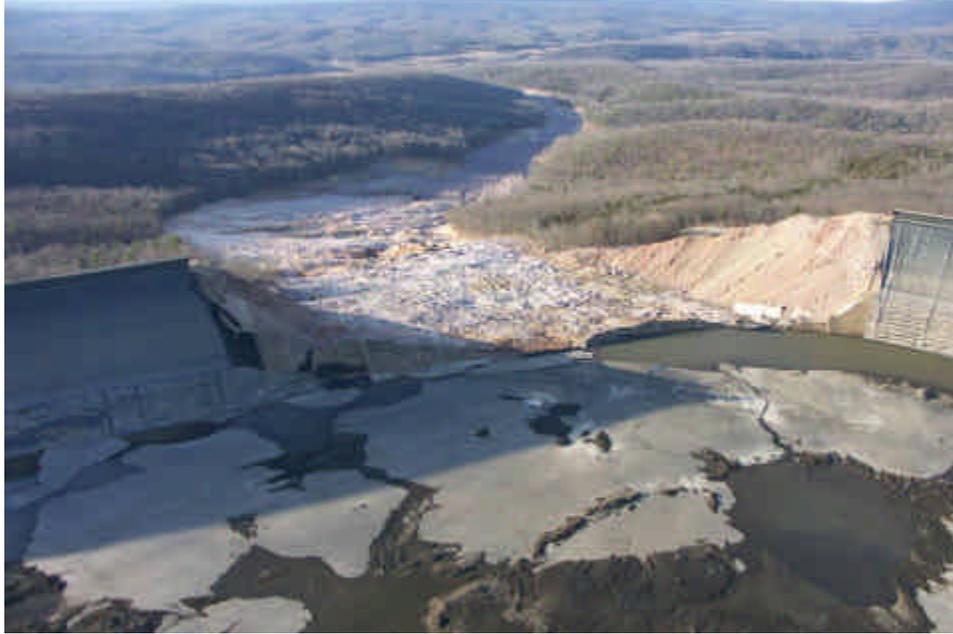
**FIGURE 4-4**

**VIEW FROM INSIDE UPPER RESERVOIR TOWARDS FLOW CHANNEL**

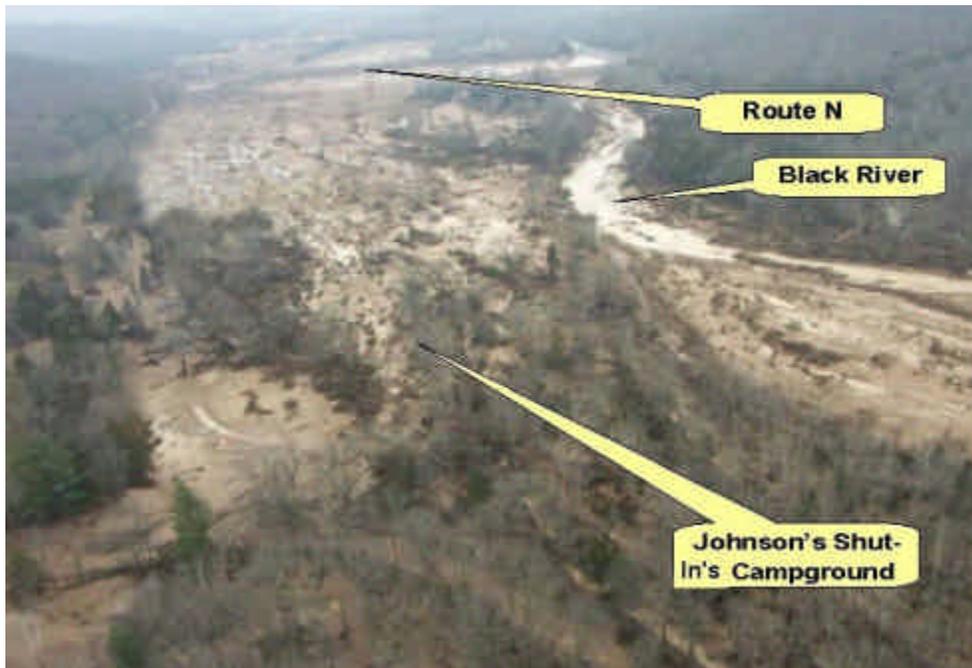
**FIGURE 4-5**

**VIEW LOOKING NORTH AT FLOW CHANNEL**

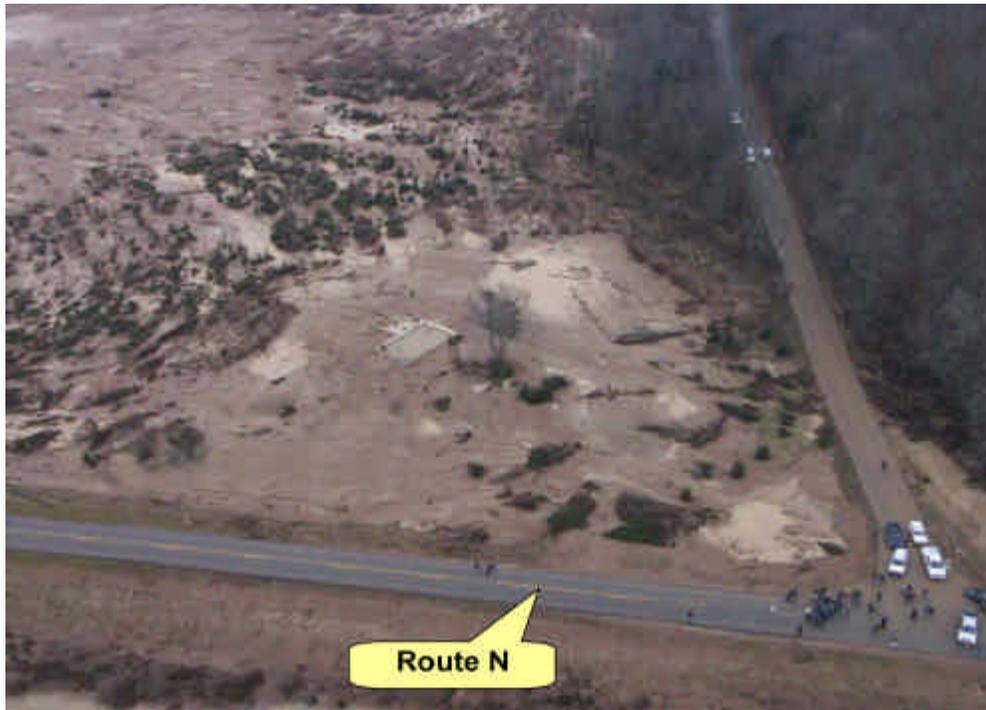
**FIGURE 4-6**

**VIEW OF FLOW CHANNEL AND ROUTE N**

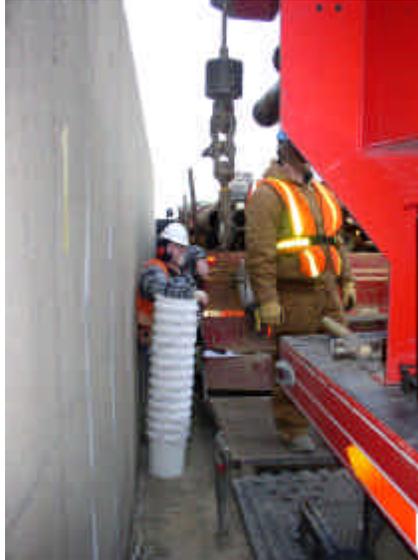
**FIGURE 7-1**

Because of space limitation on the crest of the Dike as shown on *Figure 7-1*, the material was placed directly into buckets. *Figures 7-2 and 7-3* show the sample collection procedures utilized in the field. These samples were shipped to Geotechnics Laboratory in East Pittsburgh, PA for classification and additional testing as addressed below in *Section 7.1.6*

**SPACE LIMITATION ON THE CREST OF ROCK FILL DIKE**

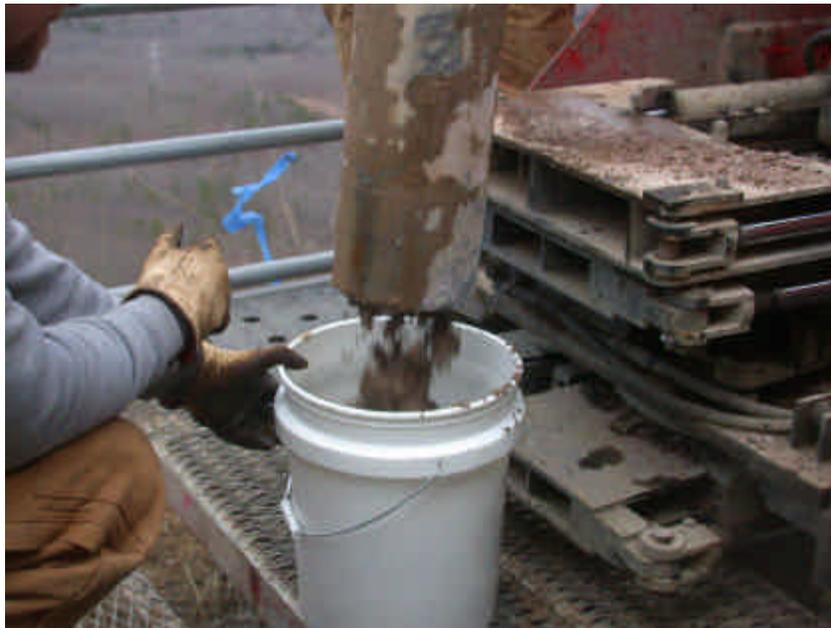
**FIGURE 7- 2**

**SAMPLING ROCKFILL**

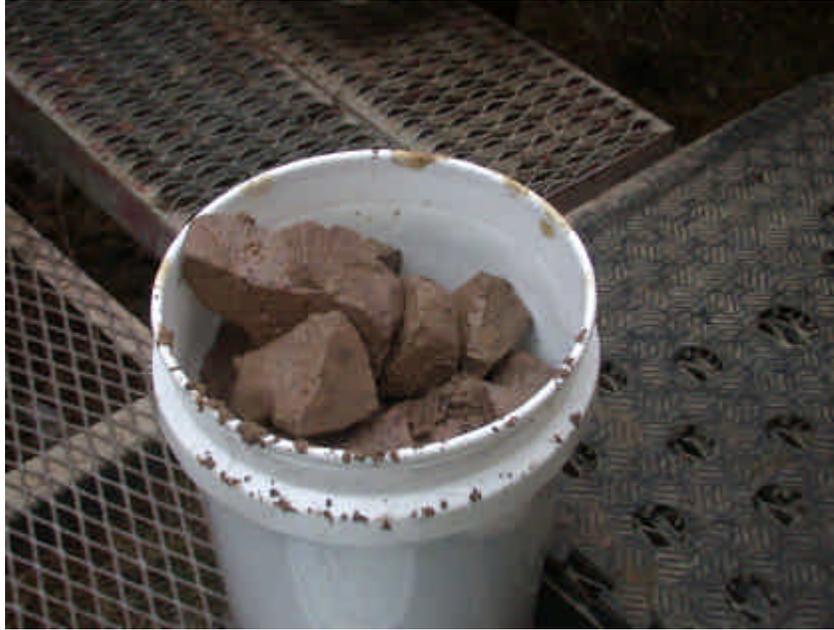
**FIGURE 7-3**

**TYPICAL ROCKFILL SAMPLE**

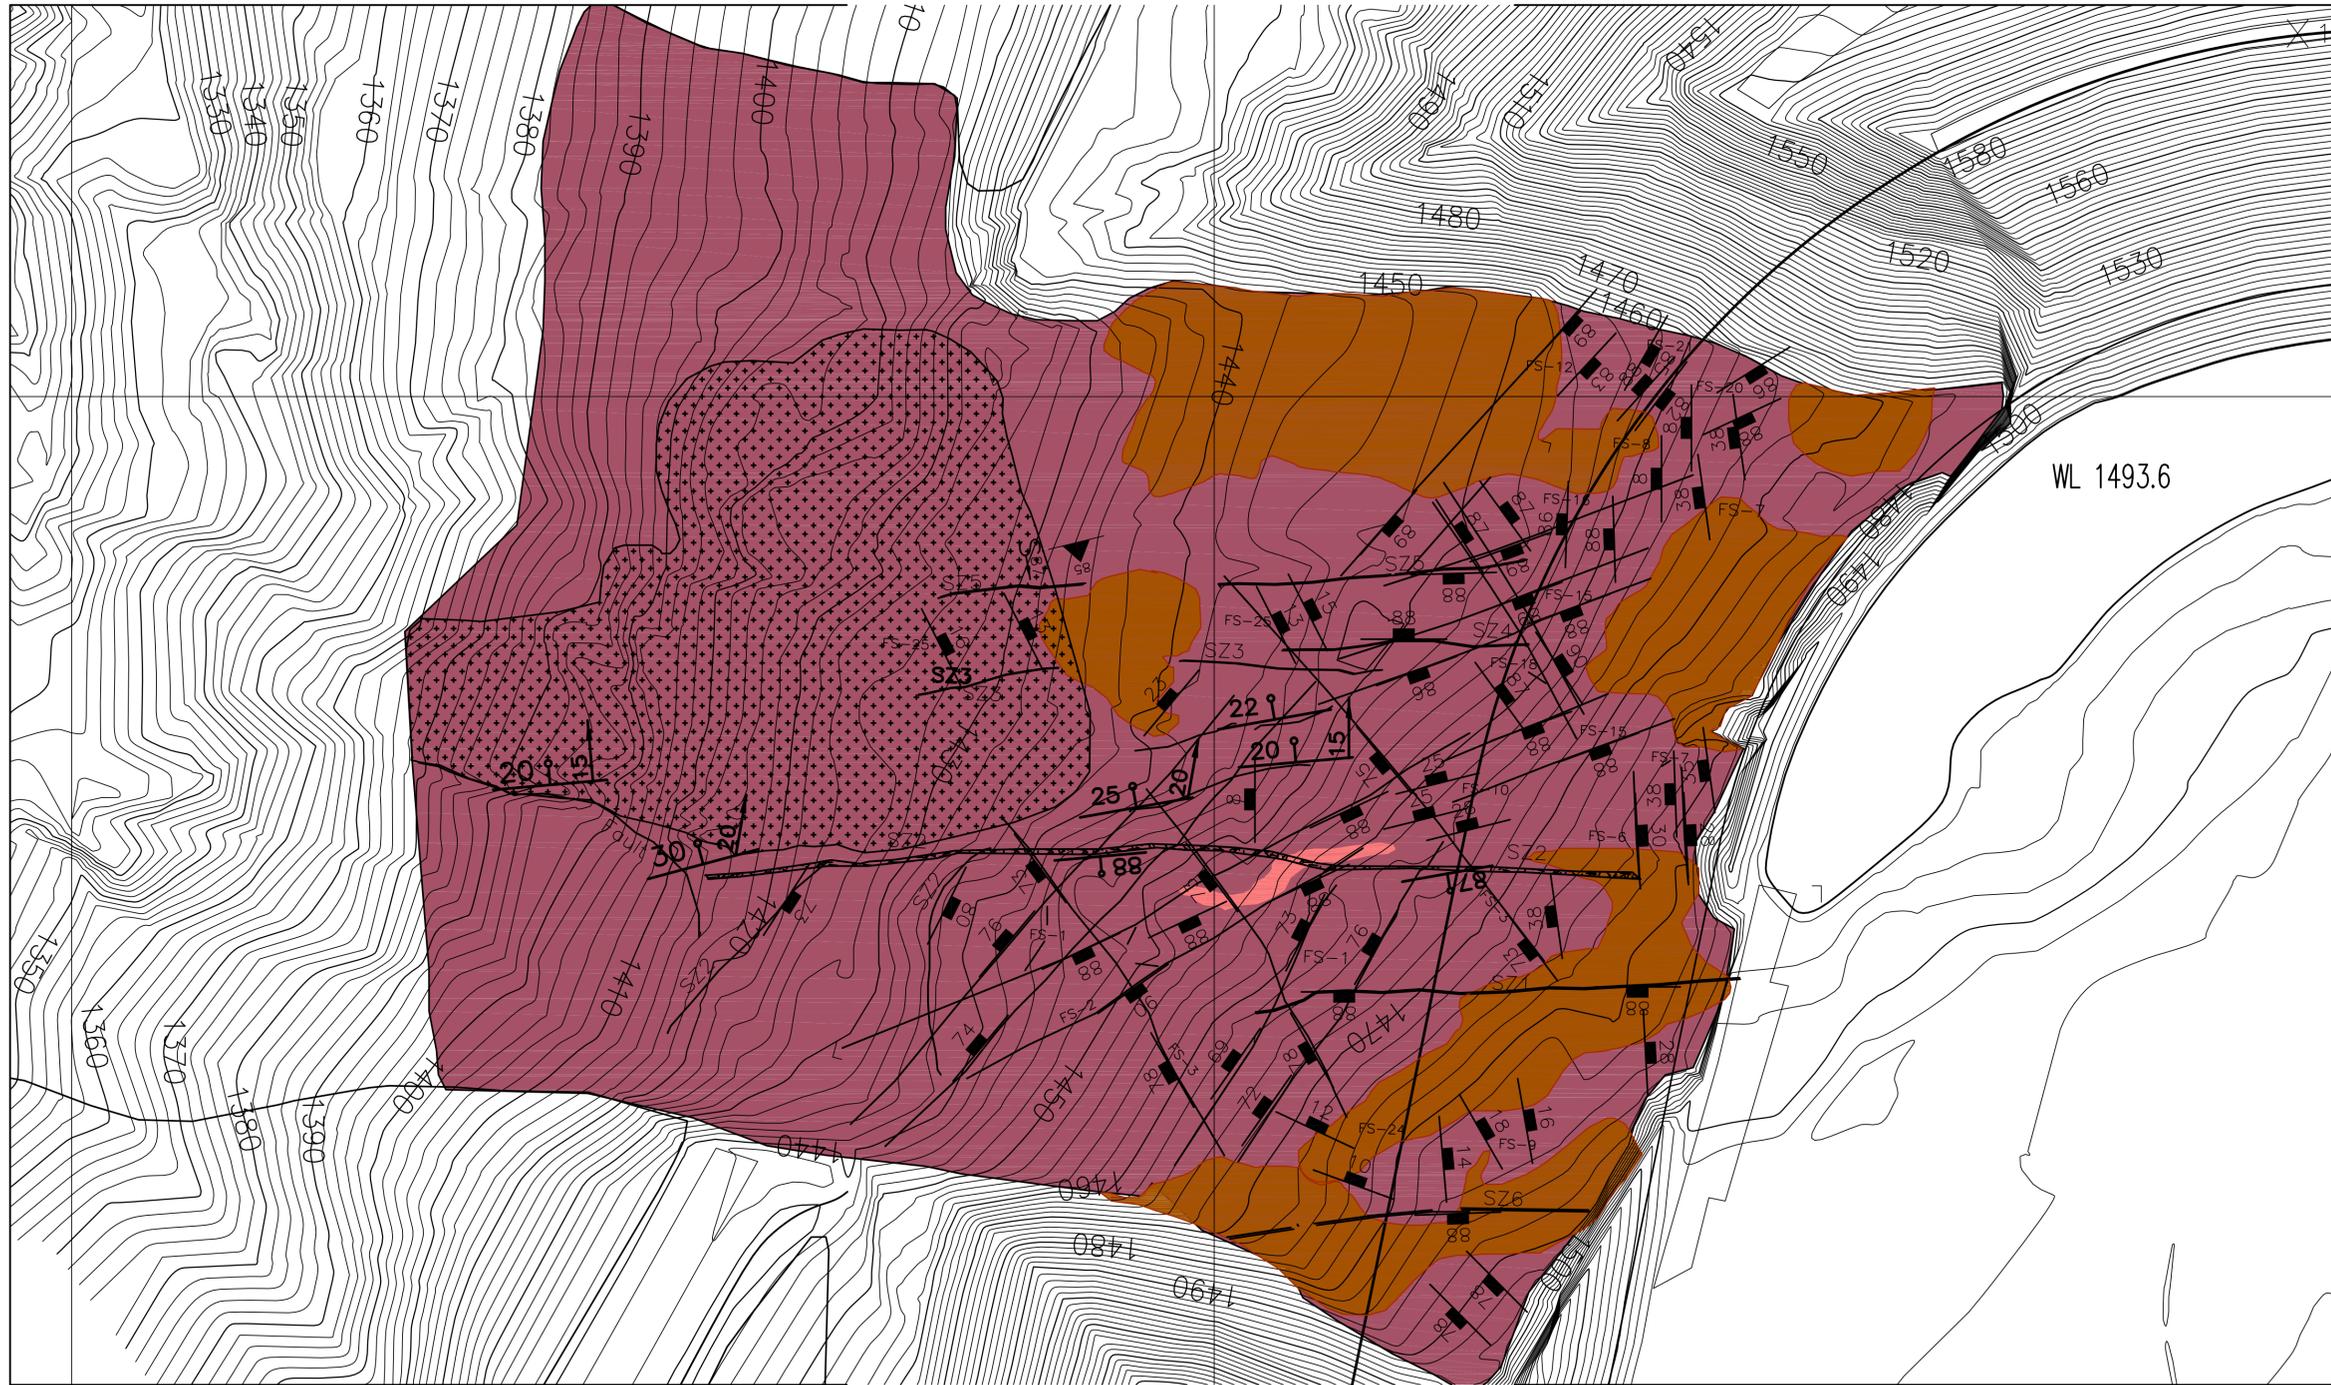
**PLATE 3.1**  
**BREACH AREA FOUNDATION**  
**GEOLOGIC MAP**  
 TAUM SAUK PLANT  
 UPPER RESERVOIR DIKE  
 PREPARED FOR  
**FOLEY & LARDNER LLP**  
 MILWAUKEE, WISCONSIN

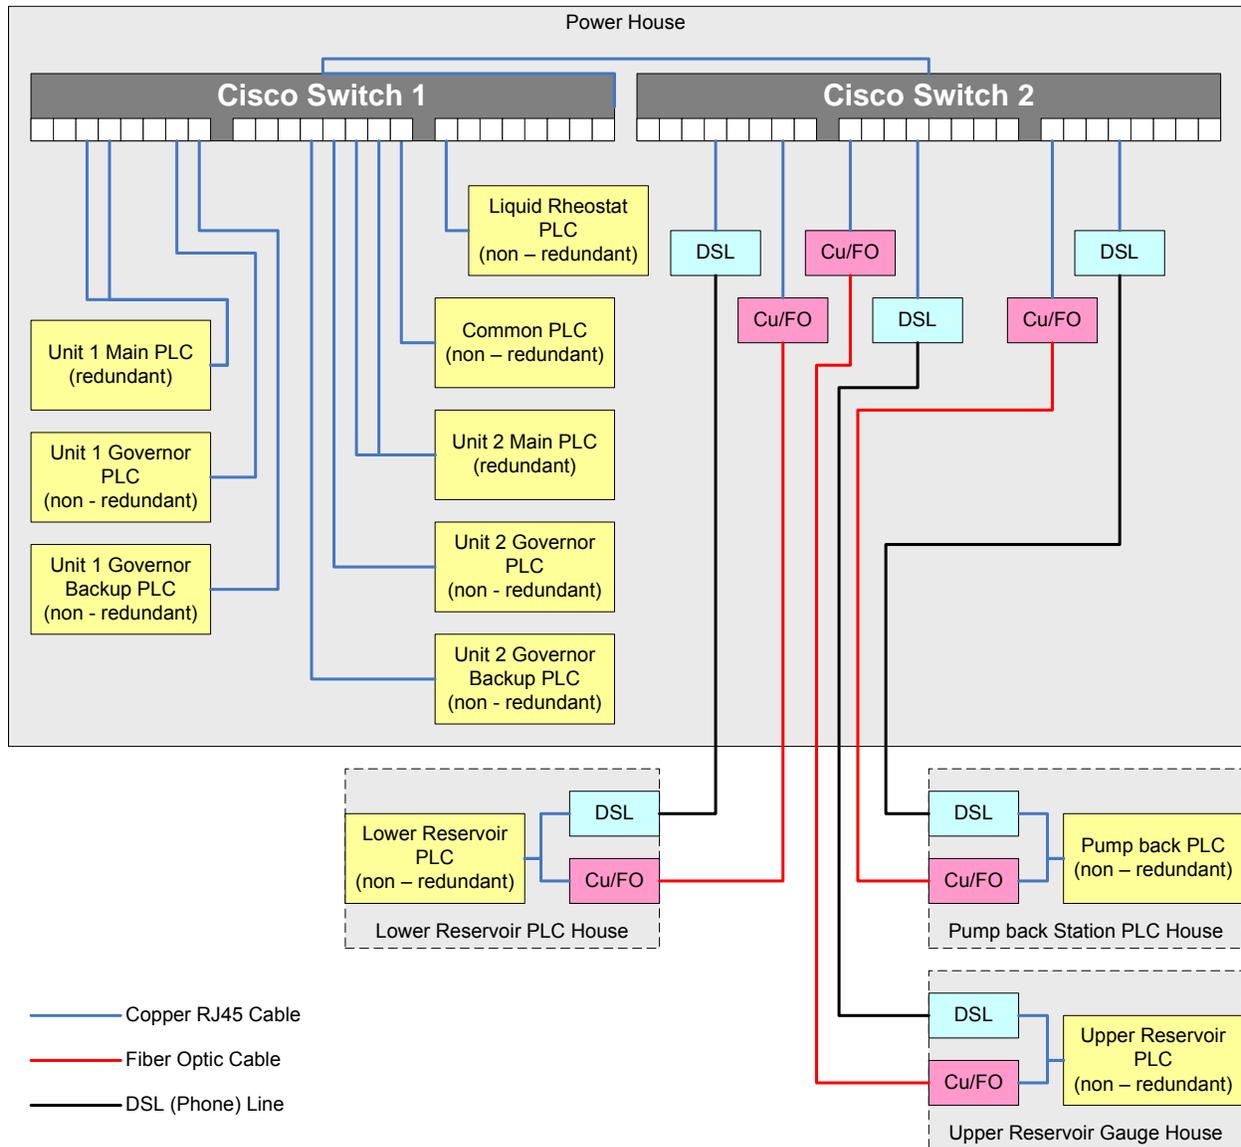
Figure 5: Taum Sauk LAN Overview

The following sketch provides an overview of the local area network installed at the Taum Sauk plant based on sketches provided by Ameren engineers. The remote upper reservoir gauge house and the lower reservoir were connected through a Fiber Optic link and a DSL backup line. The Cisco switch 2 did automatically transfer to the DSL line if the fiber optic connection failed. The historical process data submitted to Siemens indicated that the communication between the PLCs was operational during the incident.

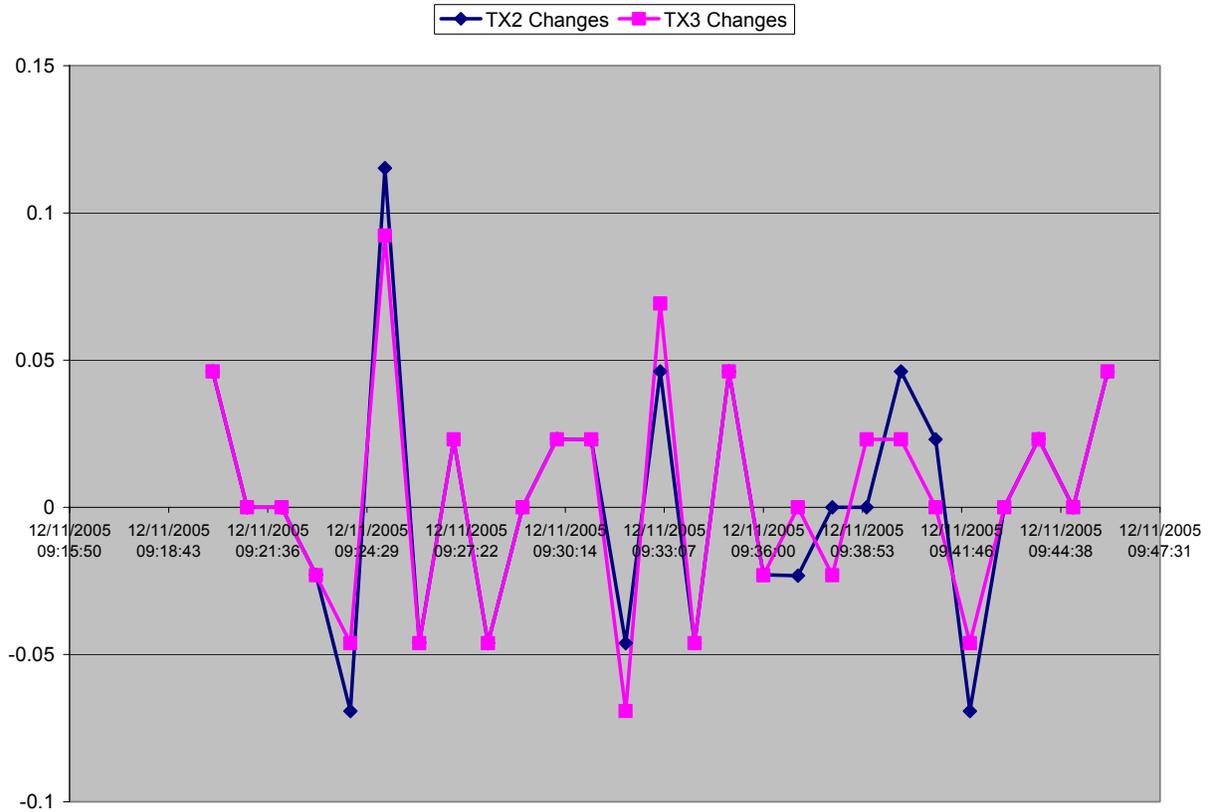
**Figure 24: Individual UR Transmitter Reading Changes on 11-Dec-05**

This data indicates that all three transmitter readings are moving in parallel. This becomes more evident if the one minute value changes are plotted (here for TX2 and TX3 which were actually used for level control):

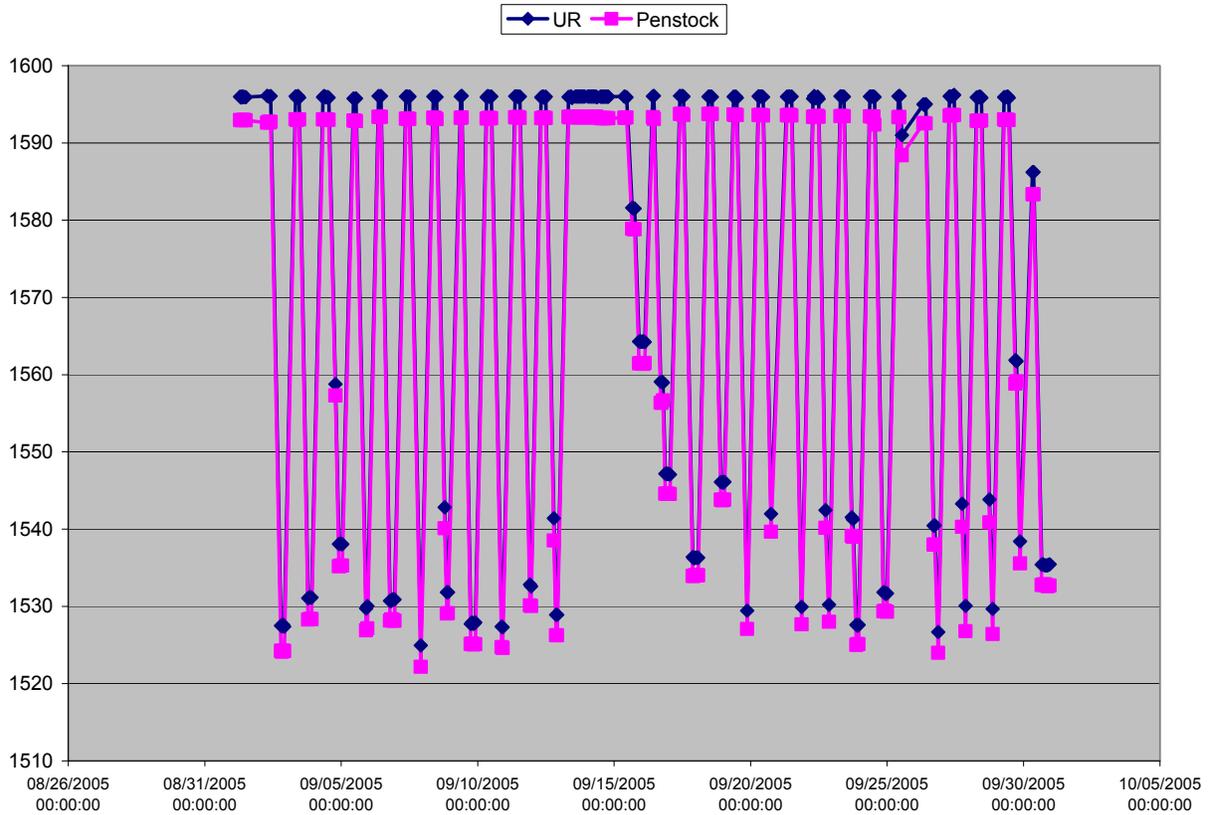
**Figure 25: Comparison between UR Average and PS Level Transmitter Readings**

The following chart shows the UR level compared to the Penstock head during calm plant conditions (no generation or pumping) for the month of September 2005. The chart indicates that the head measured by the Penstock transmitter is closely correlated to upper reservoir level:

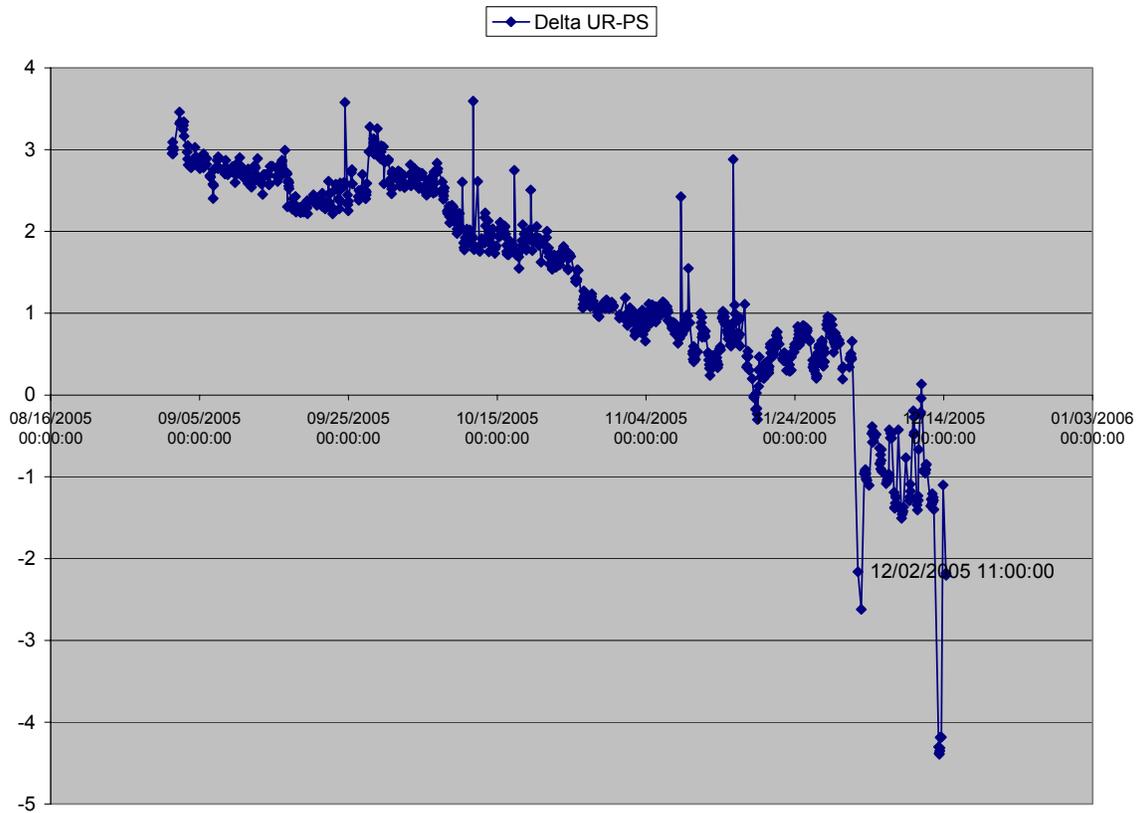
**Figure 28: Difference between UR Transmitter Average and PS Transmitter**

The following chart shows the difference between the measured UR level and the measured penstock level during calm plant conditions from 1-Sep-05 until 14-Dec-05:

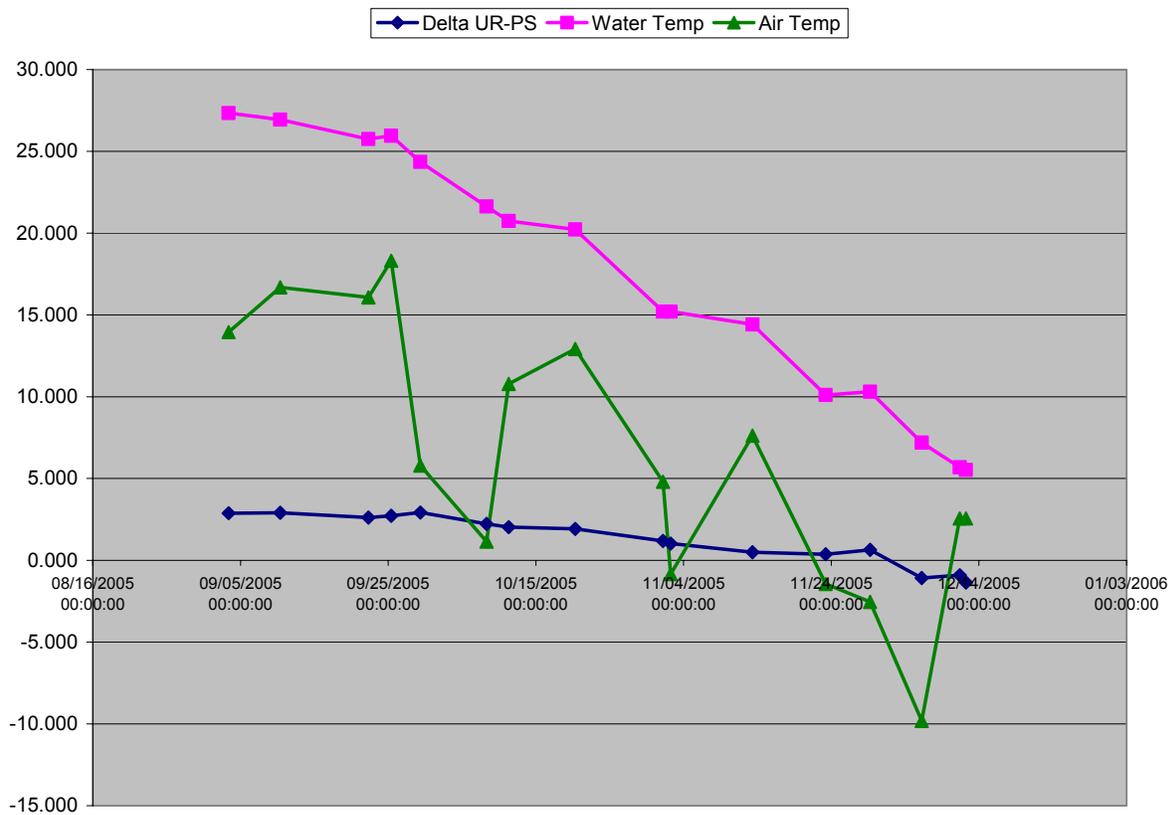
**Figure 30: Transmitter Difference and Temperatures**

The following chart shows the difference between the UR and PS transmitter readings in calm conditions (after an auto pump stop), the ambient air temperature and the water temperature between 3-Sep-05 and 12-Dec-05:
