# REPORT

## FORENSIC INVESTIGATION AND ROOT CAUSE ANALYSIS DECEMBER 14, 2005 INCIDENT UPPER RESERVOIR DIKE TAUM SAUK PLANT FERC PROJECT NO. 2277

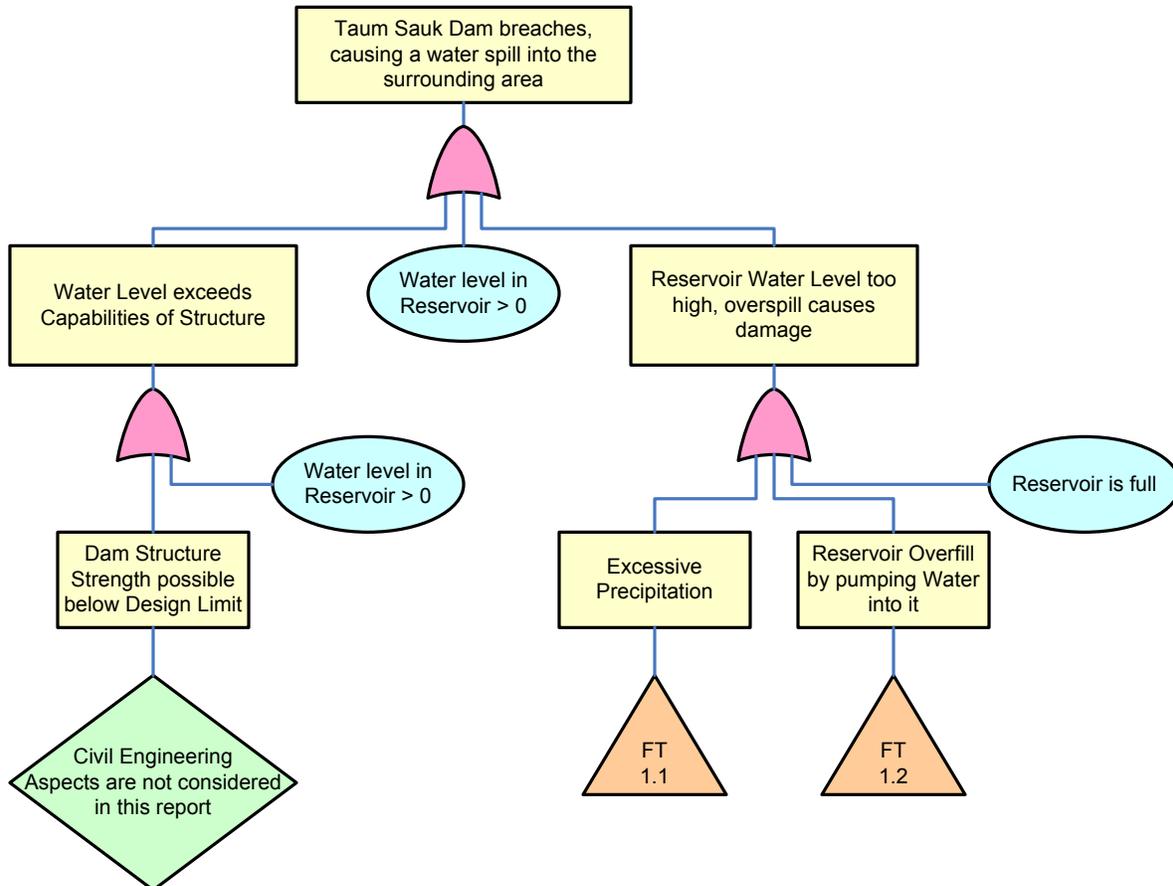
Figure 31: Fault Tree 1: Possible Causes for Dam Breach

7.2.1. Fault tree 1: Potential Causes for the Dam Breach

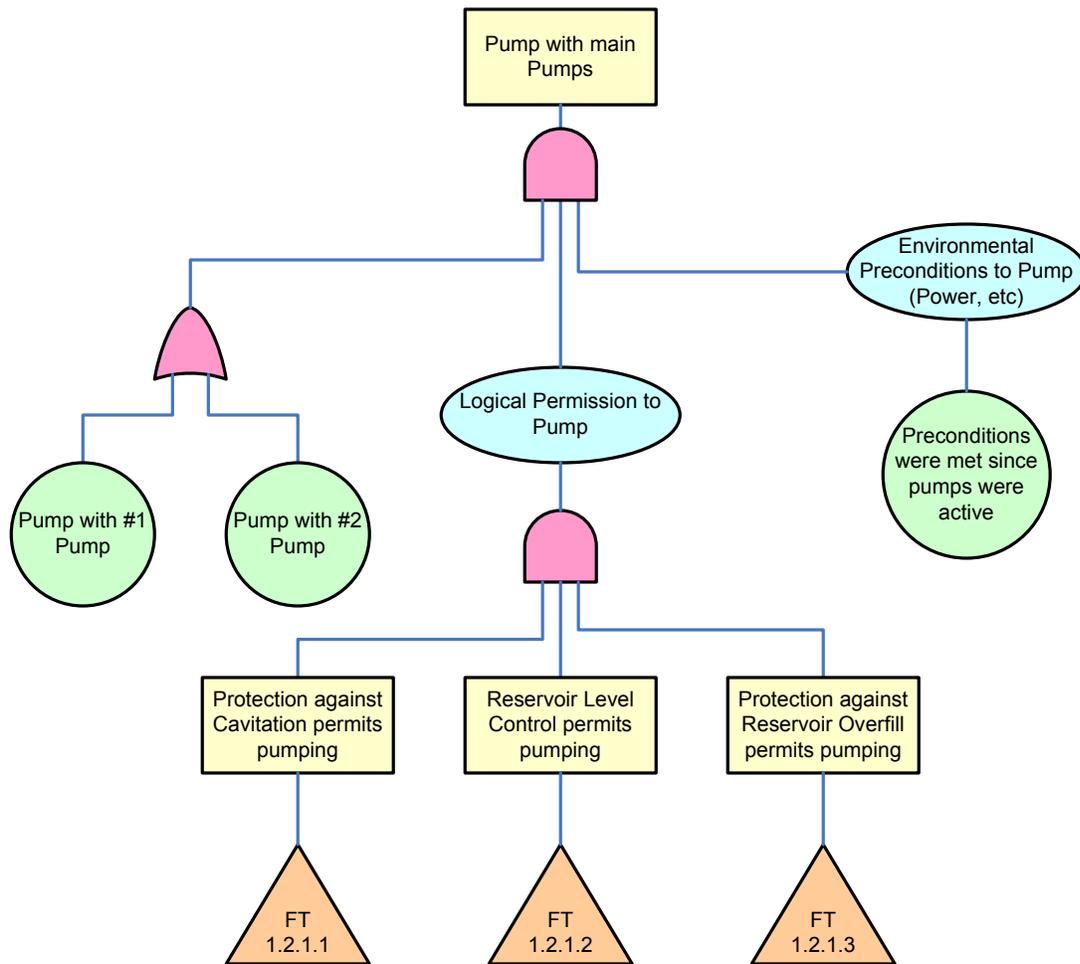
Figure 34: Fault Tree 1.2.1: Pump with Main Pumps

7.2.4. Fault Tree 1.2.1: Pump with main Pumps

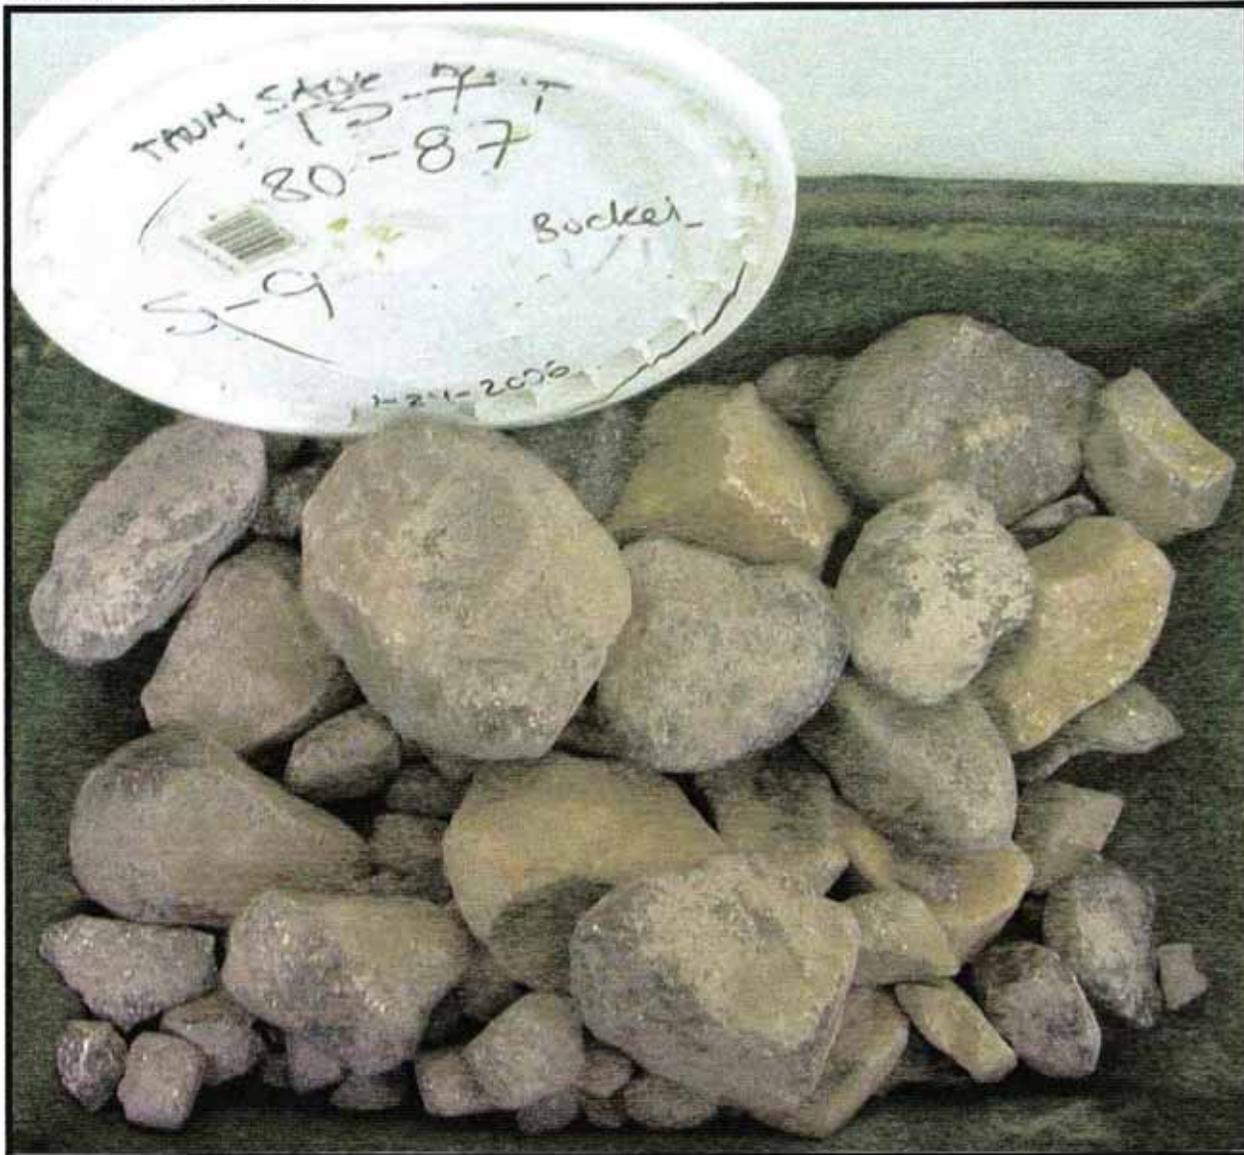
### SAMPLE AS RECEIVED:

Client	PAUL C. RIZZO & ASSOCIATES, INC.	Boring No.	TS-7
Client Project	TAUM SAUK 06-3551	Depth (ft.)	80'-87'
Project No.	2006-060-01	Sample No.	S-9
Lab ID	2006-060-01-65

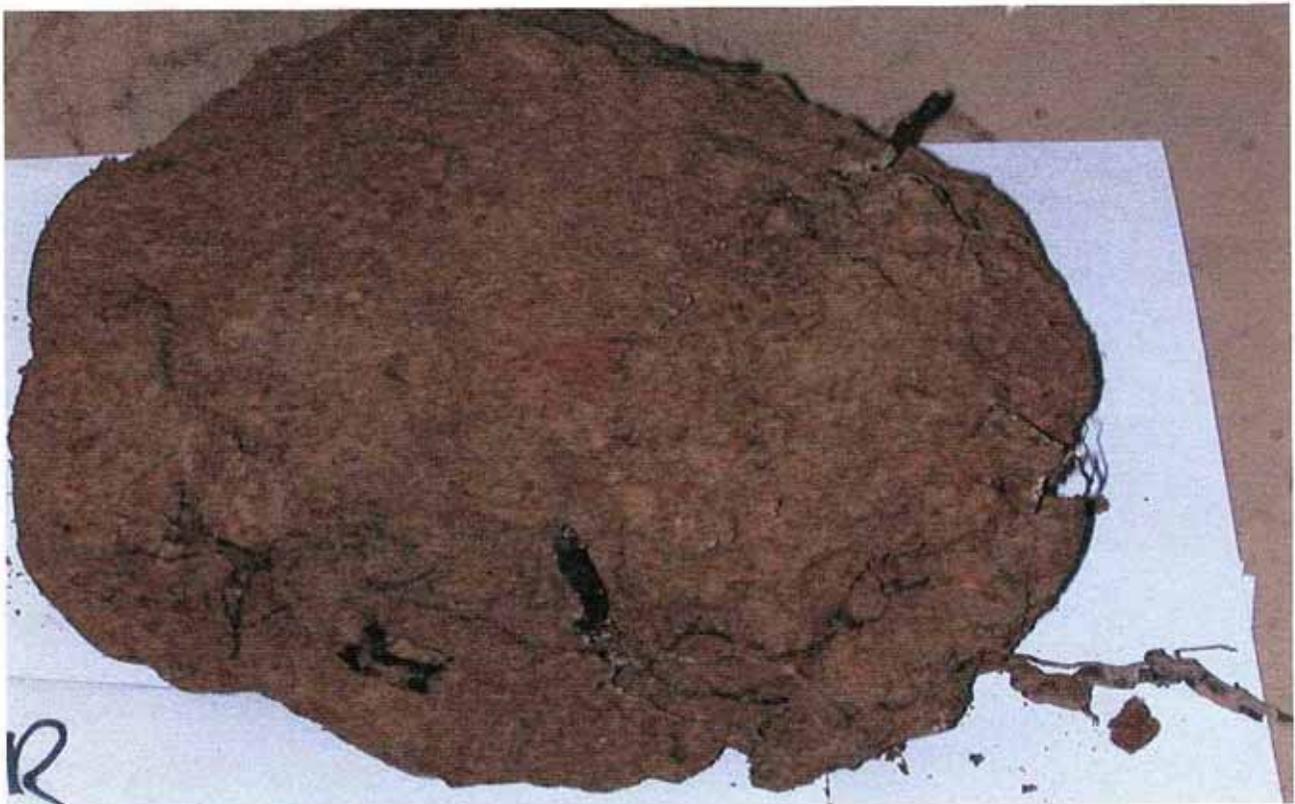
**SAMPLE AS RECEIVED:**

TS-SOIL-01  
9"-14"  
S-2

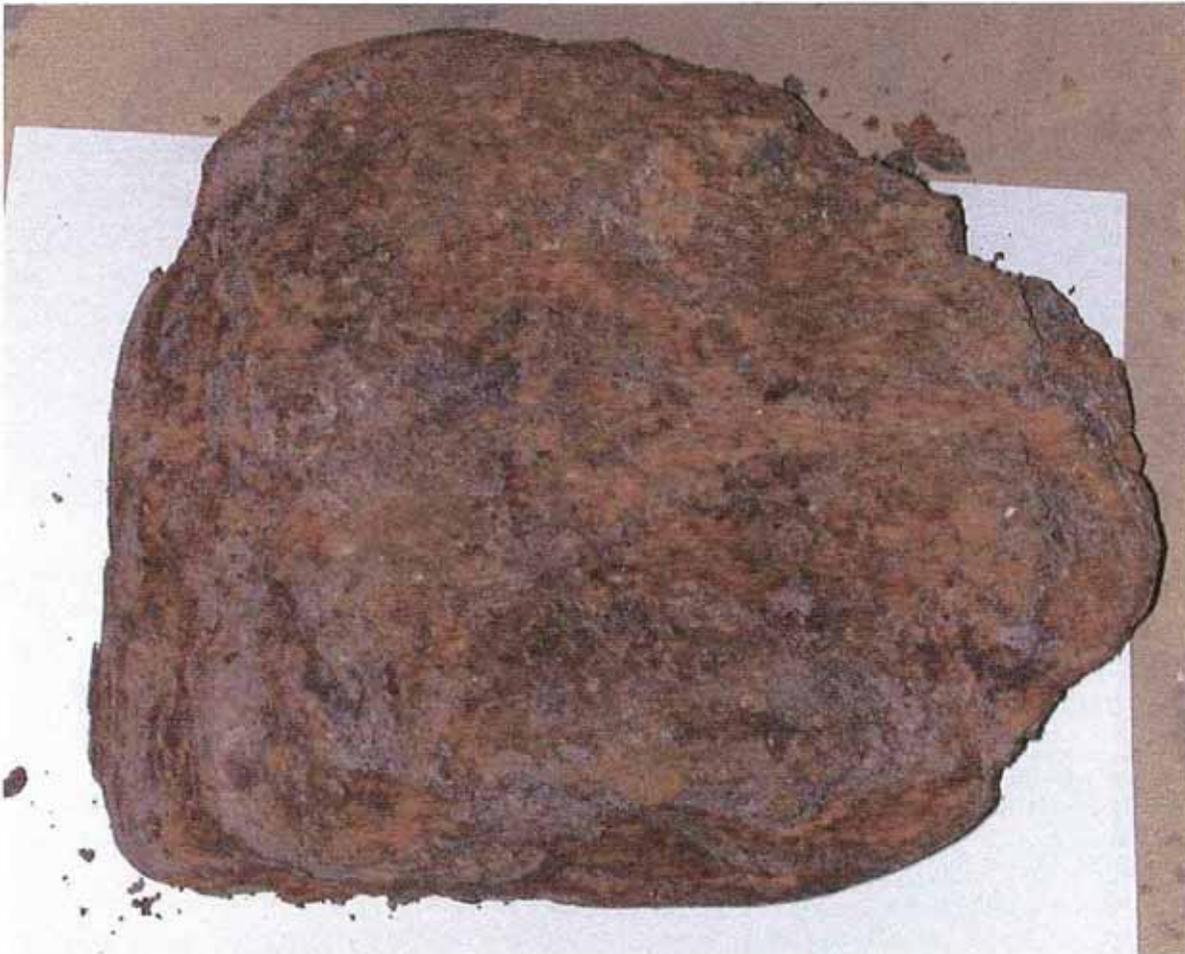
### SAMPLE AS RECEIVED:

Boring No. TS-SOIL-02  
Depth (in.) 7"-12"  
Sample No. S-2

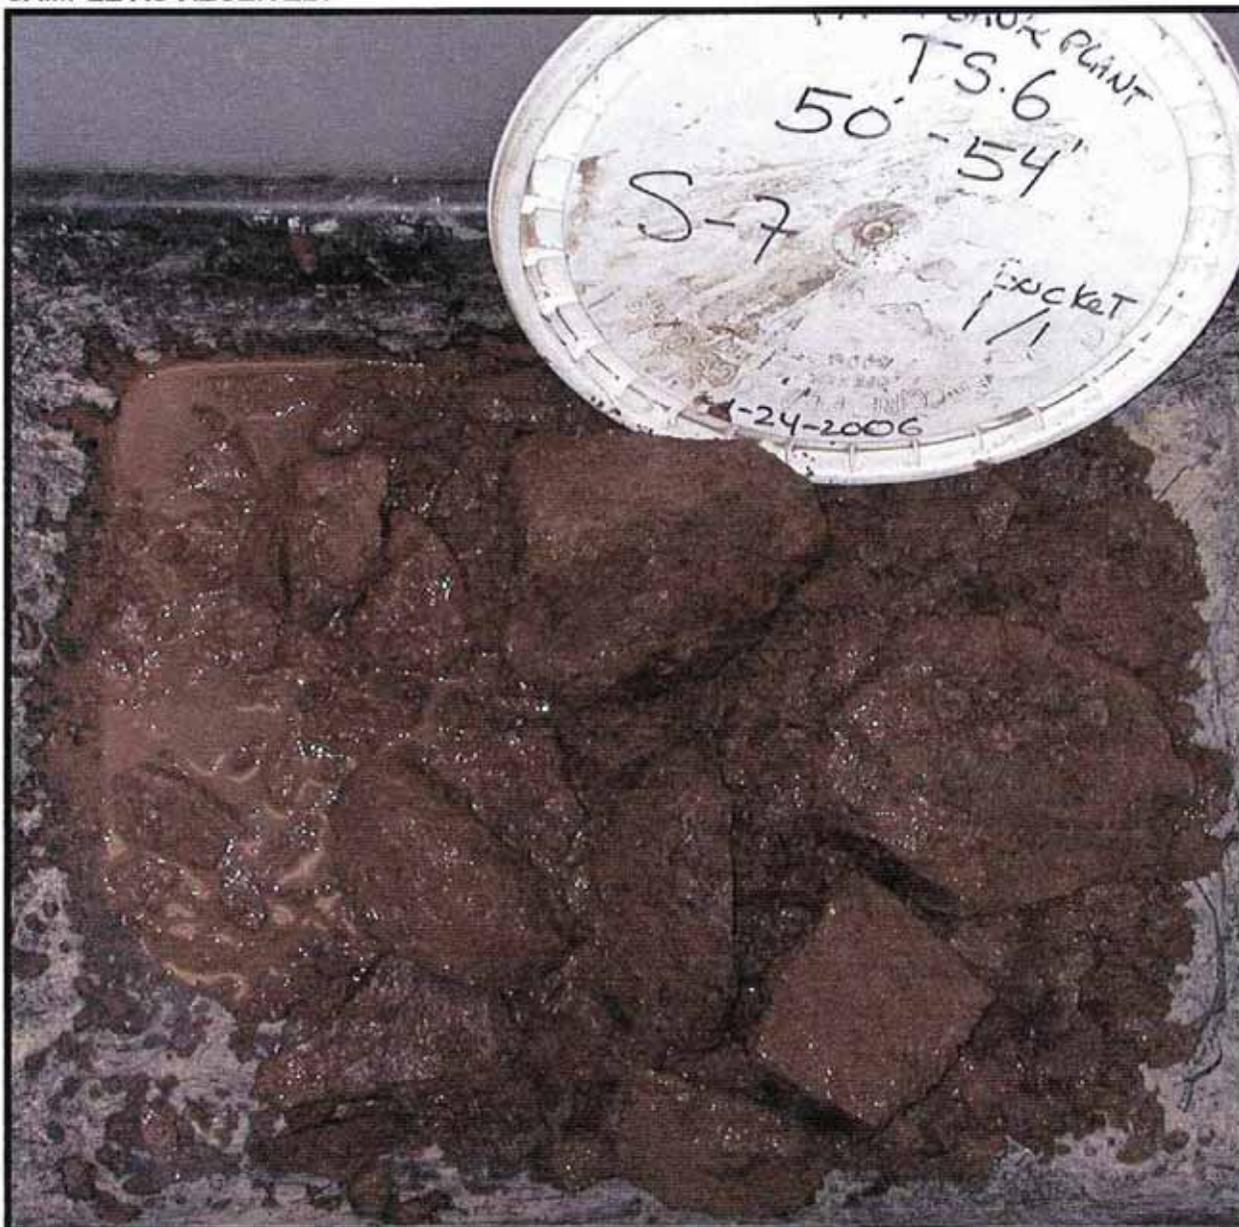
### SAMPLE AS RECEIVED:

Client	PAUL C. RIZZO & ASSOCIATES, INC.	Boring No..	TS-6
Client Project	TAUM SAUK 06-3551	Depth (ft.)	50'-54'
Project No.	2006-060-01	Sample No.	S-7
Lab ID	2006-060-02-01

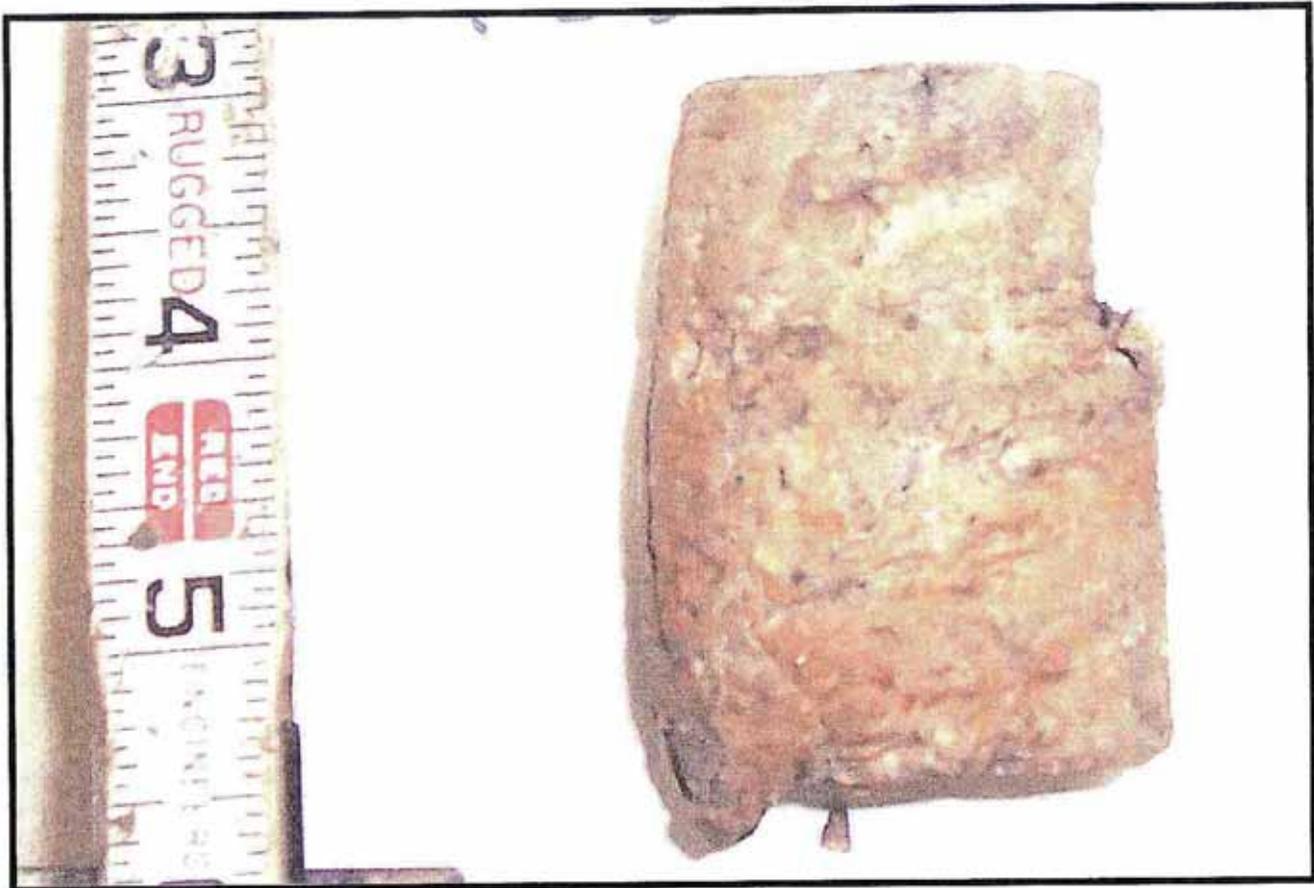
**SAMPLE: AFTER CU**

Boring No.. TS-SOIL-02  
Depth (ft.) 12-19  
Sample No. S-3

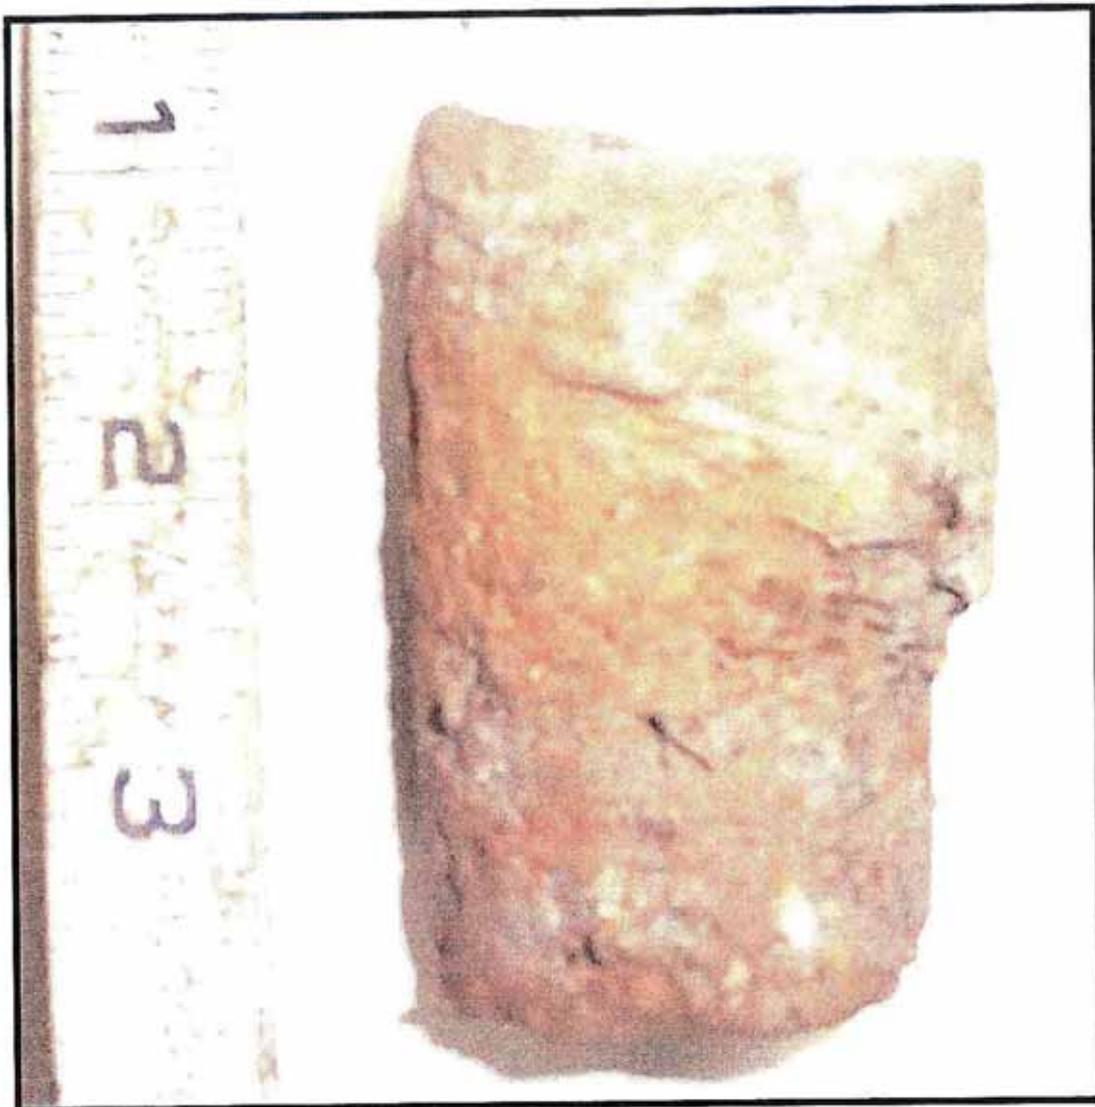
**SAMPLE: AFTER CU**

Boring No.. TS-SOIL-02  
Depth (ft.) 12-19  
Sample No. S-3

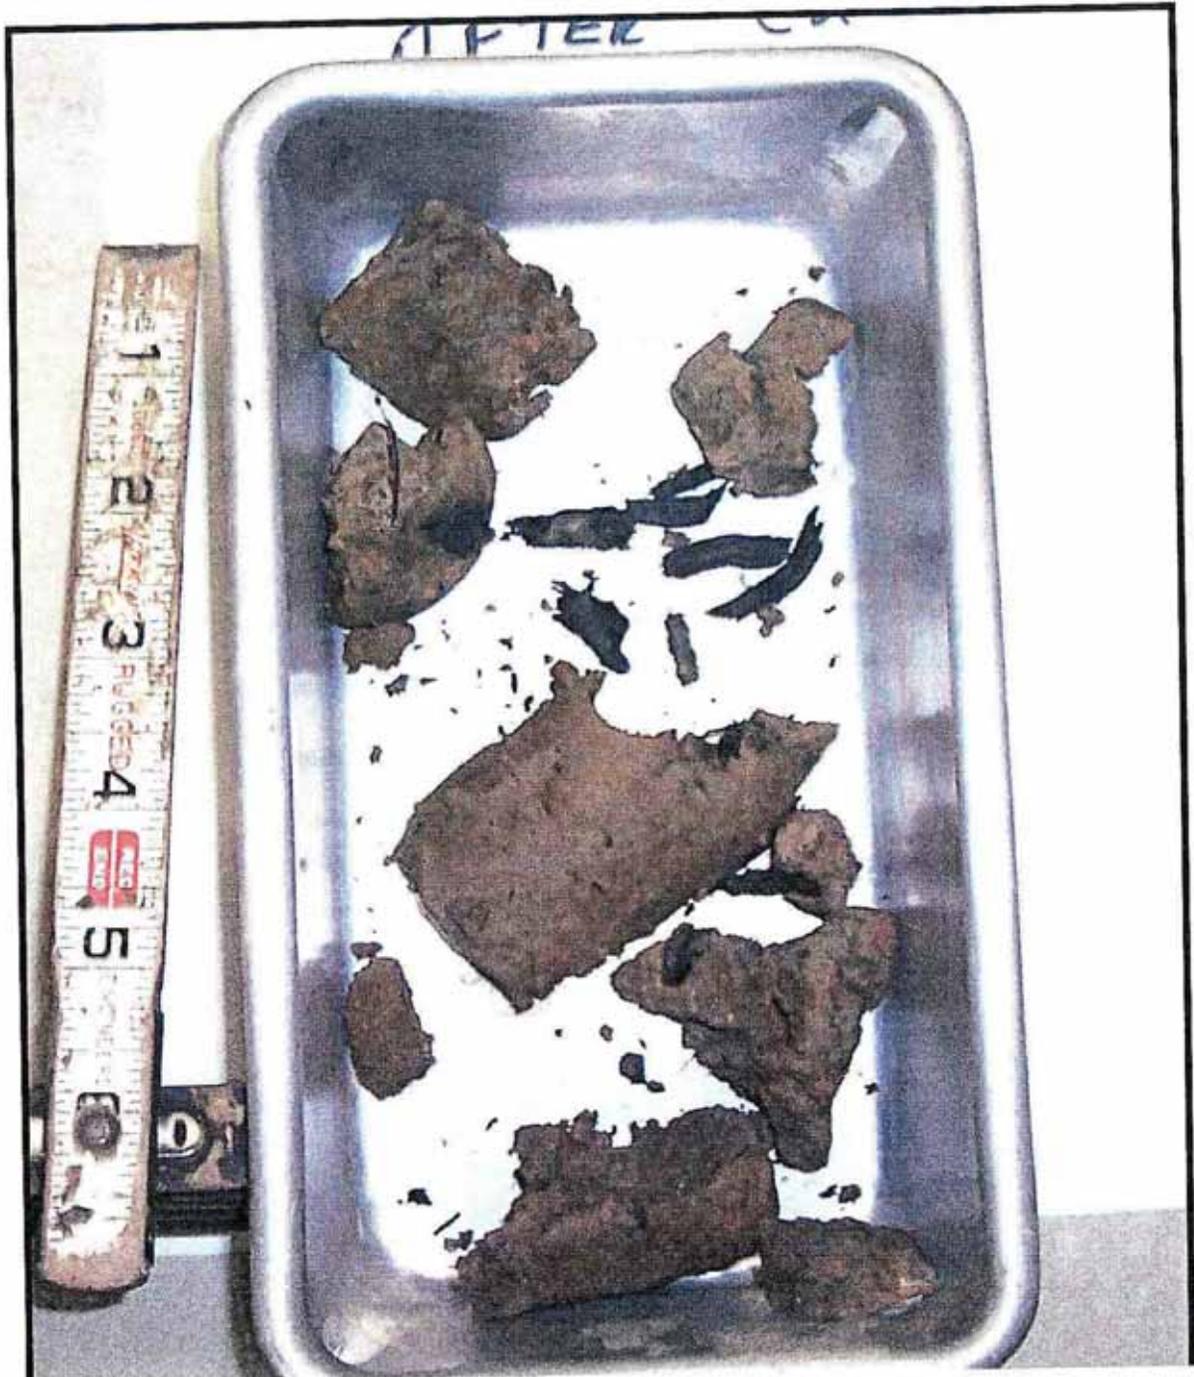
SAMPLE: AFTER CU TEST #7

Boring No.. TS-SOIL-03  
Depth (in.) 7-15  
Sample No. S-2

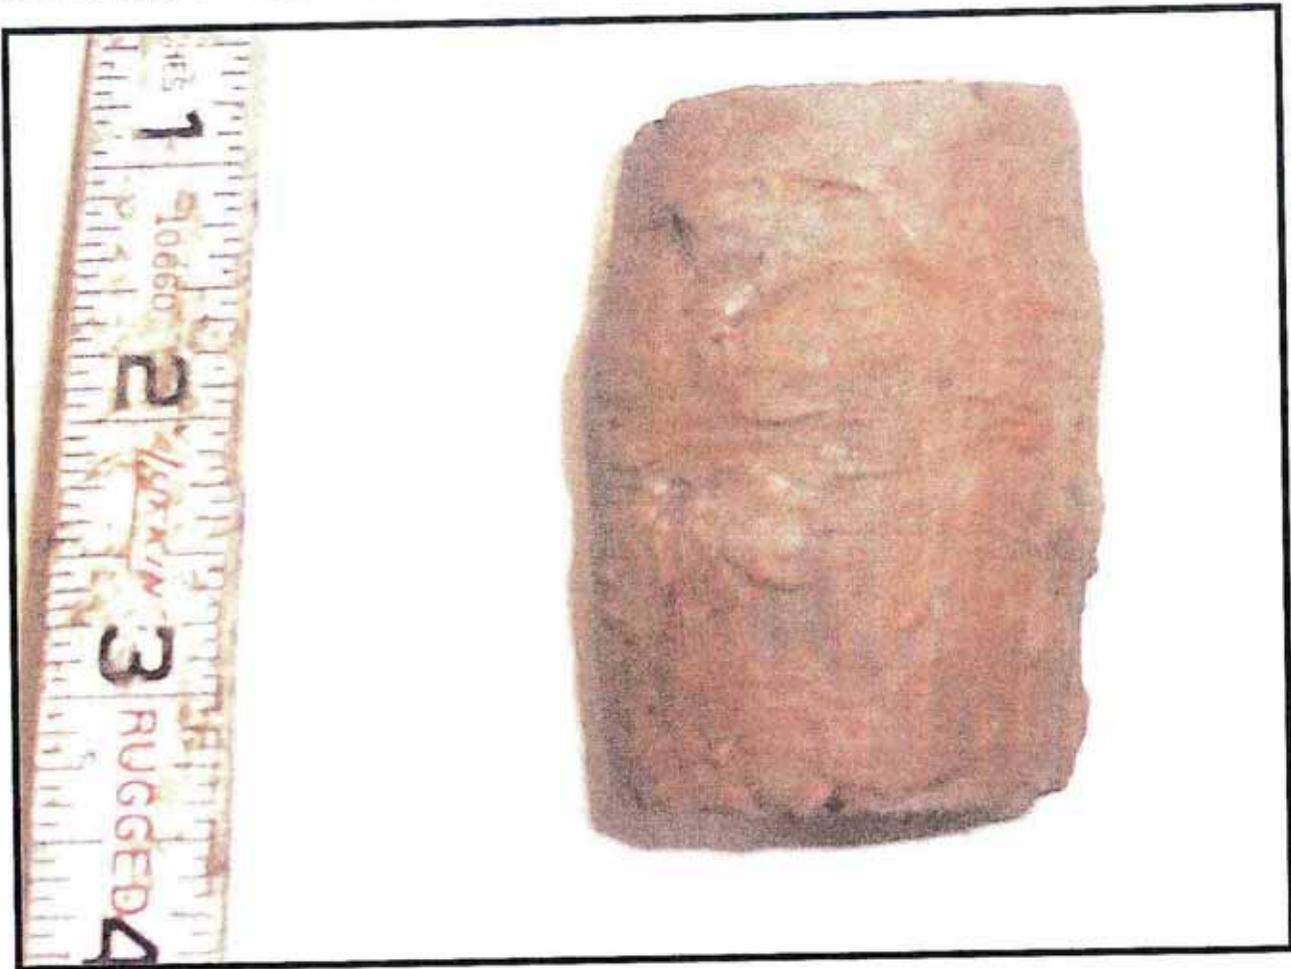
**SAMPLE: AFTER CU TEST #8**

Client	PAUL C. RIZZO & ASSOCIATES, INC.	Boring No..	TS-SOIL-03
Client Project	TAUM SAUK 06-3551	Depth (in.)	7-15
Project No.	2006-060-01	Sample No.	S-2
Lab ID	2006-060-01-72

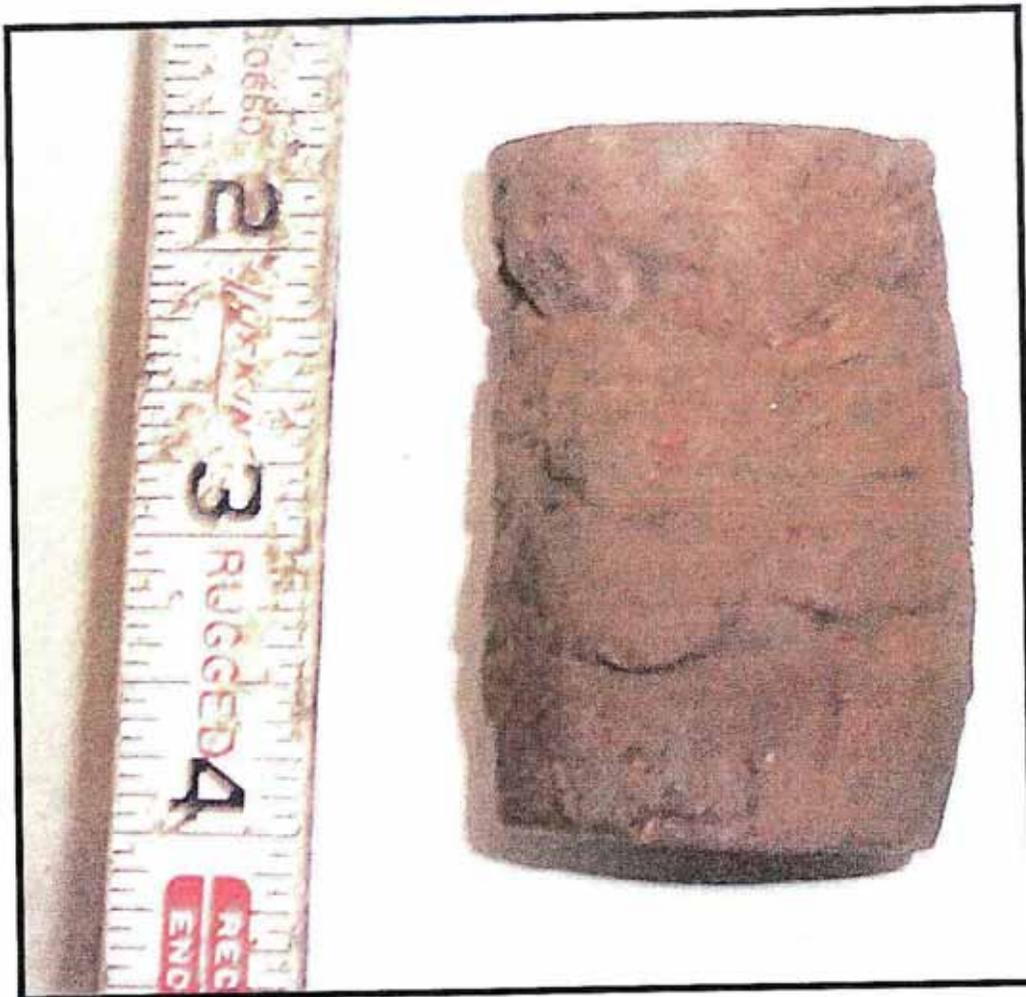
**SAMPLE: AFTER CU TEST #9**

Client	PAUL C. RIZZO & ASSOCIATES, INC.	Boring No.	TS-SOIL-03
Client Project	TAUM SAUK 06-3551	Depth (in.)	7-15
Project No.	2006-060-01	Sample No.	S-2
Lab ID	2006-060-01-72

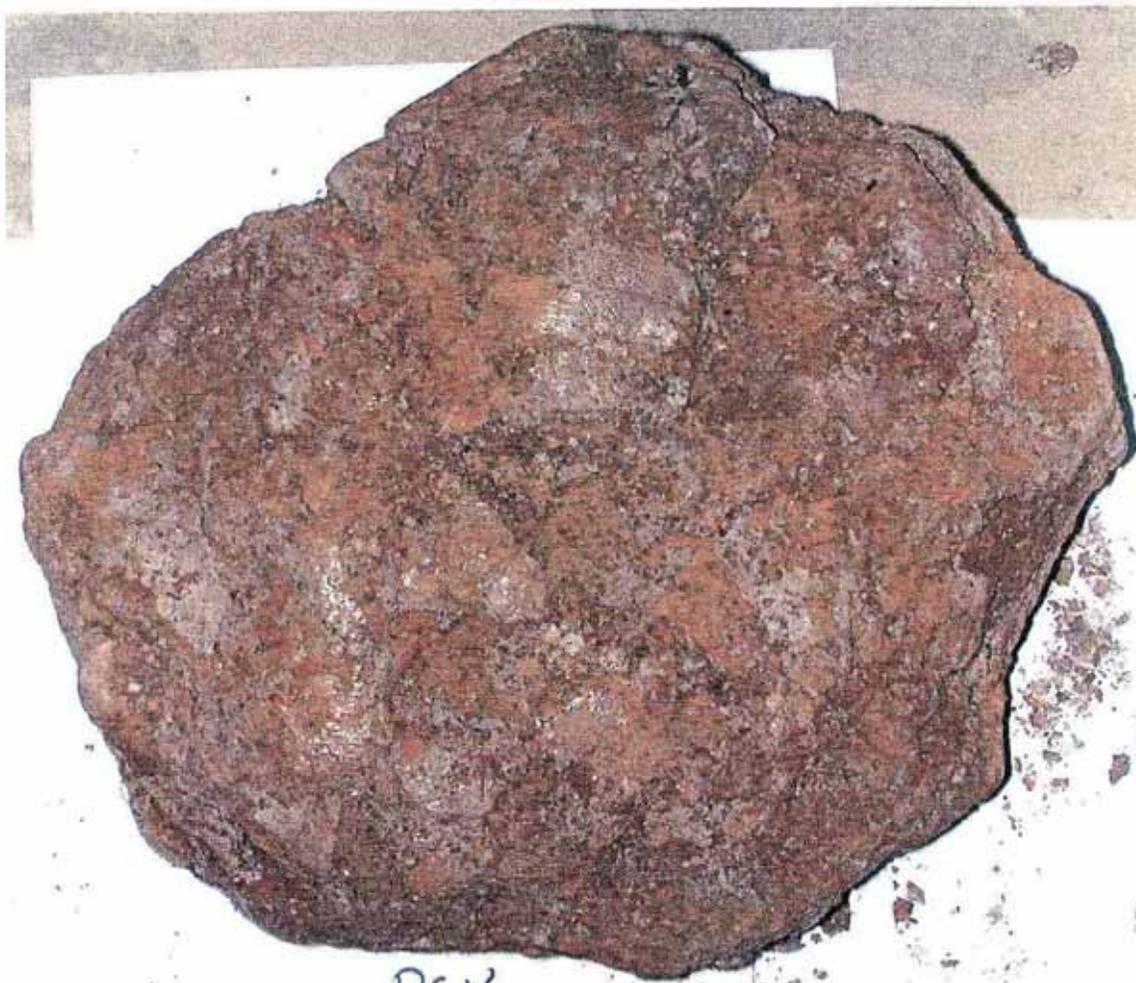
#### SAMPLE AS RECEIVED:

Boring No. TS-SOIL-04  
Depth (in.) 5" - 11"  
Sample No. S-2

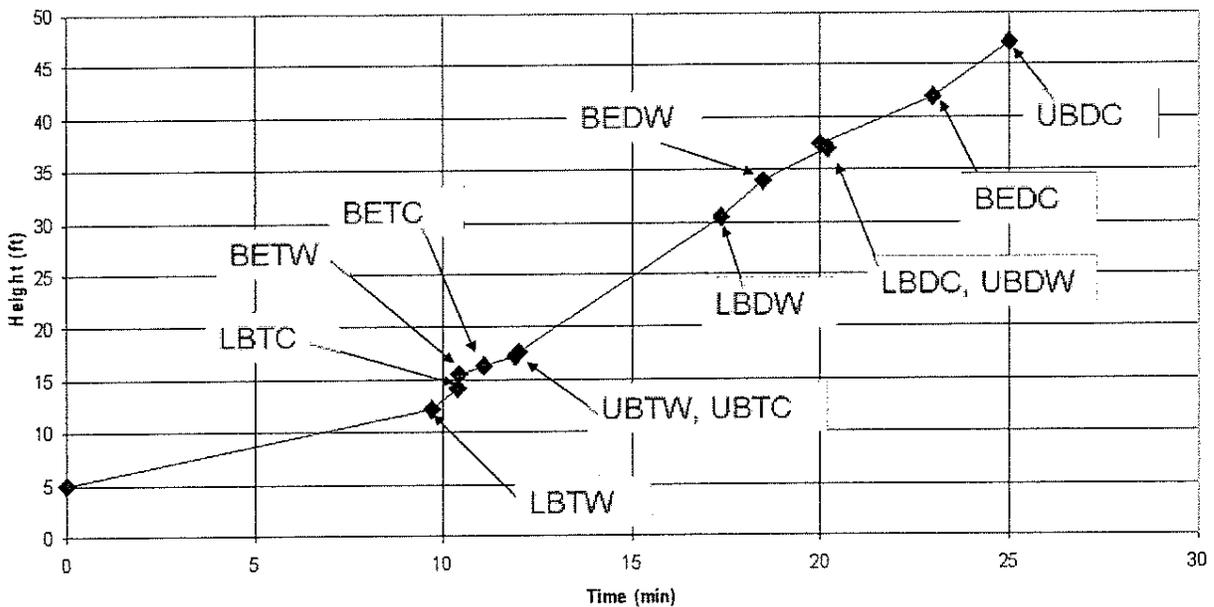
**FIGURE 1: HEIGHT OF SATURATION VS. TIME FOR CONDITION C**

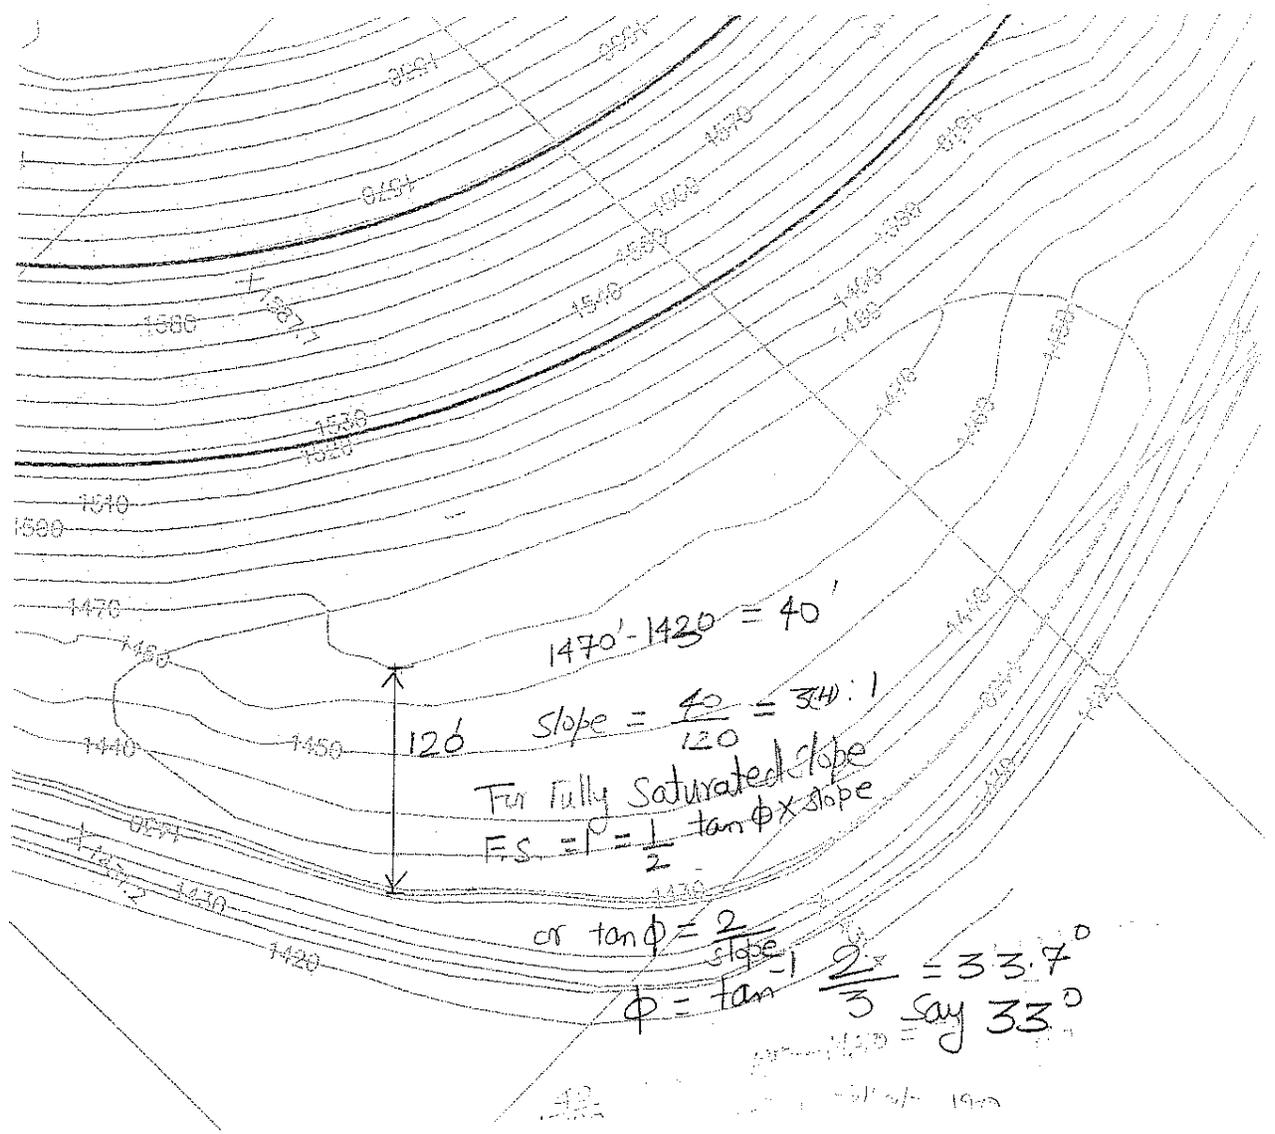
Location of Slide: The location of the slide and most critical failure plane is shown below for soil embankment

Soil Fill / Natural Soil Slide

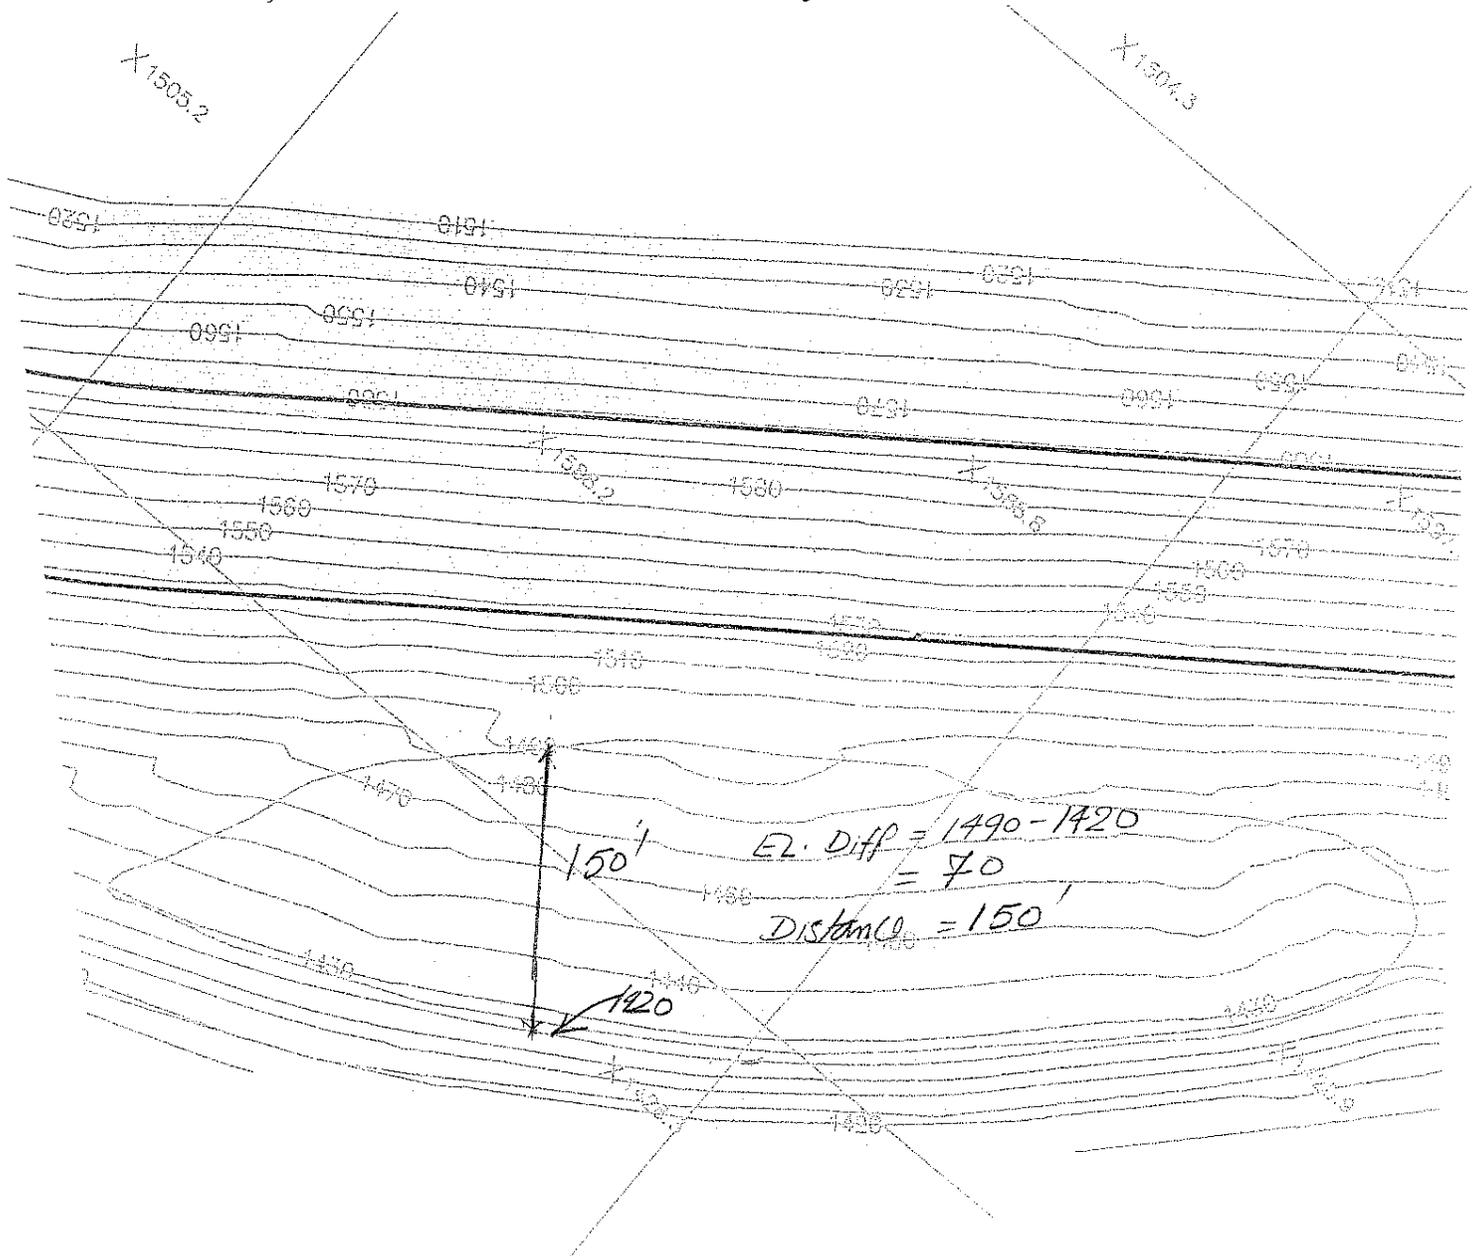
Rockfill Embankment: The location of Critical failure plane of Rock Embankment is given below:

Rockfill Slide
