Reexamining the dam and geotechnical engineering aspects of the 1889 South Fork Dam breach and Johnstown Flood

By Michael D. Bennett, P.E. – Gannett Fleming TransSystems (Audubon, PA)

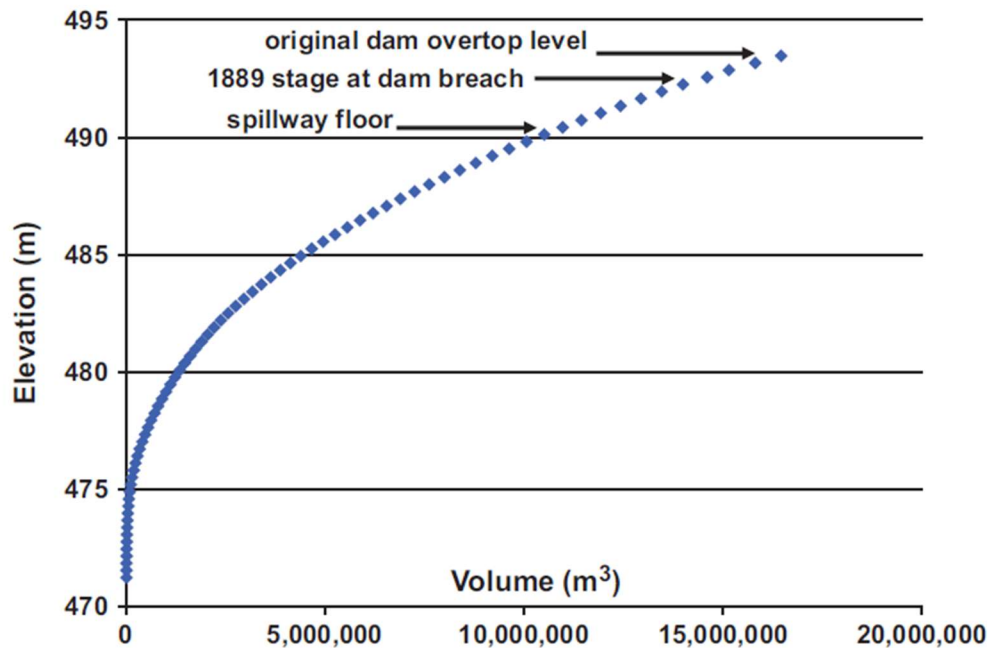
Figure 9: Storage-elevation curve generated by researchers at UPJ for the Western Reservoir and its successor, Lake Conemaugh. Source: Coleman et al. (2016).

Researchers from the University of Pittsburgh at Johnstown (UPJ) performed hydraulic analyses in the 2010s of the Western Reservoir and its dam. For these studies, they took LiDAR scans of, and soil samples from, the former reservoir bed and used them together with modern software to construct a stage-storage curve to estimate the reservoir's capacity. The researchers found that the original reservoir could hold roughly 13,200 acre-feet of water (4.3 billion gallons or 575 million cubic feet) weighing about 17.9 million tons. The researchers also estimated the

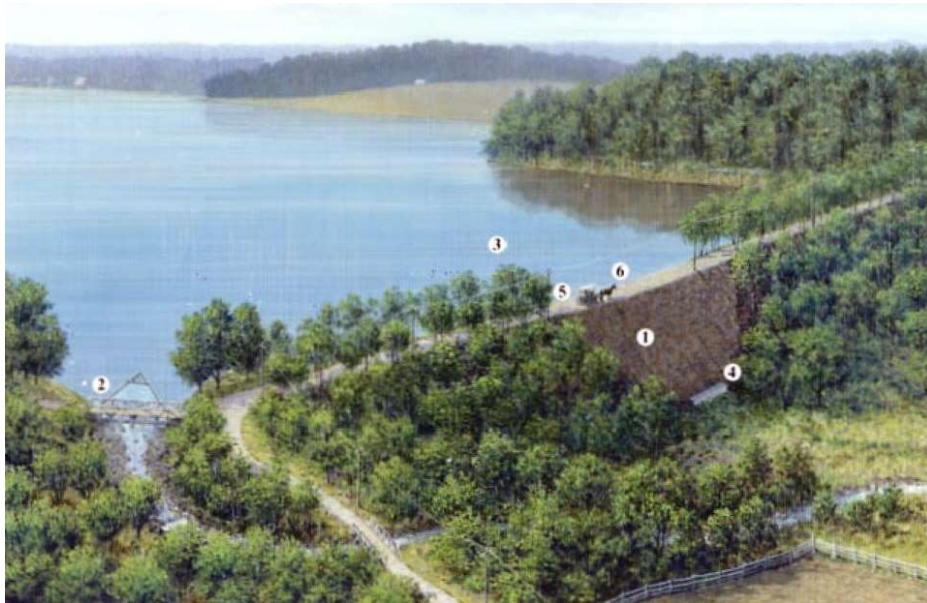
Figure 16: The South Fork Dam, 1881-1889. Note its (1,6) poorly rebuilt breach, (2) northeast spillway with fish screens and log boom, (3) lack of a control tower, (4) abandoned discharge culvert, and (5) lowered crest. Source: NPS (2023 C).

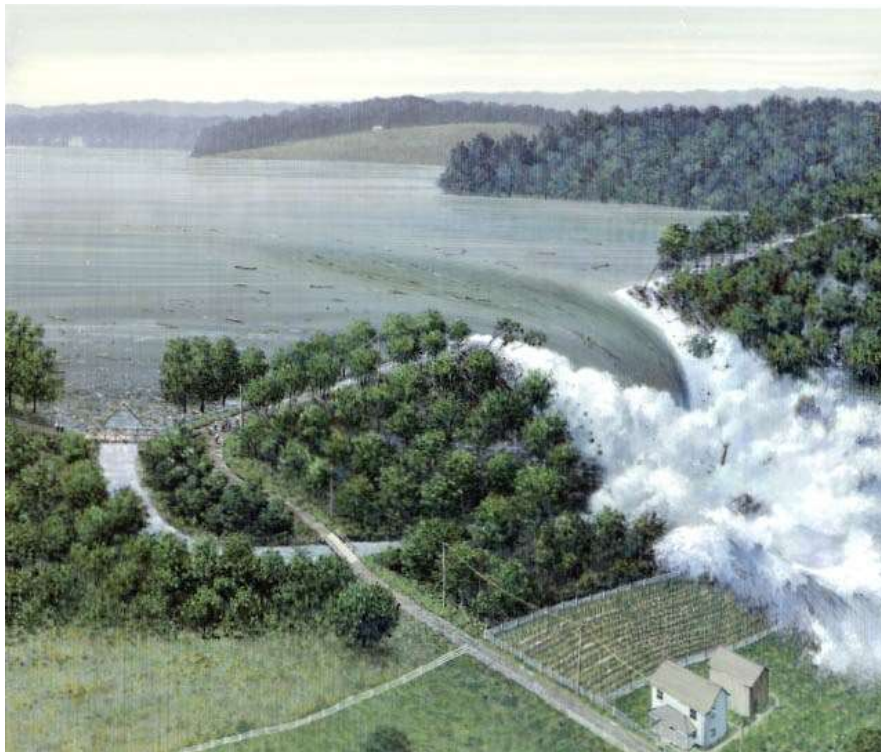
Figure 30: The final breach of the South Fork Dam on May 31st, 1889. Source: NPS (2023 C).

Overtopping caused the South Fork Dam's initial breach, but the geotechnical nature of its final breach appears not to have been discussed at length. No soil or rock from the final breach region remains available for laboratory testing, of course, and doing a full geotechnical forensic analysis of the failure would thus be highly speculative, as well as expensive. However, modern dam and geotechnical engineers can use the current state of practice of civil engineering to interpret surviving evidence from the disaster and reconstruct how the final breach most likely unfolded. Eyewitness accounts suggest that it occurred primarily due to sliding induced by the overtopping which caused the initial breach and uncontrolled seepage.

Cohesive embankments can fail by overtopping in hours, which matches eyewitness accounts from the South Fork Dam. Transverse cracking in such embankments can accelerate their failure, but firsthand accounts from Lake Conemaugh do not mention whether the dam contained such cracks. By contrast, the accounts make it quite clear that the lake's waters surged furiously through the dam remnants after the final breach. One bystander noted that the onrushing wave displaced the air in its path powerfully enough to topple mature trees and send riprap boulders flying, while another recalled that the torrent cut through the dam "like a knife." Others, including Col. Unger and John Parke, commented that the final breach was less an abrupt break in the dam than a pushing away of its center. These first-hand accounts are consistent with a sliding failure of the dam (Coleman 2019, McCullough 1968).

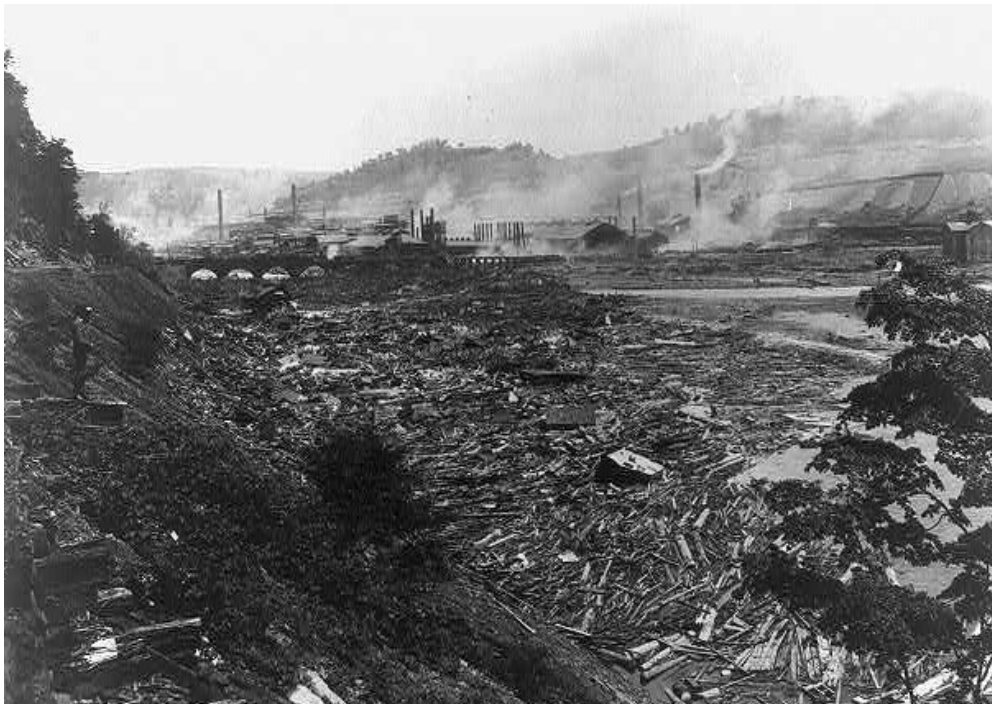
Figure 38: Debris jam at the Stone Bridge after the fire. Source: Lindberg (2024).

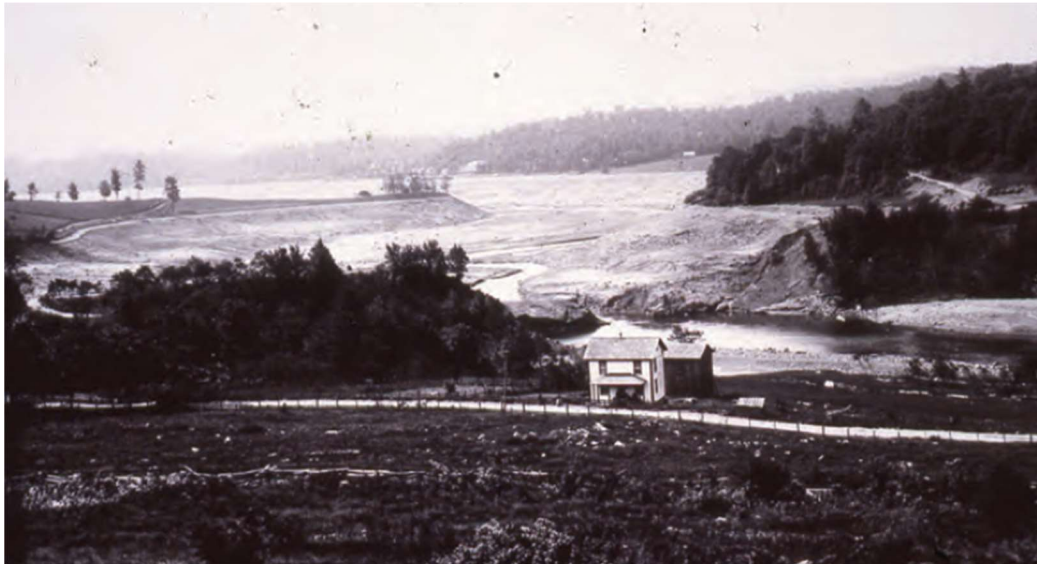
Figure 47: Former bed of Lake Conemaugh and remnants of the South Fork Dam, 1889, looking south. Source: Hanna (2021).
