*Reexamining the dam and geotechnical engineering aspects of the 1889 South Fork Dam breach and Johnstown Flood*

*By Michael D. Bennett, P.E. – Gannett Fleming TransSystems (Audubon, PA)*

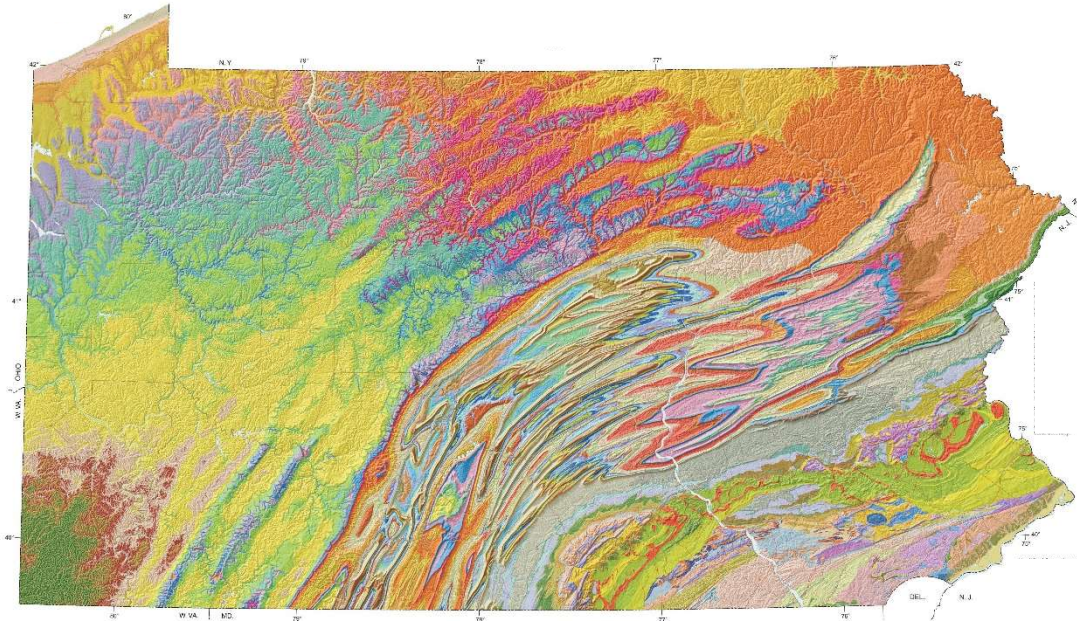
Figure 1: Geology of Pennsylvania. The Appalachian Mountains are shown as multicolored lines running through the center of the state. The Allegheny Mountains divide this zone from the Appalachian Plateau, shown in yellow. Source: Miles (2008).

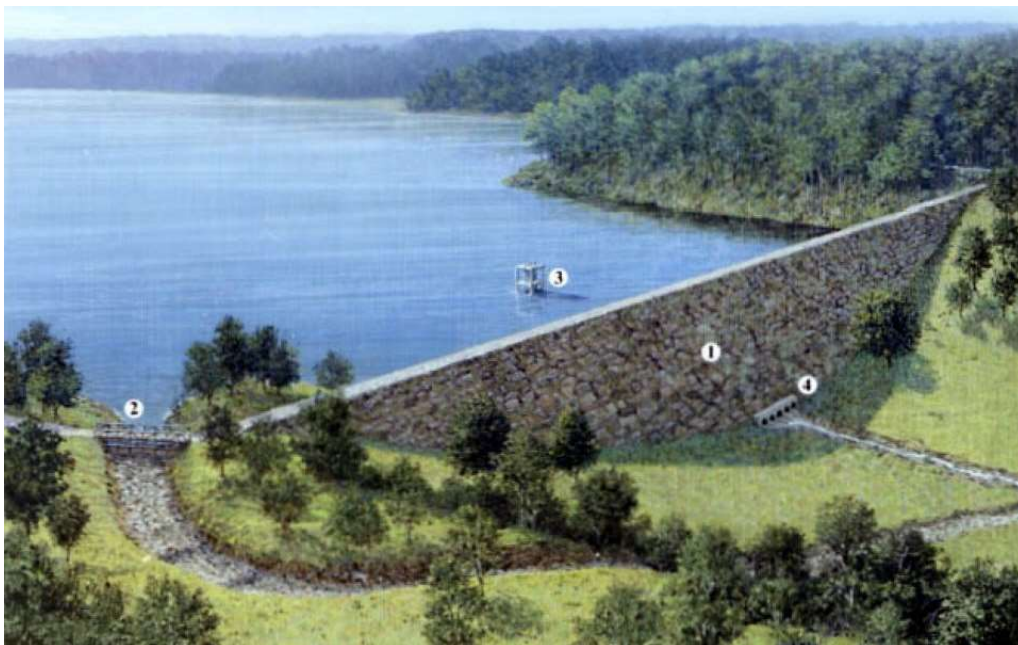
*Figure 8: The Western Reservoir dam, 1853-1862. Note its (1) sturdy construction with downstream riprap, (2) northeast spillway, (3) control tower, and (4) discharge culvert. The drawing erroneously omits the southwest spillway and shows the culvert with five openings rather than one. Source: NPS (2023 C).*

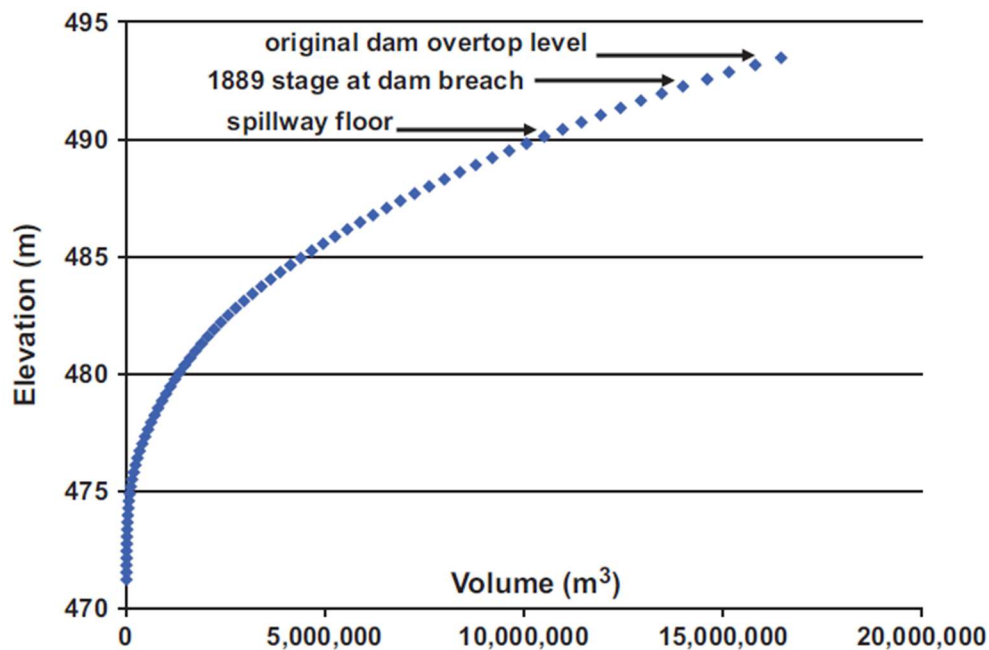
Figure 9: Storage-elevation curve generated by researchers at UPJ for the Western Reservoir and its successor, Lake Conemaugh. Source: Coleman et al. (2016).

Researchers from the University of Pittsburgh at Johnstown (UPJ) performed hydraulic analyses in the 2010s of the Western Reservoir and its dam. For these studies, they took LiDAR scans of, and soil samples from, the former reservoir bed and used them together with modern software to construct a stage-storage curve to estimate the reservoir’s capacity. The researchers found that the original reservoir could hold roughly 13,200 acre-feet of water (4.3 billion gallons or 575 million cubic feet) weighing about 17.9 million tons. The researchers also estimated the

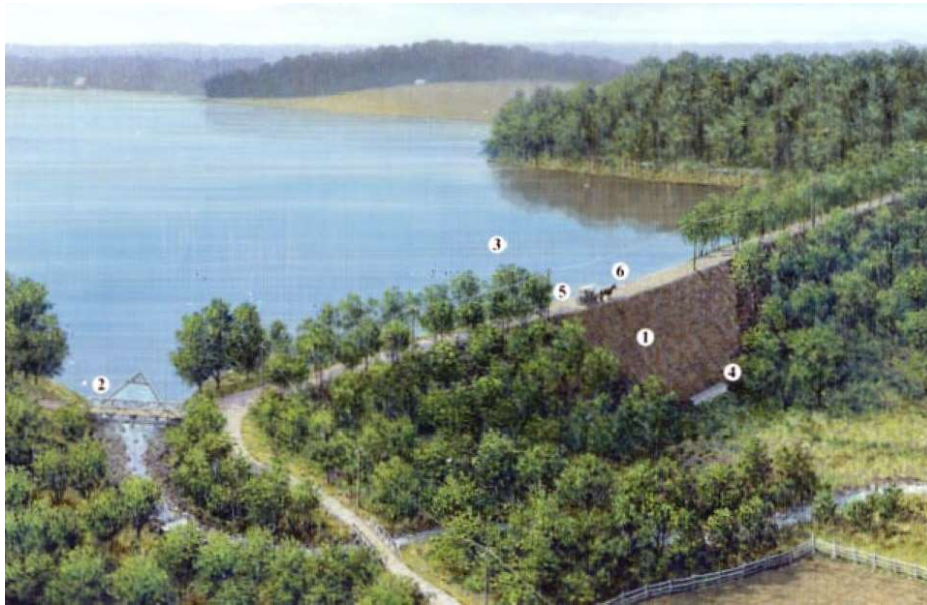
Figure 16: The South Fork Dam, 1881-1889. Note its (1,6) poorly rebuilt breach, (2) northeast spillway with fish screens and log boom, (3) lack of a control tower, (4) abandoned discharge culvert, and (5) lowered crest. Source: NPS (2023 C).

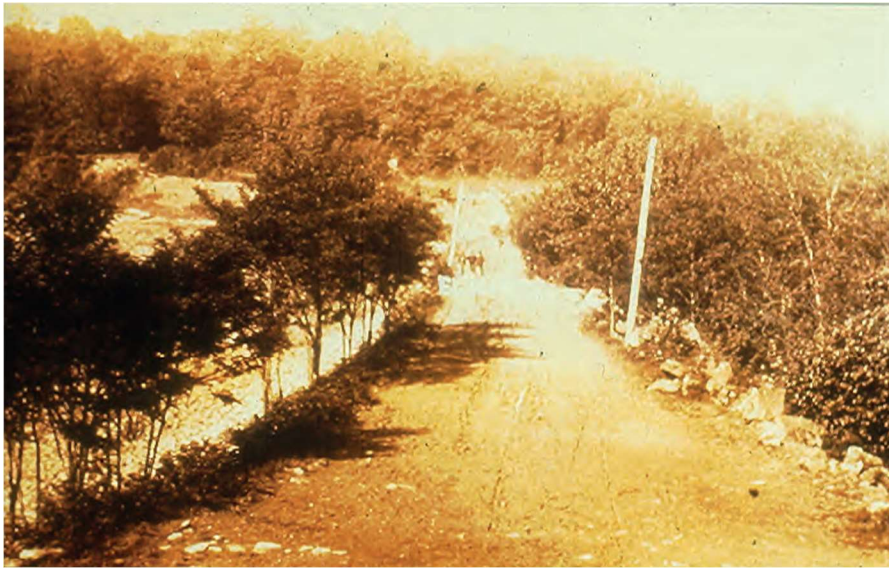
*Figure 22: The South Fork Dam's crest looking southwest, 1880s, with its perceptible central sag. Source: Hanna (2021).*

of the uncontrolled fill dumped into the 1862 breach had created a sag at least 1 foot deep in the dam's center. The increasingly perceptible sag further reduced the lake's storage capacity and the dam's discharge capacity. Moreover, new leaks kept appearing on the dam's downstream face of the dam, indicating ever-worsening internal stability issues which further compromised its integrity. Several leaks smelled of sulfur, suggesting that some of the uncontrolled fill was indeed comprised of sulfur-rich clays scrounged from local coal mine refuse. Meanwhile, Club picnickers were apparently oblivious as to how the burbling water which gave the spillway its ambience also indicated that the lake was perpetually almost full and could not be proactively lowered (Coleman 2019, Davis Todd 2017, McCullough 1968, Roker 2018).

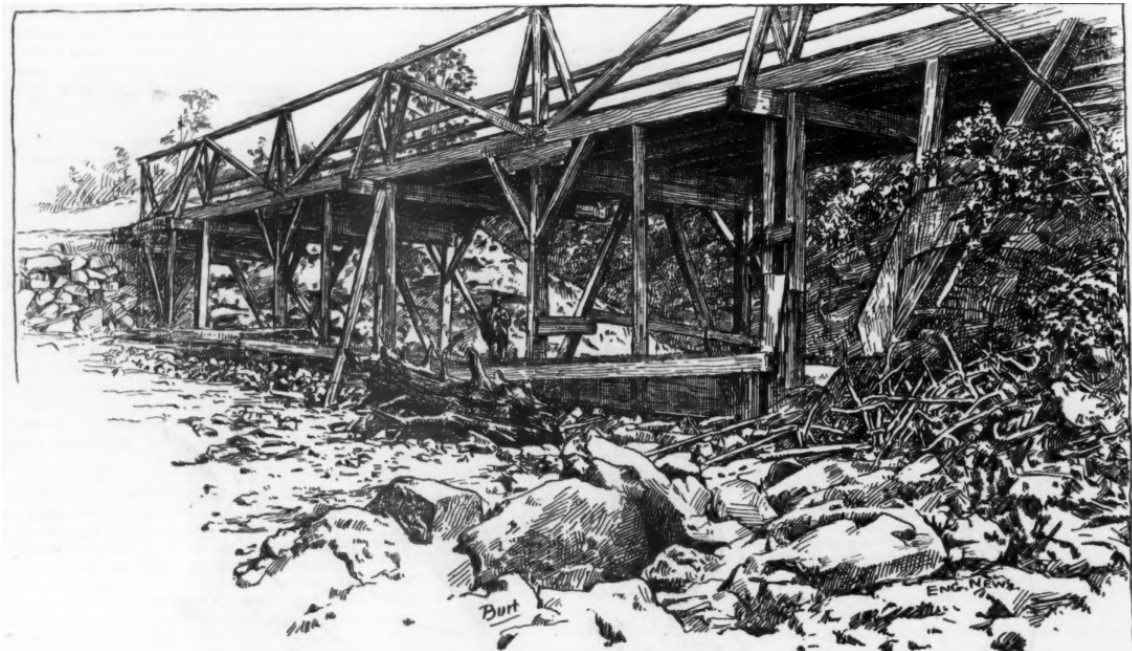
*Figure 27: Contemporary illustration of the debris-laden fish screen remnants at Lake Conemaugh's spillway after the South Fork Dam breach. Source: Wellington and Burt (1889 B).*

By mid-morning, the rain had largely tapered off. Discharges from local streams hadn't yet peaked, though, and Lake Conemaugh kept rising at around 9 to 10 inches per hour. Unger, Parke, and the laborers toiled valiantly but in vain. Years of carriage traffic had tamped the crest of the South Fork Dam down tightly, albeit not the poorly placed fill deep within it. The plow crew was thus struggling to pile even 1 foot of soil atop the dam, and this loose material would do nothing to halt overtopping. Meanwhile, the laborers in the old southwest spillway had hit bedrock before digging their already overflowing trench even knee-deep. Making matters worse, the timber and debris carried into the lake had overwhelmed the log boom and jammed the fish screens, further lowering the spillway's diminished discharge capacity. Some in the growing

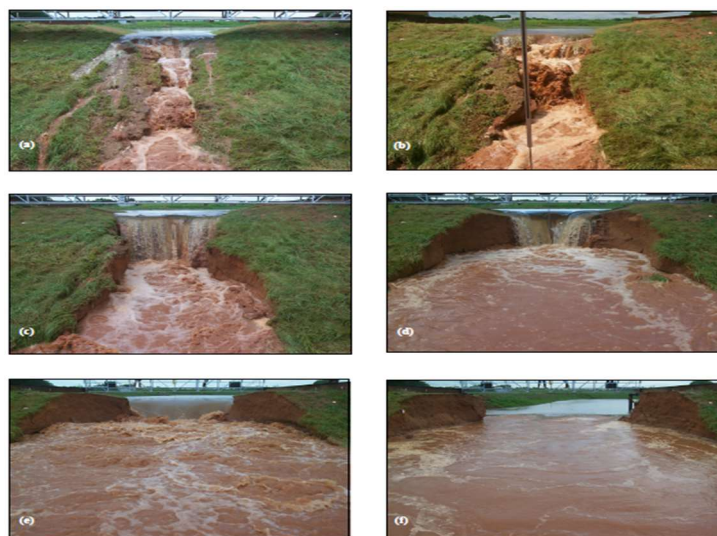
*Figure 29: Stages of failure by overtopping of an embankment built of cohesive soil, as seen in a USDA field-scale test. Source: Hanson et al. (2005).*

John Parke had done just about everything in his power to protect the South Fork Dam, but his reasonable confidence that it might survive the storm was tragically misplaced. Field studies have since determined that most embankments cannot withstand a sustained overflow 1 foot deep without a high likelihood of an overtopping failure. At the poorly rebuilt dam, even a (likely) shallower depth proved too much. While Parke ate, Lake Conemaugh's overflowing waters etched ever more, ever deeper rills and gullies into the dam's downstream face. Eventually, most of the channels merged into a single step-like gouge in the crest measuring 10 feet wide and 4 feet deep. Such a gouge, now called a headcut, represents the second step in typical overtopping failures of cohesive embankments. When Parke returned from lunch, the unpleasant sight shattered his hopes for the dam's survival. He, Unger, the laborers, and the bystanders watched helplessly as the headcut progressed, or migrated, upstream through the dam (Coleman 2019, Francis et al. 1891, Hanson et al. 2005, McCullough 1968, USACE 2017).

Embankments made of soil compacted near its optimum dry density and moisture content can resist headcut migration during overtopping by several orders of magnitude more than those made of soil compacted less carefully. Thus, Ruff's decision during the South Fork Dam rebuild to let his contractors lackadaisically dump fill material into the 1862 breach almost certainly accelerated the process. Between 2:50 and 2:55 PM, the migrating headcut reached Lake Conemaugh and breached the dam. The embankment failed at that moment, since it could no longer impound the lake. Moments later, though, the dam's myriad issues culminated far more dramatically. Its entire center appeared to give way, and a torrent of water burst forth from the lake. Eyewitnesses remembered this catastrophic final breach much more vividly than the initial, headcut-induced breach (Coleman 2019, Hanson et al. 2005).

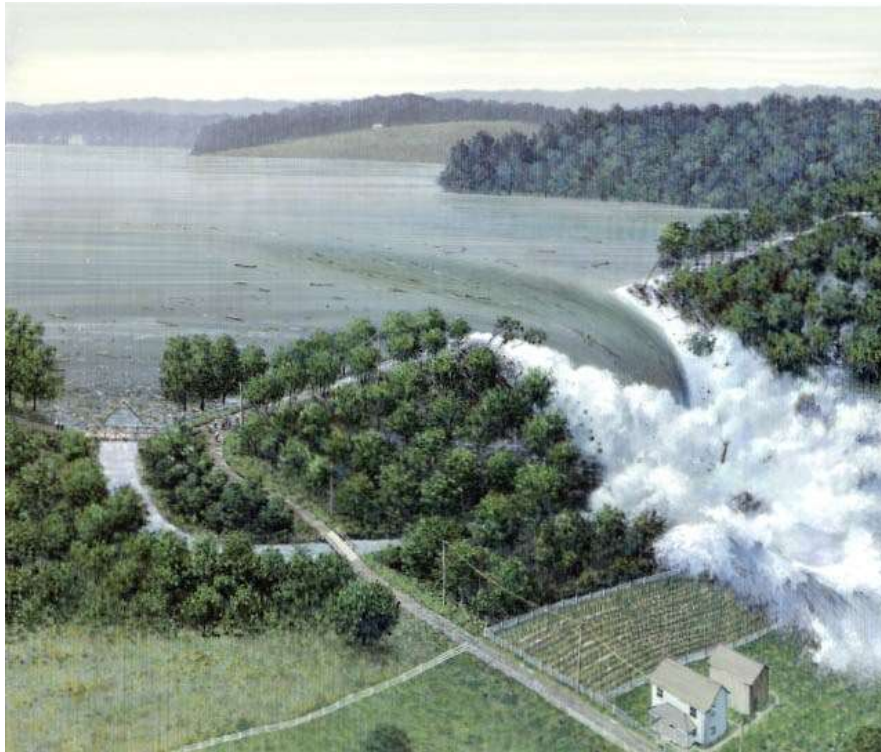
*Figure 30: The final breach of the South Fork Dam on May 31<sup>st</sup>, 1889. Source: NPS (2023 C).*

Overtopping caused the South Fork Dam's initial breach, but the geotechnical nature of its final breach appears not to have been discussed at length. No soil or rock from the final breach region remains available for laboratory testing, of course, and doing a full geotechnical forensic analysis of the failure would thus be highly speculative, as well as expensive. However, modern dam and geotechnical engineers can use the current state of practice of civil engineering to interpret surviving evidence from the disaster and reconstruct how the final breach most likely unfolded. Eyewitness accounts suggest that it occurred primarily due to sliding induced by the overtopping which caused the initial breach and uncontrolled seepage.

Cohesive embankments can fail by overtopping in hours, which matches eyewitness accounts from the South Fork Dam. Transverse cracking in such embankments can accelerate their failure, but firsthand accounts from Lake Conemaugh do not mention whether the dam contained such cracks. By contrast, the accounts make it quite clear that the lake's waters surged furiously through the dam remnants after the final breach. One bystander noted that the onrushing wave displaced the air in its path powerfully enough to topple mature trees and send riprap boulders flying, while another recalled that the torrent cut through the dam "like a knife." Others, including Col. Unger and John Parke, commented that the final breach was less an abrupt break in the dam than a pushing away of its center. These first-hand accounts are consistent with a sliding failure of the dam (Coleman 2019, McCullough 1968).

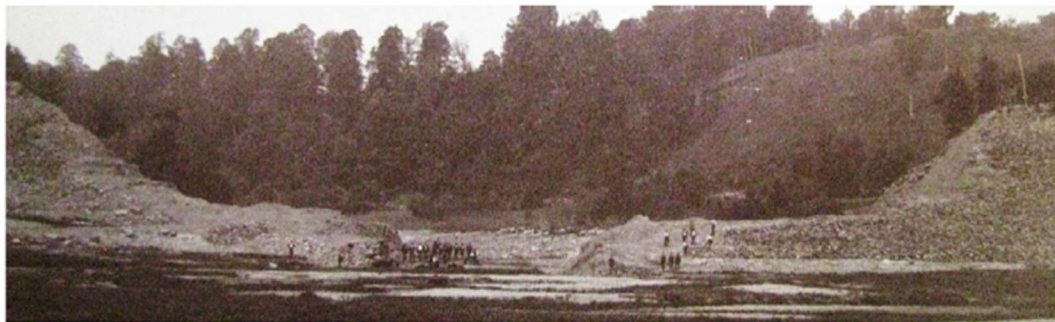
Figure 31: Matching-scale photographic and geometric representations of the South Fork Dam's final breach. Source: Coleman et al. (2016).

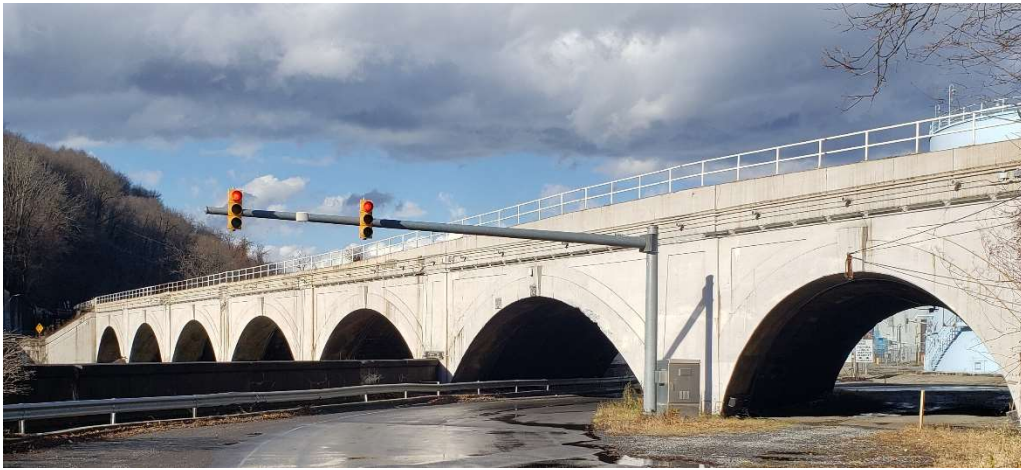
*Figure 36: The seven-arched Stone Bridge, Johnstown. The Pennsylvania Railroad later covered its upstream face with concrete during a widening project. Source: Author.*

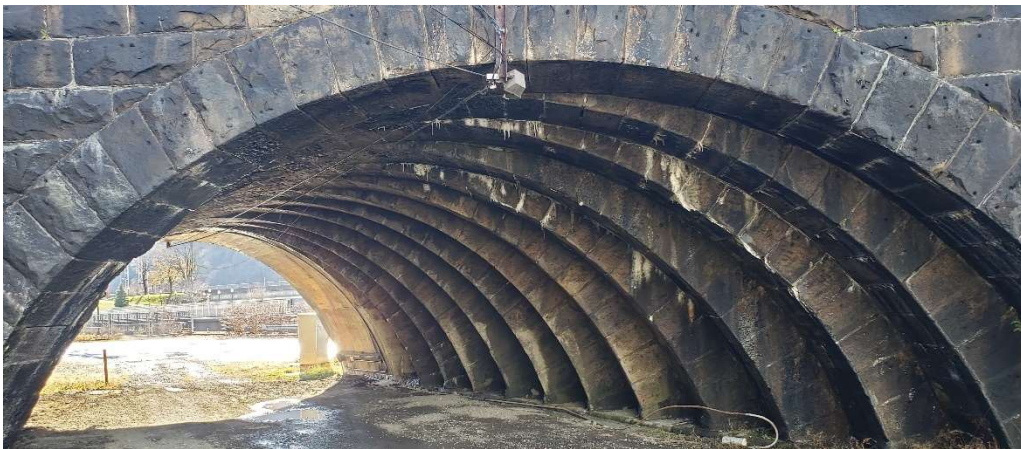
*Figure 37: Close-up of one of the Stone Bridge's ribbed arches. Source: Author.*

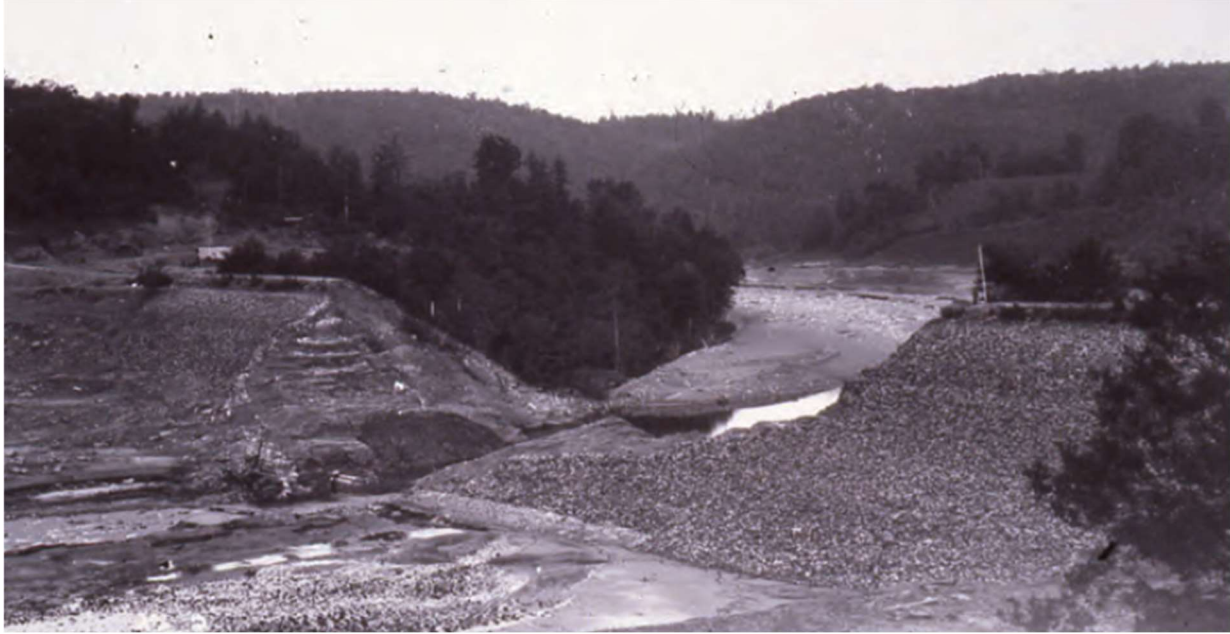
*Figure 43: Former bed of Lake Conemaugh and remnants of the South Fork Dam looking downstream, 1889. Source: Hanna (2021).*

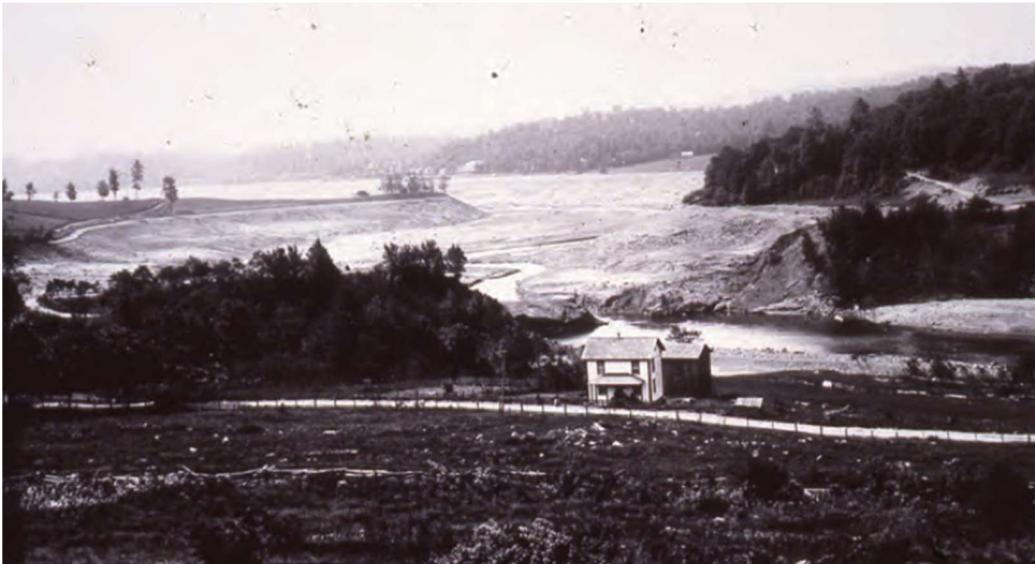
*Figure 47: Former bed of Lake Conemaugh and remnants of the South Fork Dam, 1889, looking south. Source: Hanna (2021).*

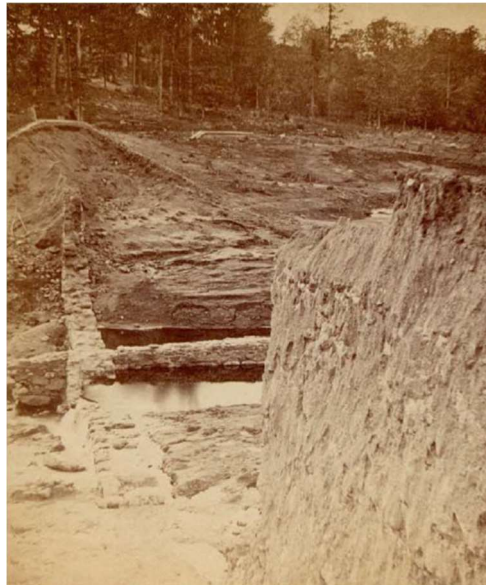
*Figure 48: Remnants of the Mill River Dam in Williamsburg, MA after its breach, 1874. Source: Wooten et al. (2014).*

formed a select committee to examine the failure almost immediately. The committee included James Francis and William Worthen, both of whom later sat on the South Fork Dam committee. The Mill River Dam committee published its searingly direct report in June 1874. The members concluded the breach had been due to a lack of engineering input, seepage through poorly placed materials, an absence of regular inspections, and “defects of workmanship of the grossest character.” Worthen criticized the Mill River Dam’s designers and builders even more frankly in ASCE’s discussion of the report. During its construction, he stated, “Men were employed who were ignorant of the work to be done, and there was nothing like an inspection, although money and life depended upon it” (Coleman 2019, Francis et al. 1874, Wooten et al. 2014).

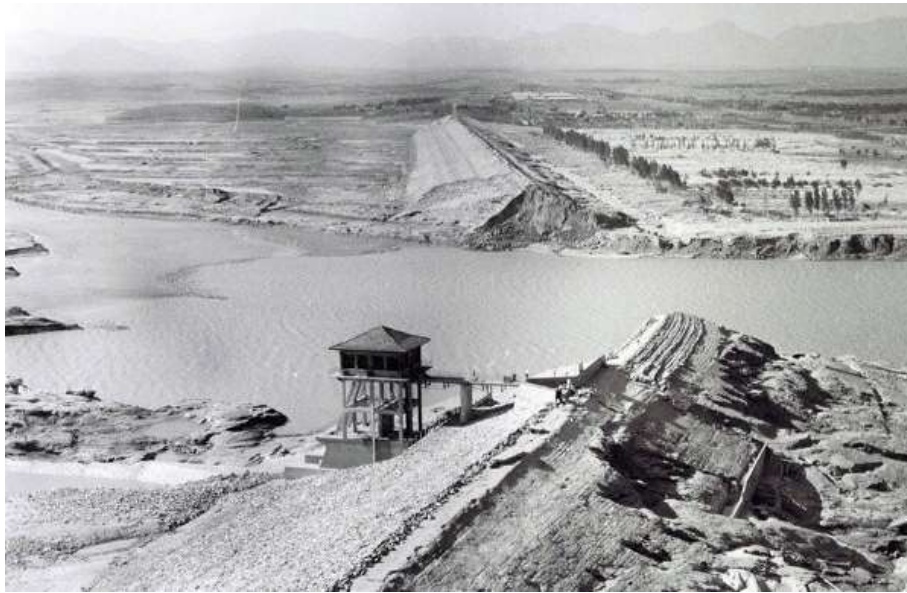
*Figure 50: Remnants of the Banqiao Dam in China after its breach, 1975. Source: Lynch (2023).*

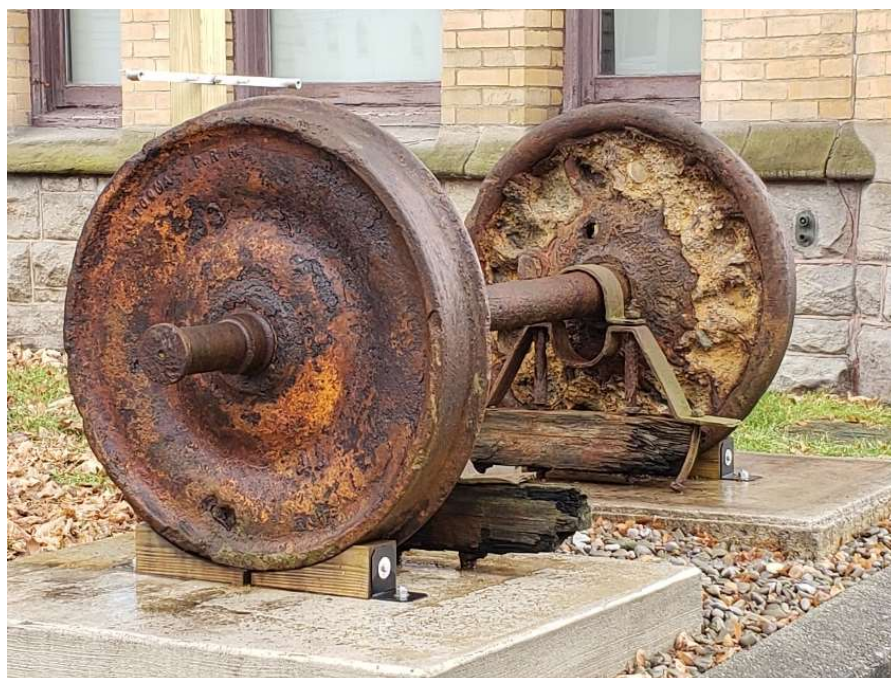
*Figure 55: Railroad car wheels and axle buried by the 1889 flood on display at the Johnstown Flood Museum. Source: Author.*

railroad car axle buried by the 1889 flood and unearthed in the early 2010s by crews constructing a bridge over the Little Conemaugh River (Murphy 2023).

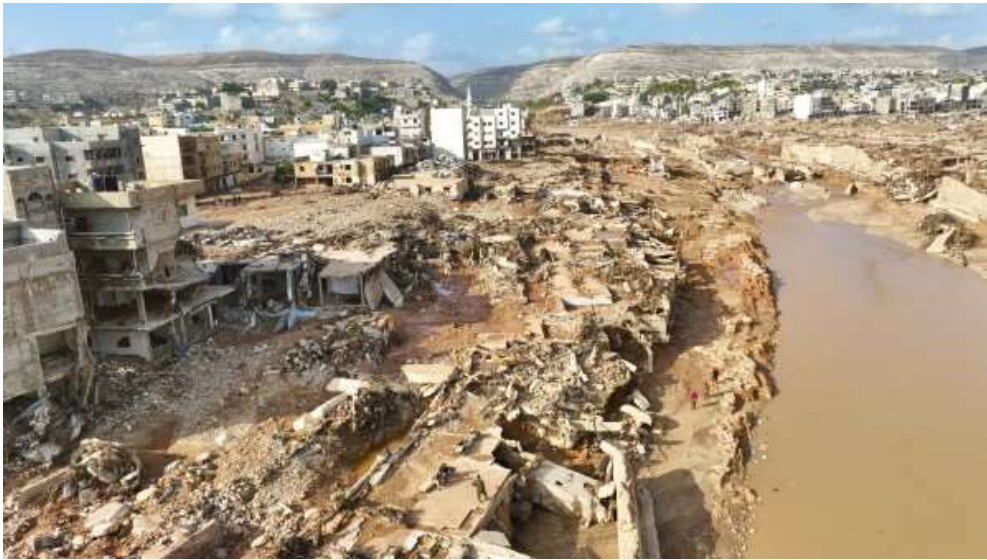
*Figure 57: Remnants of Derna, Libya, after a double dam breach obliterated the city, 2023.  
Source: Magdy (2023).*

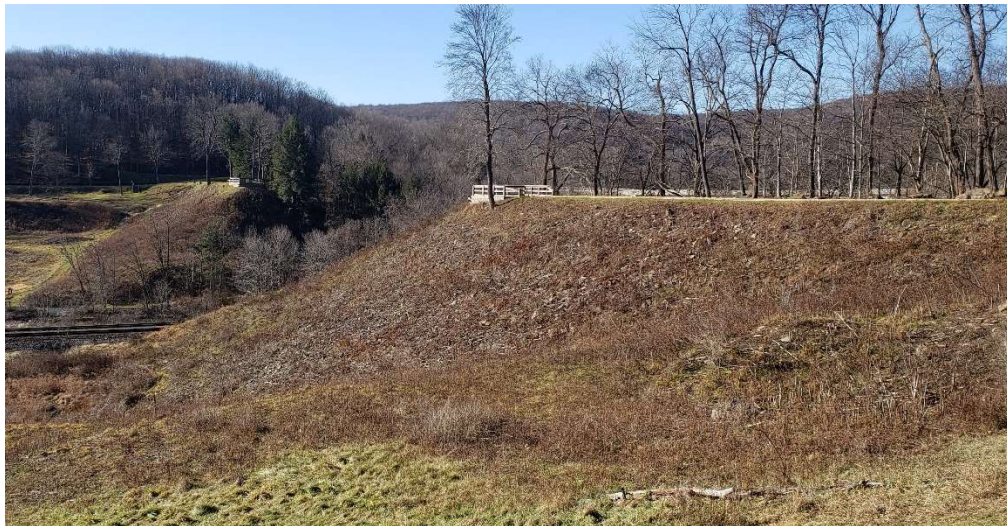
*Figure 58: Remnants of the South Fork Dam, Johnstown Flood National Memorial. Source: Author.*
