Rapid Response to Emergencies:

**ASDSO – Seattle Washington
Tuesday September 21, 2010
General Session 8:30 – 10:00 AM**

Rapid Response to Dam Emergencies Introduction; The Ah-Ha Moment

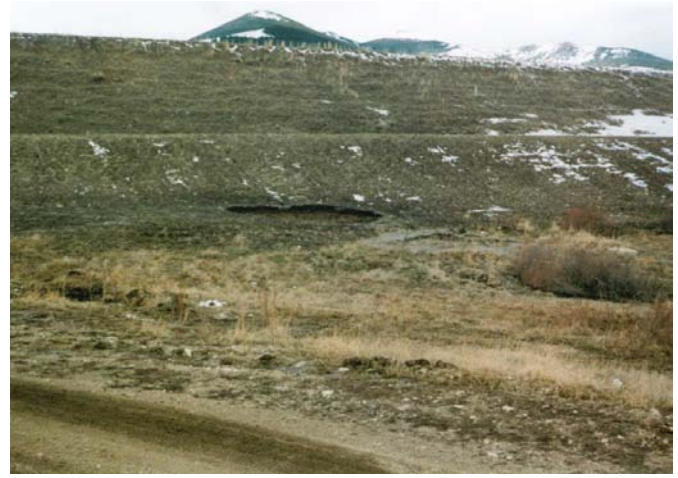
Blow out at toe of Powell dam

The blow out hole was located on the left edge of a recently constructed seepage control berm. It is suspected that construction of the seepage berm may have concentrated seepage towards the edges of the berm. Another contributing factor could have been the storage of top soil during construction. When the top soil was removed, the area may have been left with an uplift safety factor near 1. What is perplexing is the failure did not occur until the second filling after construction.

The ranch had several rolls of a woven geotextile on hand (for silt fence construction). They placed the geofabric directly over the rapidly developing hole, and weighted the fabric down with drain rock that was stockpiled nearby. This successfully stopped the seepage erosion from progressing.

A toe drain was added to the dam, intercepting and draining the gravel layer believed to be the source of the high pressures to the area. No further problems have been encountered.

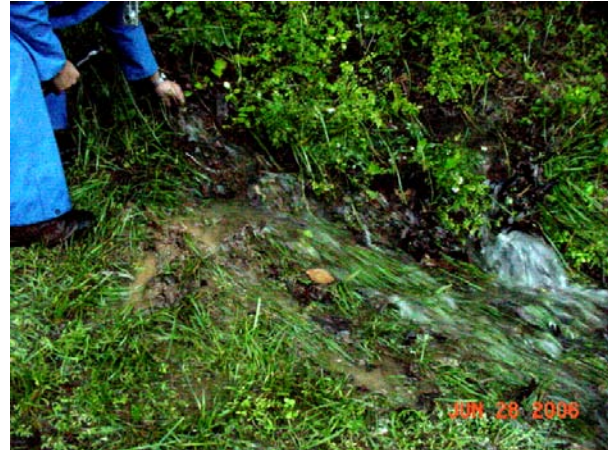
Seep on left abutment viewed from downstream slope

There were insufficient funds to grout the entire foundation during construction and only the right side was grouted. The leak occurred in the ungrouted left abutment. Some finger drains of gravel were included on the left side to control foundation seepage, but the leakage rate during the flood exceeded the flow capacity of the gravel drains and flow started exiting the embankment when the head increased.

First, gravel was spread over the entire leak area. The gravel is used to collect seepage. Next filter fabric was placed over the entire seepage area and held down with gravel and sandbags. The filter fabric was intended to minimize the loss of soils due to internal erosion. The filter fabric was then held down with sand bags and gravel. Evacuation of 2400 people also took place. A simple plywood monitoring weir was constructed to monitor the change in seepage.

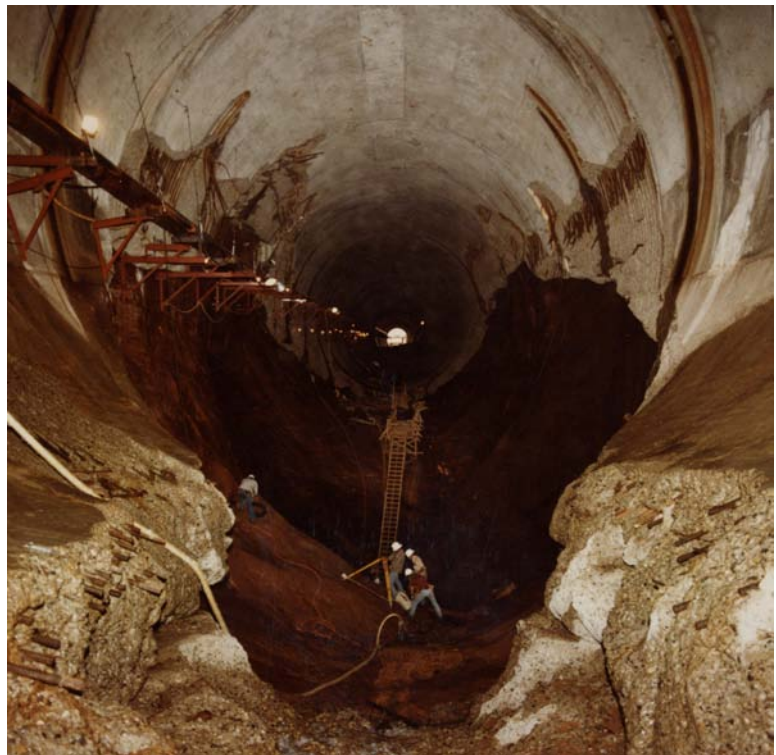
As inflows increased, the decision was made to add a 4-foot flash board on top of the spillway radial gates. As the reservoir continued to rise, these flashboards were removed and an 8-foot-tall flashboard was installed. The decision was made to operate the left spillway and to keep the right spillway in reserve by limiting its use. Loud rumbling noises were heard coming from the left spillway. Large rocks and brown water were observed in the flows exiting the spillway portal. No one knew how extensive the left spillway was being damaged. The spillway operated for a total of six weeks. After it was finally closed, inspectors entered the downstream end of the tunnel on inflatable rafts. The damage was extensive. Several hundred feet of the lining were damaged or removed and a huge 35-foot-deep hole was found eroded into the soft sandstone.

It is suspected that high flows passing over calcium deposits in the spillway elbow joints initiated the cavitation. Once cavitation damage became significant erosion became the most significant contributor to the damage. The soft sandstone was vulnerable to cavitation and erosion.

In 1983 and early in 1984 the hole was filled and the tunnels were repaired. An anti-cavitation system designed to entrain air into the water was part of the project.

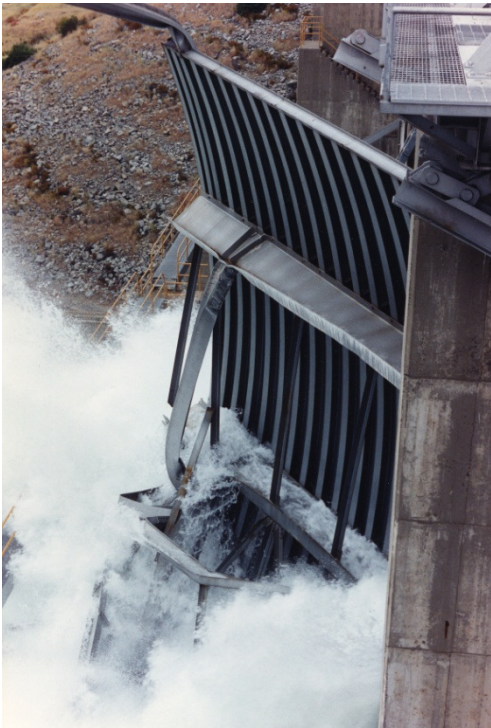
On July 17, 1995, the gate operator stationed at Folsom Dam in California attempted to operate a spillway gate during a routine release procedure. The power plant was going through a scheduled shutdown and releases from the reservoir were required to be re-routed through the spillway. The operator began to hoist the radial gate #3 and felt an unusual vibration along with groaning noise. He turned to look at the gate and saw the radial gate swing outward away from the dam while water poured from the opening. An estimated 400,000 acre-feet of reservoir was lost.

Forensic investigation of radial gate #3 indicated that trunnion pin friction was the main cause of failure. Years of service had caused corrosion and wear on the trunnion pin which led to additional moments induced on the struts supporting the gate. The added stress caused a

failure in the lower struts. Forces then transferred to the remaining members causing failure as well. The elapsed time from the operator feeling the unusual vibration to failure is estimated to be less than a few seconds.

A replacement gate was fabricated for bay #3. The remaining 7 radial gates were refurbished to handle the additional loads caused by frictional moments. Gate repair cost \$20 million.

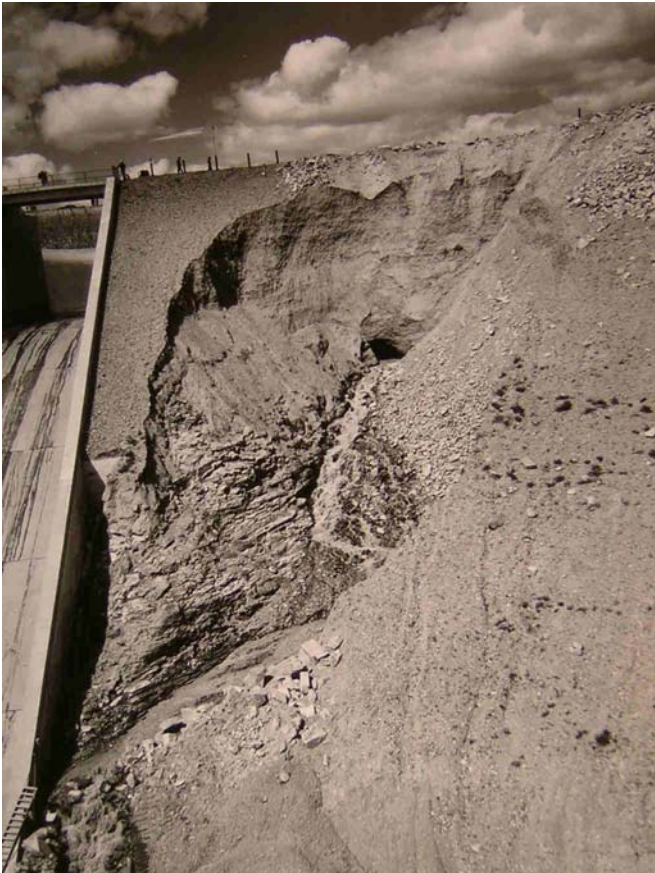
To investigate the incident, the entire right end of the dam was removed. The abutment was found to be highly fractured, no dental concrete was placed, it was very steep and there were rock overhangs. The Corps of Engineers sent a team to investigate. The leak and near failure were attributed to reservoir water passing through horizontally-bedded sandstone/shale. The single line grout curtain was inadequate. Much more effort should have been undertaken at the rock/embankment interface. Filters and drains should have been incorporated in the design.

A contractor working on the outlet works was directed to relocate their equipment in an effort to slow the leak and the sloughing. This proved ineffective. The irrigation headgate was opened and the outlet works was opened to lower the reservoir and reduce the seepage flow. Large rock was dumped from the crest of the dam into the void. This rock mixing with embankment soil caused temporary blockage of the leak but then the seepage reemerged. A 20-foot by 15-foot sinkhole emerged in the crest of the dam on the 4th day of the incident. This was filled with riprap from the upstream slope. Failure was averted due to the above actions and the lowering of the reservoir. There was extensive media coverage and public interest in the event.

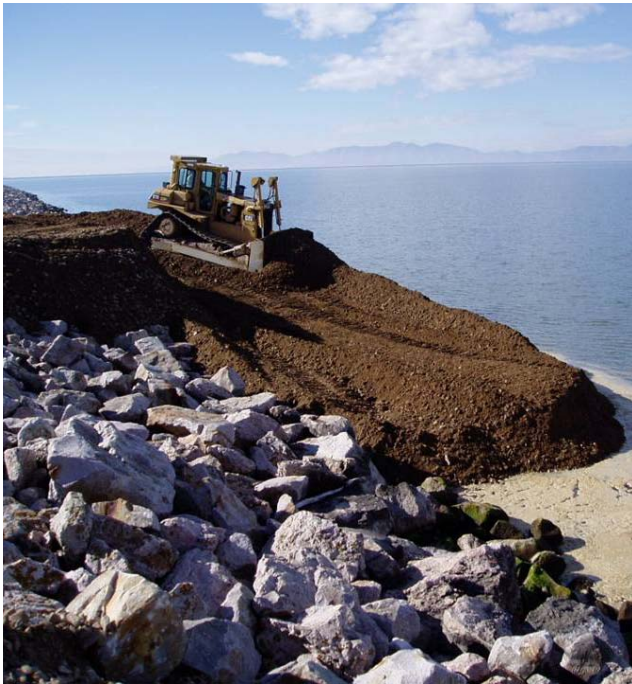
A.V. Watkins Dam is a Bureau of Reclamation dam near Salt Lake City, UT. It has a maximum height of 36 feet, is 14.5 miles long and stores 215,000 acre-ft. On November 13, 2006, a local rancher notified district personnel of seepage at the downstream toe. District and Reclamation personnel immediately went out to the site and observed active piping (internal erosion). Seepage was estimated to be 1-2 cfs. Active sand boils were observed. A substantial amount of material was found deposited in the South Drain canal located just downstream of the dam toe. A slough developed on the downstream slope and cracking indicated the embankment was being compromised.

An emergency was declared. Equipment was stationed at the west dam section in case an emergency breach was needed. Reservoir drawdown was initiated. Sand and gravel sources were located and transported to the site. An excavator and other equipment were mobilized. Reclamation and the District worked through the rainy night to save the dam. Initially, filter material washed away because of high flows. A 75' x 100' filter and stability berm was constructed at the toe of the dam and up the downstream face. However, 150-200 gpm cloudy seepage continued to emerge in the South Drain. To cut off the upstream entrance seepage location, a large berm (6,000 cubic yards) was constructed on top of the upstream slope.

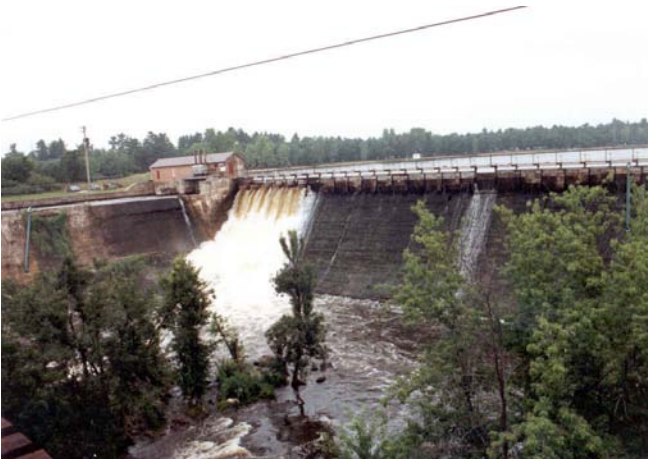
Trip gate portion of dam

The Hatfield Dam is a large dam located in north central Wisconsin holding back Lake Arbutus. The dam consists of two gated concrete gravity sections, a 3 mile long power canal, powerhouse and earthen embankments. The dam was built in the early 1920's using mule trains to excavate the long canal. A large rain event in June of 1997 caused a portion of the canal to fail draining the canal, flooding downstream Black River Falls and threatening to drain Lake Arbutus. The headgates to the mill race were shut prior to the lake draining completely. That is when the concern was noted.
