Heliyon 2 (2016) e00120

Dam-Breach hydrology of the Johnstown flood of 1889—challenging the findings of the 1891 investigation report

Neil M. Coleman^{a,*}, Uldis Kaktins^a, Stephanie Wojno^b

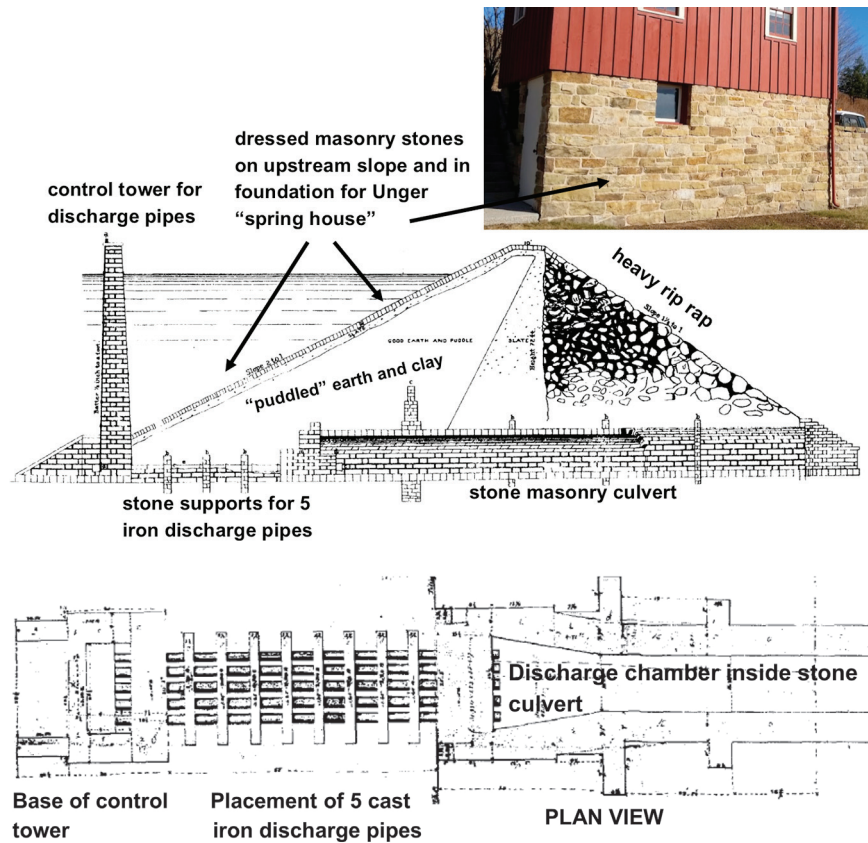
Another change relates to the masonry stones that were originally placed on the upstream side (“slope wall”) of the dam ([Fig. 2](#)). As shown in [Fig. 3](#) of [Kaktins et al. \(2013\)](#), the placement of these dressed stones on the northeastern side of the dam seemed to be incomplete at the time of dam failure. According to Benjamin Ruff, in a written reply to an engineering report from Daniel J. Morrell (Cambria

Fig. 2. View of the original design of the South Fork dam (Morris, 1841), showing heavy riprap on the downstream face, a broad "puddled" clay section on the upstream side, slope wall of dressed stone on the upstream face, and a masonry culvert beneath the dam center fed by cast-iron pipes to discharge water and control the lake level. In 1846 the plan was revised to replace the masonry control tower with a wooden frame tower (Francis et al., 1891, p. 444). Modified from Plates LI and XLVIII of Francis et al. (1891). Photo inset at upper right: dressed masonry stones in the foundation of the Unger "spring house" at the Johnstown Flood National Memorial (photo by N. Kaktins).

Iron Company), the face of the dam on the lake side was not covered with riprap, but was covered with a "slope wall" (McGough, 2002, p. 24). Therefore the masonry cover that comprised the slope wall may well have been complete for the original dam, but some of those dressed stones were apparently removed during or before the dam reconstruction. A National Park Service (NPS) photograph reproduced in McGough (2005, Illustration #9) clearly shows that, at least on the northern side, the original dressed stones have been replaced by riprap on the rebuilt dam. We found masonry stones that appear similar in size to the original specifications incorporated in the foundation of the house and spring house of the former F. J. Unger property, on the north side of the dam (Fig. 2, inset top right). Unger was the last president and manager of the SFFHC. The former barn reportedly also had dressed stones in its foundations. They may have been scavenged from the dam before it was rebuilt because photos of the lake side of the

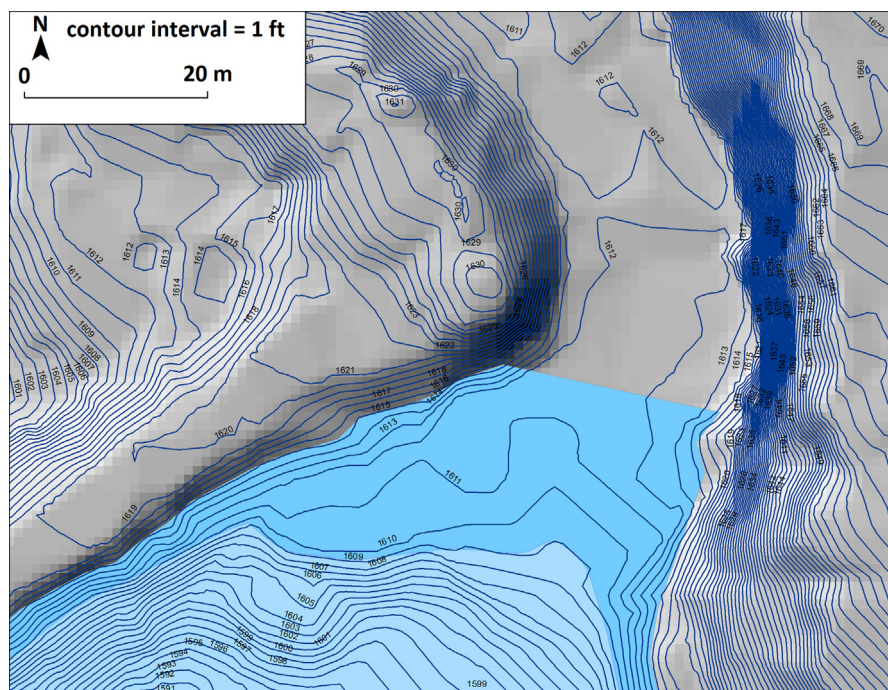
LiDAR data (PASDA, 2013b) for the surface of the main spillway show that it transitions from \sim 1609 ft at the upstream entry to a crest of \sim 1612 ft (491.3 m, NAVD 88) over a distance less than 20 m (Fig. 8). To augment the LiDAR digital elevation model (DEM), which has a vertical accuracy of $<$ 1 m, a high-resolution GPS measurement is available for the soil surface, at a point 1 m south of the 3rd bridge support post from the eastern end. The GPS elevation is 1608.8 ft (490.36 m, NAVD 88). As part of a 2011 soil survey permit (NPS, 2012) we used a thin penetrator rod to measure soil thicknesses at several points along the axis of the spillway. No soil samples were taken, only depths were determined. The depth of refusal for the thin rod represents a minimum soil thickness. These measurements are used to estimate the elevation of the subsoil spillway surface. At the GPS location the soil thickness is \geq 27 cm. Subtracting this, the elevation of the spillway rock surface is \leq 490.1 m (NAVD 88). However, this location is near the spillway

Fig. 8. Contour map of main spillway, produced using LiDAR 3.2 ft DEM of Pennsylvania (PASDA, 2013b). The elevation data for the DEM were obtained before December, 2006.

“lip” and not near the crest of the spillway. Starting from the GPS location, at a distance 35 m to the north along azimuth 12°, three measurements 0.1 m apart with the penetrator rod reveal soil depths of 53 to 56 cm. The narrow range suggests the soil was fully penetrated. The surface elevation here is ~490.9 m, determined with an inclinometer in two stages over the 35 m distance. Subtracting the soil depths, the spillway surface at the crest has an elevation of ~490.4 m (NAVD 88). The result is a difference of 6.1 ft between the 1889 survey and modern GPS-based data. Compared to the more accurate GPS measurement, the LiDAR DEM over-predicts the soil surface elevation at the spillway crest by about 0.3 m, which is within the DEM accuracy range. Part of this small over-prediction might be influenced by conditions in the spillway itself, including its vegetated surface, tree-lined upper margins, and steep side slopes. Reports of vertical accuracy testing for LiDAR data published for Pennsylvania are provided by [DCNR \(2016\)](#).

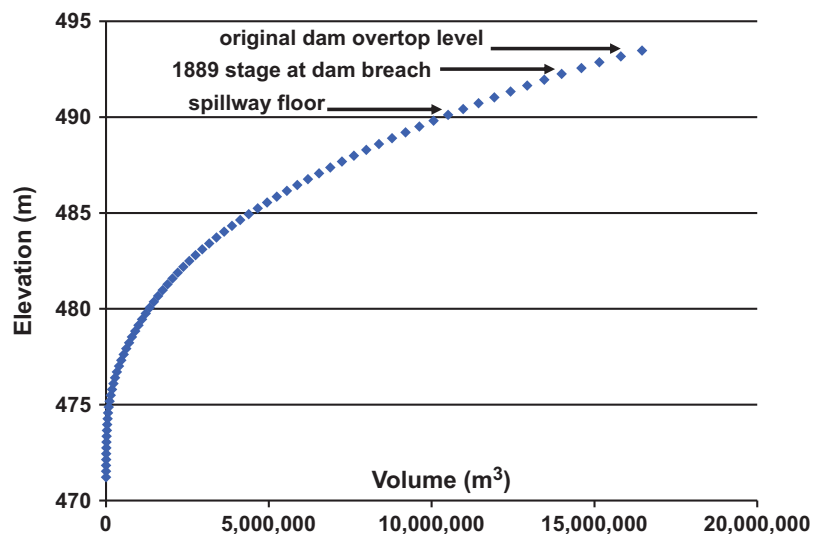
Using the LiDAR data we have developed a new storage elevation curve that shows the amount of impounded water beneath any given lake stage (Fig. 9). The shape of the curve shows that small increases in stage height reflect nonlinear increases in lake volume. We have not included a correction for lake-bottom sediments that would have been present in 1889 and would have diminished slightly the original lake volume. There is post-flood photographic evidence that such sediments were present (Fig. 3 of Kaktins et al., 2013), but the average sediment thickness over the basin before the dam breach is not known. A significant fraction of the former lake bottom sediment probably washed away in the first years after the dam breach, before it could be stabilized by vegetation. As part of a former NPS research permit (NPS, 2012), in October 2011 soil samples were collected and analyzed from five locations in the southern part of the lake basin. The samples were collected under the supervision of NPS employees. In this small sample set the soils had an average depth of 27 cm based on depth-of-refusal. Part of this soil depth would have included native soils that were present before the dam and reservoir existed.

Fig. 9. LiDAR-based storage-elevation curve for Lake Conemaugh. The highest point on the curve represents an overtopping level of 493.5 m for the South Fork dam *as originally built*. Data Source: PASDA (2013a, b).

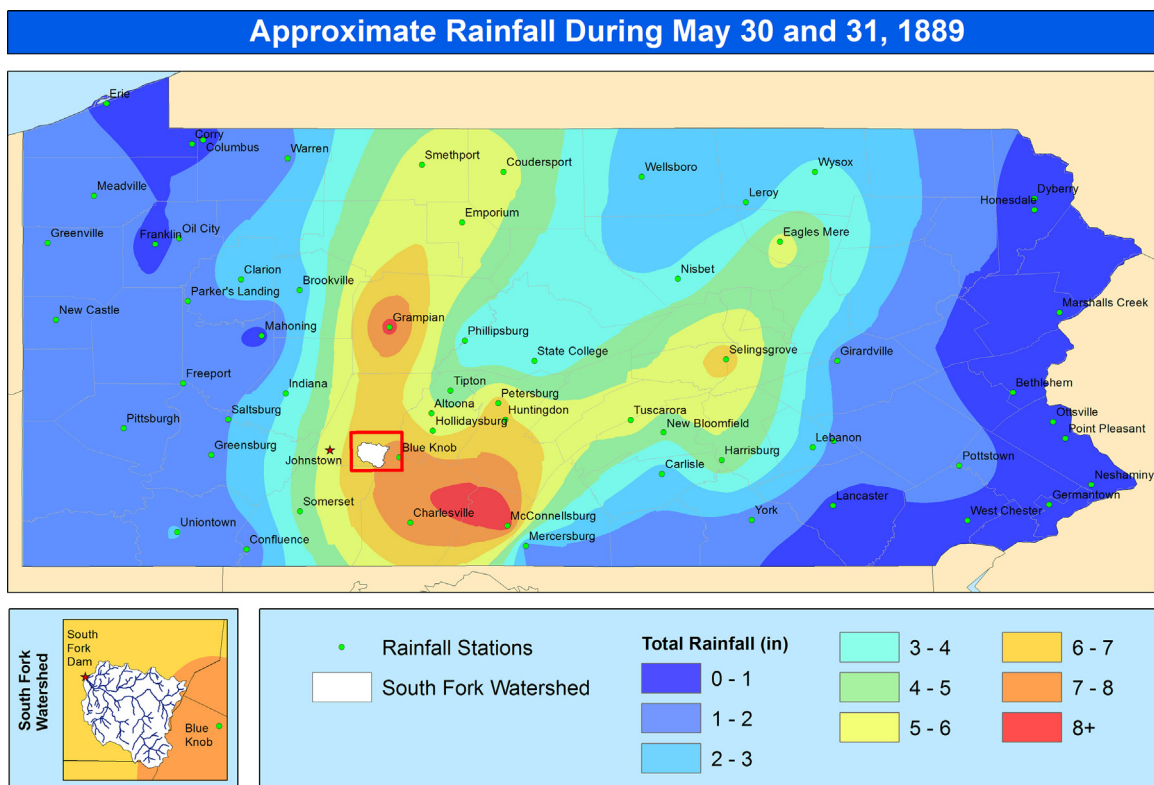
exceeded the threshold for 100-year, 24-h storms (Fig. B-8 of [USDA, 1986](#)). [Fig. 10](#) shows the approximate rainfall distribution in Pennsylvania during May 30–31, 1889. Station data used to develop the map are given in a Table in the online supplementary material. The closest stations to the South Fork dam included Blue Knob (19 km east) and Hollidaysburg (34 km east). The rainfalls associated with the 1889 event were 9 inches (1.00 in = 2.54 cm) or less, with the highest measurements being reported at Grampian (8.60 in), Blue Knob (7.90 in), Charlesville (7.60 in), and far to the east at McConnellsburg (8.99 in). The Blue Knob station lies just east of the watershed. We consider that a plausible average rainfall total over the South Fork watershed was 6 to 7 in, with as much as 7+ in in the easternmost parts of the watershed. There was no precipitation station in the watershed in 1889, but one anecdotal observation was documented by [Francis et al. \(1891, p. 468\)](#). A small dam existed on one of the tributary streams that fed Conemaugh Lake. The proprietor of this dam stated that “. . . a pail, which was empty the night before, had 6½ inches of water collected in it from the rain during

Fig. 10. Approximate rainfall distribution in Pennsylvania during May 30–31, 1889 (data are from Table in online supplementary material). Contour interval = 1 inch of rainfall. Cities and towns on the map are data locations. Contours were developed using the kriging interpolation method with the measured data points. This method of interpolation is based on the statistical relationship between measured points to produce a predictive surface and provides a measure of accuracy in those predictions ([ArcGIS 2011](#)) (sources: [Blodget, 1890](#); [Russell, 1889](#); [Townsend, 1890](#)).

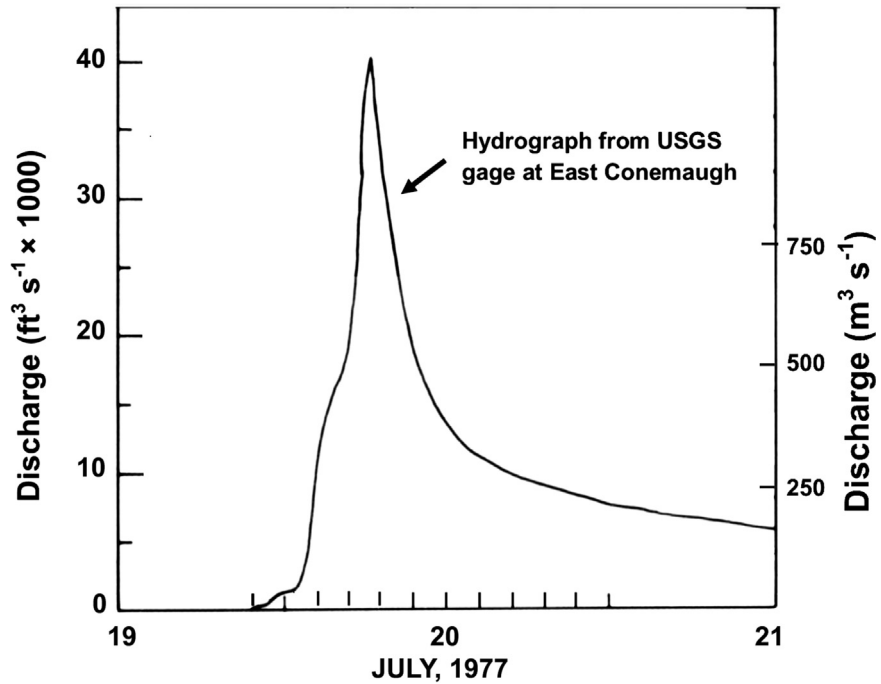
Fig. 11. Discharge hydrograph for the Little Conemaugh River at East Conemaugh during the Johnstown flood of 1977 (after Brua, 1978). In this extreme runoff event, the discharge rate at this gage downstream on the main stem of the river exceeded 50% of its peak for only 5 h.

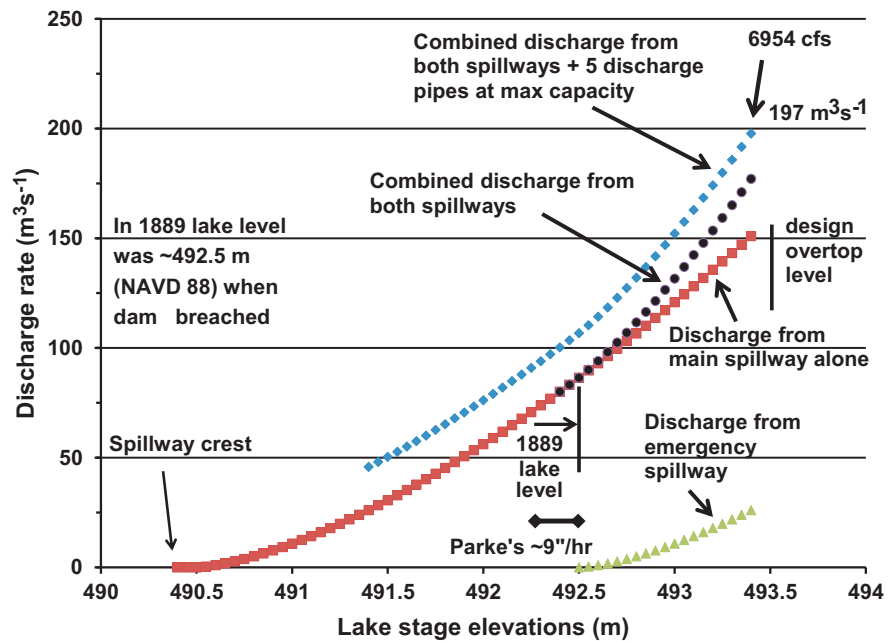
Fig. 12 shows the discharge capacity of the dam via its two spillways and five sluice pipes, assuming the dam had been rebuilt to its original specifications. Table 4 summarizes key data for the dam and watershed. Our analysis shows that the lake surface at time of dam failure had an elevation of ~492.5 m (NAVD 88).

Fig. 12. Discharge capacity for the South Fork dam as originally designed, with crest ~ 1 m higher. The base level of this chart is ~ 490.4 m which is our estimate of the modern-day elevation of the subsoil spillway crest (see Section 2.3.2). Overtopping would have occurred at ~ 493.5 m (NAVD 88) if the dam had been rebuilt to its original crest height. The spillway flow level would have been ~ 0.1 m less.

The dam as originally built could have discharged floodwater at a maximum rate of $\sim 197 \text{ m}^3 \text{ s}^{-1}$ (6954 cfs) given a spillway flow surface elevation of 493.4 m (NAVD 88), more than 2 times greater than the estimated discharge capacity of the reconstructed dam. This greater discharge capacity has major implications for the survivability of the dam *as originally built*.

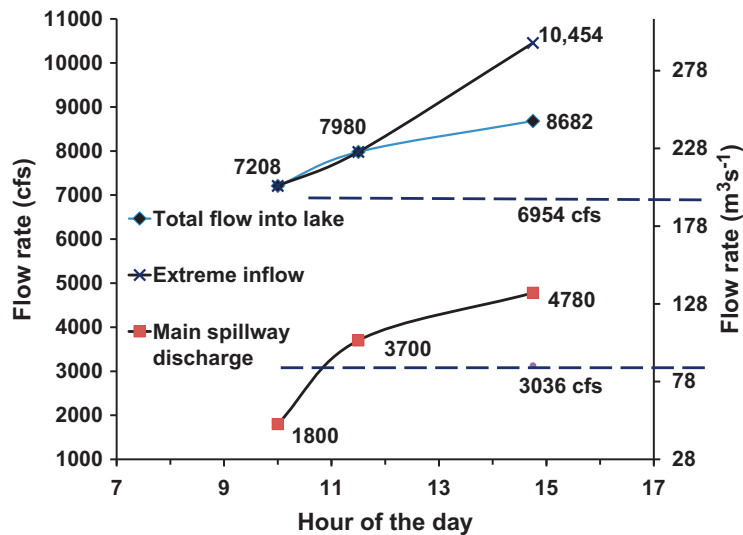
Fig. 13. Various inflow rates estimated by Francis et al. (1891) for the South Fork dam and reservoir. Upper two plots represent total estimated inflows to reservoir. Lower plot represents estimated discharges in main spillway. Lower blue dashed line is maximum discharge in main spillway based on 6.7 ft (2.0 m) height of flood marks measured by Davis (1889). We estimate $86 \text{ m}^3 \text{ s}^{-1}$ for the spillway at that time. Upper dashed line is our estimate of the total discharge capacity of the dam as originally built ($197 \text{ m}^3 \text{ s}^{-1}$).

Interestingly, the committee did a further calculation (Fig. 13) to estimate an upper limit for the inflow that day, by assuming a rainfall rate of $2/3$ inch (1.7 cm) per hour on the watershed (20,900 cfs) and that half of this influx (10,450 cfs) would discharge into the lake (Francis et al., 1891, p. 454). The committee predicted that a flow rate of this magnitude or higher could have entered the reservoir by 4 p.m. (or later) on May 31, more than an hour after the actual breach. This calculation appears intended to show that water levels could only have been expected to go higher, strengthening the basis to conclude the dam would have failed even if it had been repaired to its original specifications. However, the committee did not

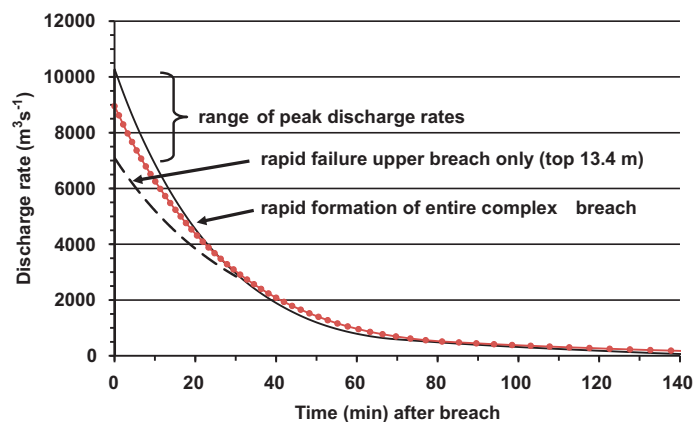
Hydrographs were developed by summing the discharges from the inner and outer breaches over time as the lake gradually drains (Fig. 15). The model fully incorporates the complex breach shape in the South Fork dam and is based on the storage-elevation curve of the reservoir (Fig. 9) and a dam breach weir equation that allows specification of the breach side slopes. Eq. (6) was used with data from the storage-elevation curve by numerically evaluating lake stages and volumes that correspond with integrated model discharges through the breaches. One scenario

Fig. 15. Dam breach discharge hydrographs for the 1889 flood. Red dotted line represents scenario where the entire breach formed instantly. Solid black line includes 15% increase in initial discharge to incorporate uncertainty (see text). These calculations represent maximum theoretical discharge through the breach and spillway, with $Q_p \sim 8970$ to $10,300 \text{ m}^3 \text{ s}^{-1}$. Dashed black line represents early-time discharge from only the top 13.4 m of the breach. This line intersects the vertical axis at $\sim 7100 \text{ m}^3 \text{ s}^{-1}$. Adding $\sim 100 \text{ m}^3 \text{ s}^{-1}$ for the spillway and ditch yields the minimum Q_p of $\sim 7200 \text{ m}^3 \text{ s}^{-1}$.

we analyzed includes a 15% increase in initial breach discharge rate to incorporate uncertainty in the overall analysis. Sources of uncertainty may include complexity of flow through the unusual “double” breach, accuracy of breach reconstruction from 19th century data and images (present breach is highly altered from original), and the possibility that a transient deeper channel formed in the lower breach that was infilled during the waning flood. The latter point is less likely because the original dam base was excavated to bedrock.

We include a hydrograph plot that represents early-time (0 to 30 min) discharge through the top 13.4 m of the breach, assuming it formed instantly (dashed black line in Fig. 15). The lowest part of the “inner” breach may have formed gradually. Hydrographs for all scenarios of erosion (rapid or gradual) of the lower 7.9 m of the inner breach (see Fig. 14) would lie between the red line and the dashed black line in Fig. 15. We emphasize that all the discharge hydrographs represent conditions at the breach and for the stream immediately below the dam and upstream from the juncture of the South Fork with the Little Conemaugh River. Our present work focuses on the dam breach and does not analyze the flood routing along the Little Conemaugh to the former boroughs that now comprise Johnstown.

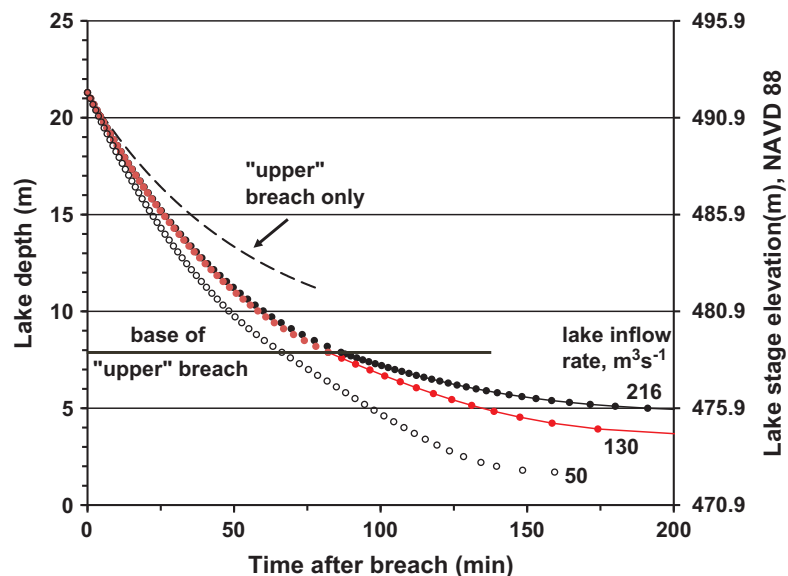
The lake stage hydrographs are shown in Fig. 16, illustrating the decline in lake level during the flood. Plots for three lake inflow rates are shown. Spillway flow is

Fig. 16. Lake stage hydrographs for Johnstown Flood of 1889. Curves are plotted for three different lake inflow rates. Dotted lines represent cases where the entire complex breach formed rapidly, which would have drained the lake in the shortest time. Plot of open circles includes 15% increase in initial discharge rate to incorporate uncertainty (see text). Dashed line shows hypothetical lake stages if only the upper 13.4 m of the breach had formed. The zone between the dashed and dotted lines represents a family of curves for all plausible erosion times for the lower 7.9 m of the inner breach.

incorporated only in the early minutes before the lake fell below its crest. The plot for total inflow of $216 \text{ m}^3 \text{ s}^{-1}$ corresponds to the lake rise reported by J. Parke (9 in h^{-1}) just before overtopping, plus an added inflow of $15 \text{ m}^3 \text{ s}^{-1}$ to address uncertainty. Curves for two lesser inflows are shown because the lake inflow likely declined during the more than 3 h from the time of initial overtopping until the dam failed. At least 65 min were needed for the stage to fall below the floor of the upper breach. At late times the lake levels approach equilibrium as discharges through the lower breach approach the lake inflow rates. To help verify the calculations for the discharge and stage hydrographs, Fig. 17 was prepared to demonstrate the close water balance in the model. This calibration plot compares cumulative model flood discharge with the storage elevation curve for Lake Conemaugh (Fig. 9).

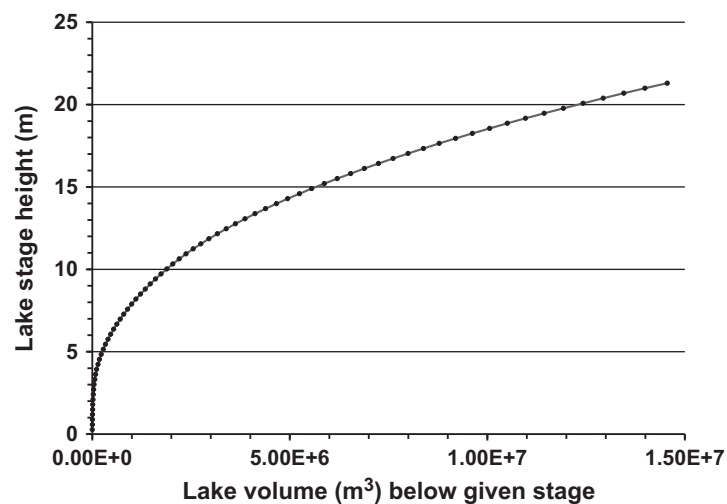
Fig. 17. Calibration plot shows good water-balance fit between the storage-elevation curve for Lake Conemaugh in 1889 (black data points) and total lake volume minus cumulative model discharge for the rapid breach scenario (curved line). For this plot model discharge does not include lake inflow. The curve match is consistent with a lake floor shape factor (m) of 2.7, which represents a basin with gently sloping sides and bottom (see Walder and O’Connor, 1997, p. 2341).

drop enough to expose the base of the upper breach, and parts of this base may have been exposed in a shorter time. This may have led some observers to think the lake had fully drained in that time. However, the flow depth would still have been ~8 m in the lower breach. Certainly after 65 min large areas of former lake bottom would have been exposed by the rapidly falling lake level. It is therefore easy to see why different observers gave a wide range of time to drain the lake. If the lowest part of the inner breach took a significant time to form, then the drainage time should have been longer. One further insight from the hydrographs is that tailwater effects at the outlet were probably not significant, otherwise even more time would have been needed to drain the lake.

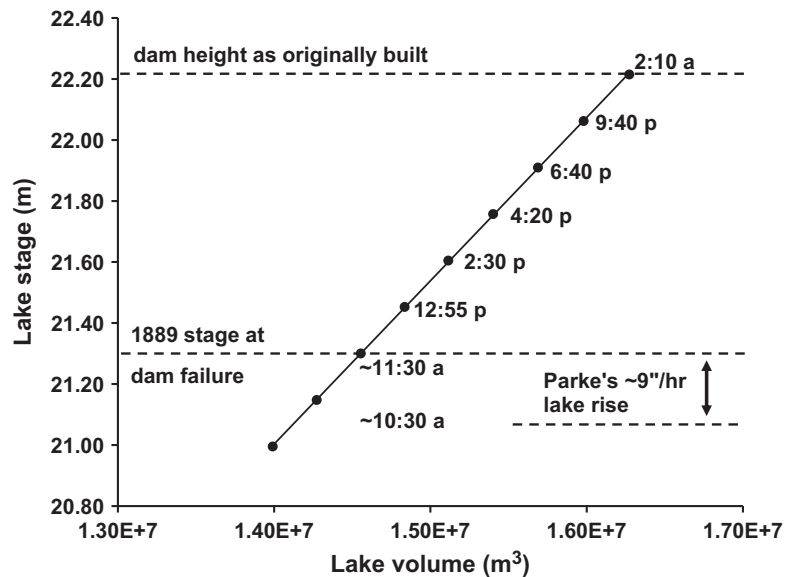
We prepared Fig. 18 to clearly show how the dam as originally built would have resisted overtopping on May 31, 1889. Even if extremely high lake inflows had continued unabated, overtopping of the dam at its original design height would have been averted for 14 h. In the absence of alternate failure mechanisms such as piping, the dam would have been preserved because lake inflows would have substantially diminished during the afternoon and evening. In the actual event, if the estimated peak inflow had time to fall just 9%, from ~ 216 to $\leq 197 \text{ m}^3 \text{ s}^{-1}$, overtopping would have been entirely prevented had the dam been rebuilt to its original height. Fig. 18 also reveals that had the reconstructed dam been built only

Fig. 18. Graph showing time needed to reach various hypothetical lake stages. Graph was prepared using the discharge capacity curves in Fig. 14 with the storage elevation curve in Fig. 11. The plotted times assume that a constant lake inflow of $\sim 216 \text{ m}^3 \text{ s}^{-1}$ would continue for many hours. Even in this extreme and unrealistic scenario, the nonlinear increase in spillway and pipe flow capacities and rise in lake storage would have averted overtopping for $\sim 14 \text{ h}$. In reality the dam would never have been overtopped.

0.6 m higher, overtopping would have been delayed more than 7 h even at the high and constant inflow rate assumed to develop this figure.
