United States Committee on Large Dams

**Observed Performance  
of Dams  
During Earthquakes  
Volume I**

July 1992

Prepared by the USCOLD Committee on Earthquakes

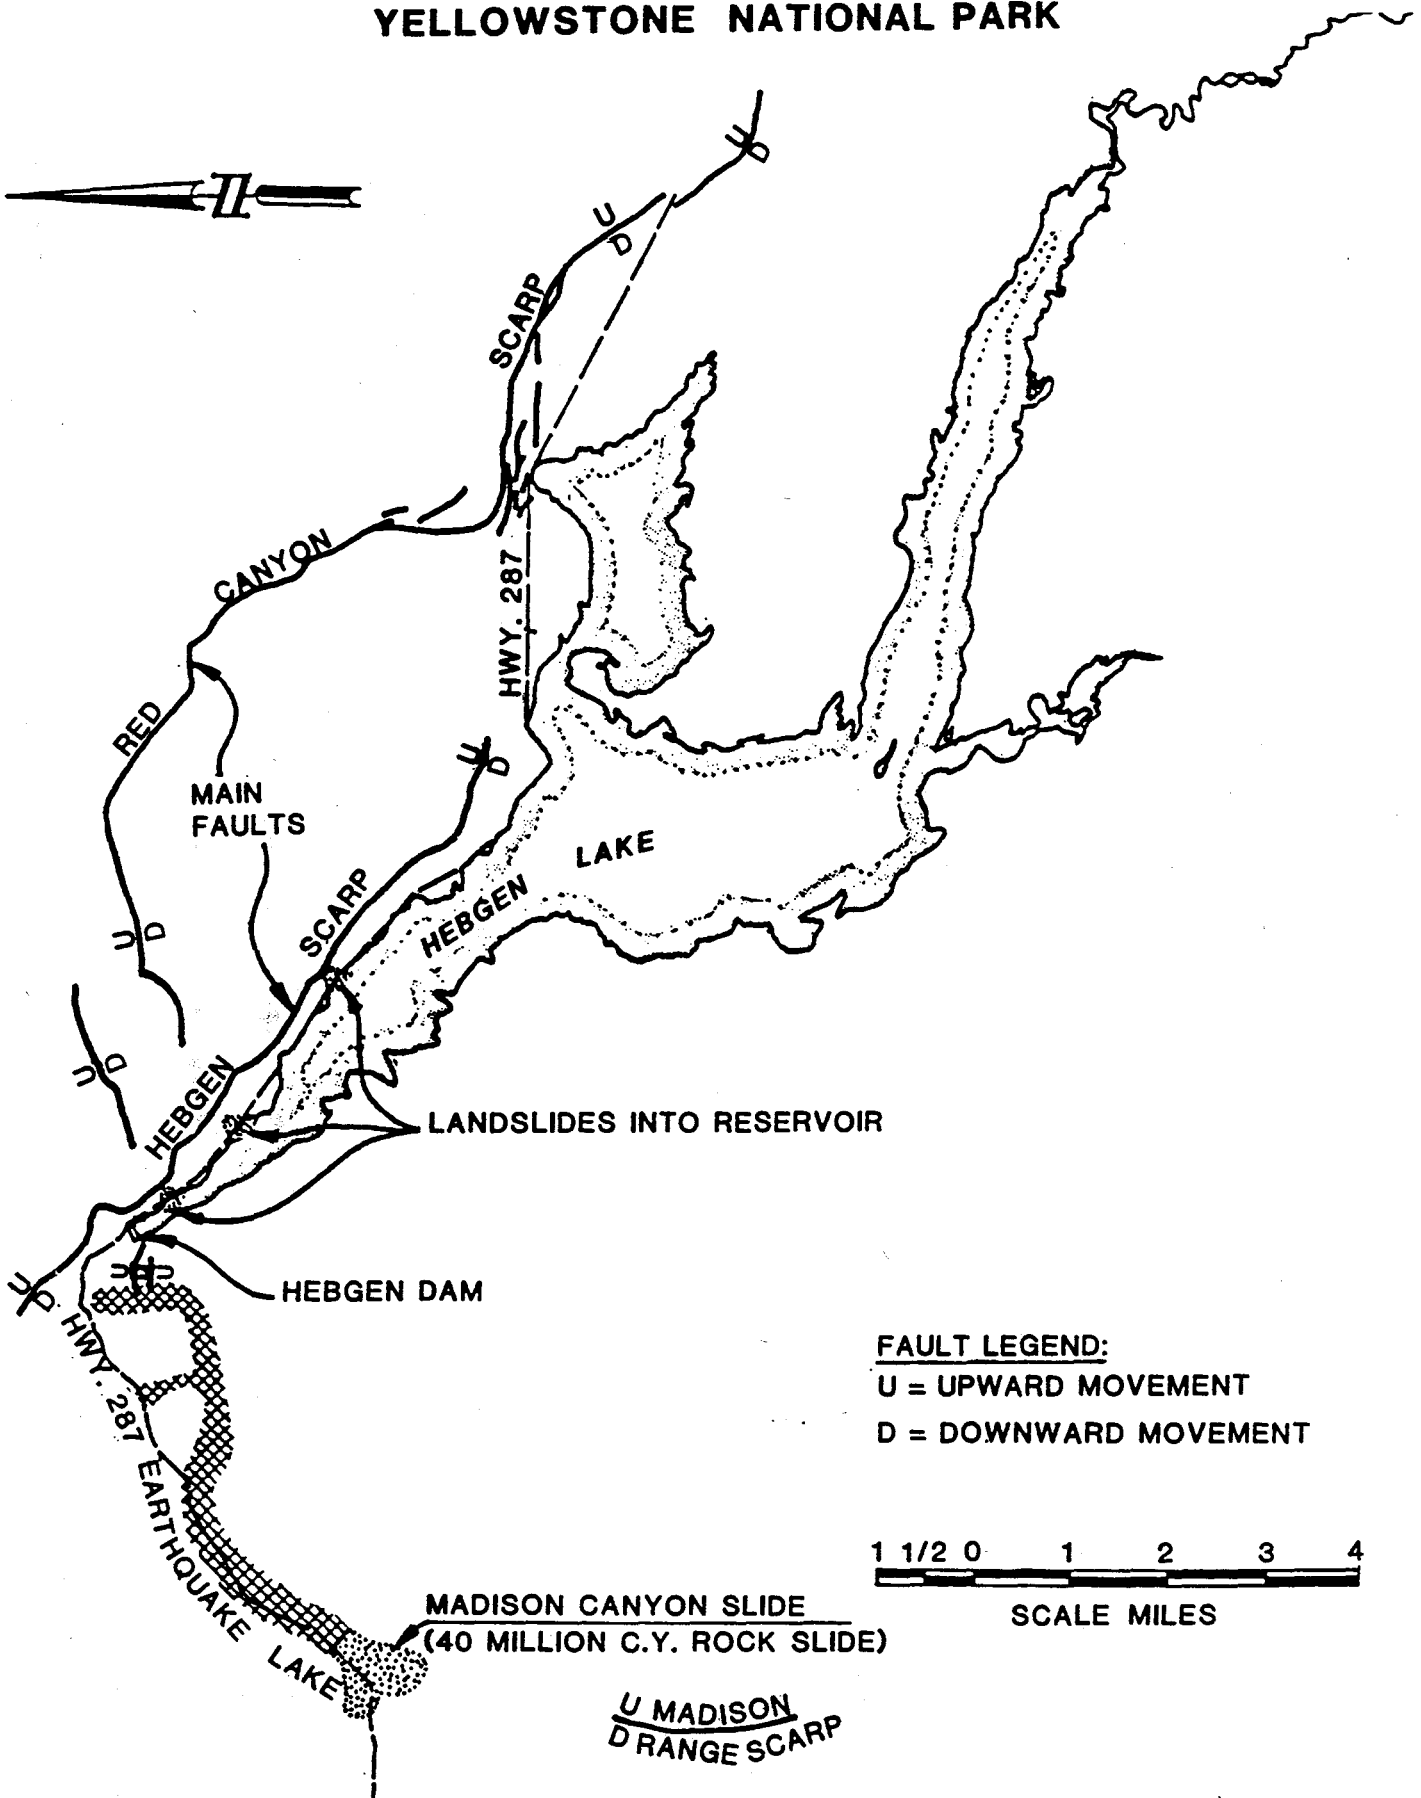
Major landslides occurred along the banks of Hebgen Reservoir and downstream, where 40 million cubic yards of rock and soil filled the Madison River canyon for a distance of nearly one mile, forming a natural dam 230 feet high (Figure 1).

33 **FAULTING AND LANDSLIDES AT RESERVOIR**  
 Hebgen Dam  
 Figure 1

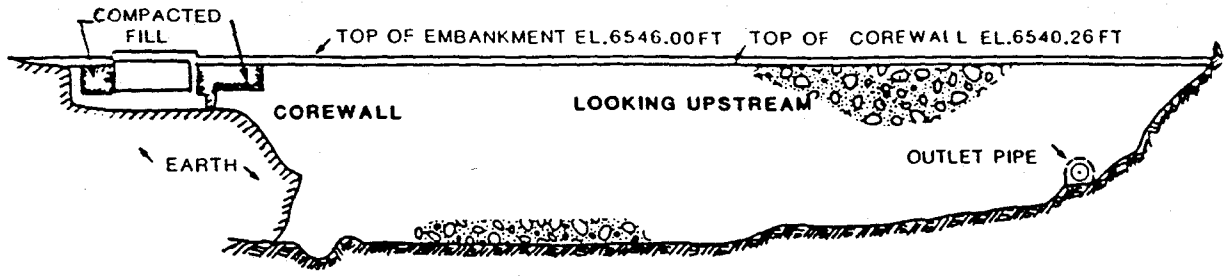
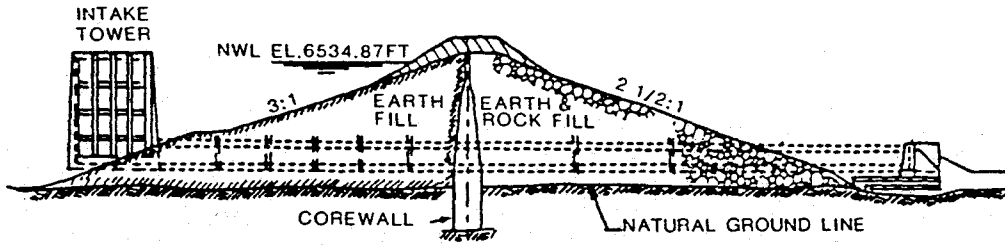
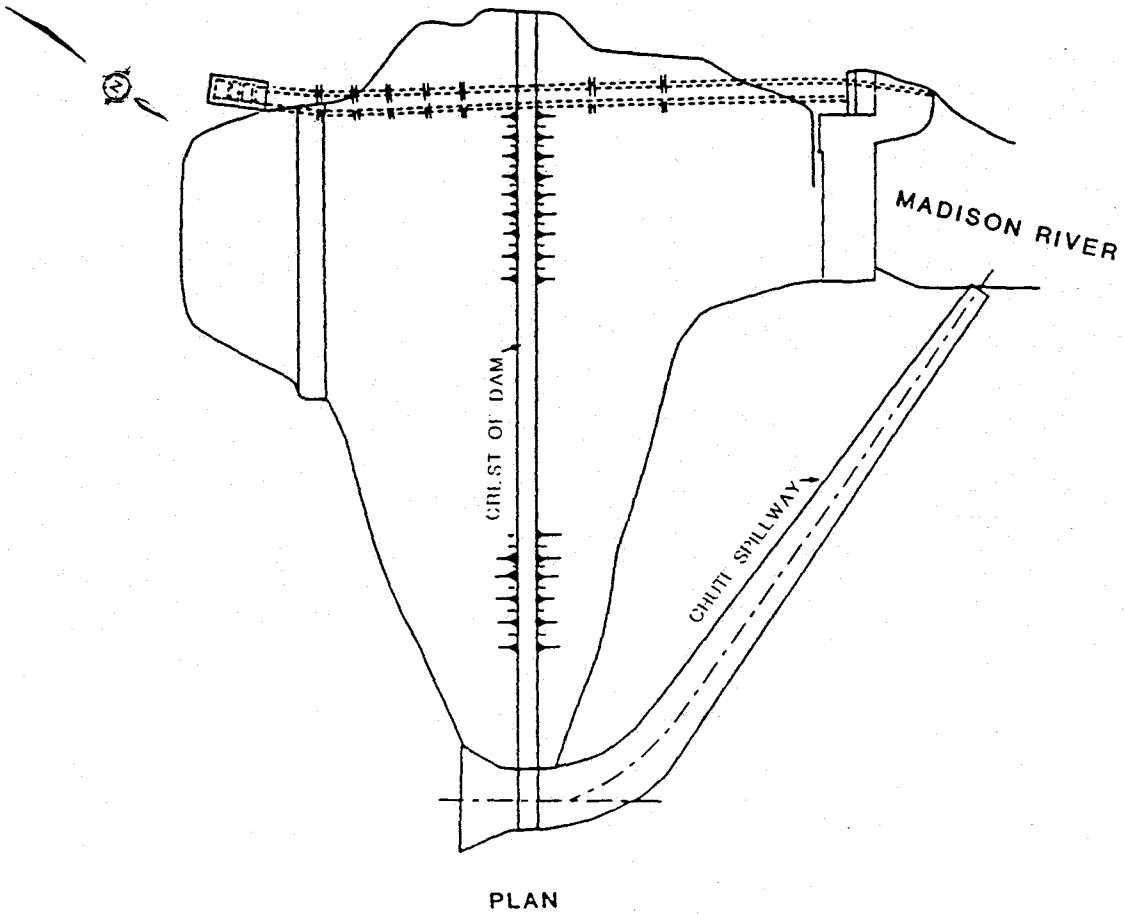
LAYOUT  
 Hebgen Dam  
 Figure 2

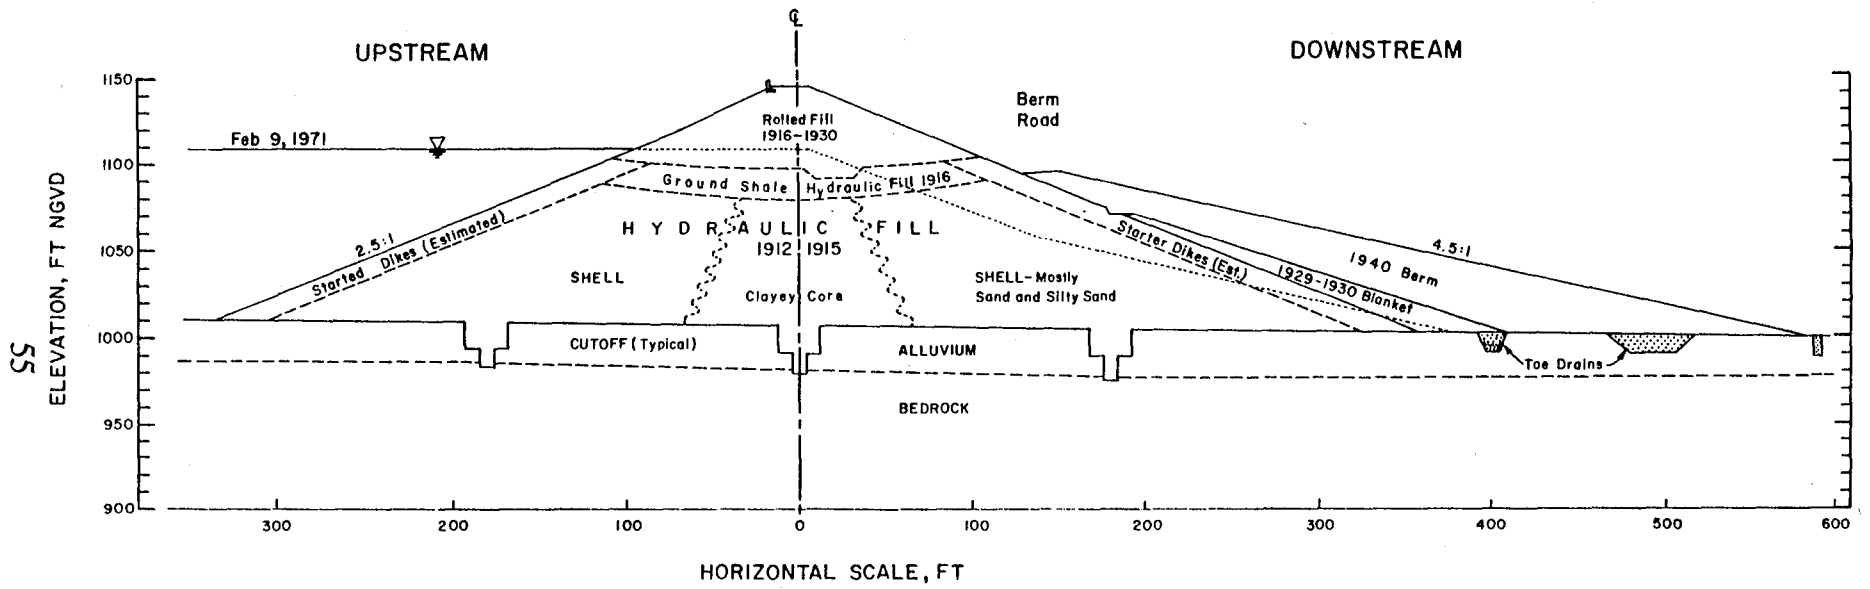
**SECTION**  
Lower Van Norman Dam  
Figure 2

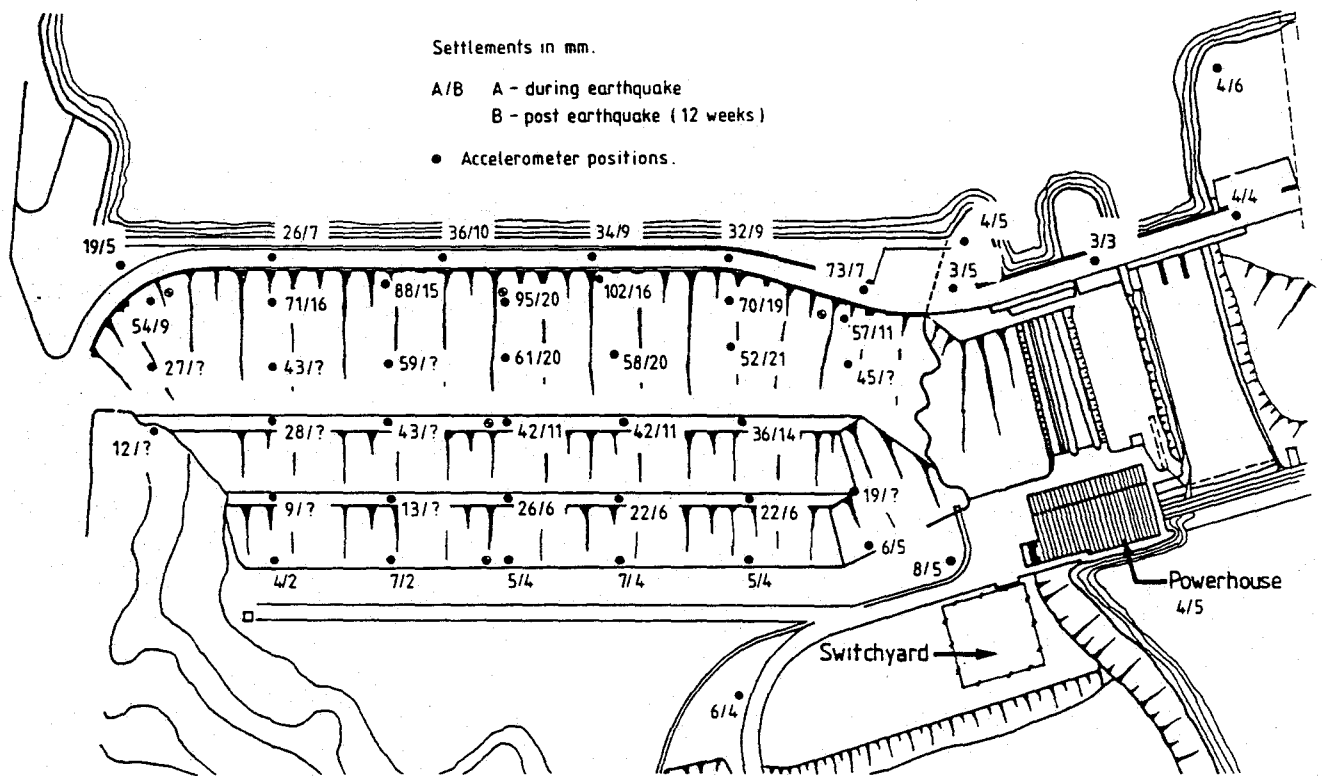
**MEASURED SETTLEMENTS  
(PLAN)**  
Matahina Dam  
Figure 5

Detailed inspection of Matahina Dam following the Edgecumbe earthquake revealed surface cracking near the abutments and significant settlement and downstream movement of the upstream and downstream rockfill shells (Figures 4 and 5). The abutment areas were investigated using trenching, boreholes and geophysical exploration. The cracks were shown to be shallow and not continuing through the core, but trenching exposed a large cavity below the crest pavement, upstream of the core in the right abutment. This cavity was concluded to be probably related to earlier core cracking, seepage and internal erosion which occurred shortly after the dam first impoundment in 1967. The earthquake shaking compacted loose materials in the former leakage area, thereby creating a cavity below the pavement.

The extensive network of surface monuments of the dam had been resurveyed about three weeks prior to the earthquake. Post-earthquake surveys indicated that the dam settled significantly as a result of shaking. Most of the settlement occurred immediately, but it continued for several weeks. The crest settled a maximum of 4.02 inches and moved

downstream as much as 10 inches, due to the earthquake. Local settlements of the upstream shell of up to about 31.5 inches were common, as evidenced through the discoloration of the previously submerged riprap. No submerged slope failures were found using exploration sonar. Settlements were concluded to primarily result from the earthquake-induced compaction of the rockfill.

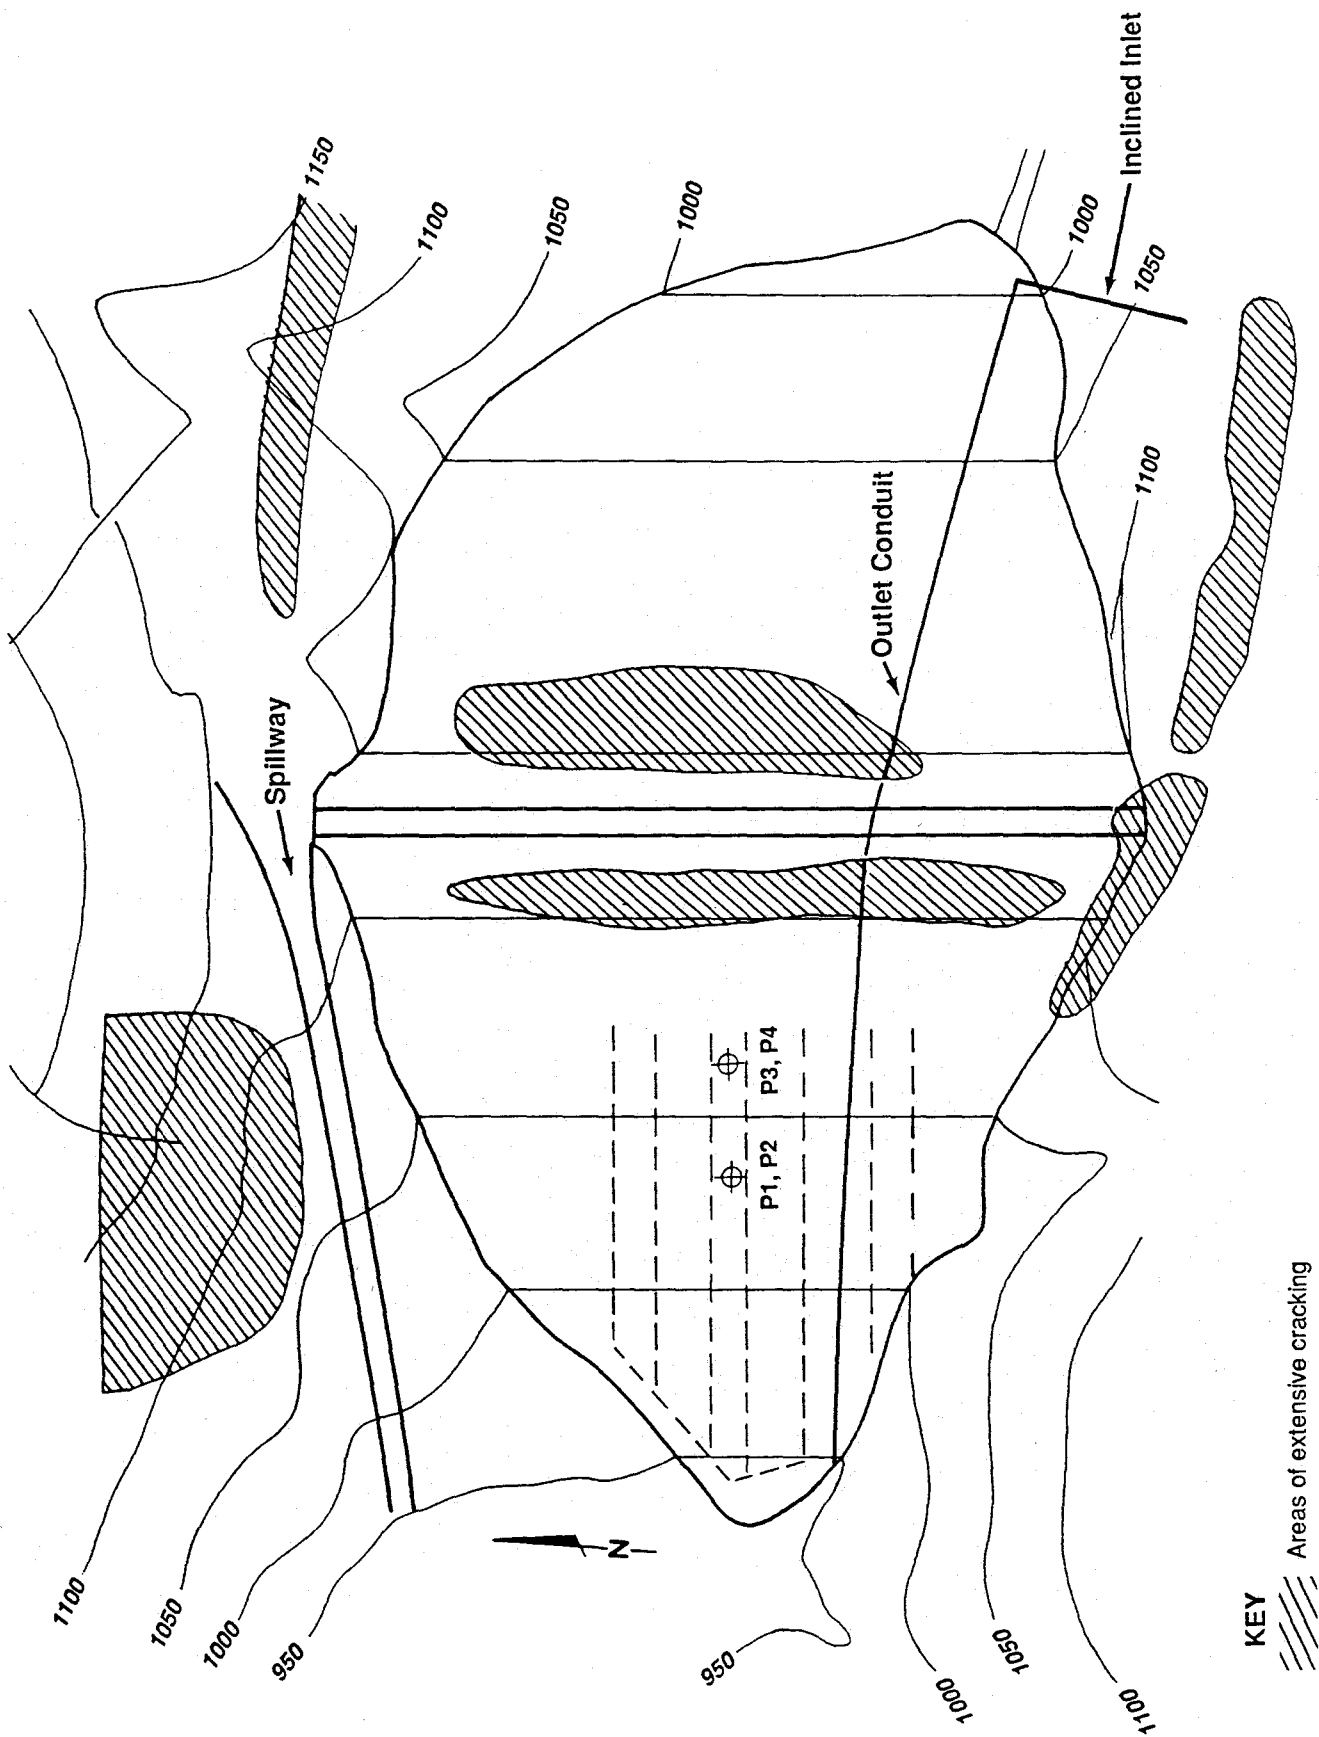
**PLAN**  
 Austrian Dam  
 Figure 1

**KEY**  
 Areas of extensive cracking  
 Piezometer locations

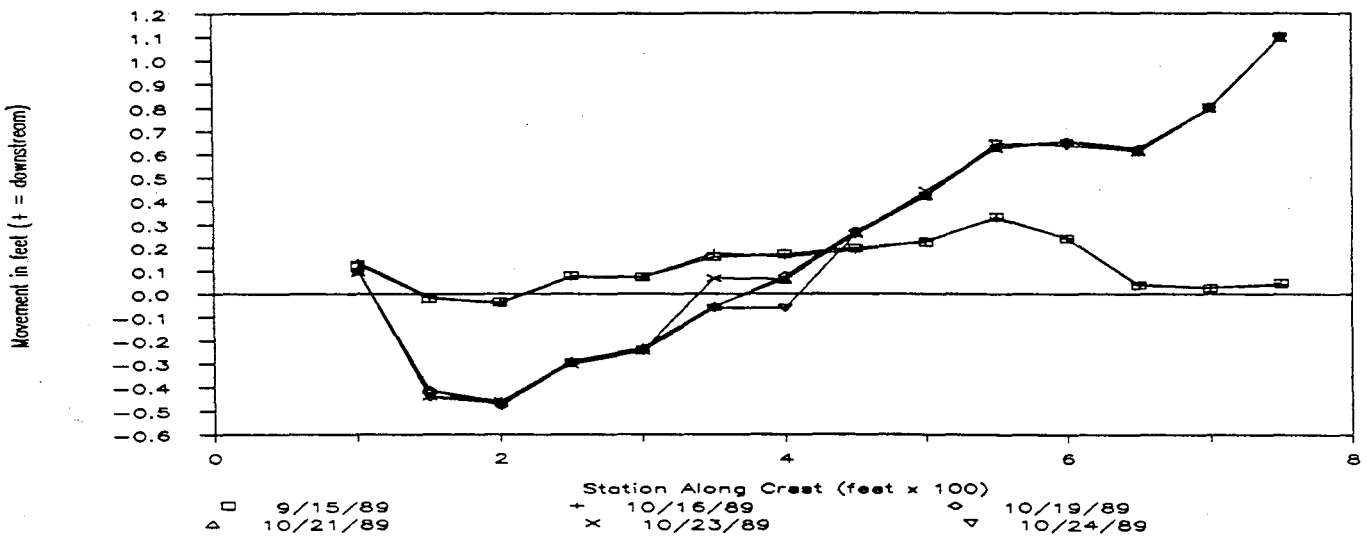
**TRANVERSE CREST MOVEMENT,  
LOMA PRIETA EARTHQUAKE  
Austrian Dam  
Figure 5**

Austrian Dam was located about 11 km from the October 17 epicenter (Figure 3). Embankment crest movements caused by the earthquake accentuated the historic settlement pattern (Figure 4). Maximum settlement was 2.8 feet, with significant deformations occurring over the right two-thirds of the dam. Maximum downstream movement was 1.1 feet near the spillway wall on the right abutment, and maximum upstream movement was 1.4 feet at the left quarter point of the embankment (Figure 5). Longitudinal cracks up to 14 feet deep occurred within the upper 25 percent of the upstream and downstream faces. Shallower longitudinal cracks were found on much of the downstream face. Crest cracking was confined to the abutment contact areas. A transverse crack was traced 30 feet down the left abutment, where the dam had been constructed on weathered, highly fractured rock. Transverse cracking and embankment separation from the spillway structure occurred to a depth of 23 feet on the right abutment. Water levels increased in the open well piezometers in the embankment (Figure 6).

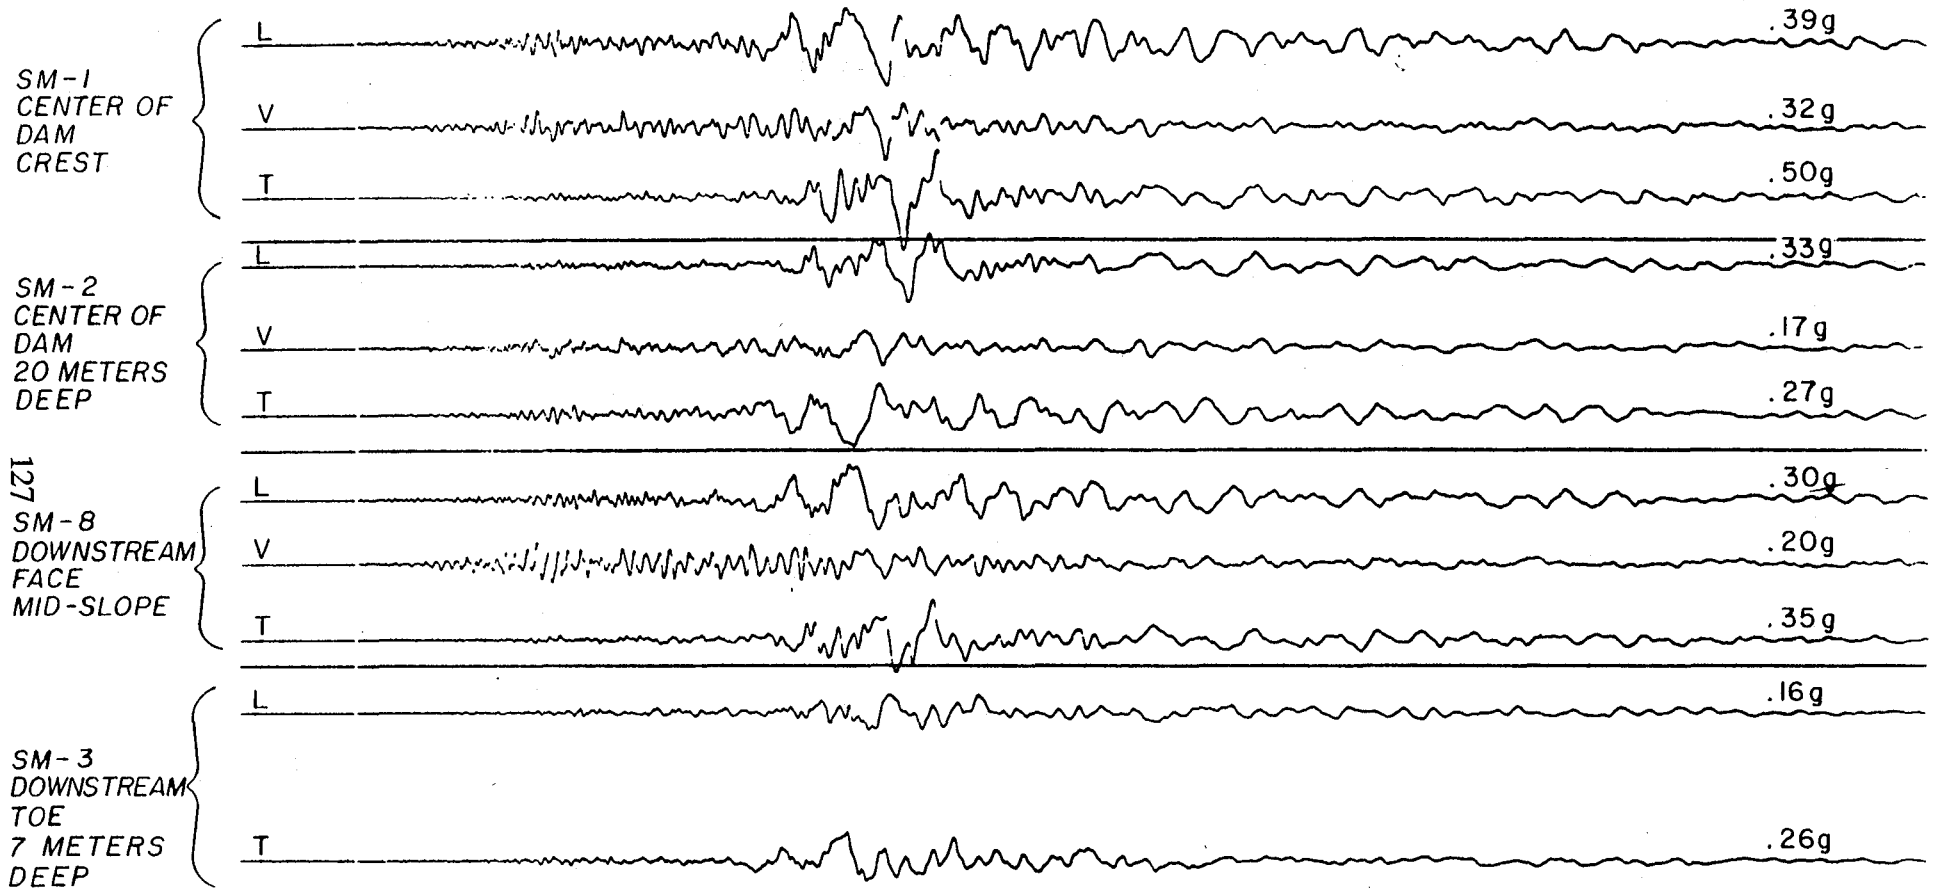
**STRONG MOTION RECORDS OCTOBER 17, 1989**  
**LOMA PRIETA EARTHQUAKE**  
San Justo Dam  
Figure 4

The Loma Prieta main shock strong-motion records from San Justo Dam are shown in Figures 4 and 5. The maximum acceleration recorded at the dam was 0.50g at the center of the dam crest. That component of motion was horizontal and transverse to the axis. The ratio of amplification between crest and toe accelerations is about 2. Observations from other instrumented dams indicate that a 1.5 to 2.5 amplification factor of crest response motion to base motion may be typical of the level of shaking experienced by San Justo Dam, when crest and toe records are compared. There is generally a tendency to have higher amplification factors with increased height of dams and lower levels of base motion. The

San Justo Dam accelerograms from 4 locations. Orthogonal, three-component sets of accelerometers are at each location, and are connected by hard-wire to a central recorder. A minor equipment (galvanometer) failure caused the downstream toe vertical component to be lost.
