Reassessment of the Castlewood Dam Failure

Chris Leibli, P.G.
Gregg Scott, P.E.
Pete Schaffner, P.G.
Risk Management Center, Denver

US Army Corps of Engineers
BUILDING STRONG®

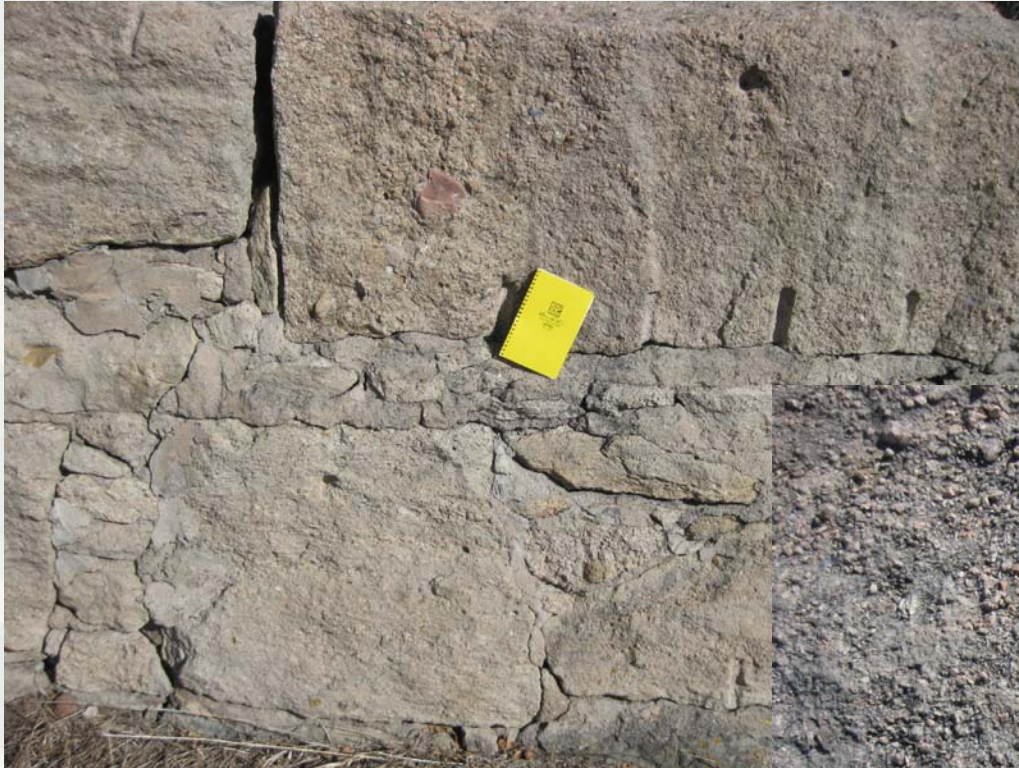
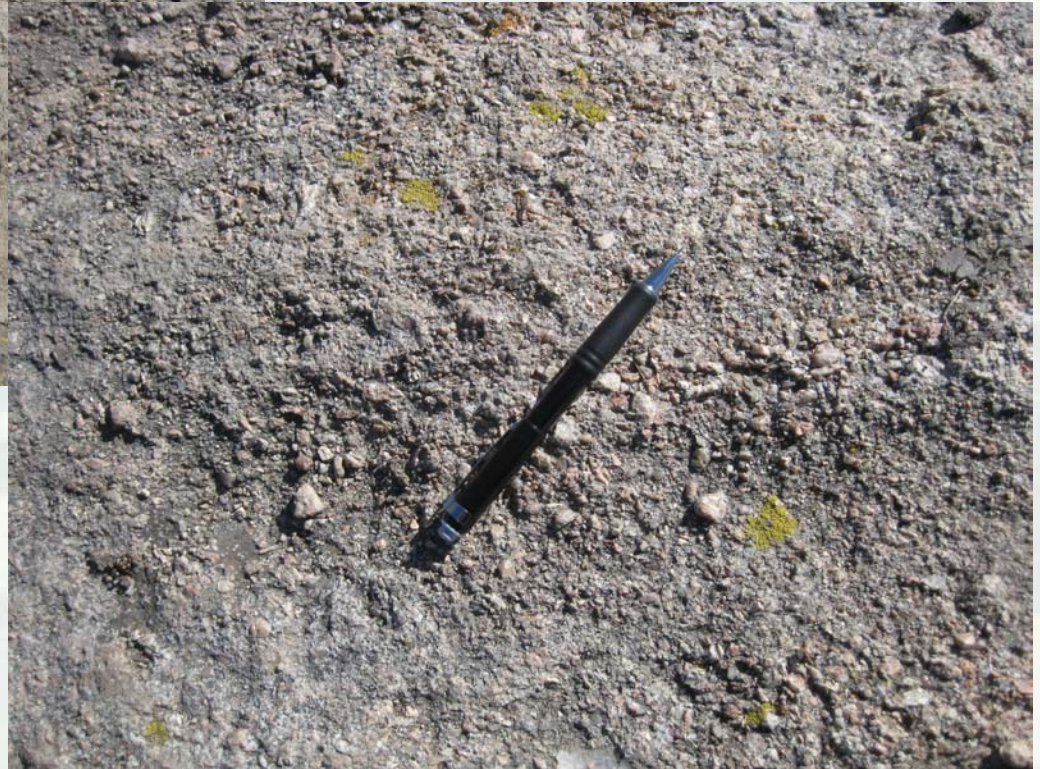
- Masonry Shell of the Dam (AF1)
 - ▶ Conglomerate blocks cemented with mortar.
 - ▶ Blocks quarried from Castle Rock Conglomerate outcrops above the dam site.
 - ▶ Lithology same as typical Castle Rock Conglomerate but with a lower percentage of cobbles and boulders.
 - ▶ Schmidt hammer UCS 14 MPa to 47 MPa average 30 MPa (4350 psi).
 - ▶ Testing on five core samples from Reuter-Hess drilling UCS 7.4 MPa to 30 MPa average 14 MPa (2030 psi).

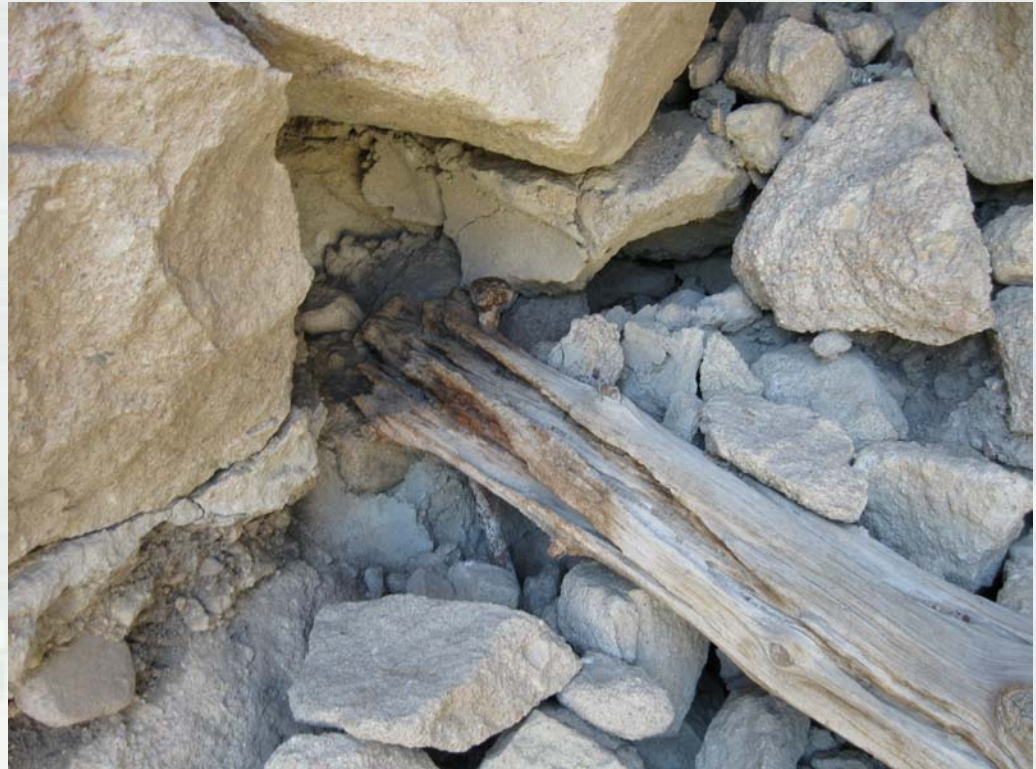
- Rubble Fill (AF2)
 - ▶ Irregular and variable sized blocks of Castle Rock Conglomerate.
 - ▶ Some sand, silt, and clay.
 - ▶ Many large voids.
 - ▶ Scattered wood fragments (may have deposited later) including one 4 inch diameter log.

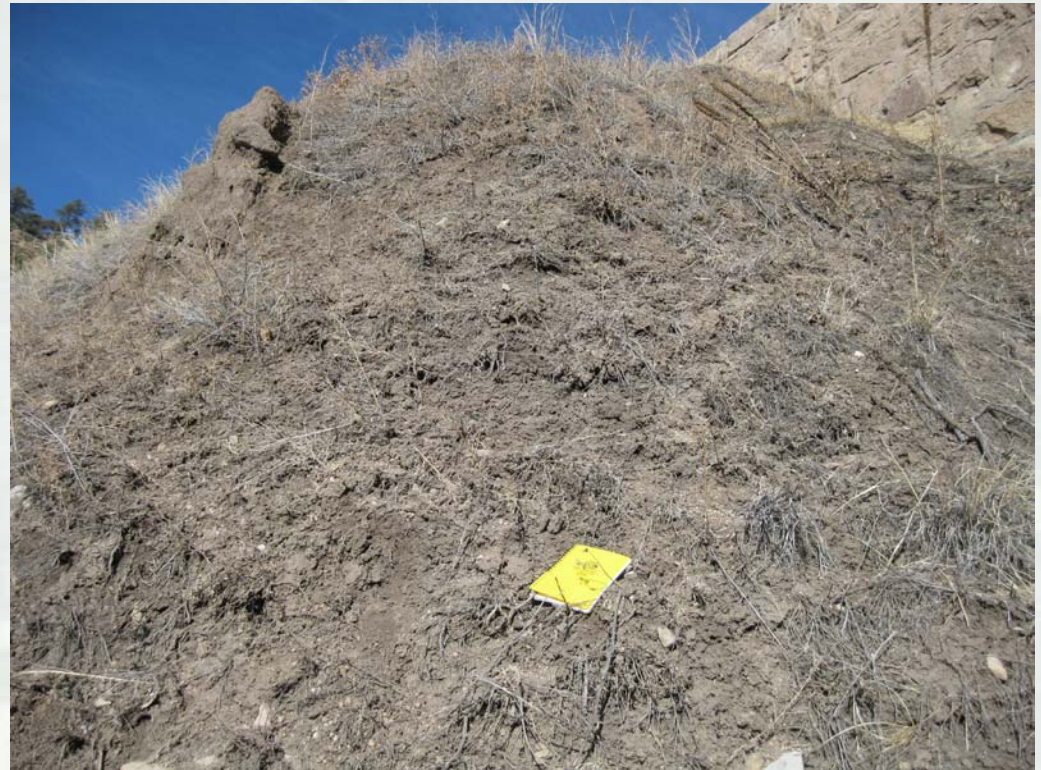
- Upstream Embankment Fill (AF3)
 - ▶ Dark brown clayey sand with gravel.
 - ▶ Medium dense.
 - ▶ Slightly moist.
 - ▶ Scattered cobbles, boulders, and organics.
 - ▶ Properties somewhat variable across the site.

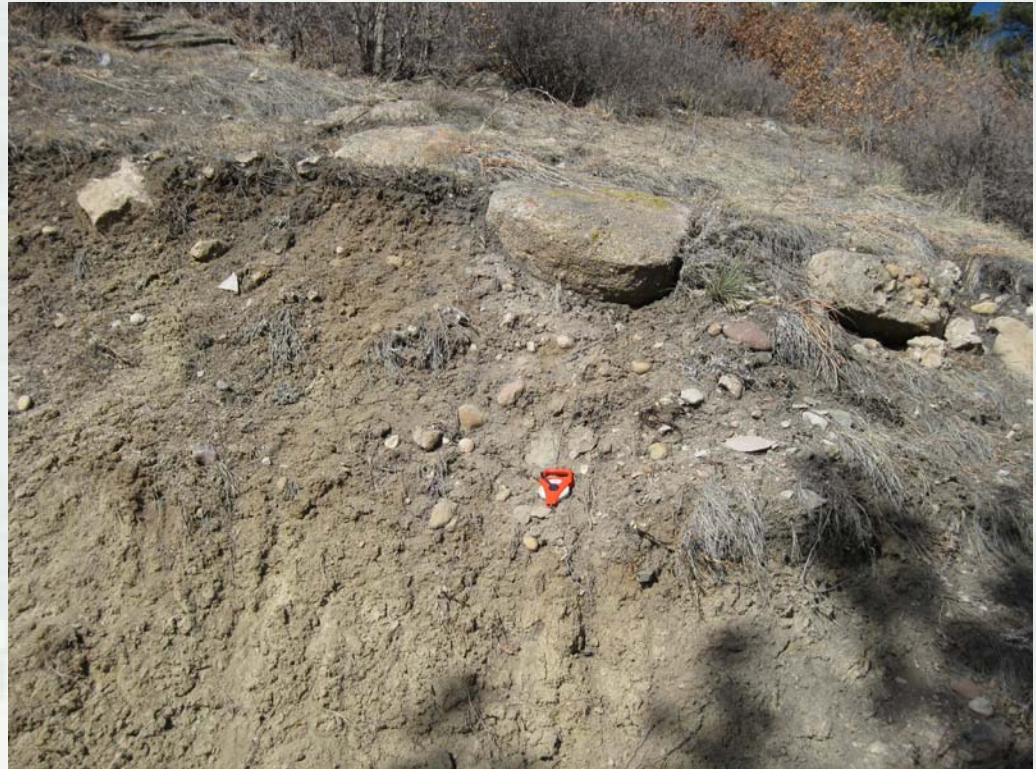
- Quaternary Colluvium (Qc)
 - ▶ Orange-brown clayey gravel with sand, cobbles, and boulders.
 - ▶ Medium dense to dense.
 - ▶ Moist.
 - ▶ 50-70% gravel, cobbles, and boulders up to 6 ft diameter.
 - ▶ Scattered boulders up to 30 ft in diameter (mostly on left side of dam).
 - ▶ 1 to over 10 ft thick.

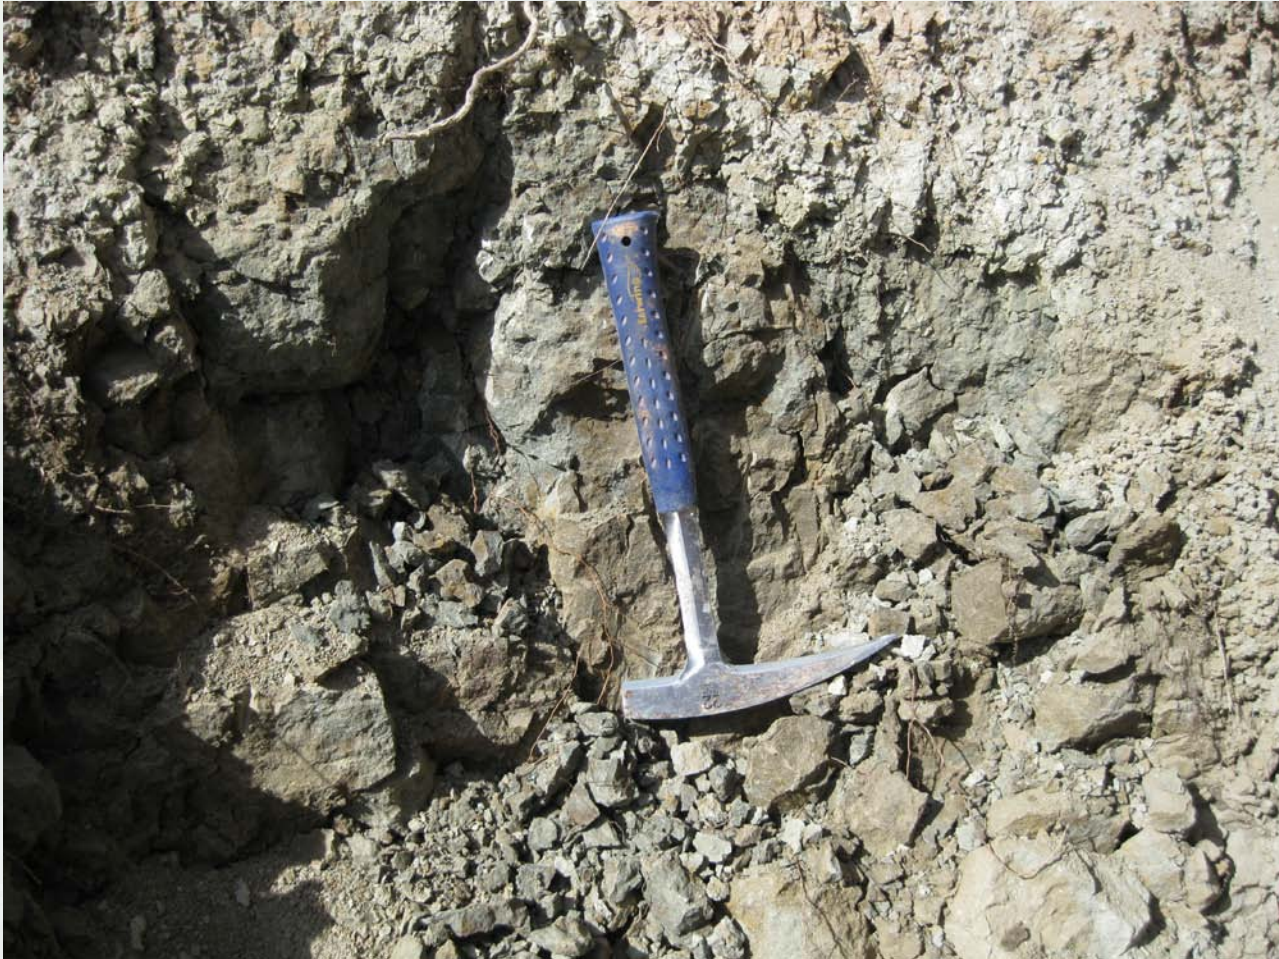
- Mudstone Unit 3 (MS3)
 - ▶ Dark bluish gray siltstone with trace fine sand.
 - ▶ Weak to moderately strong.
 - ▶ Fresh to slightly weathered.
 - ▶ Closely to very closely spaced tight fractures.
 - ▶ Fracture walls slightly rough to rough and planar with some iron staining.
 - ▶ Schmidt hammer results below range of instrument (<10 MPa).
 - ▶ Point load testing UCS of 1.0 to 2.6 MPa average of 1.7 Mpa (250 psi).
 - ▶ Reuter-Hess correlations UCS 0.048 to 1.5 Mpa (220 psi); RQD generally below 50% but ranging 0 to 100%.

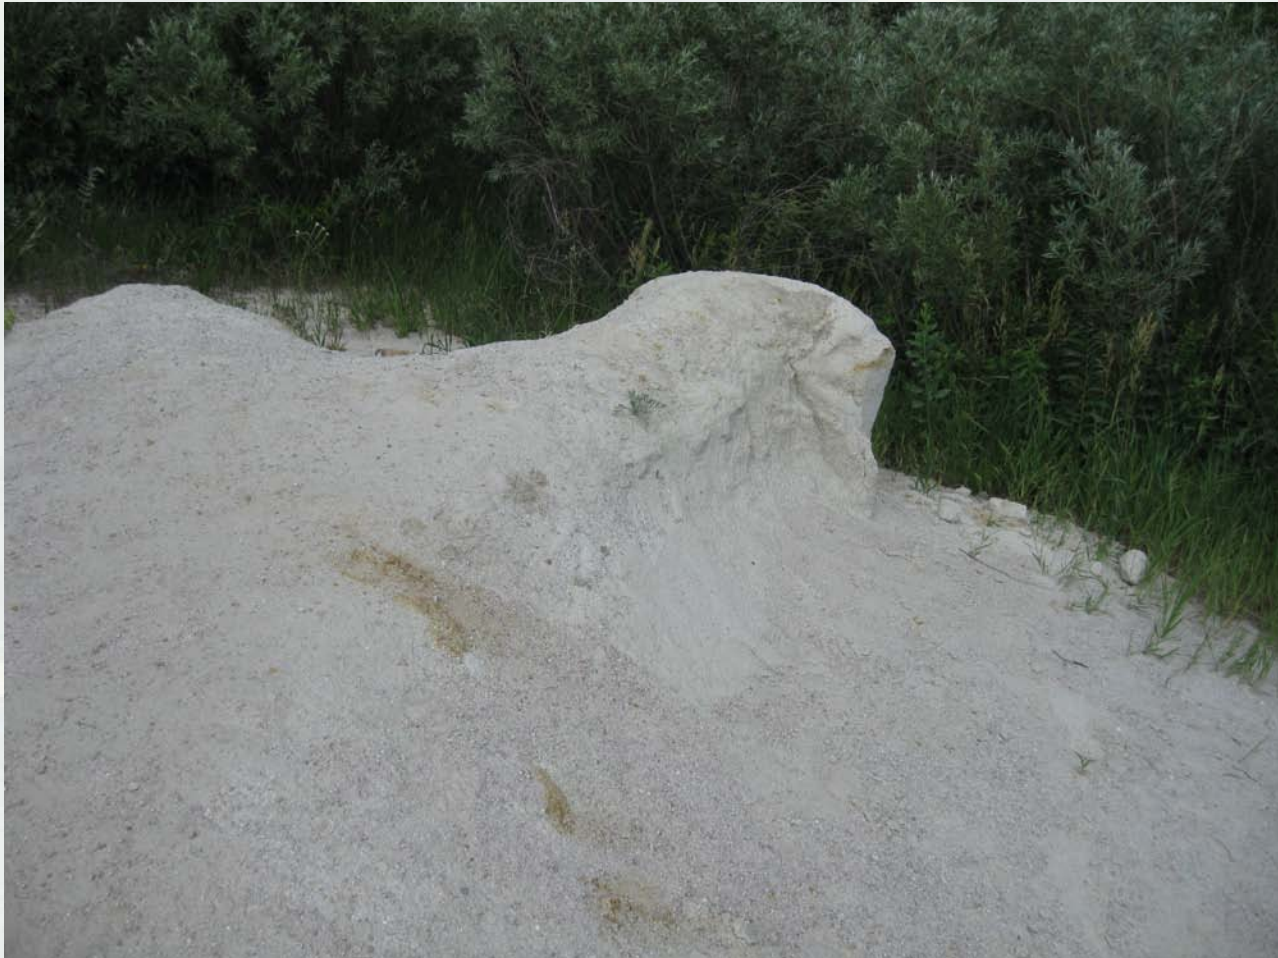
- Sandstone Unit 3 (SS3) and Sandstone Unit 2 (SS2)
 - ▶ Friable, weak, pinkish-tan, fine to coarse grained sandstone.
 - ▶ Scattered gravel up to 1 inch diameter.
 - ▶ Fresh to slightly weathered.
 - ▶ Thin to thickly bedded with cross-bedding.
 - ▶ No jointing or fracturing apparent.
 - ▶ Too weak for Schmidt hammer or point load testing.
 - ▶ Reuter-Hess one UCS test at 0.028 MPa (5 psi)
RQD generally below 50% but ranging 0 to 100%;
SPT testing 47 to over 200 blows per foot.

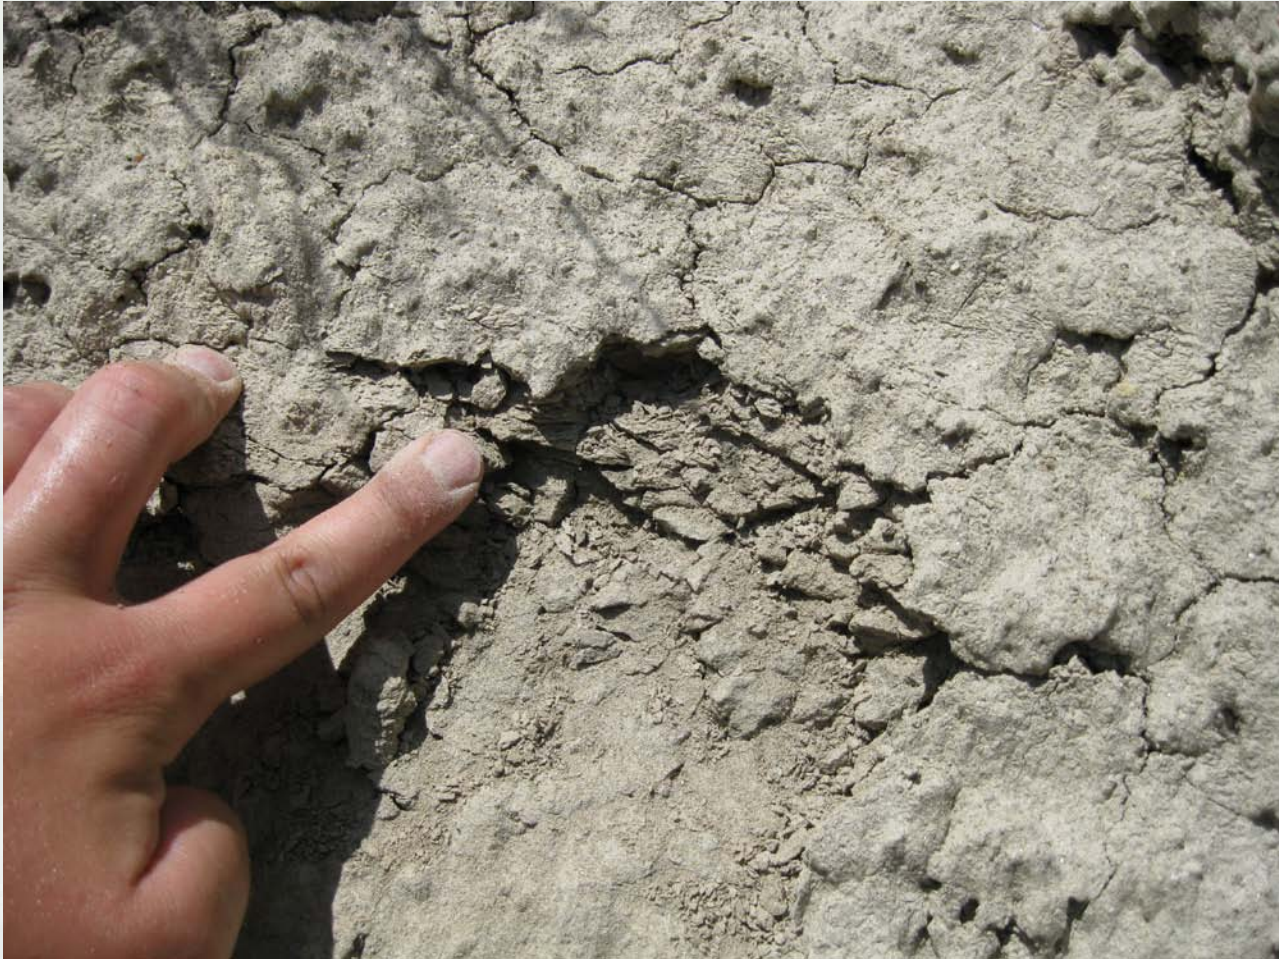
Base of dam founded on MS2, significant stream erosion subsequent to failure.

- Mudstone Unit 2 (MS2)
 - ▶ Dark olive brown sandy siltstone.
 - ▶ Very weak to weak.
 - ▶ Moderately weathered.
 - ▶ Very closely spaced tight fractures.
 - ▶ Fracture walls slightly rough to rough and planar with some iron staining.
 - ▶ Schmidt hammer below range of instrument (UCS<10 Mpa – 1450 psi).
 - ▶ Point load below seating load of instrument (UCS<0.7 Mpa – 100 psi).
 - ▶ Reuter-Hess correlations same as for MS3
