INTRODUCTION

WHY WASN'T CASTLEWOOD WORTH A DAM?

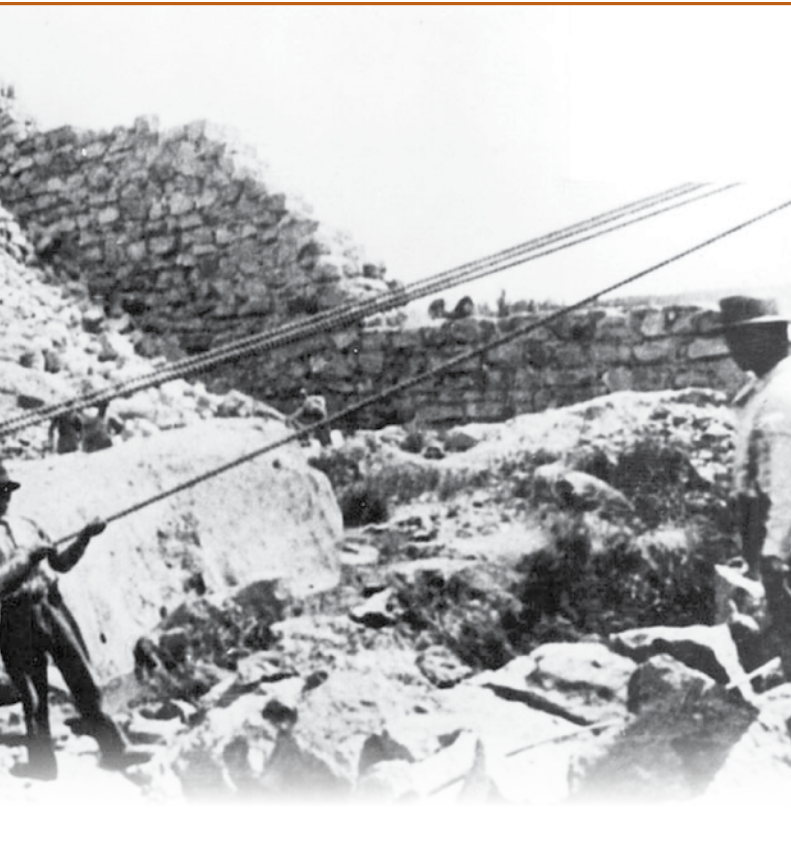
Figure 4. View of downstream face of Castlewood Dam showing leak near left abutment, May 1900 (Fellows, 1911, Photo Courtesy of Denver Public Library, Western History Collection)

In mid to late April of 1900, high rainfall filled the reservoir to capacity. Newspaper reports indicate that at this time, large amounts of water were flowing through the dam, near a bulge in the lower left side of the downstream face. As evident in Figure 4, there also appears to be a substantial amount of water flowing along the dam/foundation contact near the middle of the center spillway. The highest reservoir level during this time period was reached on April 30, 1900. Exact reservoir levels for this event could not be found but it was reported that 500 cfs was flowing through the main spillway and bypass spillway for approximately 30 hours, causing substantial erosion of the bypass spillway on the left abutment (Engineering Record, 1900). This spillway erosion is still visible today.

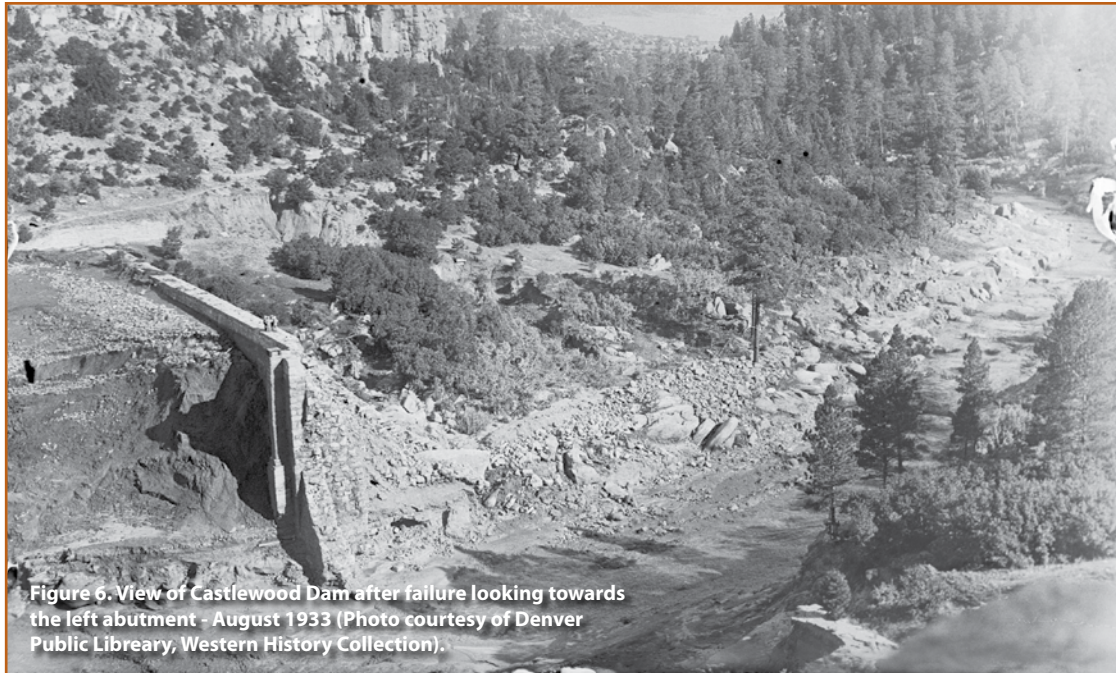
Photos taken the day after the failure and descriptions of the failure indicate that almost the entire right half of the dam had washed away, including the center spillway (Figure 6). It appears from these photos that erosion occurred to just below the base of the foundation contact near the upstream wall of the dam and to a somewhat lower elevation near the downstream wall of the dam.
