Geotechnical Extreme Events Reconnaissance (GEER)

## **Preliminary Observations of the Fujinuma Dam Failure Following the March 11, 2011 Tohoku Offshore Earthquake, Japan**

June 6, 2011

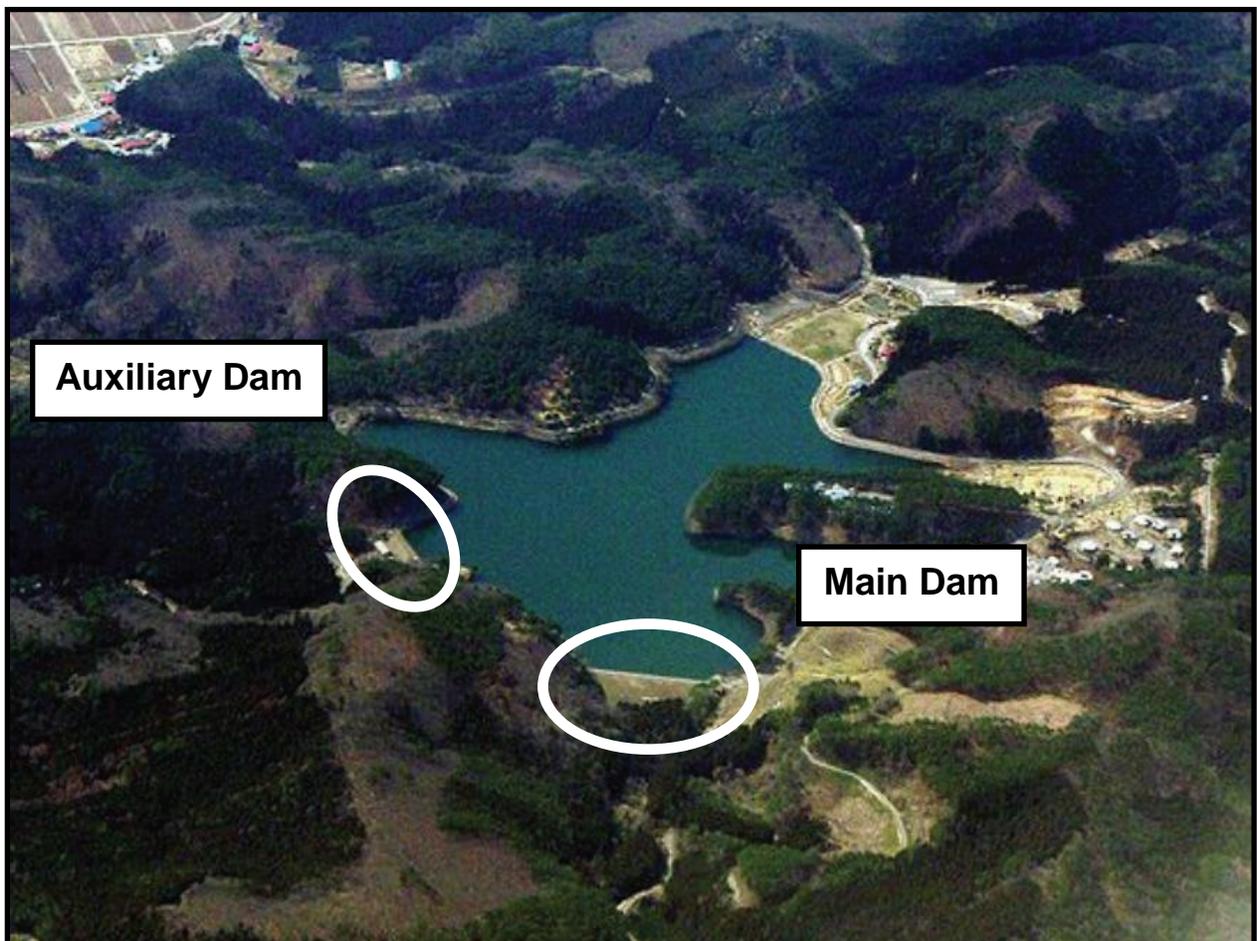
Figure 2: Aerial View of Fujinuma Main Dam and Auxiliary Dam in 2009  
(modified from Wikipedia/JAC, 2011)

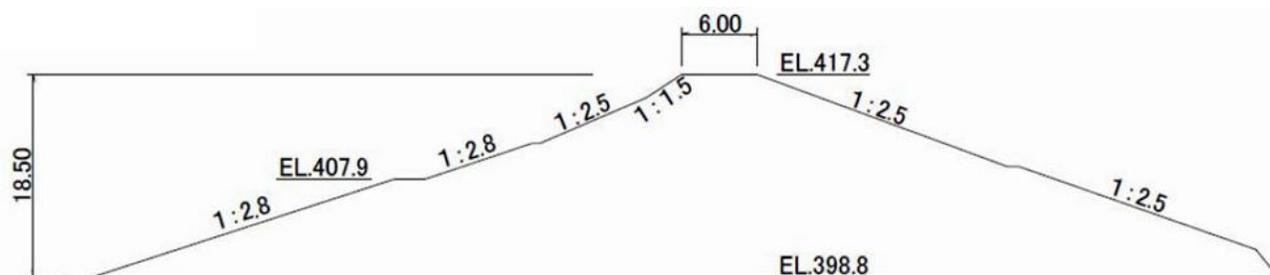
Figure 3: Cross Section of Fujinuma Dam  
(from Matsumoto, 2011)

7. There was no sign in the breach area that a cutoff trench through the black residual soil and into the tuff bedrock had been constructed. This observation matches the drawings and the diagram found on the left abutment (see Figures 3 and 6).

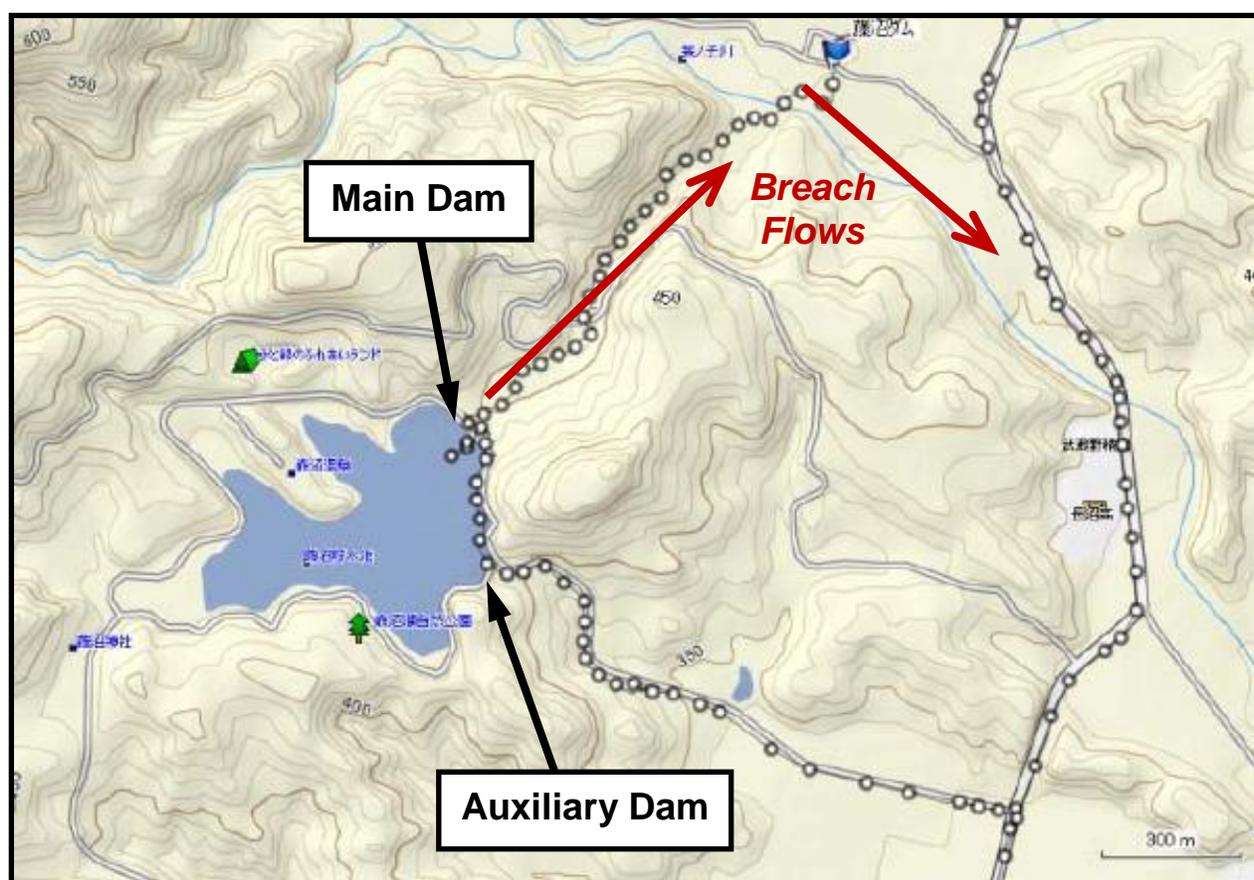
There are currently no drawings available at the time of this writing to detail the design and construction history of the dam. It is not known what the zoning of the dam was designed to be, although some reports indicate that it was a homogeneous embankment design (Matsumoto, 2011). Nor is there any information currently available regarding what type of and amount of foundation treatment was provided at either the main dam or auxiliary dam. At the time of the March 11, 2011 earthquake, the main outlet appeared to be through the main dam's right abutment. However, there appears to be at least one additional outlet near the left abutment of the auxiliary dam. It is not clear whether any of these outlets were used to dewater the foundation and provide diversion capacity while the dam was under construction and/or during the construction shut-down during the war, or whether other temporary measures were employed. Figure 4 illustrates the hilly topography that the dams and reservoir were situated in.

Figure 4: Topography of Fujinuma Dam and Reservoir Area  
(from Chigira et al., 2011)

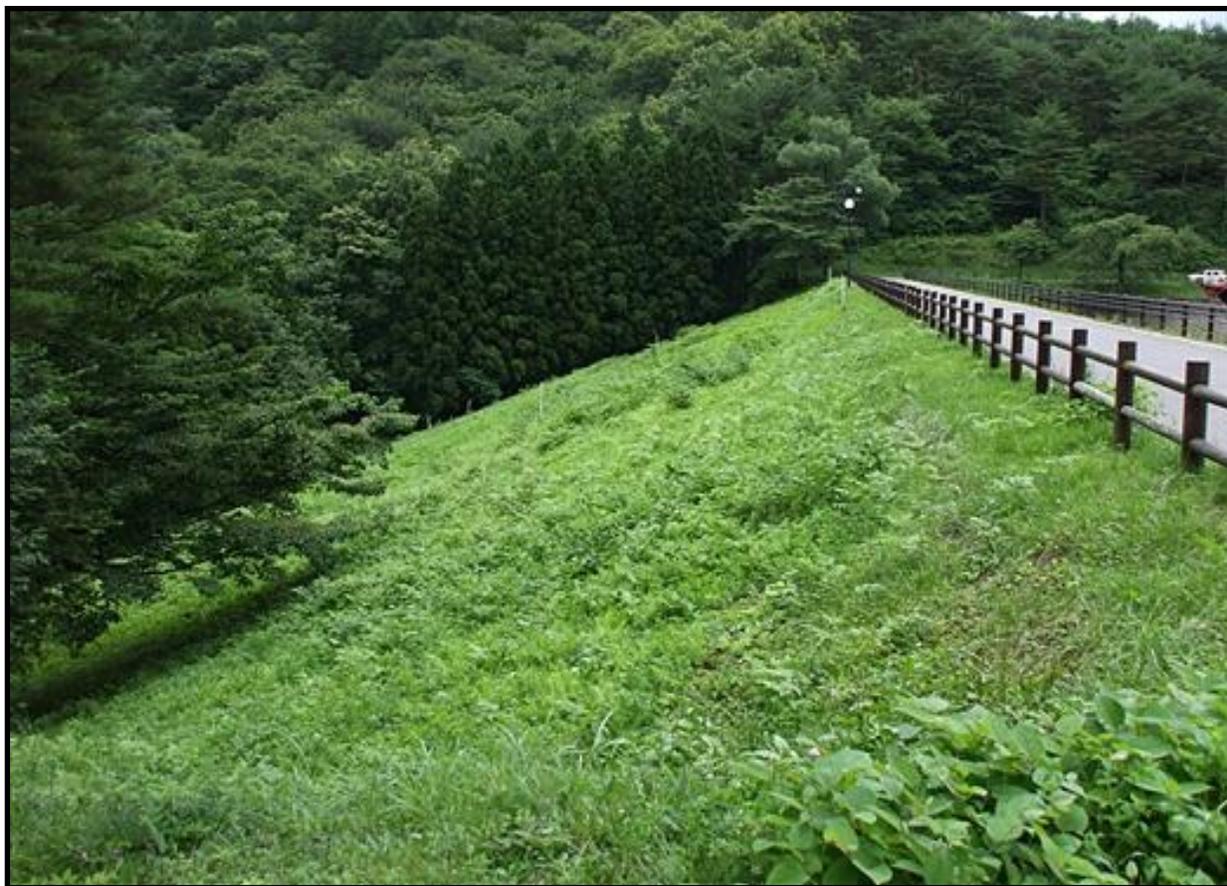
completed through the crest of the main dam in 1994 and into the upper foundation, presumably to control seepage. In addition, two lines of three piezometers appear to have been drilled and installed in the downstream slope down to the foundation contact. Information from this remedial program and the data from the piezometers over time are not currently available. Figure 7 presents a photograph of the downstream slope of the main dam taken in 2009.

Figure 7: Pre-Earthquake Photograph of Crest and Downstream Slope of Fujinuma Main Dam (from Dam Association of Japan, 2009)
