# ***The Fontenelle Dam Incident: The Investigation, Likely Causes, and Lessons (Eventually) Learned***

Presented to: Association of State Dam Safety Officials, Annual Conference, Washington DC, September 2011. Authored and presented by: Mark E. Baker, PE, National Park Service, [Mark\\_E\\_Baker@nps.gov](mailto:Mark_E_Baker@nps.gov), phone: 303-969-2921

## **Summary**

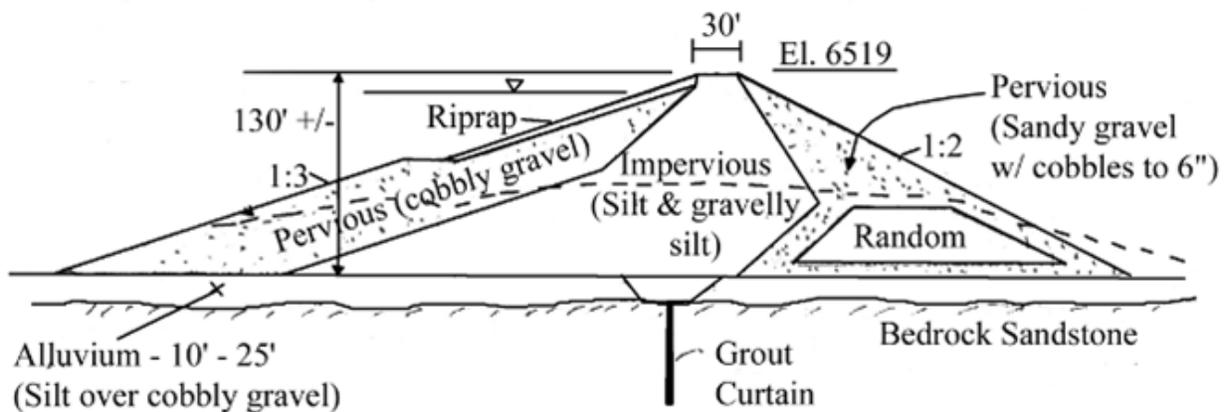
A version of this general design was used at the 127-foot-high Fontenelle Dam (see figure 4). The Zone 1 core consists of a mixture of sand, silt, clay and gravel compacted by tamping rollers in 6-inch lifts. The Zone 2 shells were a mixture of free draining sand, gravel, and cobbles compacted by crawler-type tractors and placed in 8-inch lifts. And a Zone 3 (random) was included within the downstream Zone 2. It consisted of miscellaneous materials obtained from excavation, compacted by tamping rollers, and placed in 12-inch lifts.

Figure 4: Fontenelle Dam typical cross section

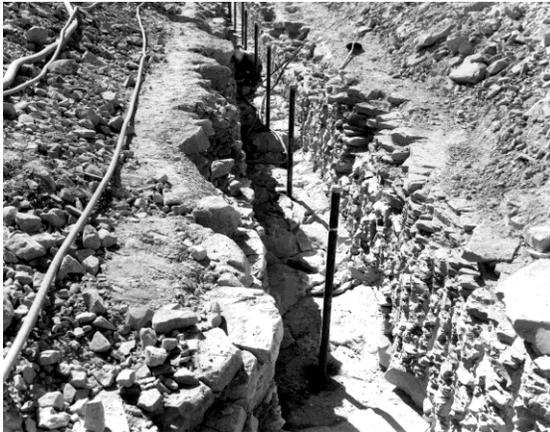
The foundation of the mile-long dam consists of fine-grained and bedded sandstone. The designers specified an 80-foot-wide cut off trench and a single line grout curtain (see figure 5). The grout curtain extended 60 feet into the foundation. Grouting was performed on 10-foot centers in the trench with additional holes in areas of high grout take. A 3-foot by 3-foot notch was excavated in the bottom of the cutoff trench to cut-off seepage in the rock directly below the embankment fill. Following grouting the grouting program, this notch was filled with concrete and became the grout cap (see figure 6).

*Figure 5: Top of grout curtain*

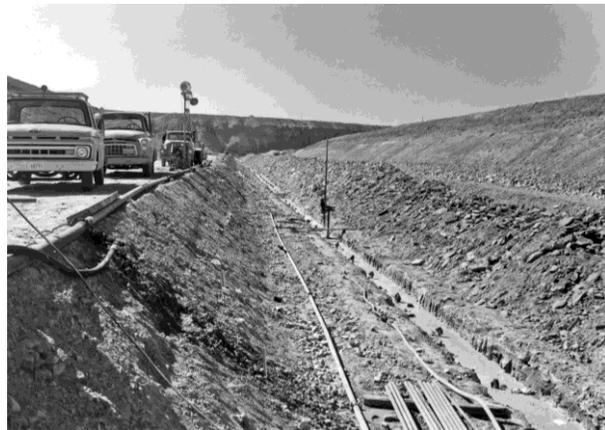
*Figure 6: Cutoff trench with grout cap*
