# Replacement of a Deteriorated Earthfill Dam with an RCC Gravity Dam

## The Penn Forest Dam Replacement Project

1999 USCOLD 19th Annual Meeting and Lecture

**Paul G. Schweiger**, Project Engineer, Gannett Fleming, Inc., Harrisburg Pennsylvania

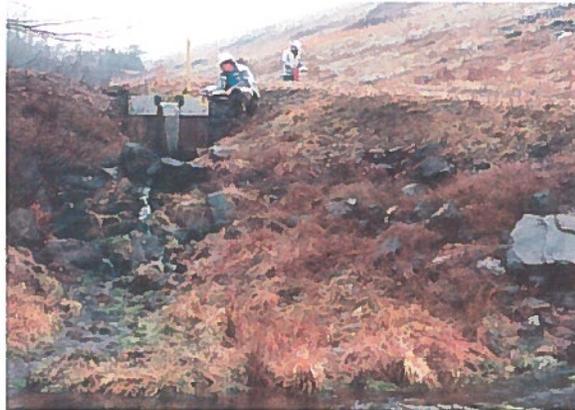
Through the 26-year period from 1969 to 1995, the embankment dam was aggressively monitored. Summary reports assessing the condition of the dam were prepared in 1975 and 1983. In both reports, ongoing changes in piezometric levels were reported along with high but stable seepage flow rates. Throughout the 26-year period, the scope of the monitoring program was scaled back. Near the end of this period the monitoring program consisted of reading approximately 184 instruments on a biweekly basis, including five seepage weirs and two seepage flumes. Data for 49 of the instruments judged to be key indicators of the dam's performance were regularly plotted and reviewed for changes and long term trends.

*Monitoring Seepage*

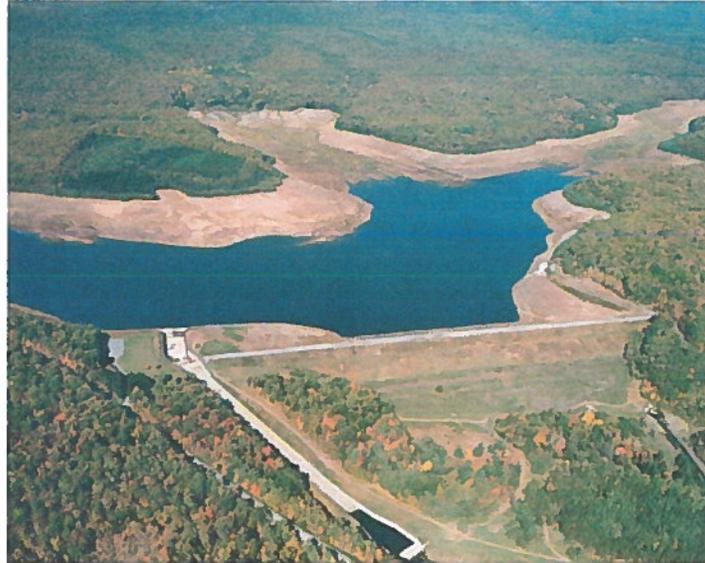
In response to the observed conditions and the overall history of Penn Forest Dam, the City of Bethlehem implemented a series of emergency response measures recommended by Gannett Fleming. The emergency response measures, summarized below, remained in effect until January 1995, at which time the pool had been drawn down to approximately Elevation 975, 25 feet below spillway crest. Following the emergency measures, the reservoir was further drawn down and held at Elevation 950 during subsequent investigations.

*Penn Forest Reservoir at Elevation 950*

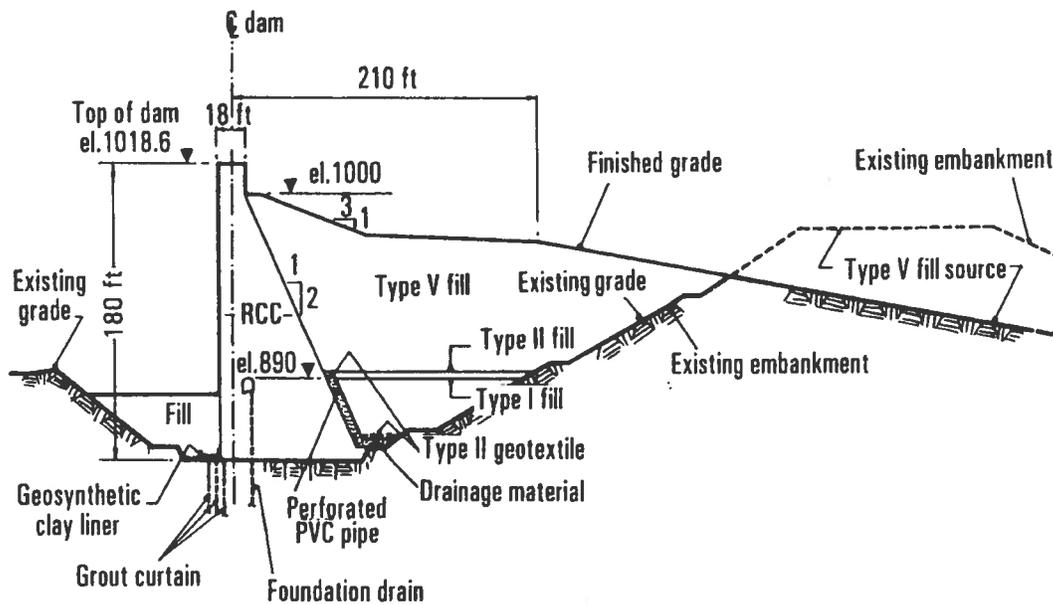
*Typical Section of RCC Replacement Dam*

Option 5 - remove the existing dam and replace with a new structure was chosen by the City. This option consisted of constructing a roller-compacted concrete (RCC) gravity dam approximately 460 feet upstream of the existing embankment dam. The alignment of the RCC dam is such that it allows continued use of the existing spillway and outlet works. The RCC gravity dam is buttressed on the downstream face by earth fill from the existing embankment. Advantages associated with this option included: (1) it restored Penn Forest Dam to its original operating level, (2) the proposed RCC gravity section relied on the existing embankment only for minimal support and a minor failure of the embankment, even though highly unlikely, would not have a significant impact on the overall performance of the new dam, and (3) it had the longest service life with minimal maintenance and risk of failure. The alignment and location of the RCC dam resulted in savings of about \$20 million compared with a new stand-alone dam, since the intake tower and outlet works conduit was recycled, and road relocation and environmental impacts associated with a new dam site downstream of the existing site were avoided.

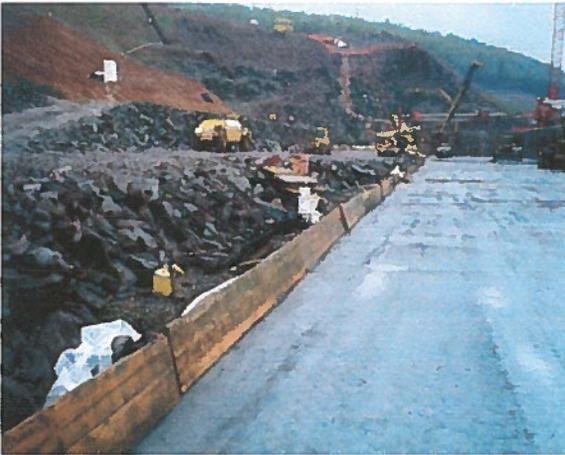
*Temporary Forms for RCC*

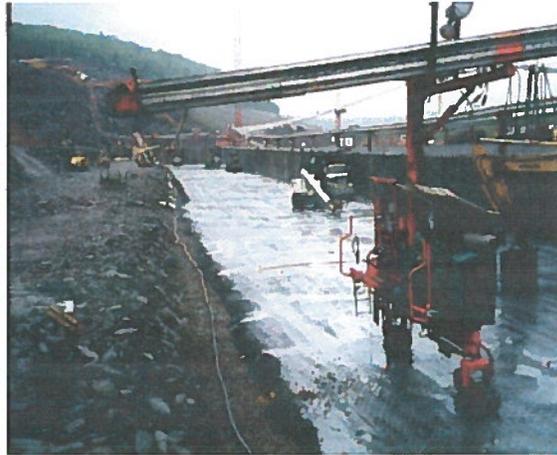
The downstream face of the dam was formed by concurrent placement of RCC and the earthfill embankment. This allowed the downstream slope of the dam to be steepened from 0.8H:1V to 0.5H:1V, thereby reducing the volume of RCC. The buttressing effect of the embankment fill enhances the stability of the reduced cross section. RCC waste or overbuild was minimized by placing the downstream end of the RCC lift against a temporary 1-foot high form before placing the downstream fill. In addition to providing a form for the RCC, the soil fill covering the downstream face of the RCC protects the untreated RCC face from weathering, provides a thermal blanket to reduce cracking from thermally induced stresses, and increases the sliding and overturning stability of the dam.

*RCC Placed Concurrently With Fill.*

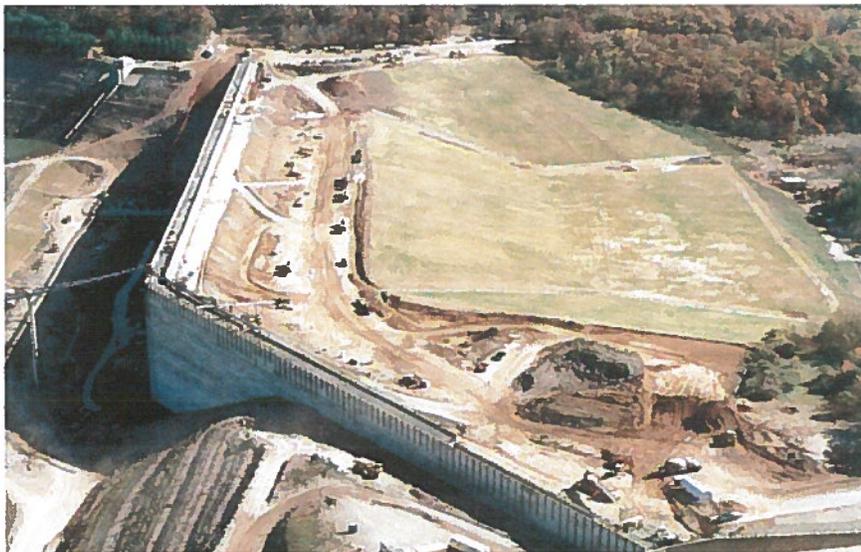
*Overview of New RCC Dam With Regraded Embankment Against Downstream Face of the Dam*

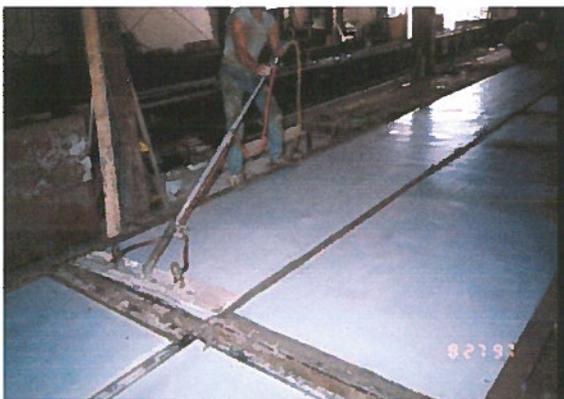
***Casting Precast Panels***

At Penn Forest Dam, an improved method of attaching the sheets of liner material was developed. The PVC liner material (Sibelon CNT 2800) was manufactured by CARPI of Italy, and consists of an 80 mil high performance PVC coupled with a 200g/m<sup>2</sup> geotextile. The liner was attached to the panels by first placing the concrete mixture into the panel forms, followed by rolling and vibrating the liner material onto the exposed concrete surface of the panel with the geotextile side of the material placed on the wet concrete. The liner remains attached to the panel through the bond made between the concrete and the geotextile.

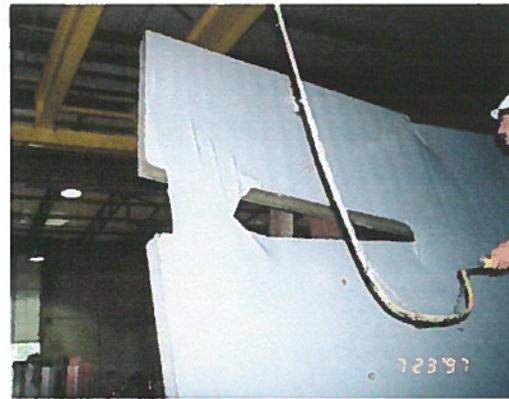
This method of attaching the PVC liner to the precast panels was initially tested for the Penn Forest project by pulling apart several panels after the PVC liner had been partially welded to adjacent panels. The destructive testing demonstrated that the stress concentrations in the PVC liner material did not concentrate at the welds between panels, but became distributed over much of the panel area. It was observed that as the panels were pulled apart, the bond between the geotextile and the PVC liner failed first, allowing the liner material to behave elastically and stretch more than 18 inches at the joints before failing. This method of liner attachment offers several benefits over the traditional "T-Lock" surface anchor system for liner attachment, including: reduced cost, greater flexibility, improved liner properties, and better resistance to stress concentrations.

***Destructive Testing of Panel Welds***

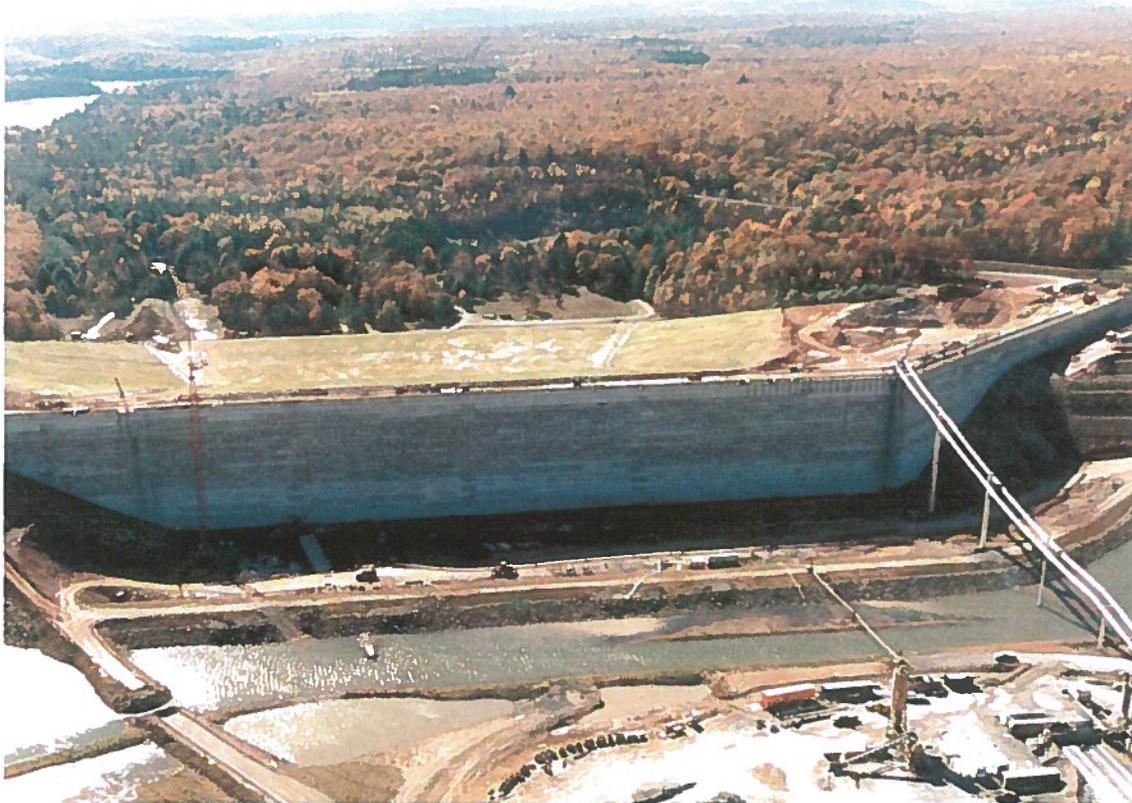
*Looking at Upstream Face of New RCC Dam During Construction, September 1998*

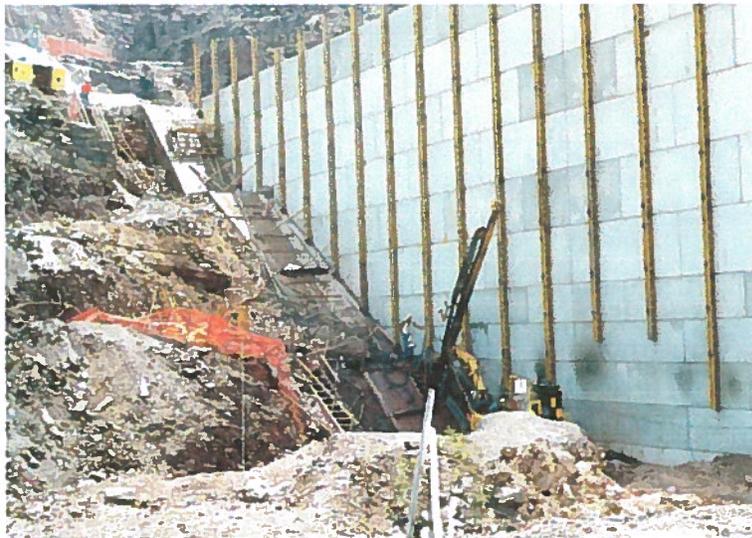
pressure transducers, magnetic flow meters, automated recorders linked to computers, and a radio communication system. This software called CAGES provides real-time graphical plots of the flow rate, pressure, and apparent lugeon value with time. The advanced grouting was performed through a plinth constructed along the upstream heel of the dam outside of the dam's footprint. This enabled the grouting of the B- and C-Lines to proceed concurrently with the construction of the RCC dam.

*Grouting Through Plinth*

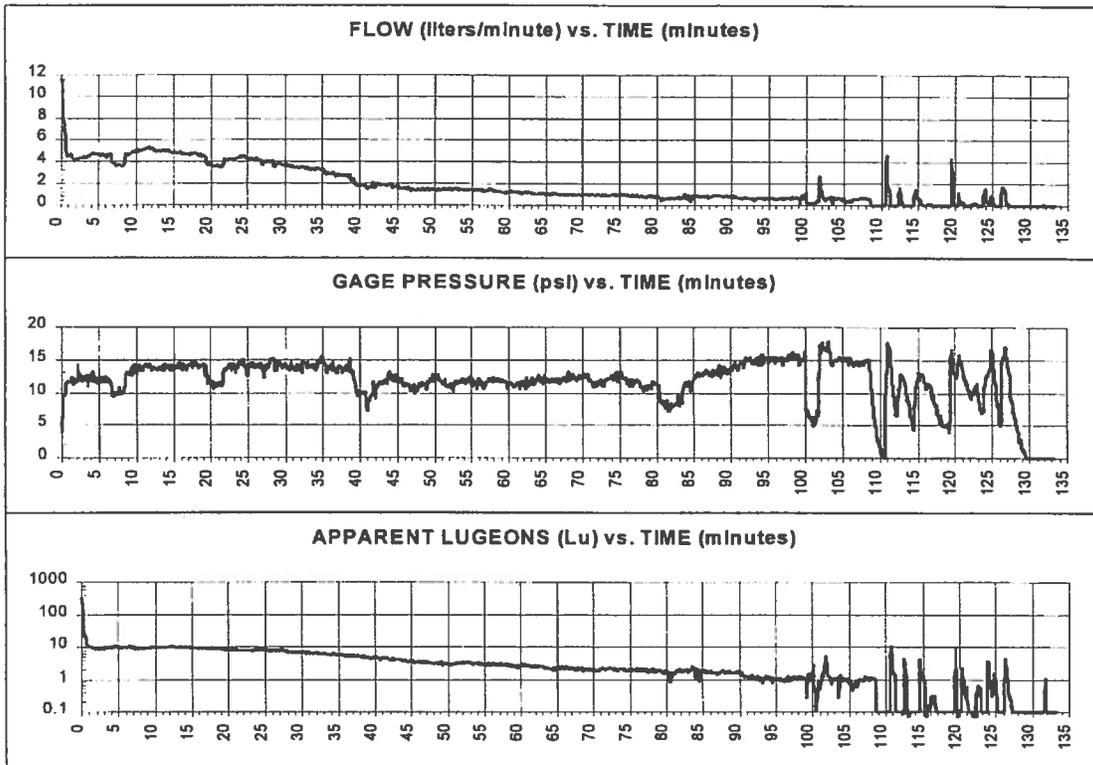
- Real time data is obtained at 5-15 second intervals thus eliminating critical events such as pressure spikes
- Data obtained is more accurate enabling use of higher grouting pressures
- Provides detailed, permanent graphic records showing the entire time history for each operation on each stage
- Provides a more reliable grout curtain with better durability.

*Typical Real-Time Data From Advanced Grouting Method*
