REEXAMINATION OF THE 2004 FAILURE OF BIG BAY DAM, MISSISSIPPI

Keith A. Ferguson, P.E., National Dam and Hydraulic Structures Practice Leader¹
Scott Anderson, P.E., National Technology Leader for Numerical Modeling²
Elena Sossenkina, P.E., National Technology Leader for Risk³

ABSTRACT

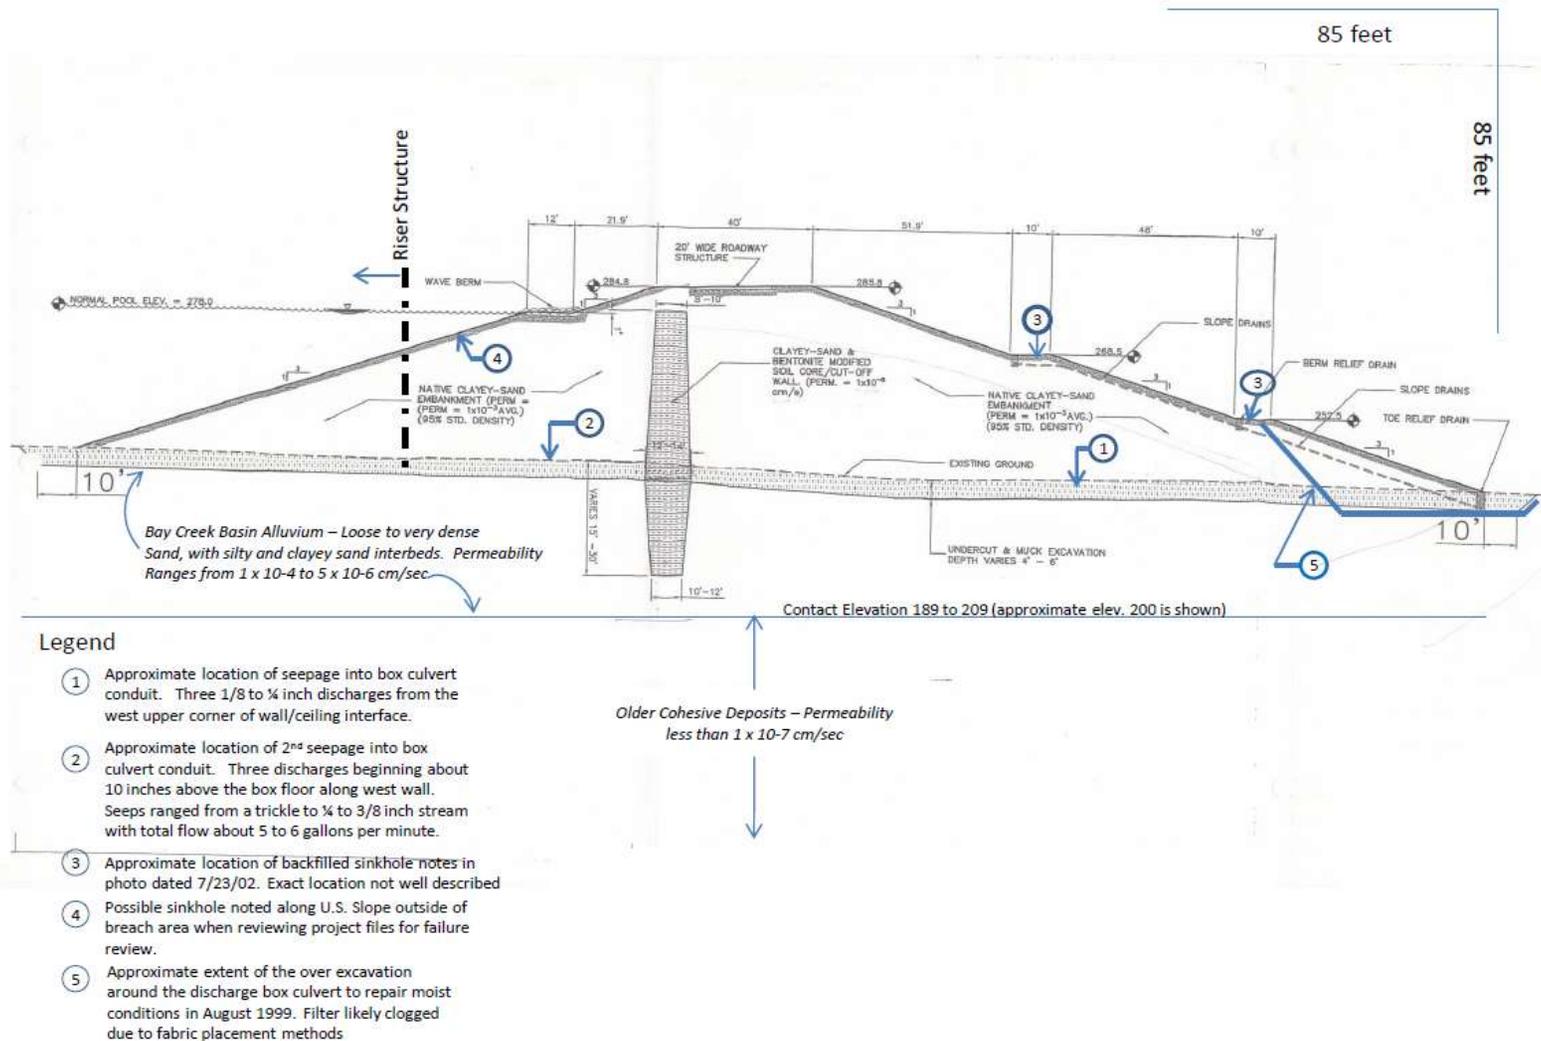
Figure 8. Estimated Bottom of Cutoff in Breach Formation Area

A fence diagram of boring results summarizing the foundation subsurface profile upstream of the planned cutoff wall location is shown on Figure 8. We have added two
