Influence of Tree Roots and Mammal Burrowing Activity on Levee Performance: Volume 1. – Review of Literature and Case Histories

Technical Report · August 2013

Geotechnical Engineering
University of California, Berkeley
Report UCB GT 13-03 vol. 1

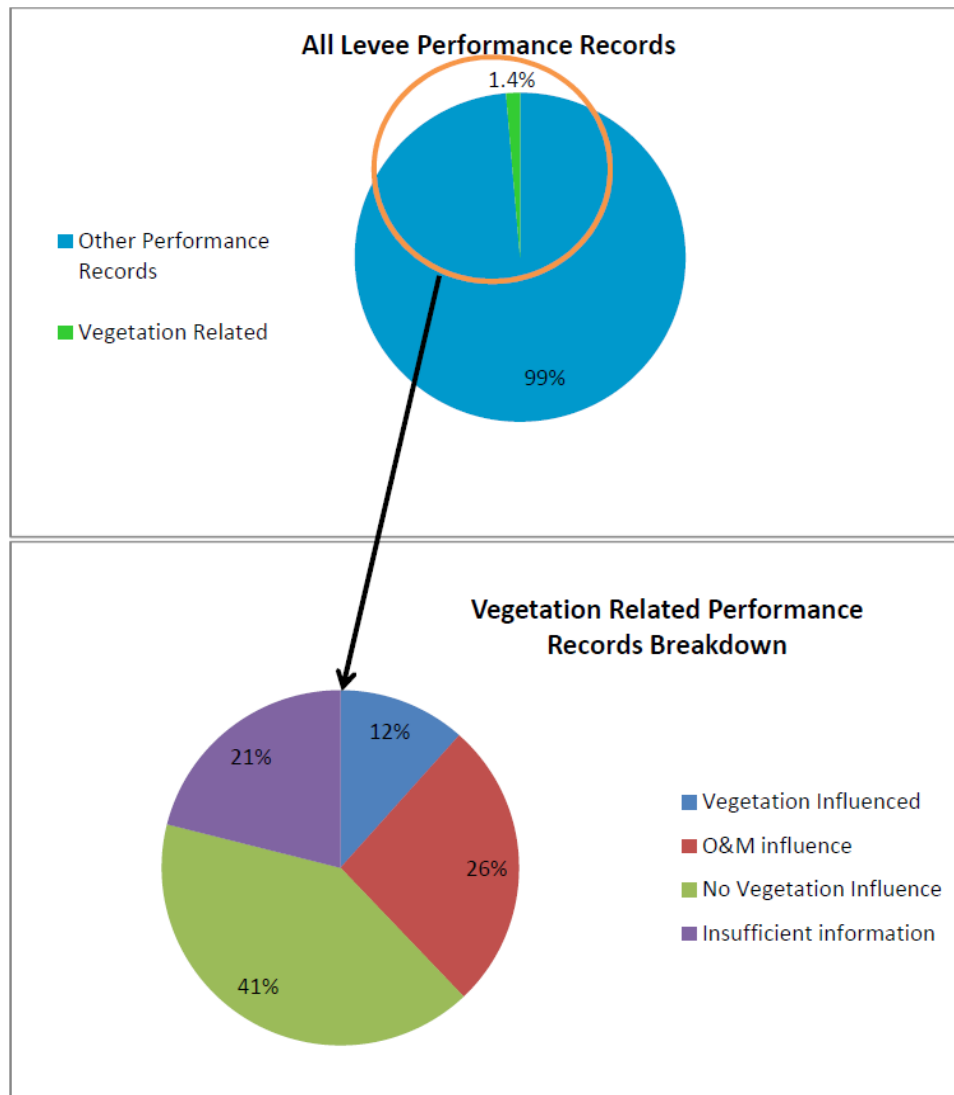
The results of the URS analysis of over 10,000 records showed that 6,970 performance records contained some observations with respect to vegetation. Of these, 348 were levee breaches resulting in water flooding the protected side, but none of the records identified vegetation as having influenced the reported breaches. The remaining 6,622 records contained 95 performance reports that indicated the presence of vegetation in the vicinity of an identified performance issue (Figure 2-1). From these 95 records, 11 identified vegetation as a factor influencing performance, 25 indicated vegetation had an influence on Operation and Maintenance (O&M), 39 had references to vegetation in a way that was not relevant to an O&M or performance issue; and finally, 20 referenced vegetation but had insufficient information to assess its role.

Figure 2-1. Performance records related to vegetation in California levees (URS, 2011)

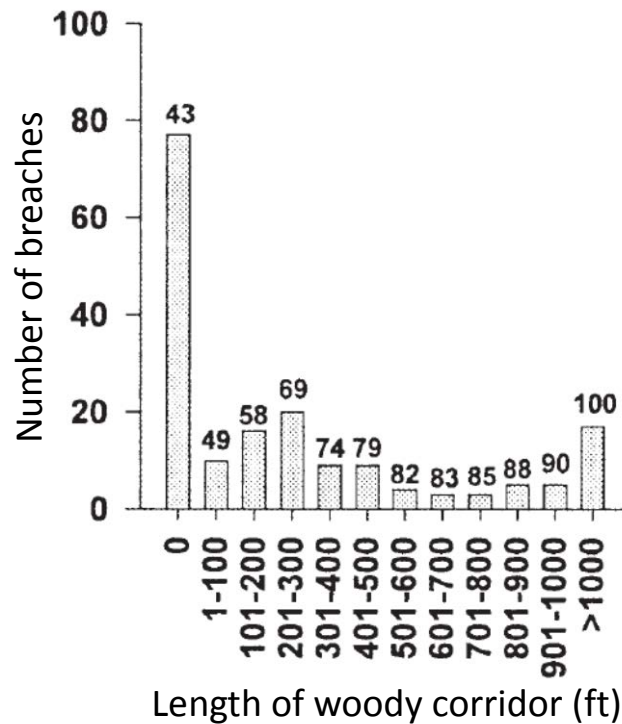
River Mile 0-226 Break Distribution

Allen et al (2003) investigated a series of levee breaches along the Missouri River after the 1993 floods, and concluded that vegetation played a significant role in the reduction or prevention of damage of levees. Their study of a 353 mile long segment along the Missouri River concluded that areas where vegetation corridors were present exhibited a smaller number of levee failures, and that the length of the failures or breaches was almost halved when a vegetated corridor existed (Figure 2-22). Moreover, they concluded that discontinuities within these corridors can be weak links for initiation of failures. The figure shows number of levee failures based on incremental increases in the width of woody corridors for level mile 0-226. The numbers above each bar correspond to the cumulative percentage of levee failures occurring with the addition of each increase in woody corridor width.

Figure 2-22. Number of breaches as a function of woody corridor length (modified from Allen et al., 2003) [1 ft: 0.3048 m]

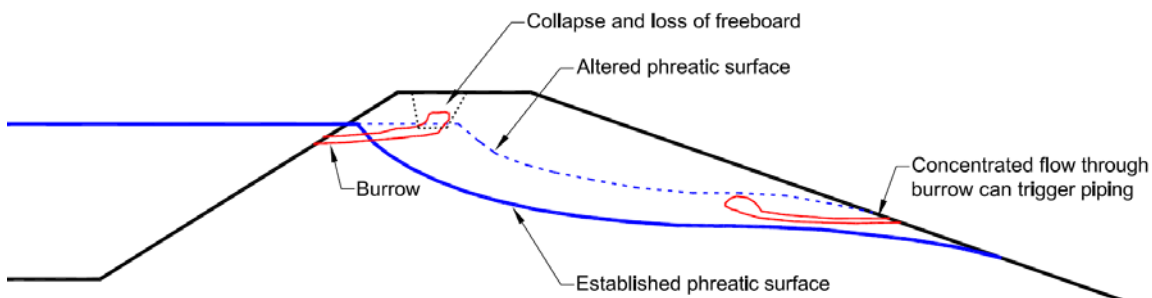
For dams, which share some characteristics with levees, FEMA (2005) identifies potential risks from animal burrowing as (1) hydraulic alteration, (2) structural integrity losses, and (3) surface erosion. Hydraulic alteration (Figure 2-23) is basically a distortion of the phreatic surface established through the embankment, as burrow dens and complexes located on the waterside can allow water from the waterside to enter inner portions of the embankment with no loss of hydraulic potential. If the burrows are on the protected side (landside), burrows that extend below the phreatic surface can concentrate the flow lines and potentially lead to piping. This phenomenon is most often cited as the greatest concern because it is progressive and can rapidly lead to failure (FEMA, 2005). Structural integrity losses occur when a large number of burrows or dens collapse, generating a localized loss of freeboard or flood protection elevation (Figure 2-23) or slope instability in the vicinity of the collapse. Finally, surface erosion by the downslope biogenic movement of soil ejected from the animal burrows eliminates vegetal cover that provides erosion protection.

Figure 2-23. Effects of animal burrows in embankments

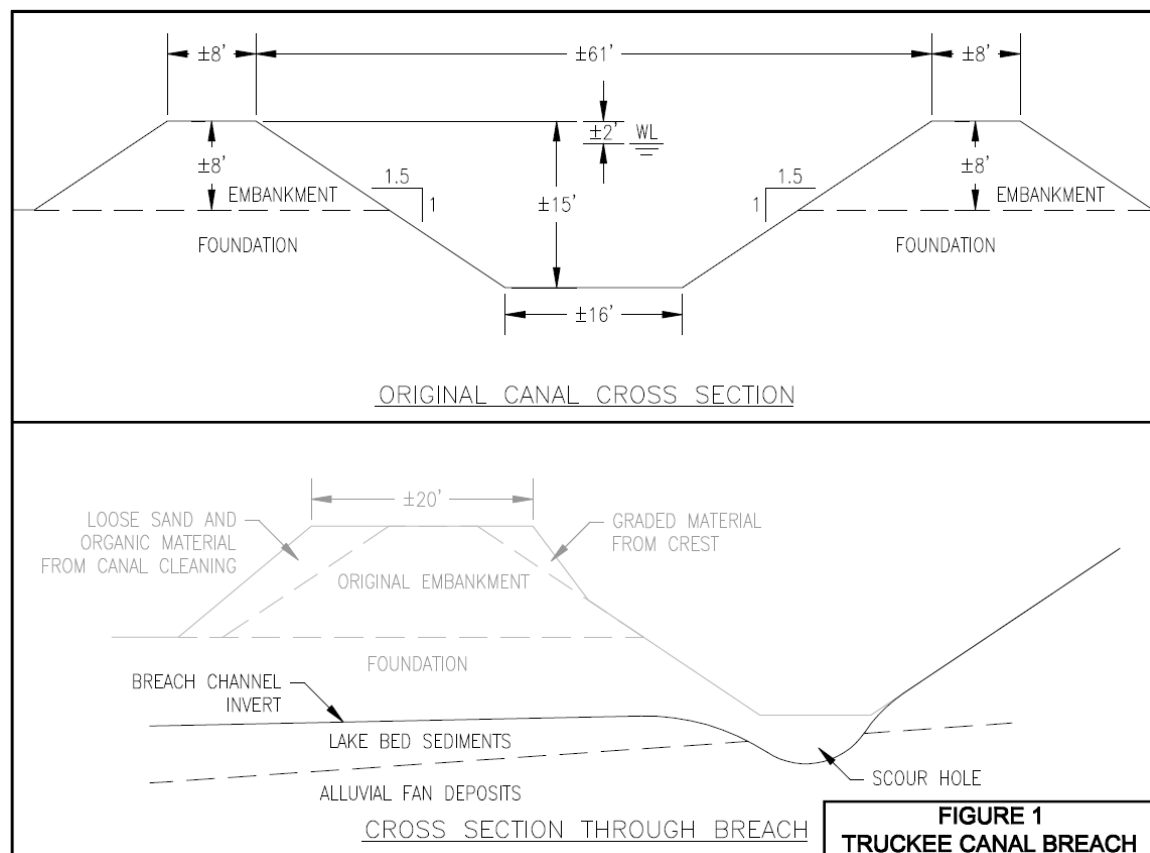
breached levee lined the Truckee Canal, which serves as a diversion for excess flows from the Truckee River as well as a water conveyance for miscellaneous uses. The embankment was about eight feet high, with slopes of approximately 1.5:1 (horizontal to vertical) (Figure 2-26). Embankment materials were mainly silts and clays dredged from the bottom of the Truckee Canal and piled over the years (URS, 2011).

Figure 2-26. Truckee Canal cross sections (URS, 2008)
