Dodging a Bullet: Lily Lake Dam and the 2013 Colorado Flood

Mark E. Baker, P.E., Dam Safety Officer, National Park Service

This paper is about identification of high risks at a dam, multiple efforts to promptly mitigate those risks, and how the 2013 Colorado Flood severely tested those mitigation efforts. Had the National Park Service (NPS) not made major efforts to improve the safety of the dam before the event, the dam could have failed by lateral spillway erosion and head cutting, threatening the lives of people in more than two dozen homes downstream.

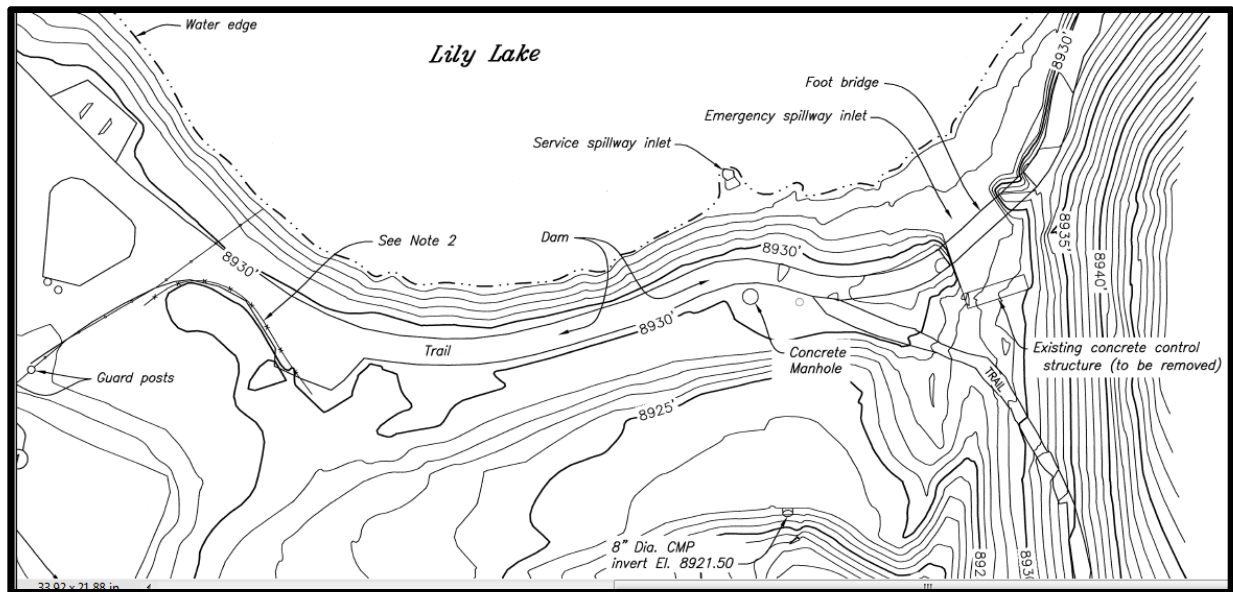
Figure 1 - Survey of Lily Lake Dam before repair (Reclamation)

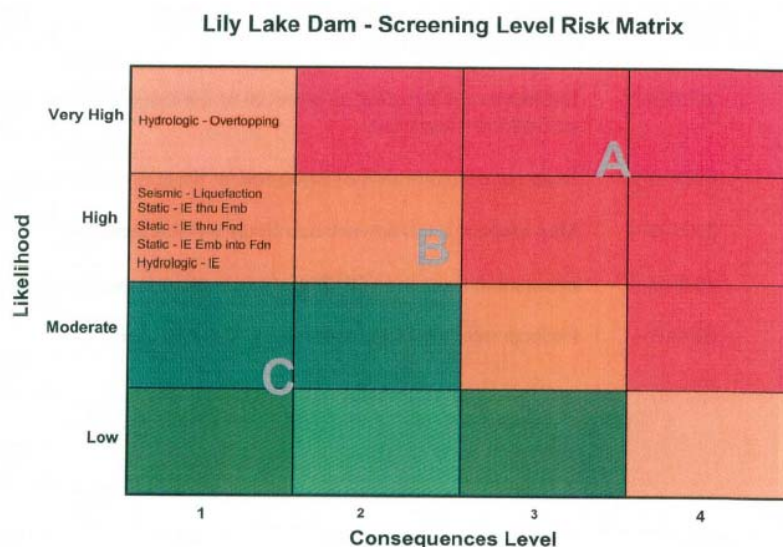
Figure 3: Risk Screening Report Results for Lily Lake Dam, (2011 Reclamation)

The hydrologic overtopping failure mode had the highest risk. Seismic liquefaction and 4 internal erosion-related failure modes also had high risk.

The report stated that overtopping occurs at approximately the 1:100 chance-per-year flood. For the hydrologic overtopping failure mode, progression is described as: “During a large flood, the dam is overtopped starting at the overflow spillways on each abutment, eroding the downstream slope until the crest is breached and erosion of the embankment occurs to the base of the dam at about elevation 8915.” The report made recommendations for additional studies but also stated that these studies were unlikely to change the existing high risk estimations for the dam (especially hydrologic overtopping).

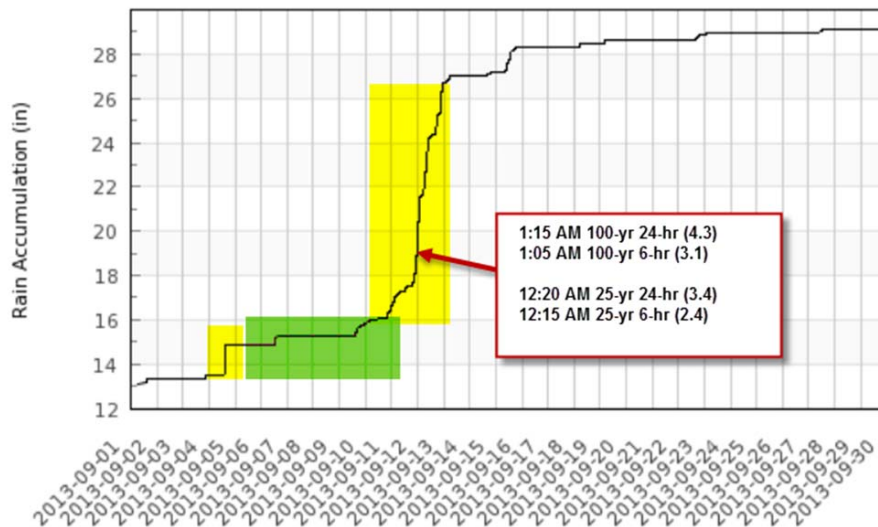
Figure 12: Cumulative rainfall measured by the Lily Lake EWS (Reclamation)

A total of 10-1/2 inches of rain fell from late September 11 to September 14. The flood destroyed all of the canyon access routes to Estes Park except for Highway 7. Thus, the park played an important role in also monitoring the badly corroded Highway 7 culvert just below Lily Lake Dam.

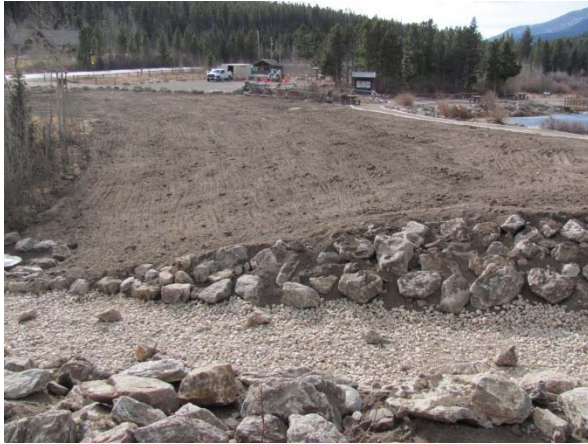
Figure 15: Looking right across the spillway chute after dam repair and before flood (circa 12/1/12 NPS)

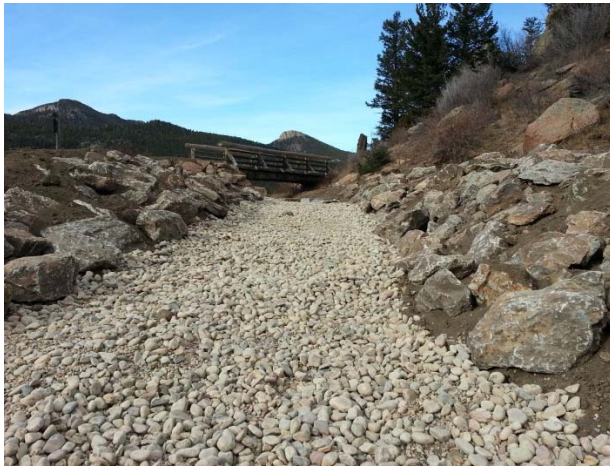
Figure 17: Spillway channel before flood (after dam repair) (11/21/12 NPS)

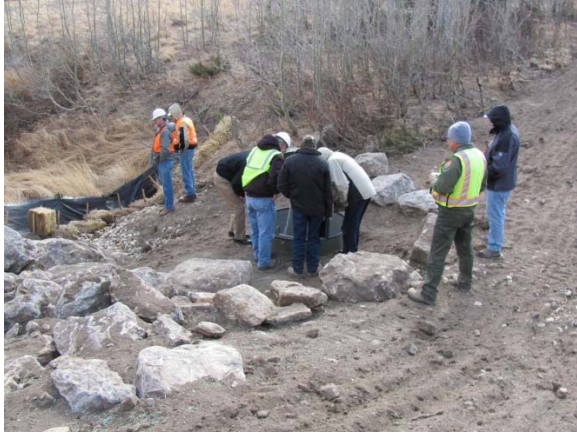
Material was also eroded from around the downstream toe outfall and inspection well area (see figures 19 and 20). This area will require a repair.

Figure 19: Inspection well area after modification and before flood (NPS circa 12/1/12)
