A Synopsis of Notable U.S. Dam Failures

1874 to present

U.S. Department of the Interior Bureau of Reclamation

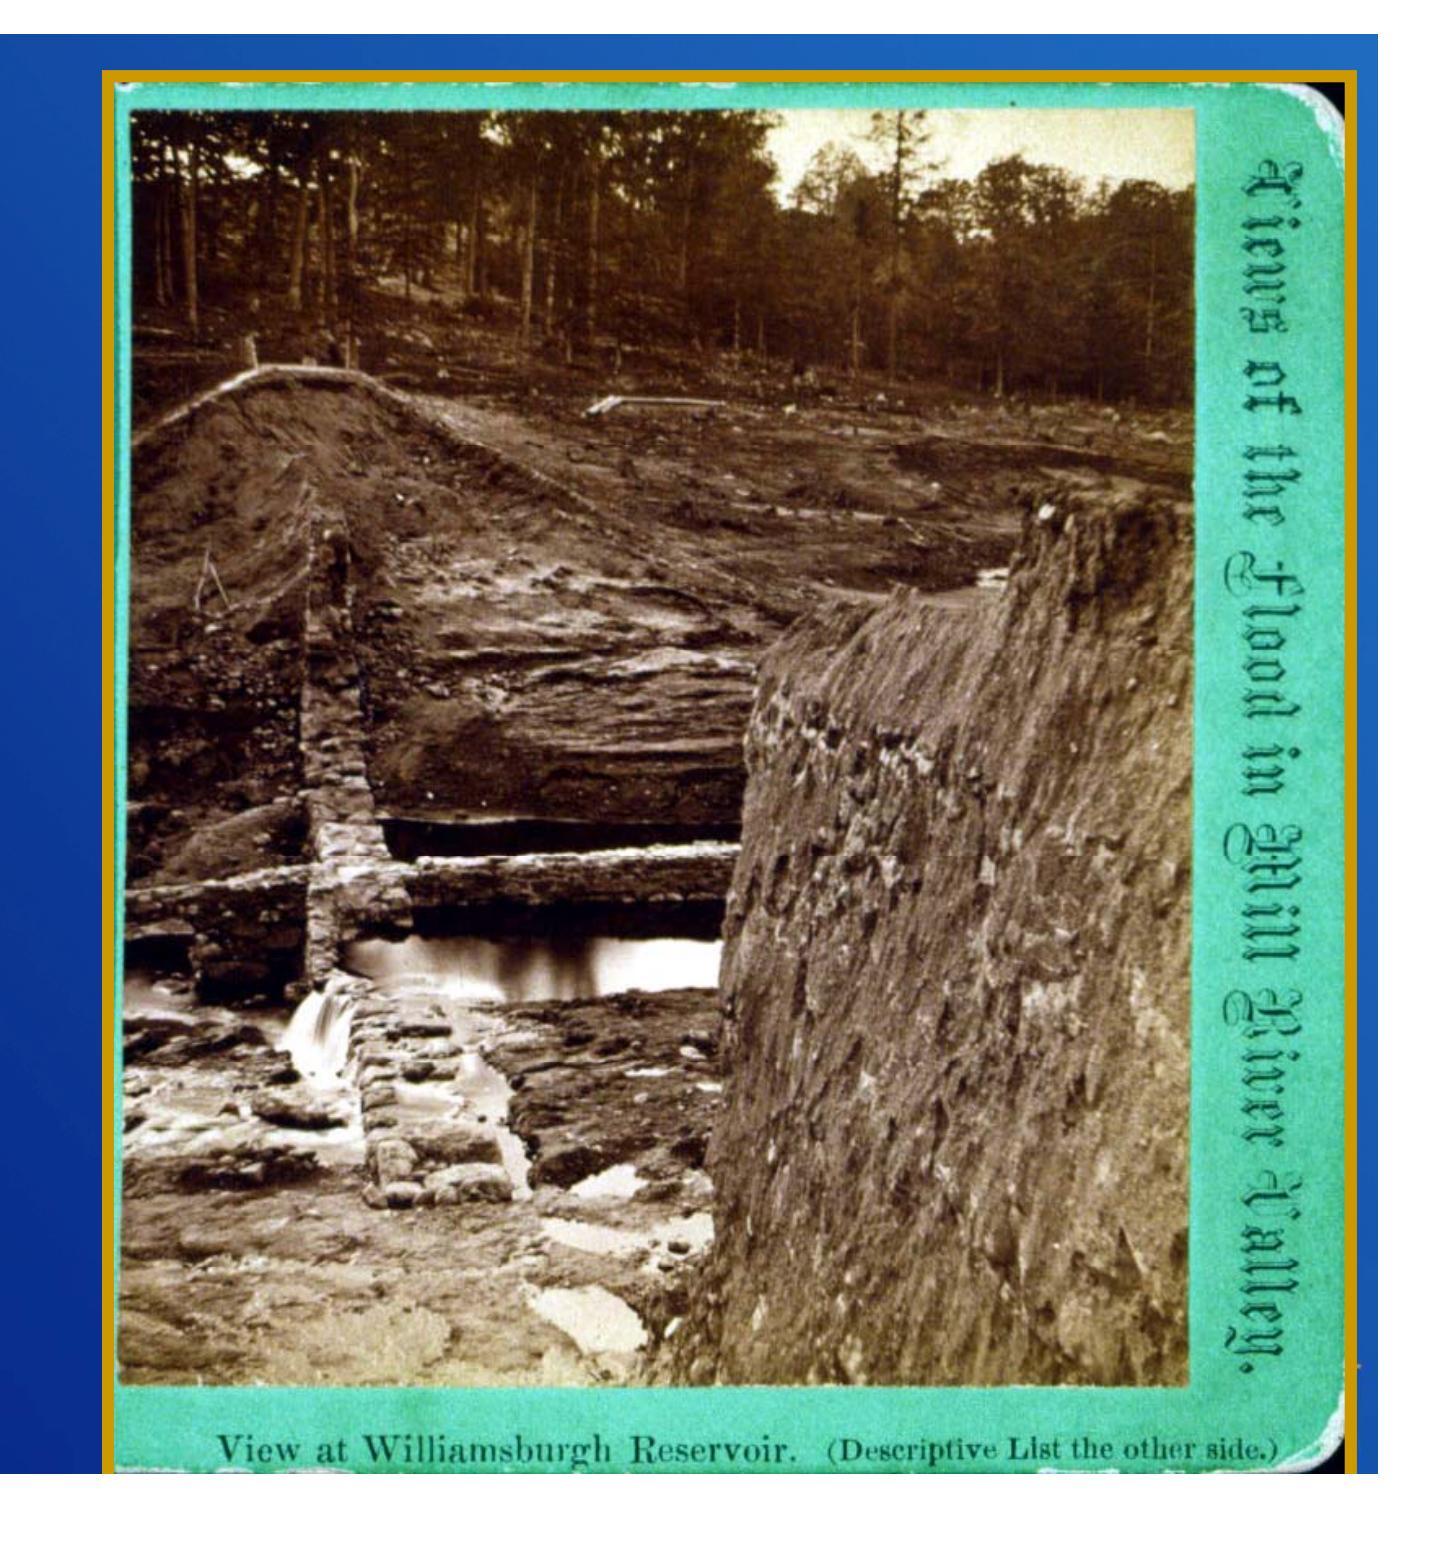
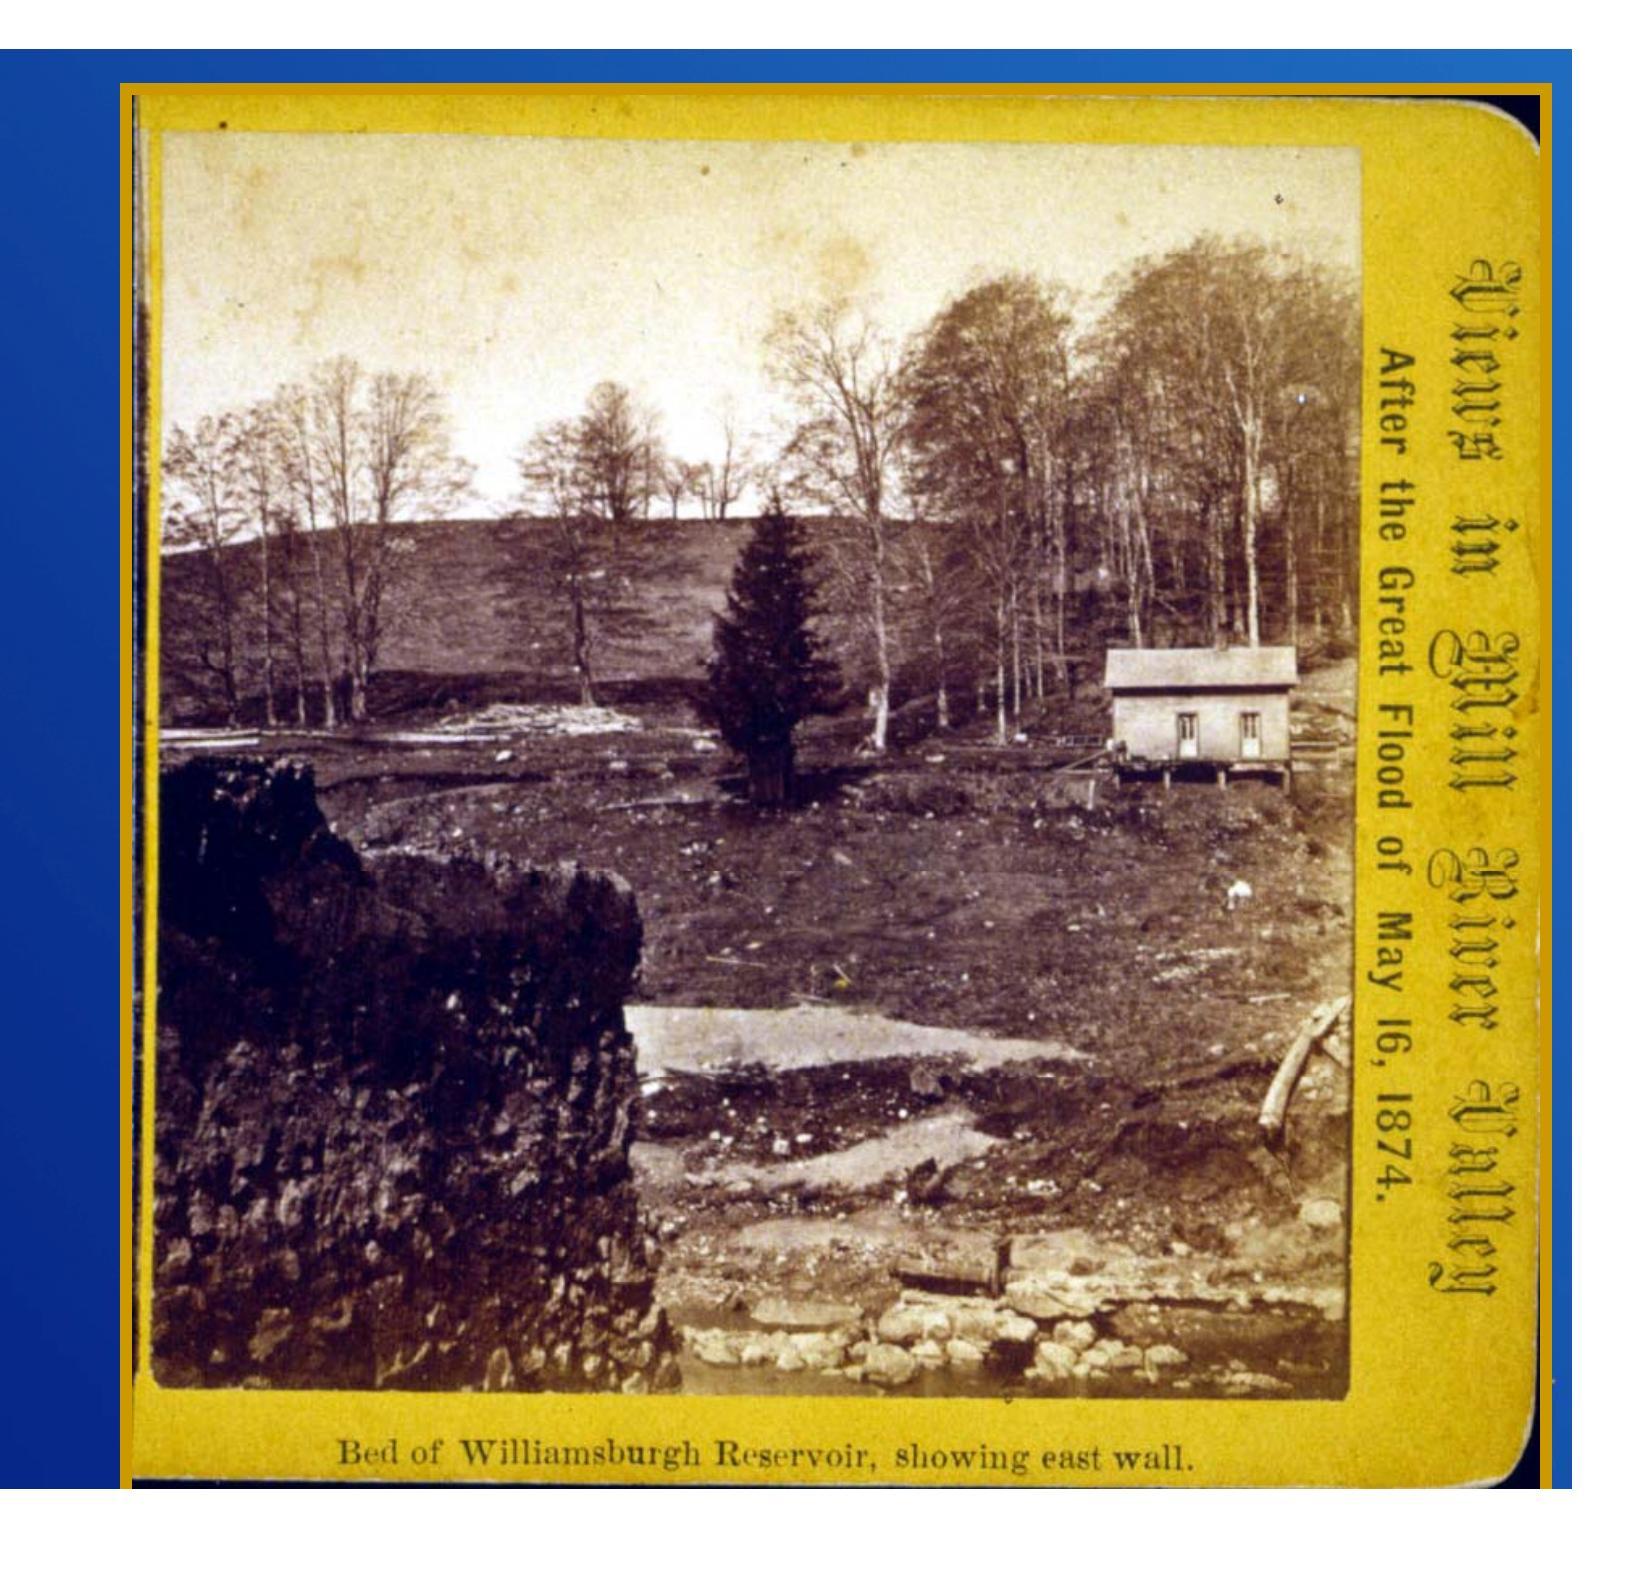
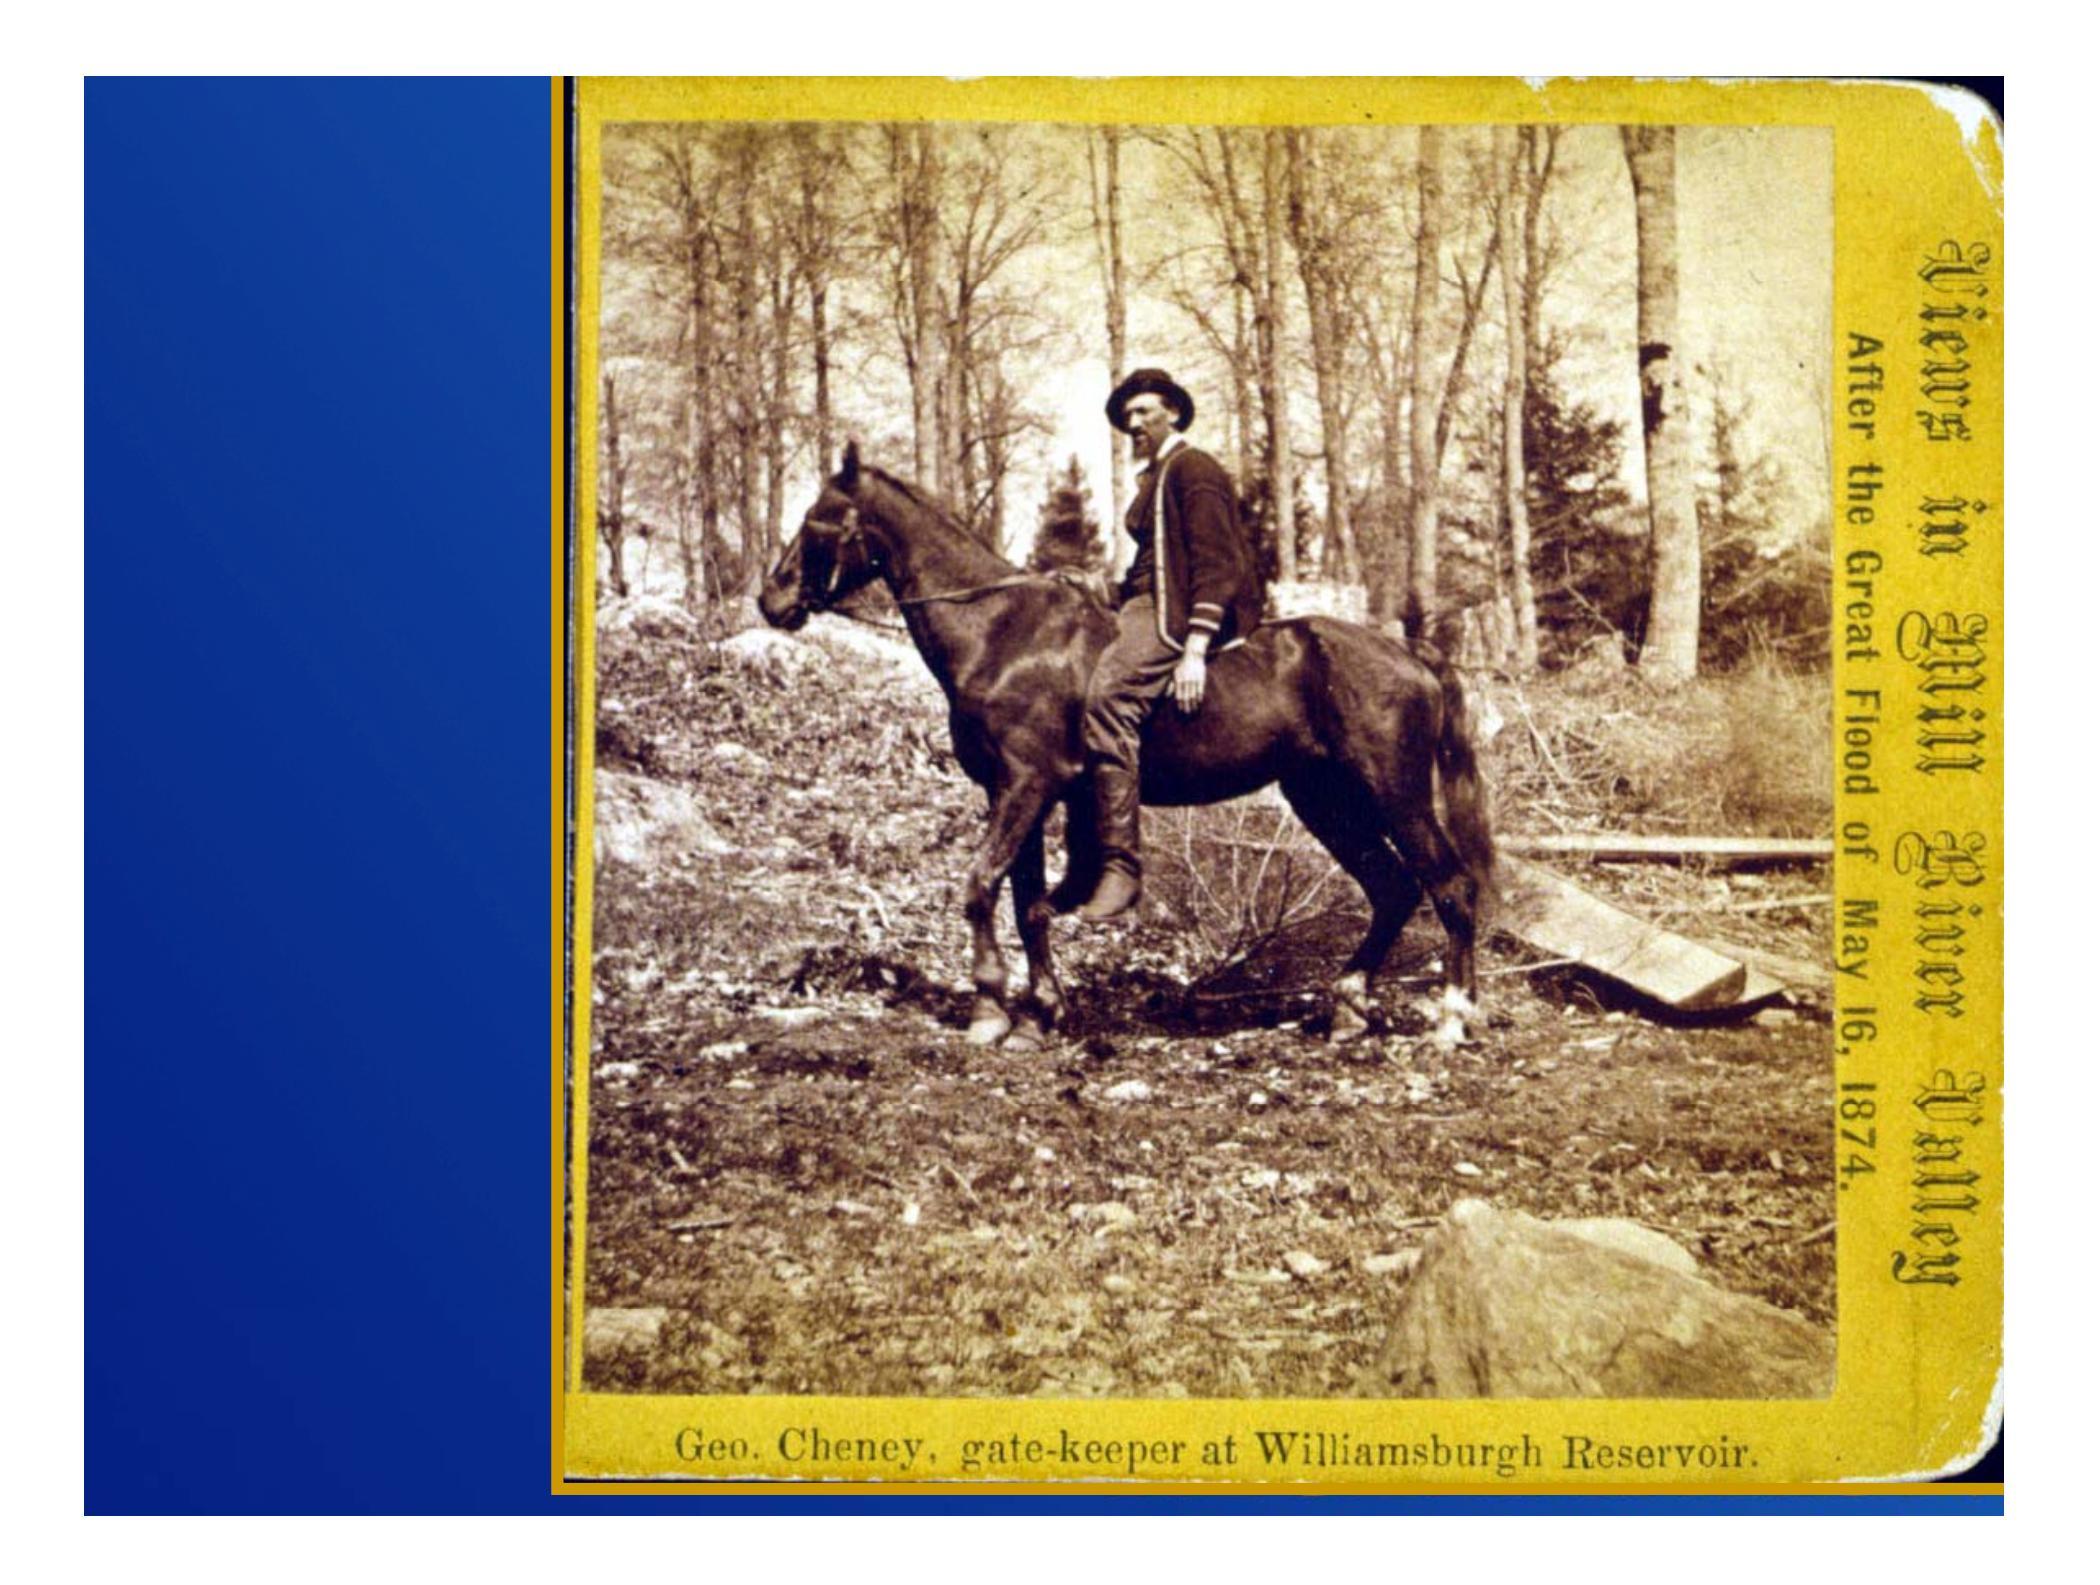
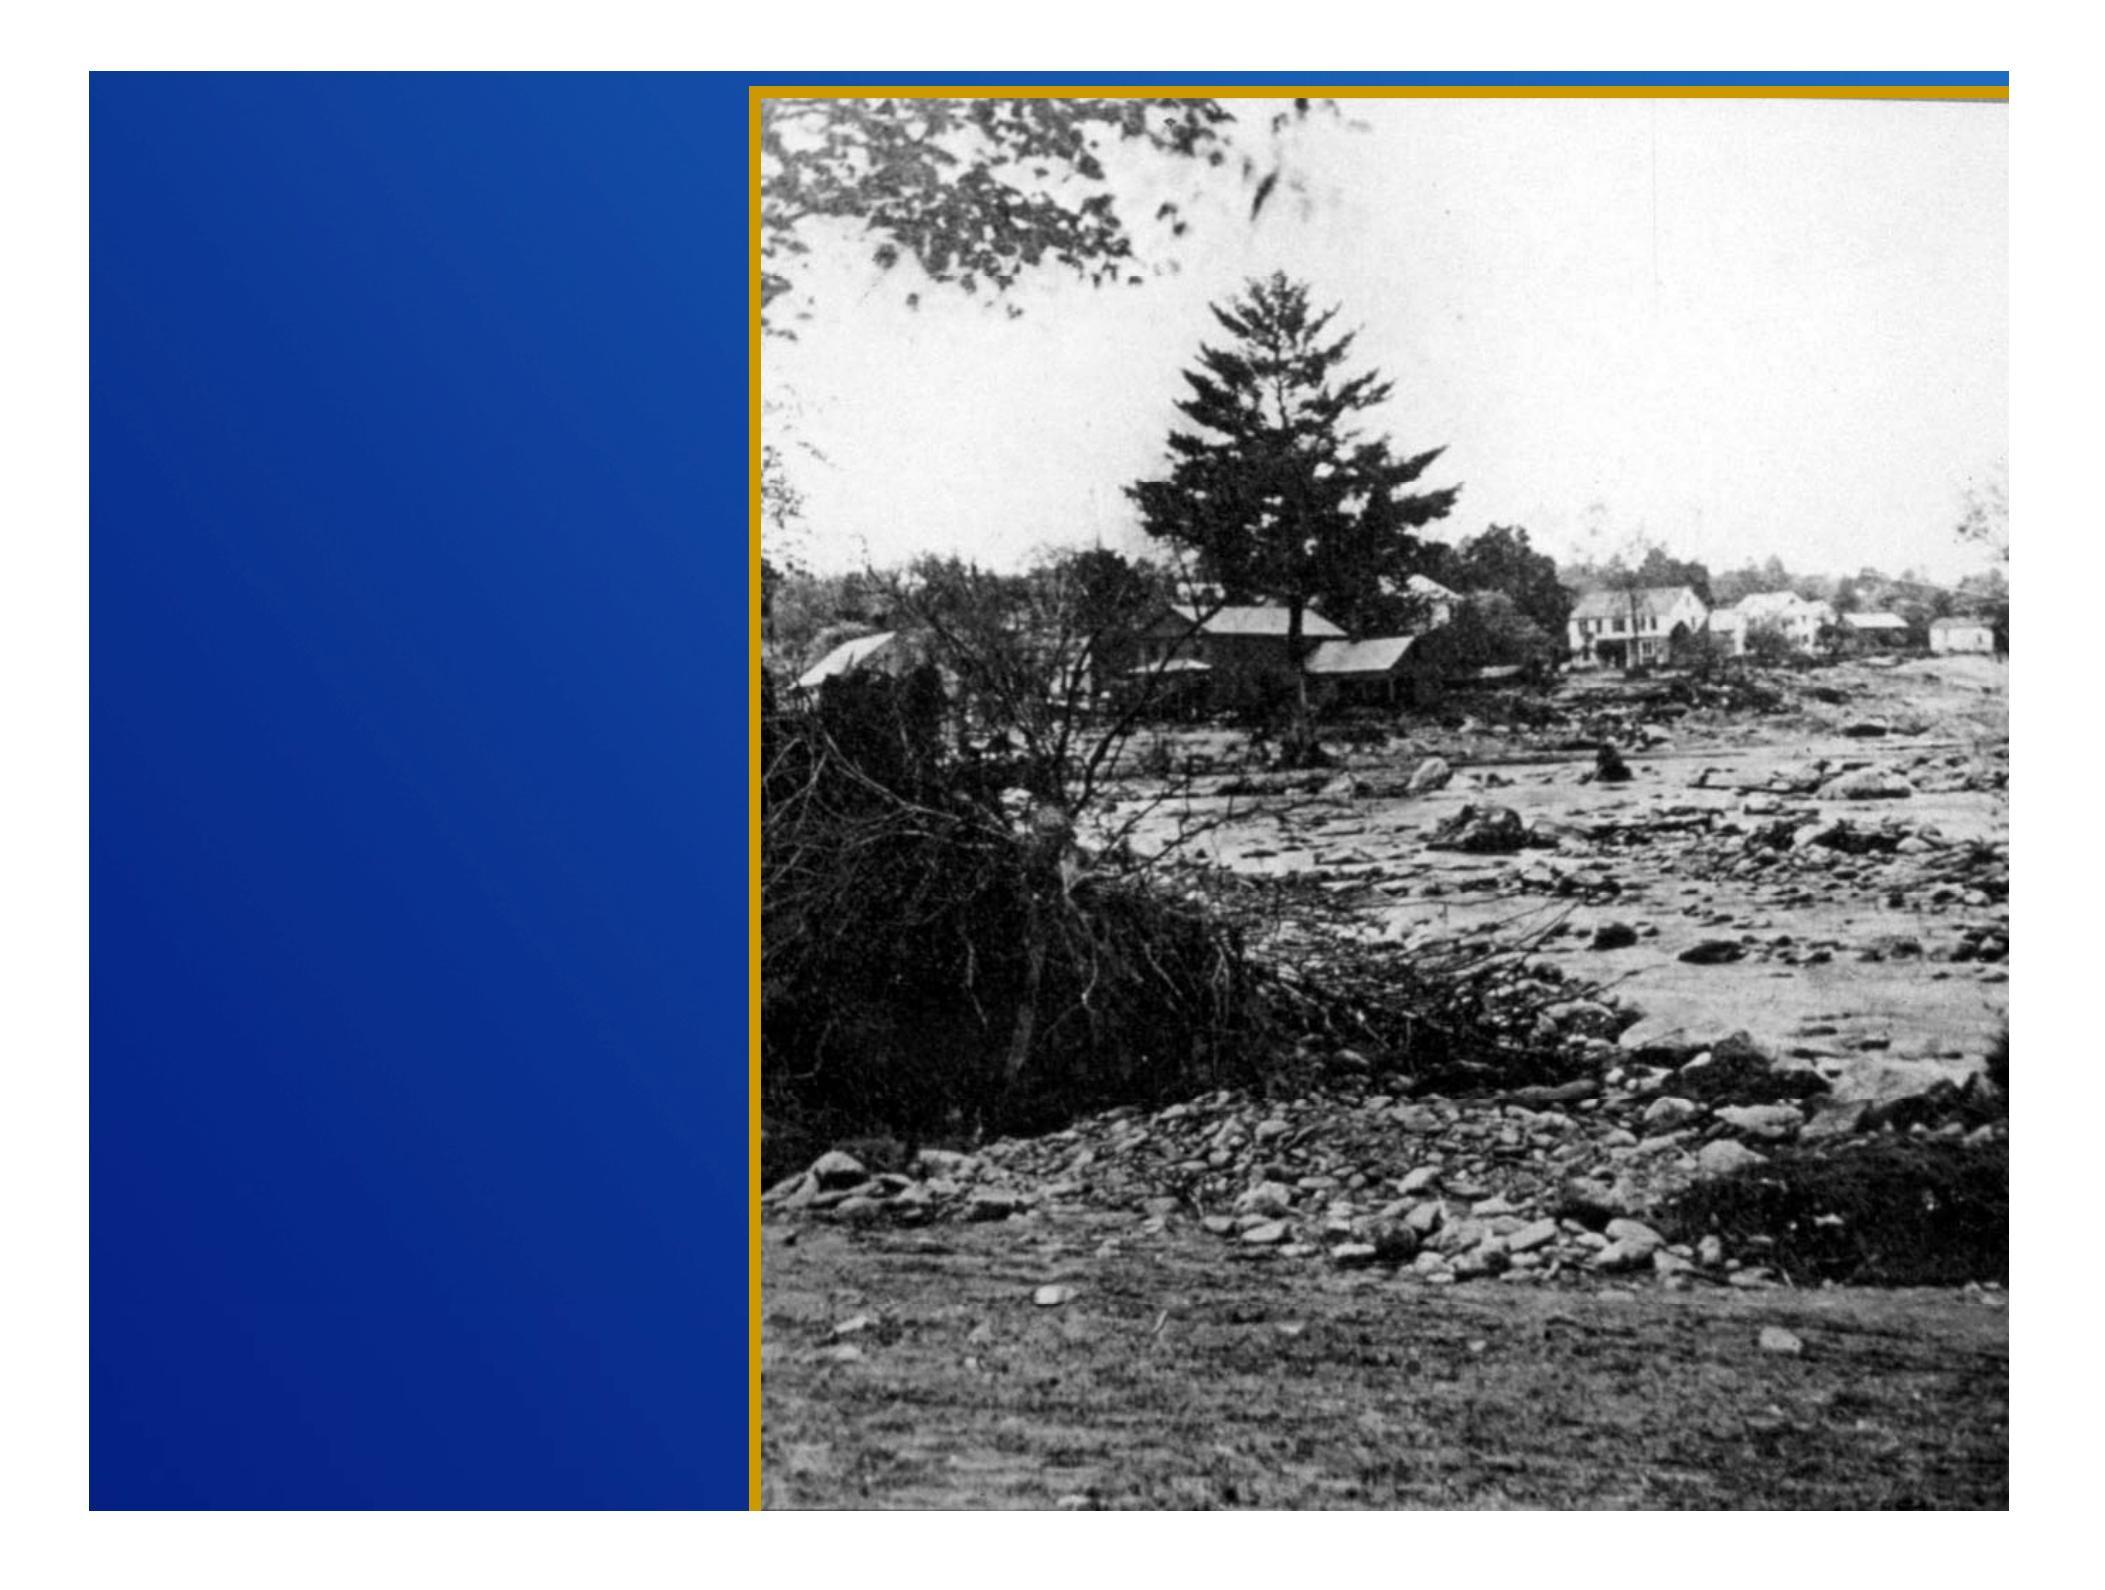
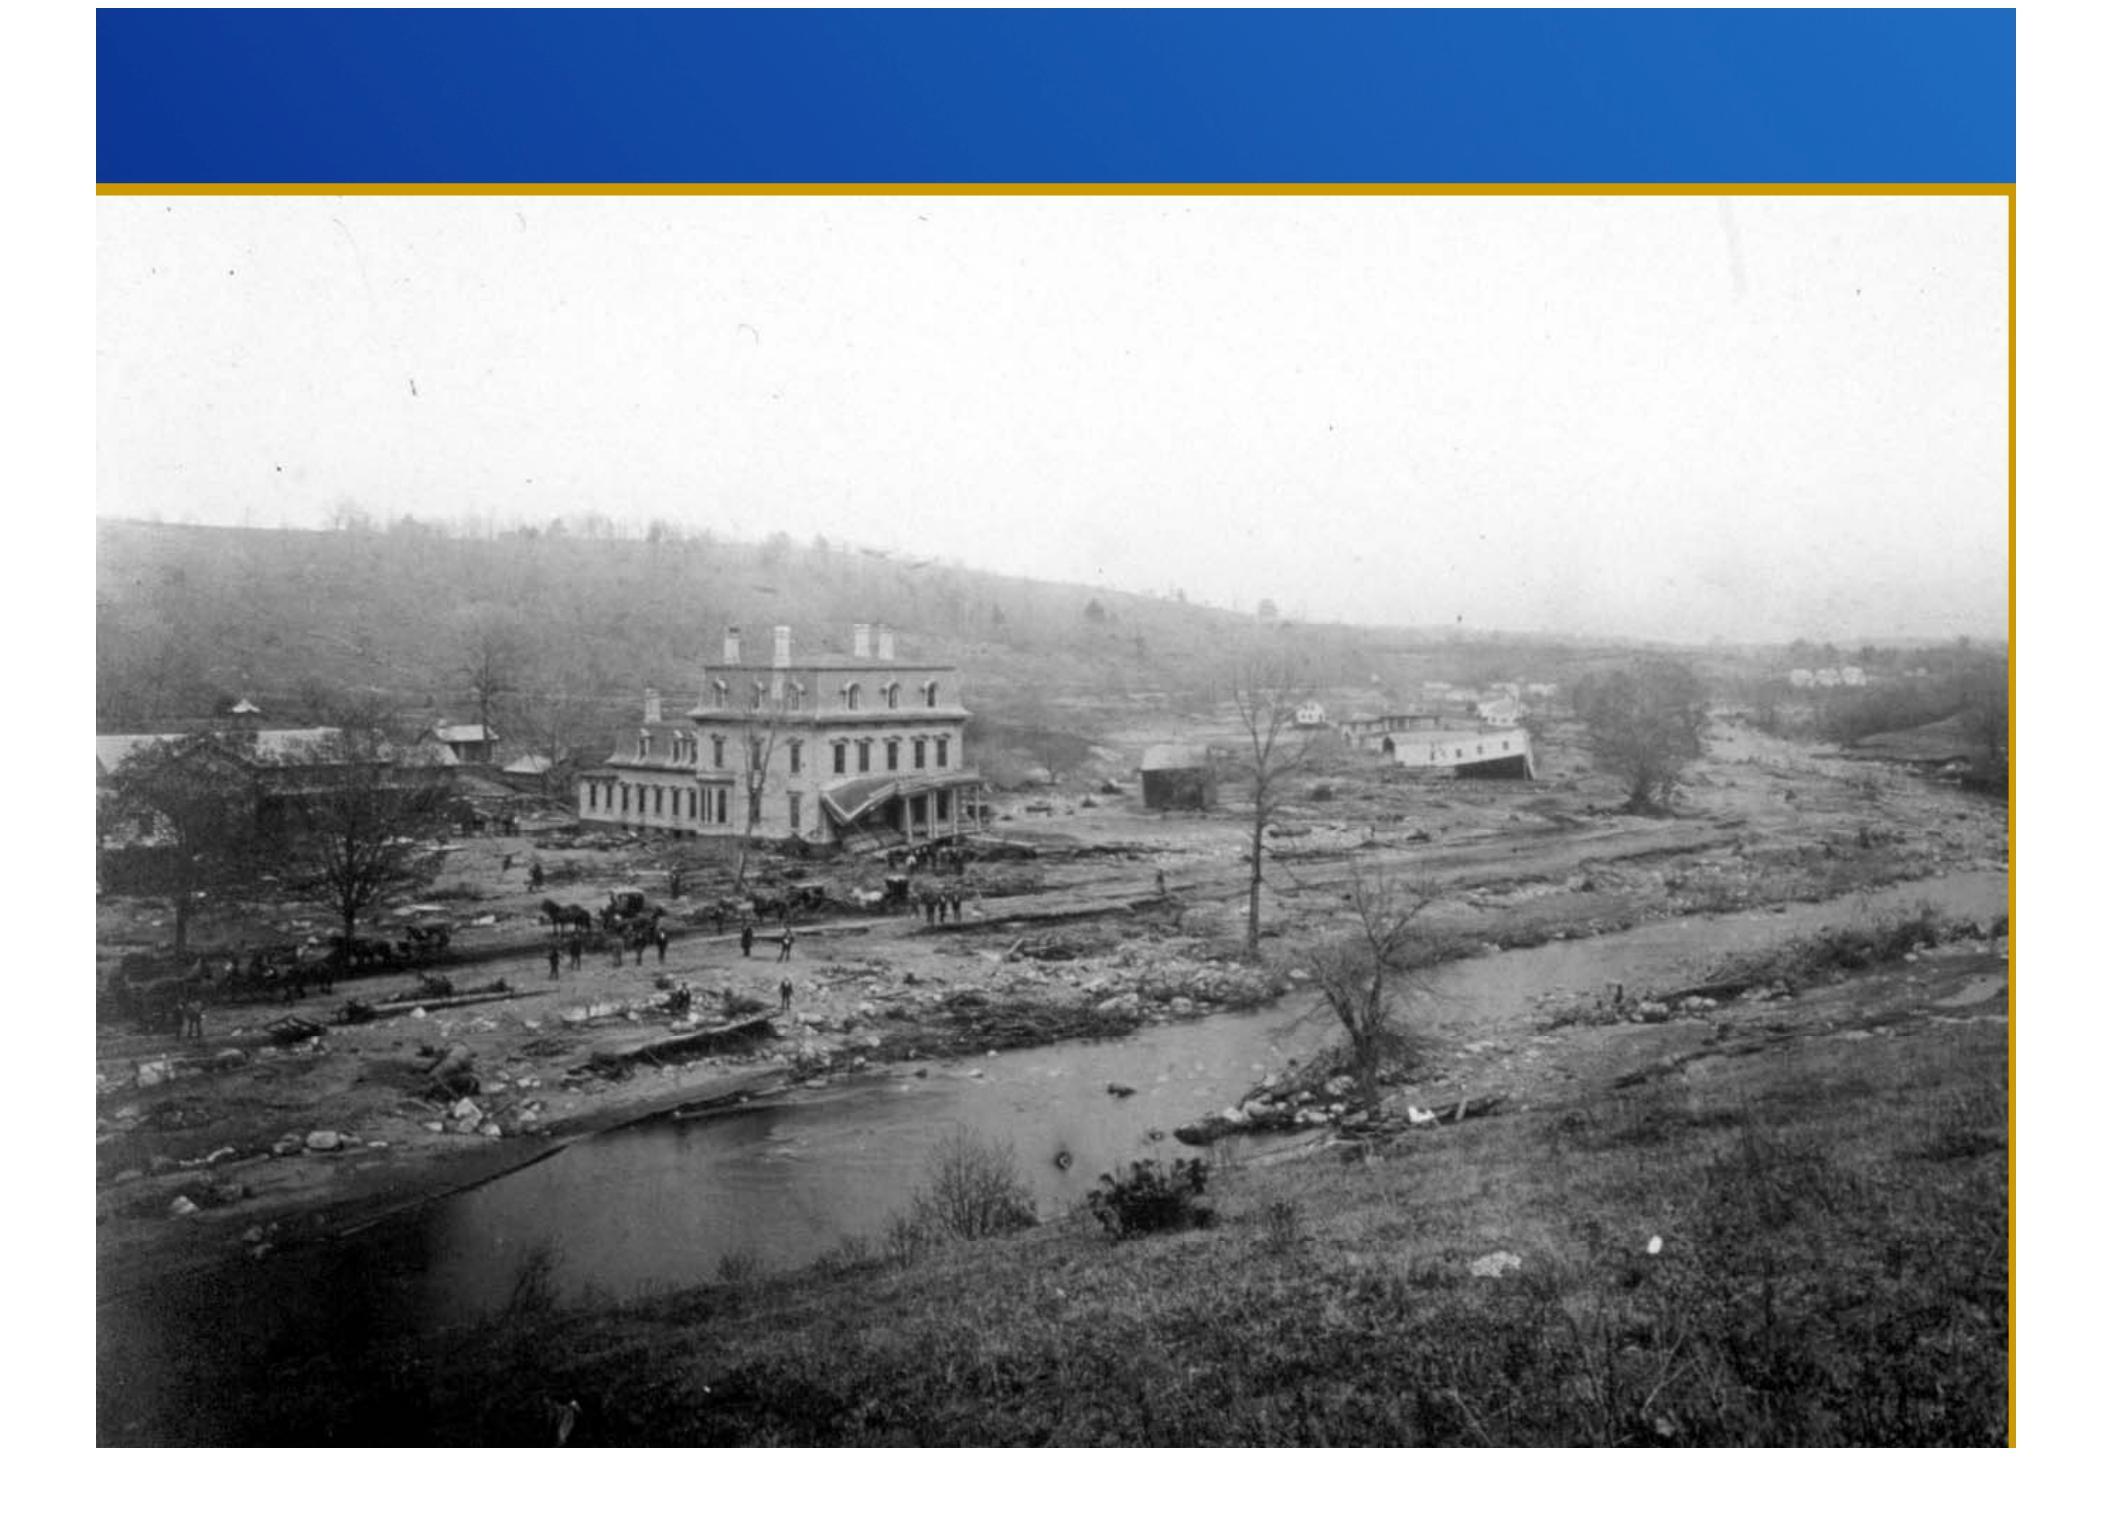
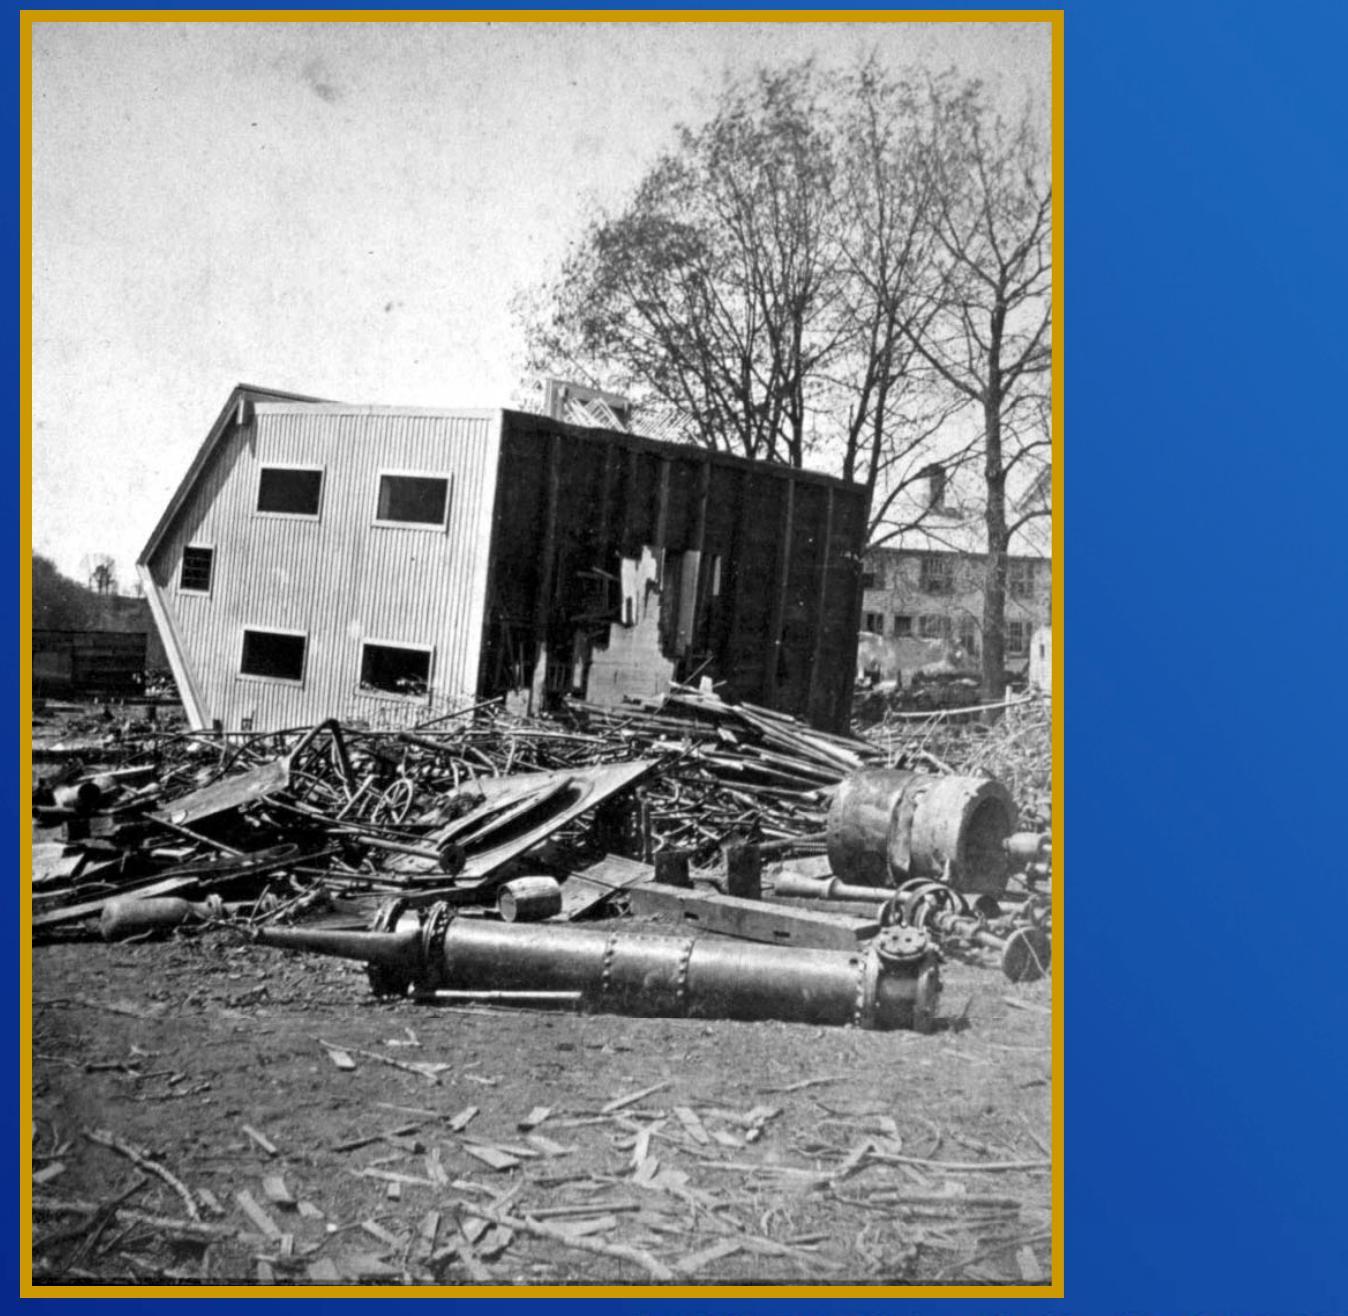
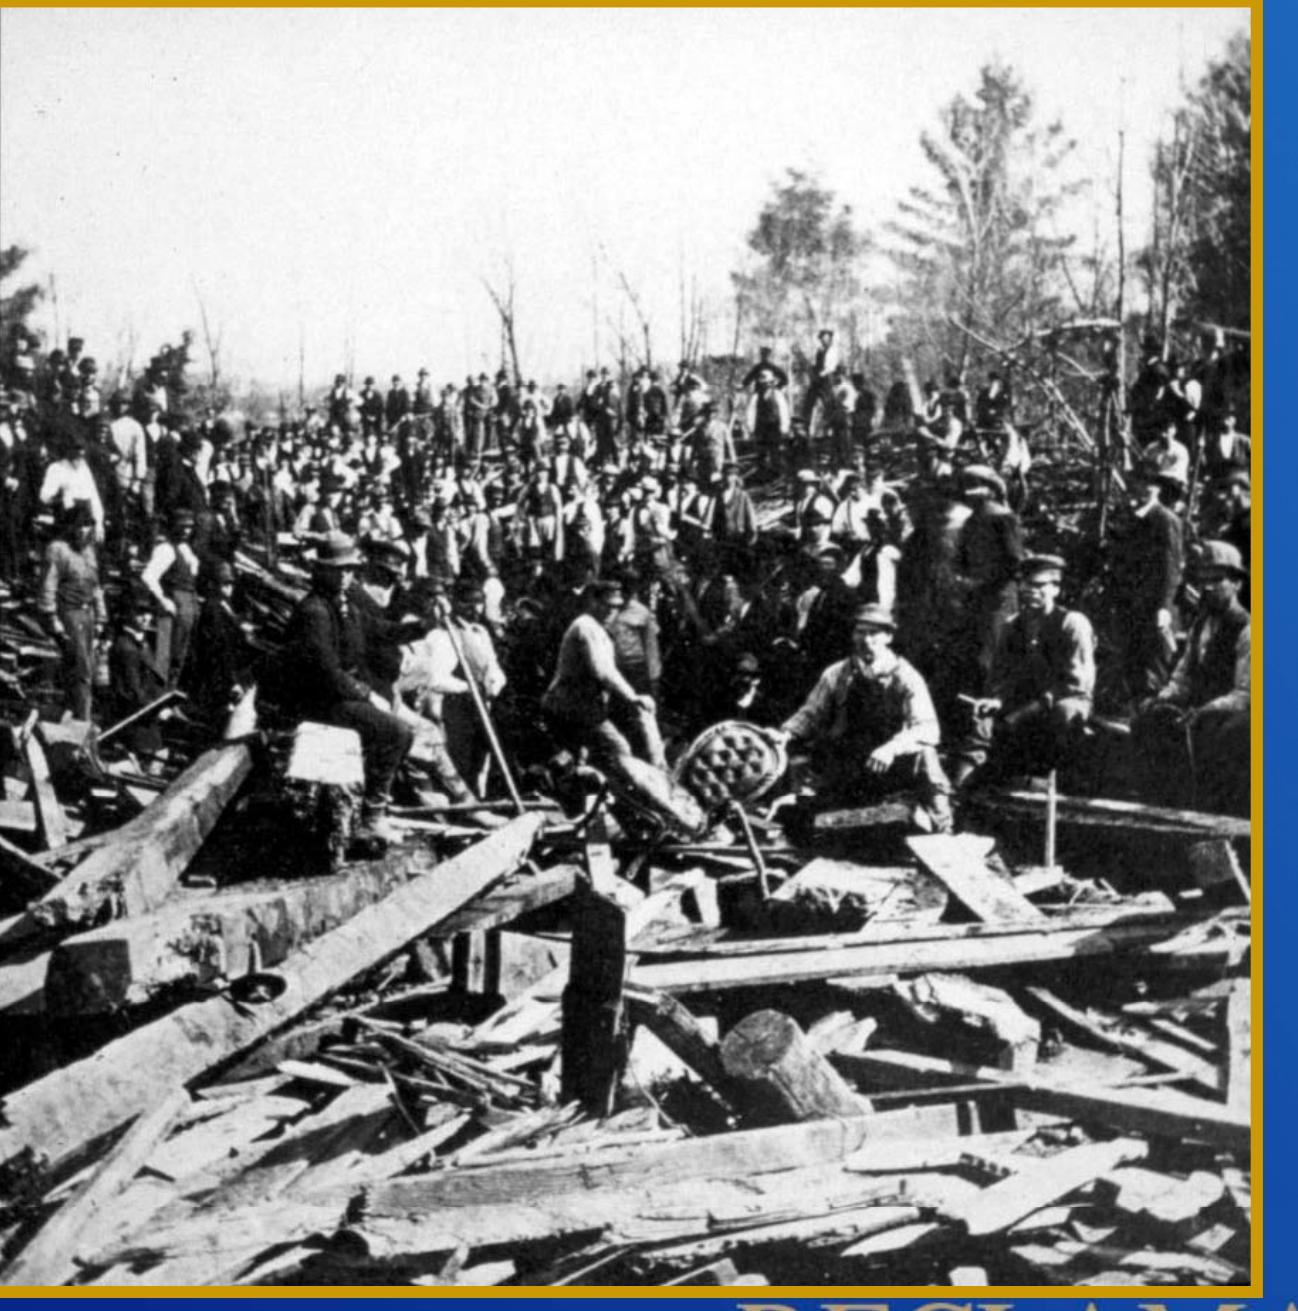
Mill River Dam (Williamsburg Dam) Located in western Massachusetts

- 43 Feet High
- Earthfill
- Failed May 16, 1874 at 7:20 a.m.
- Failed due to piping, embankment slide and then collapse of core wall.
- No warnings were issued before dam failure.
- 138 Fatalities
