A Synopsis of Notable U.S. Dam Failures

1874 to present

U.S. Department of the Interior Bureau of Reclamation

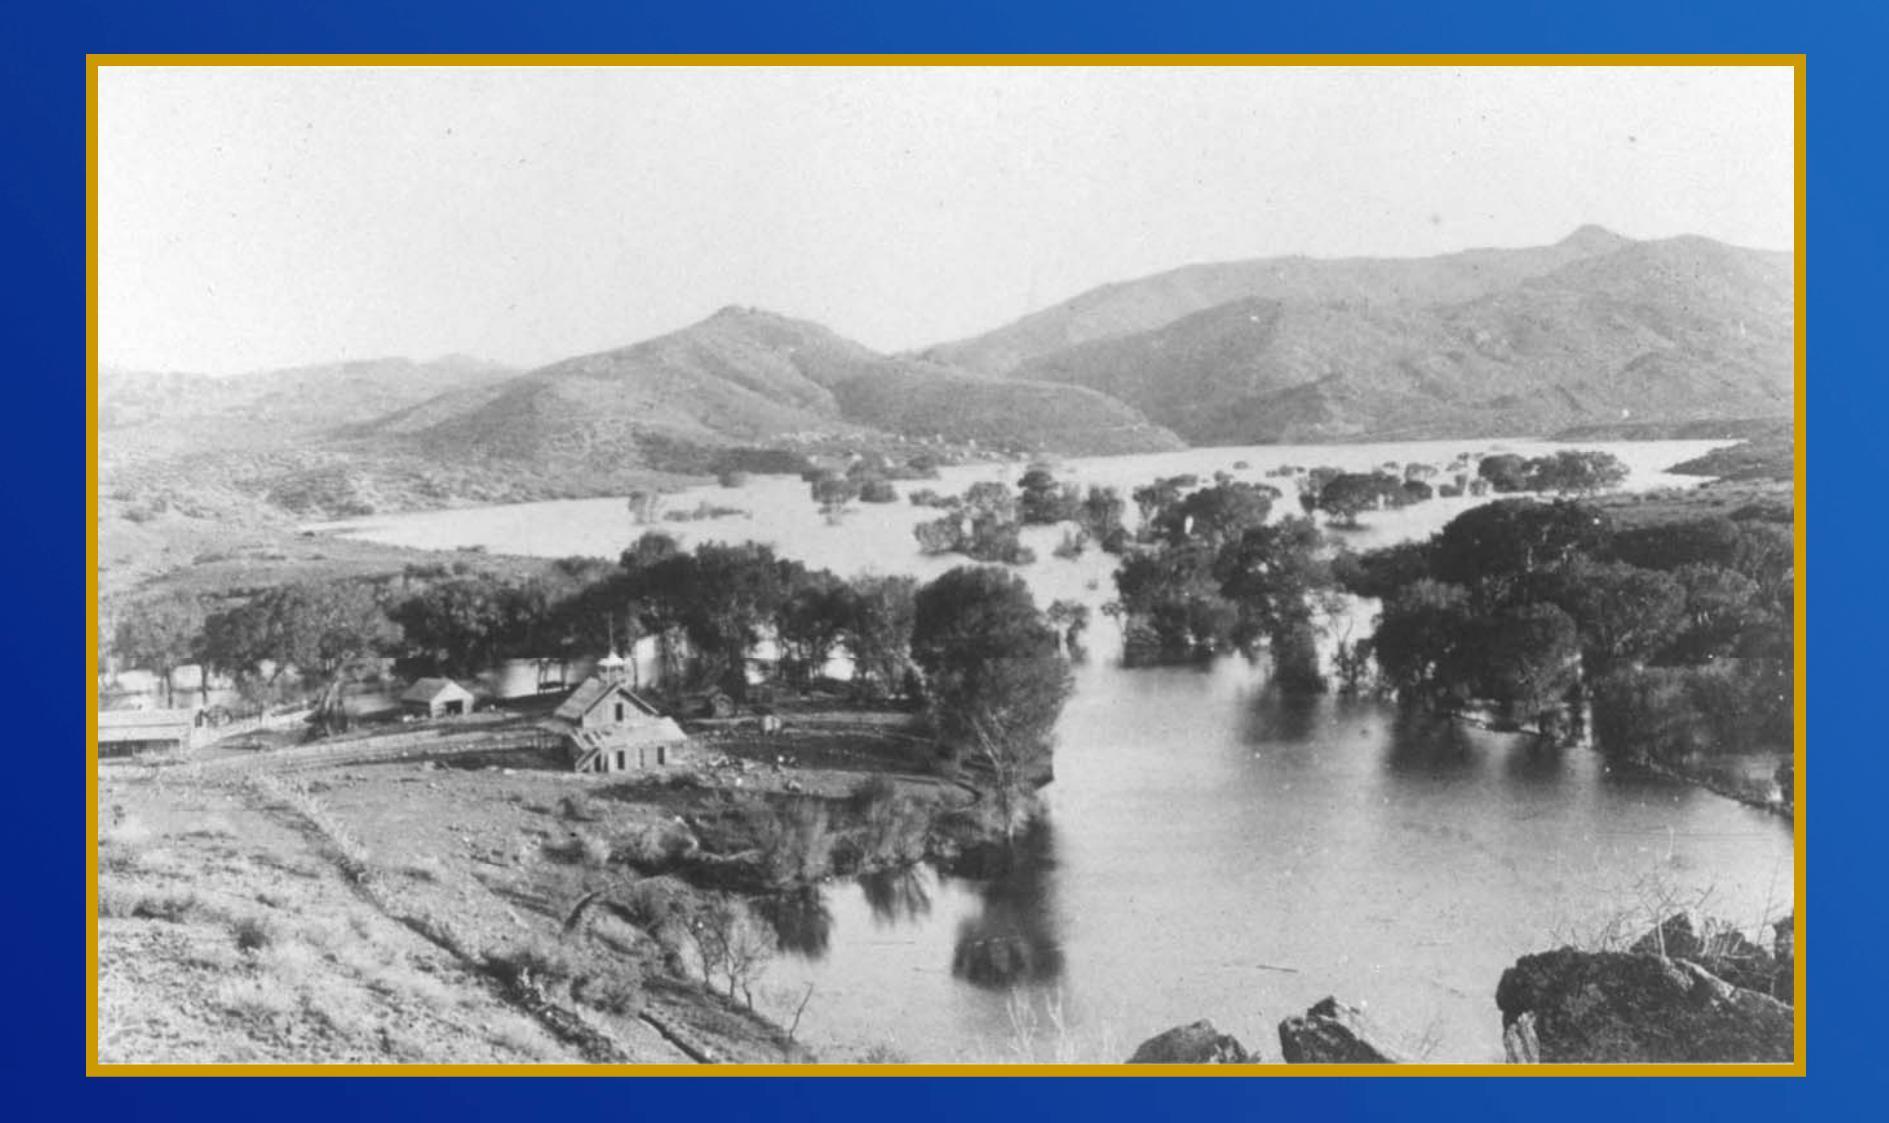
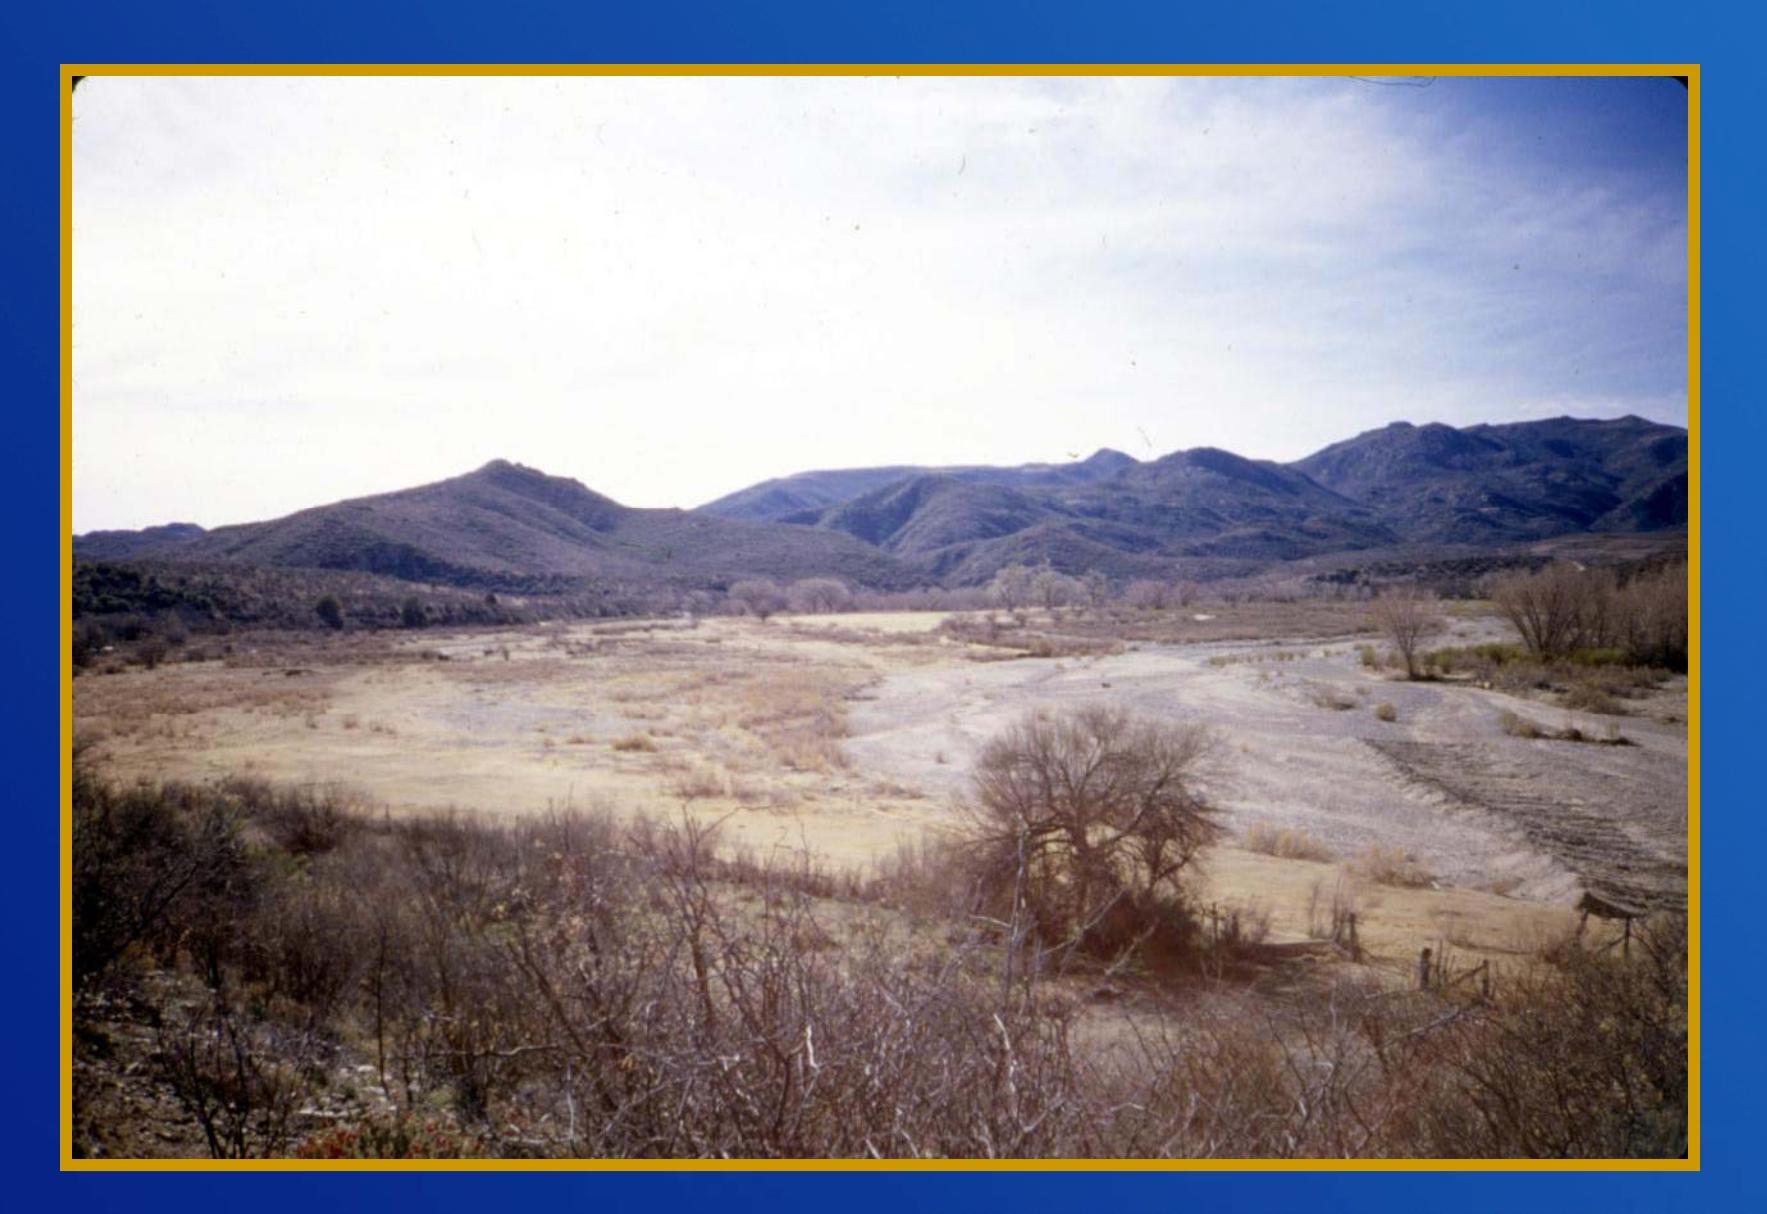
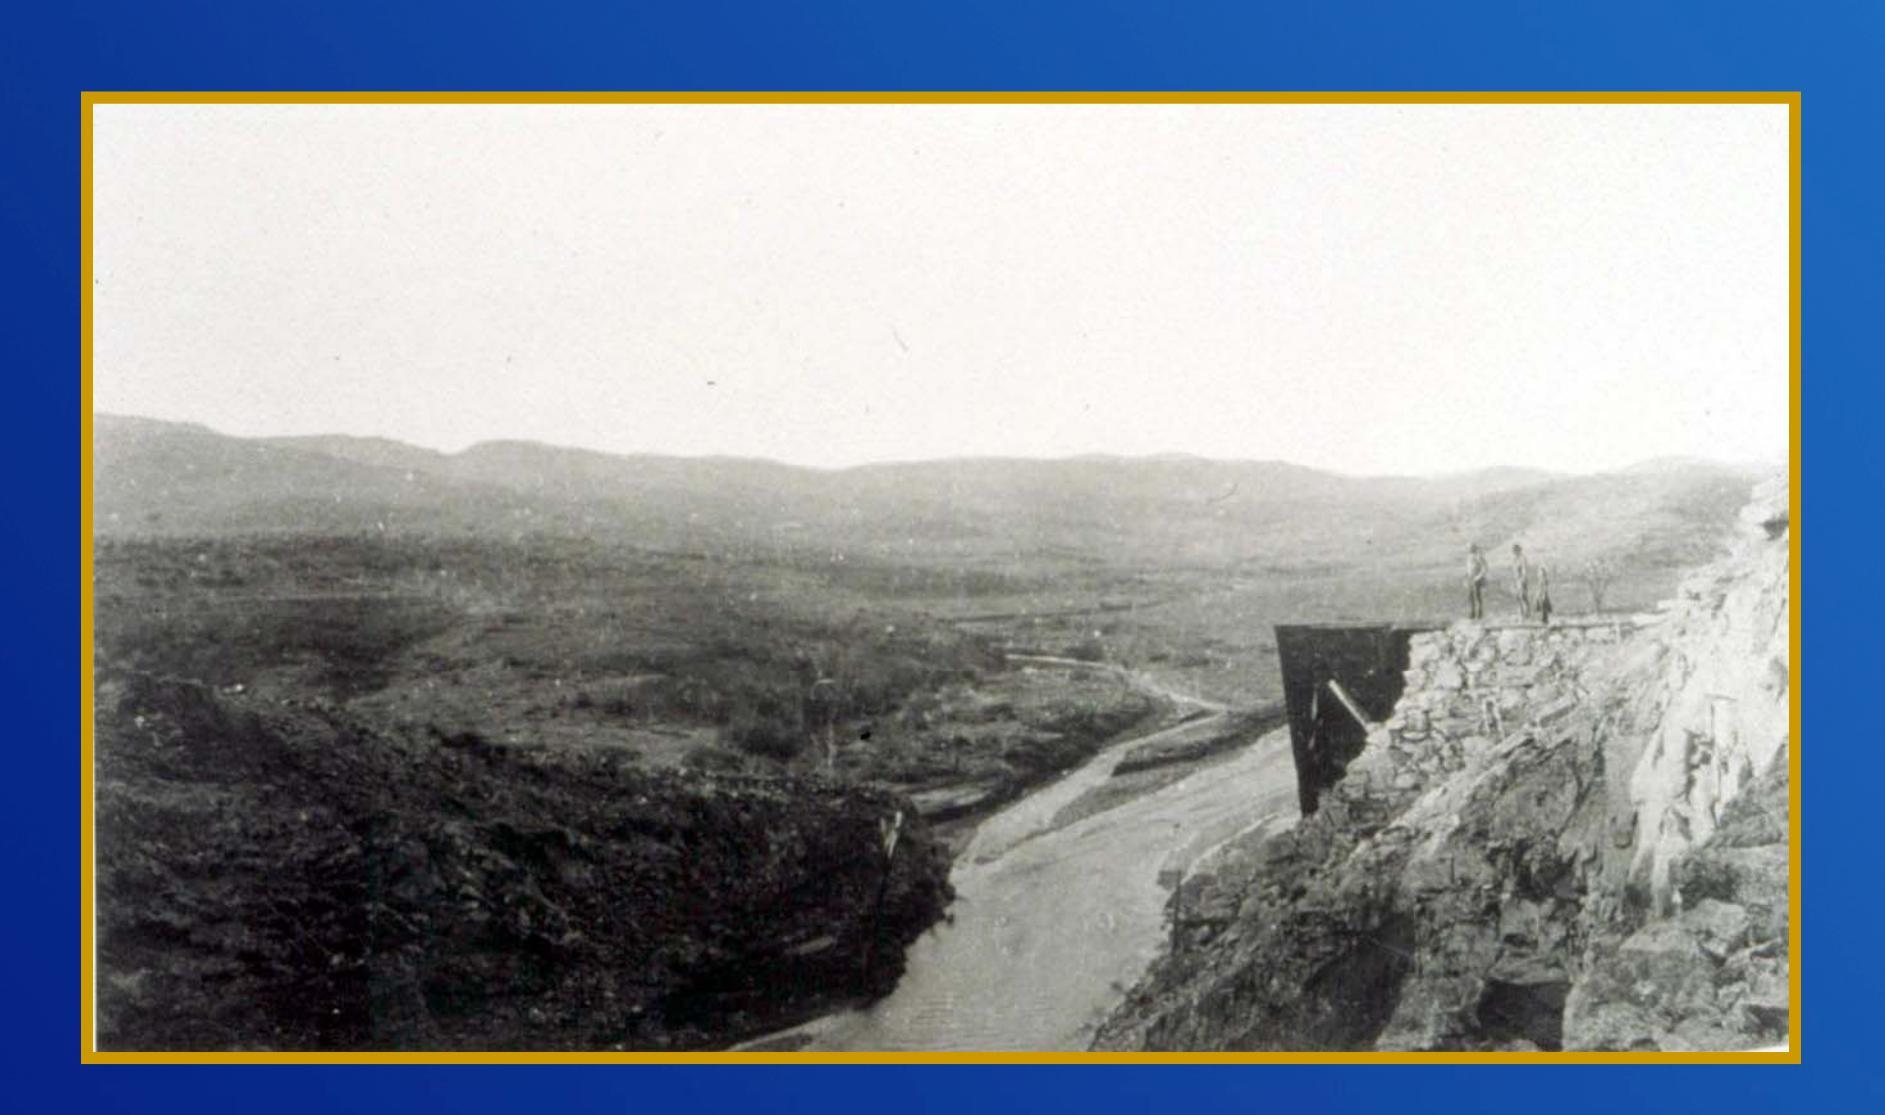
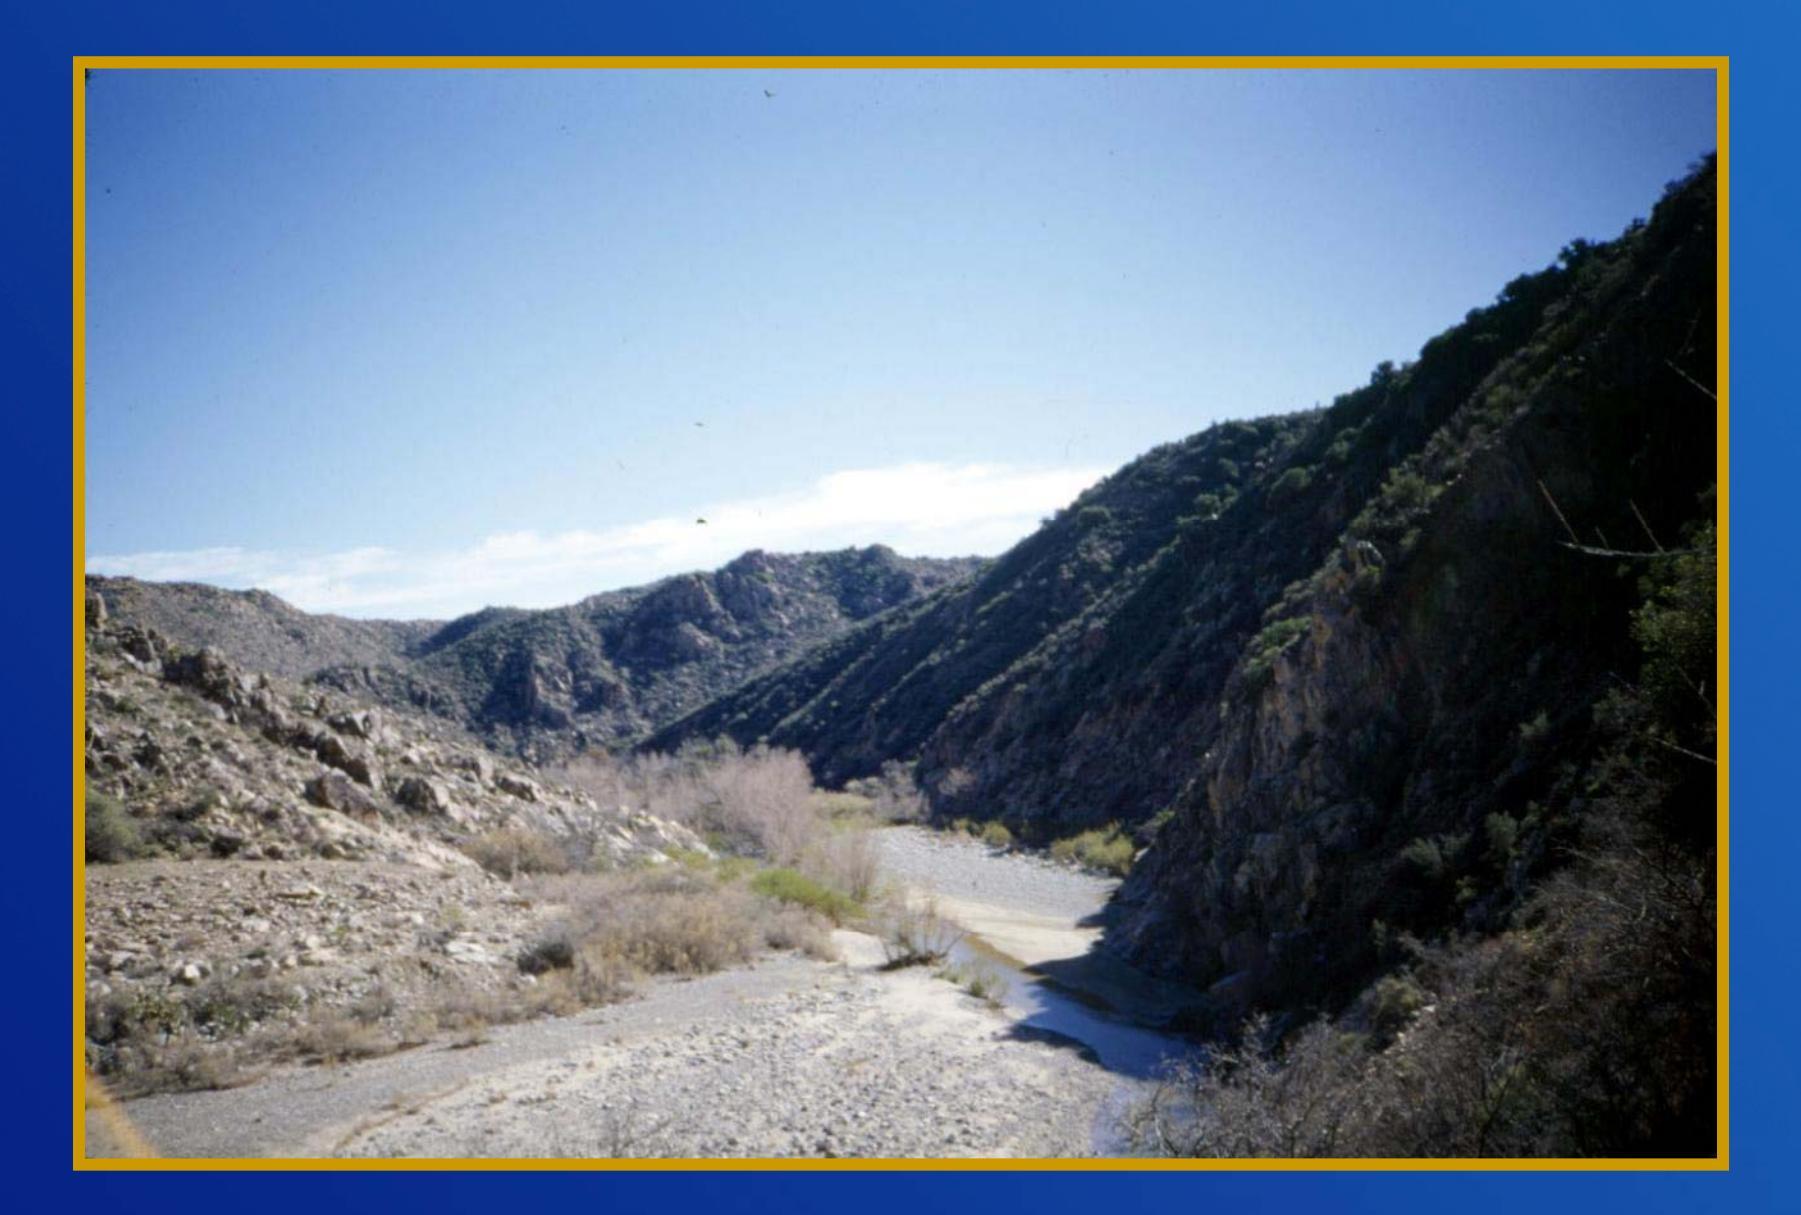
Walnut Grove Dam, Arizona

- 110 feet high
- Rockfill
- Failed February 22, 1890 at 2:00 a.m.
- Failed due to overtopping
- No warnings issued before dam failure
- 70 to 100 fatalities

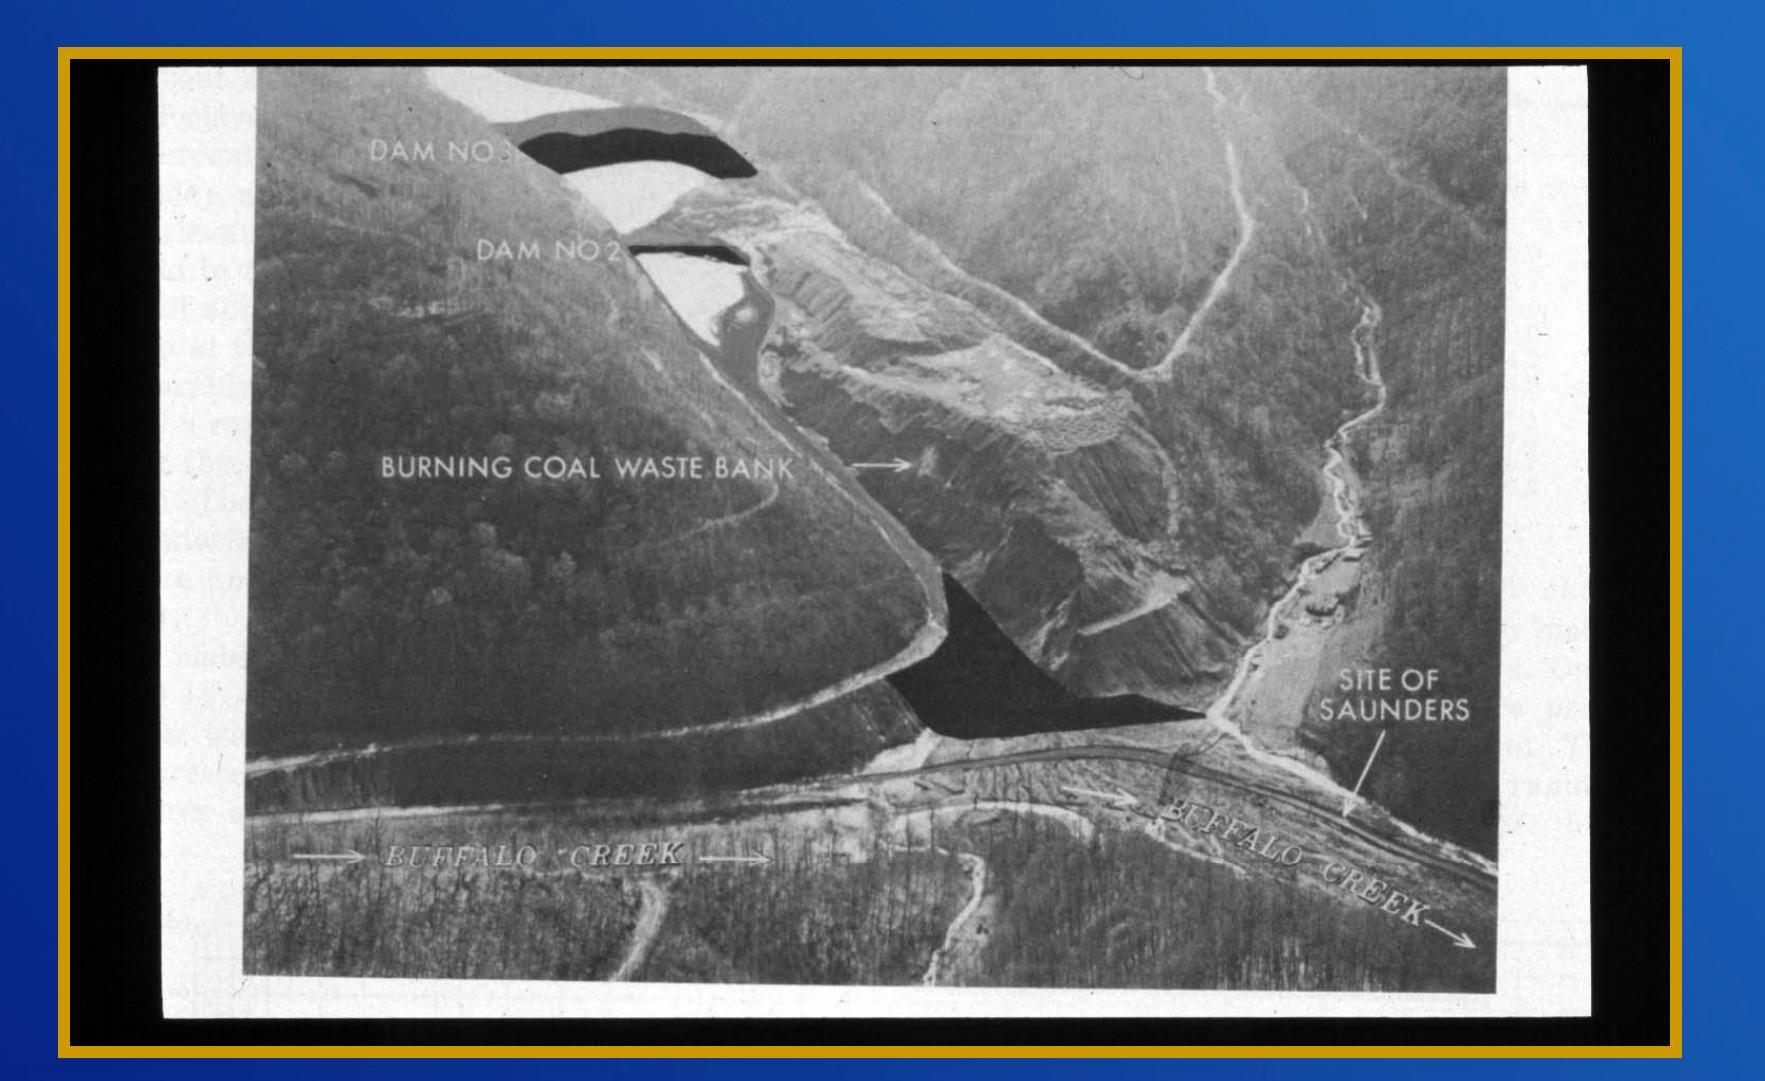
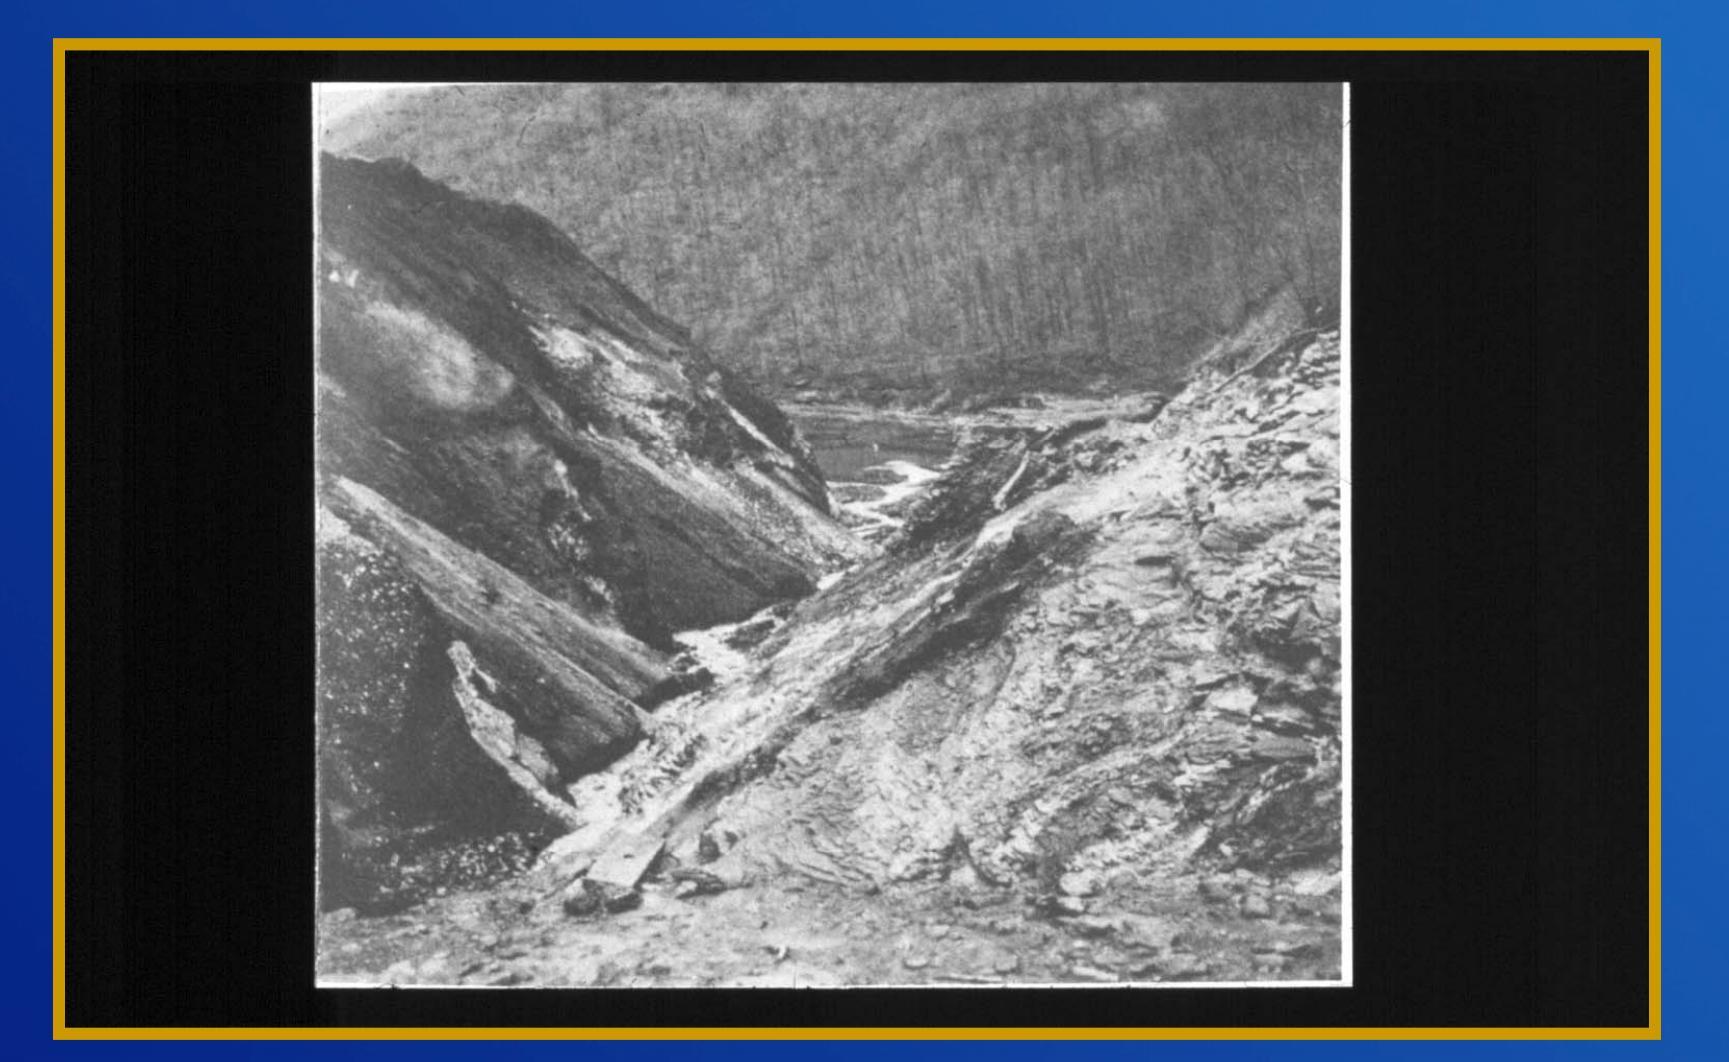
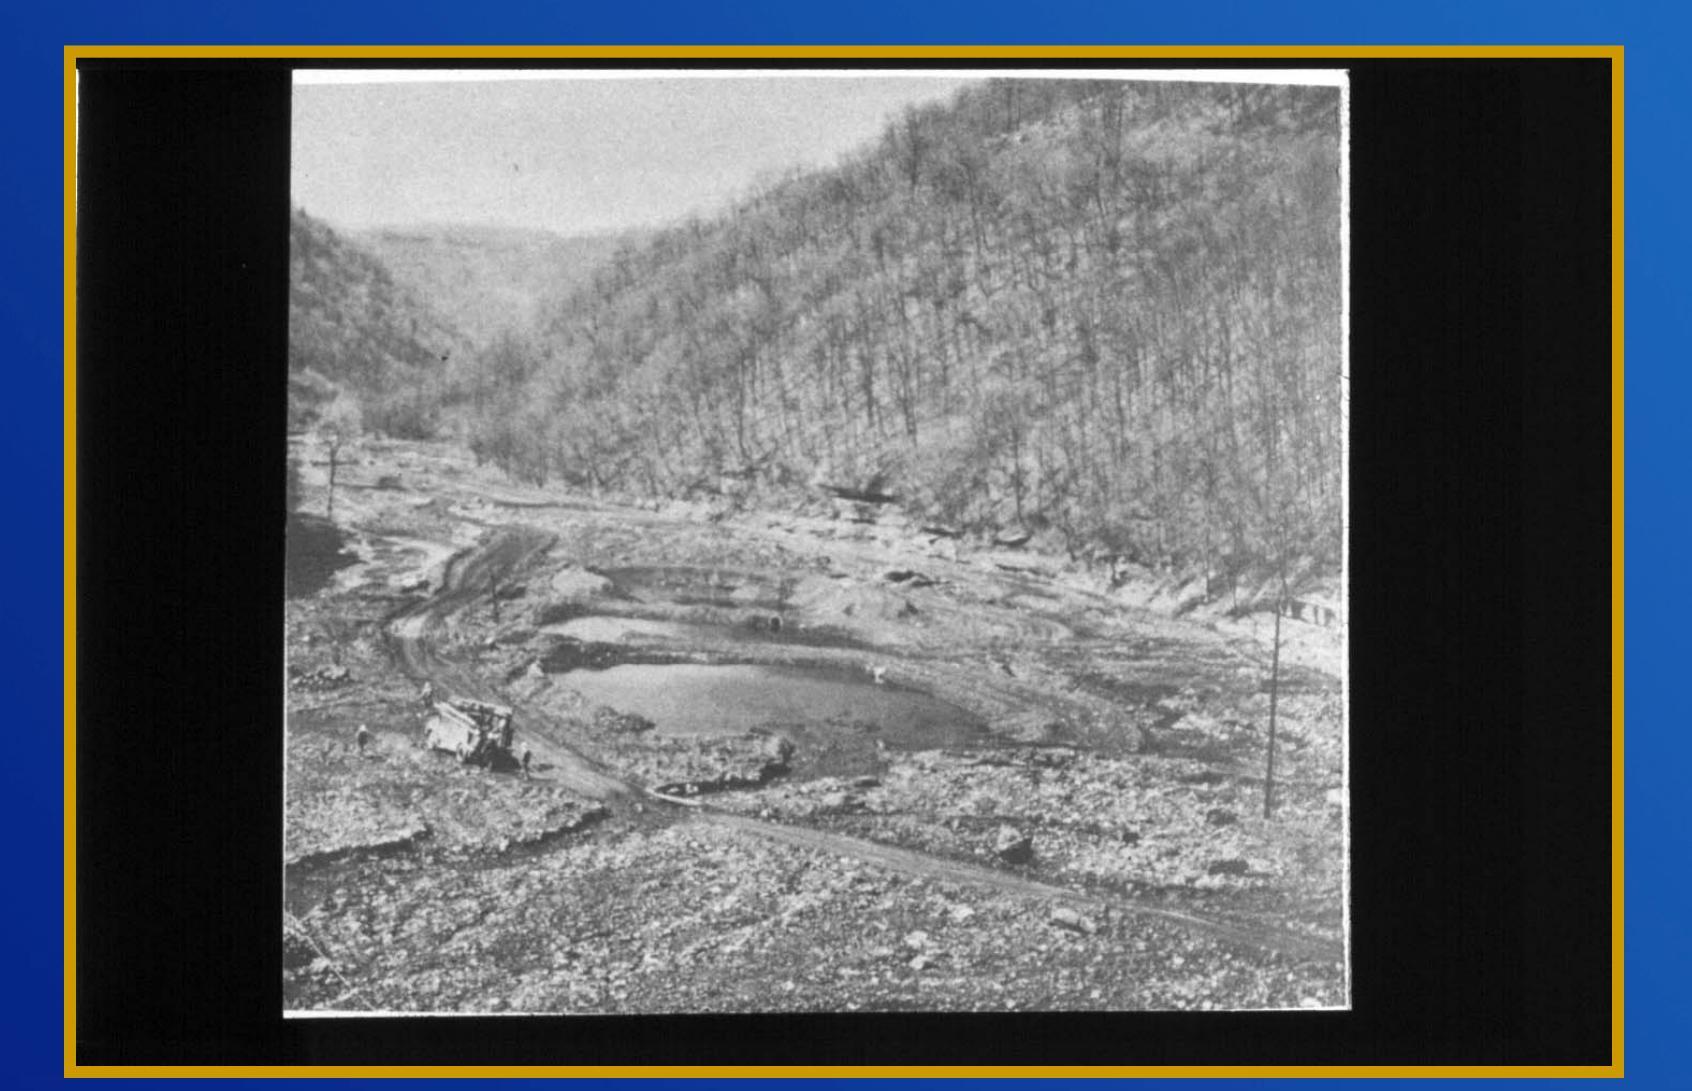
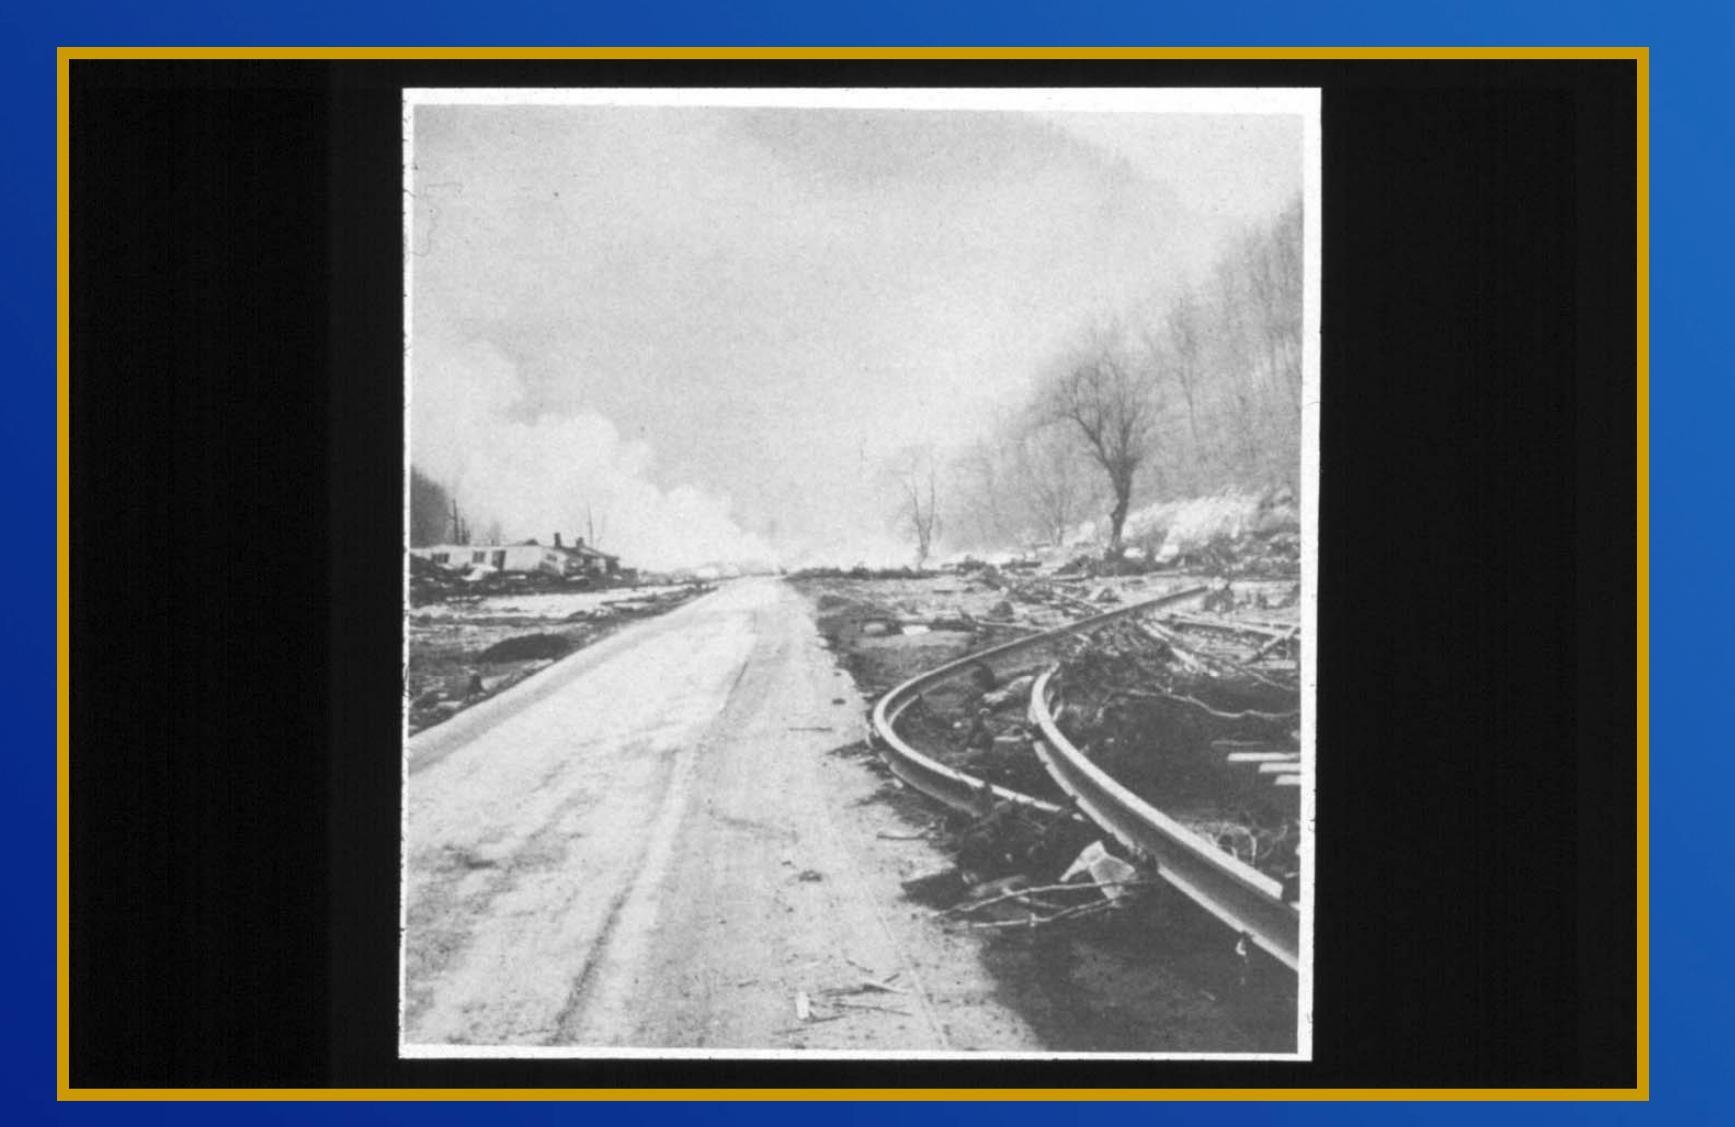
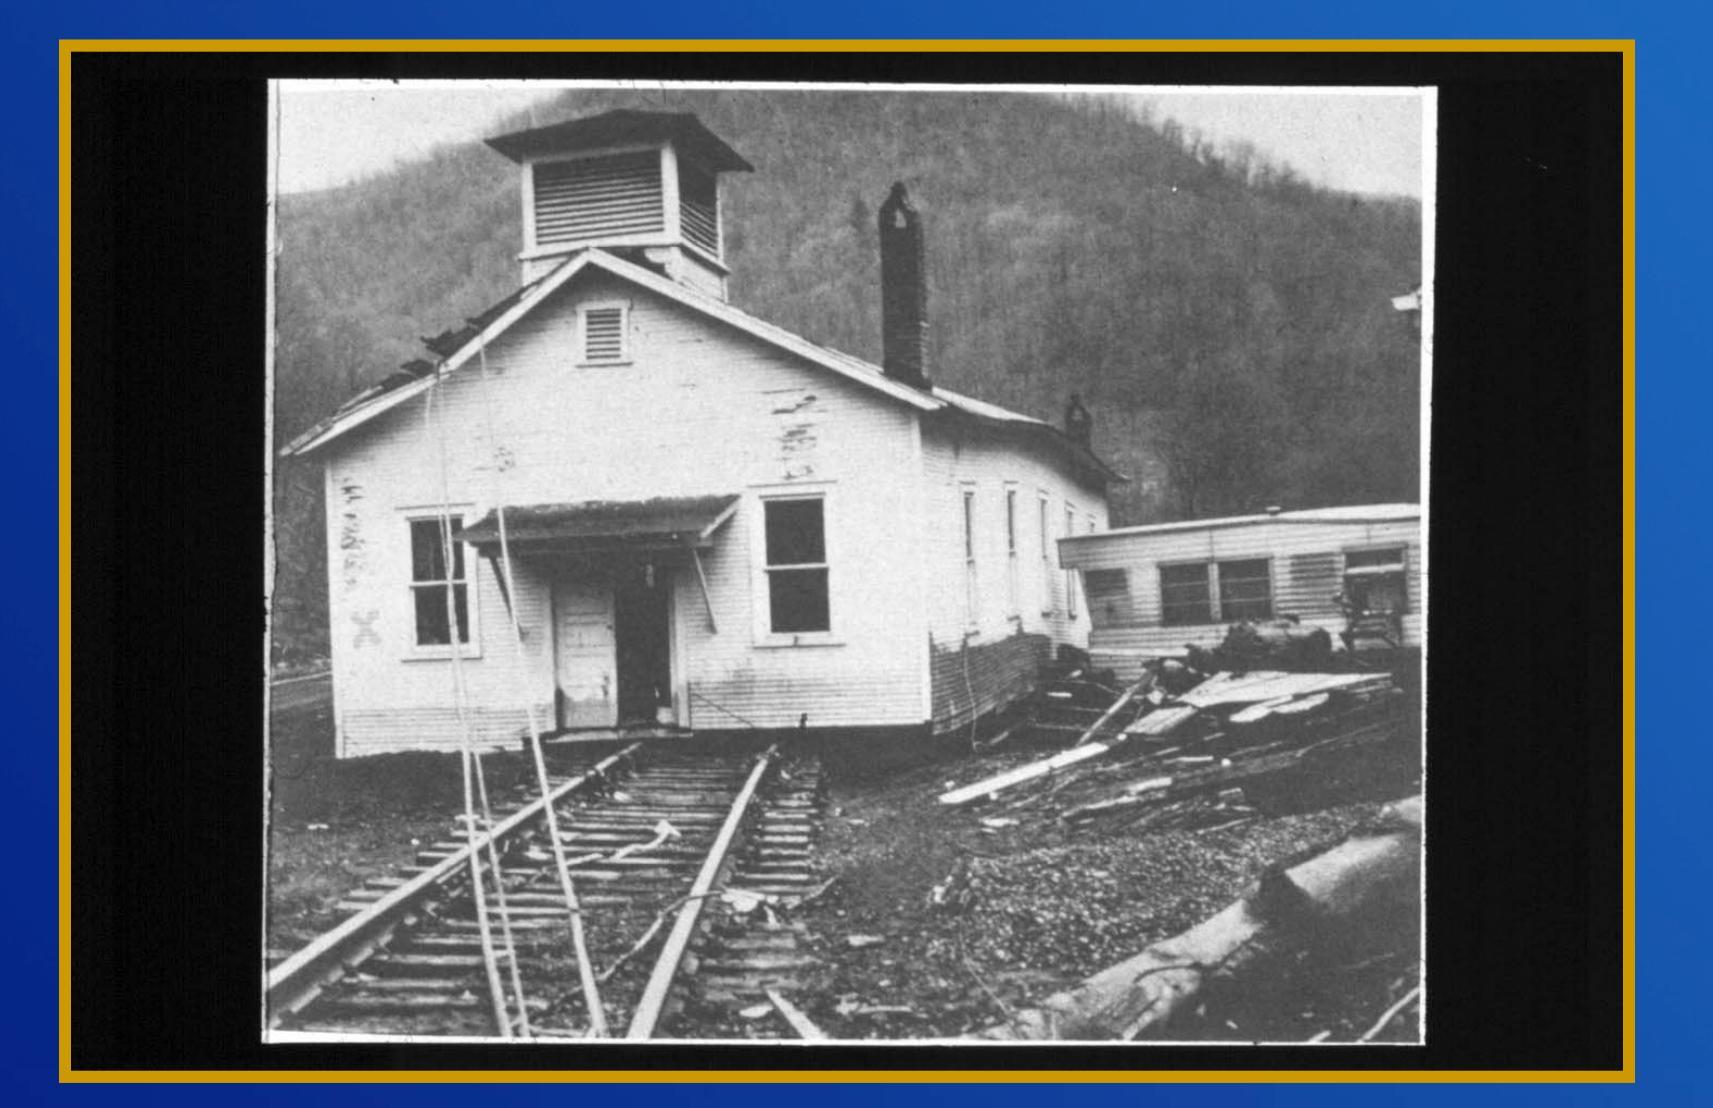
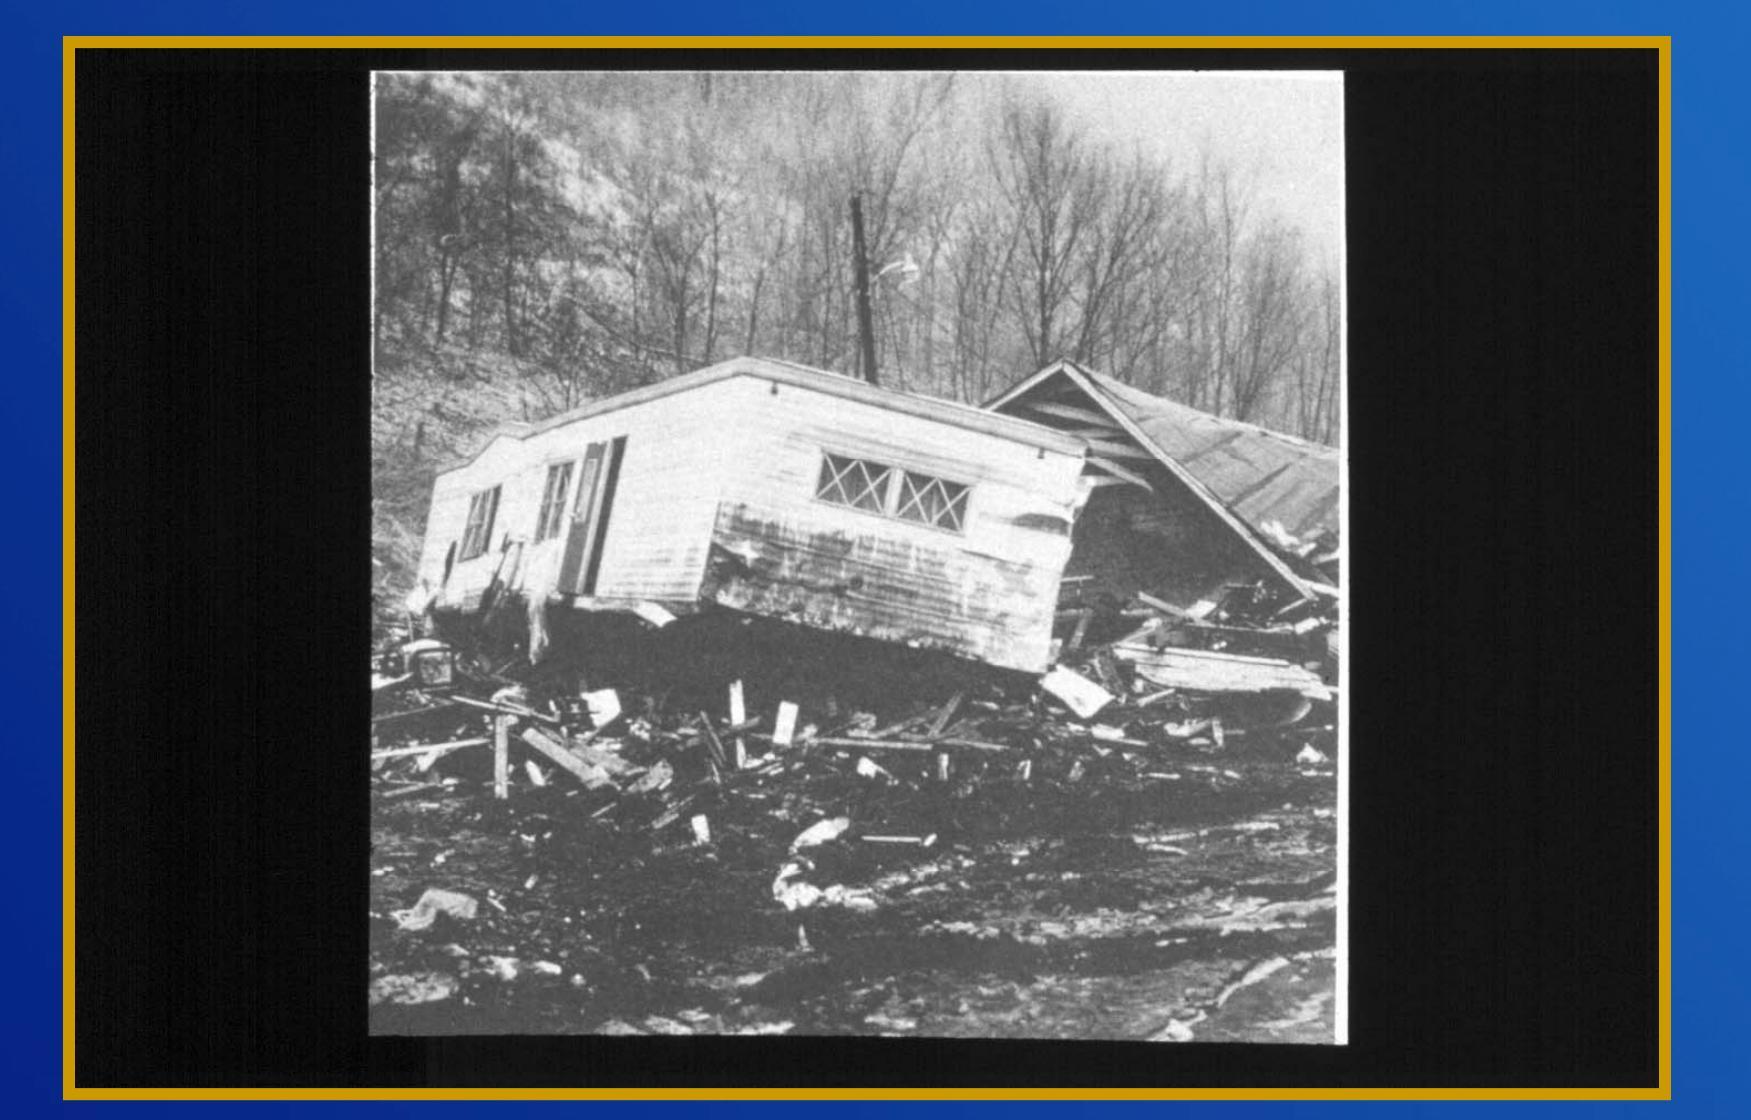
Buffalo Creek Coal Waste Dam in the mountains of West Virginia

- 46 feet high
- Dam formed with waste material from coal mining.
- Failed February 26, 1972 at 8 a.m.
- Failed from slumping of dam face during a 2-year rain.

- No warnings issued before dam failure.
- 125 fatalities
