A Synopsis of Notable U.S. Dam Failures

1874 to present

U.S. Department of the Interior Bureau of Reclamation

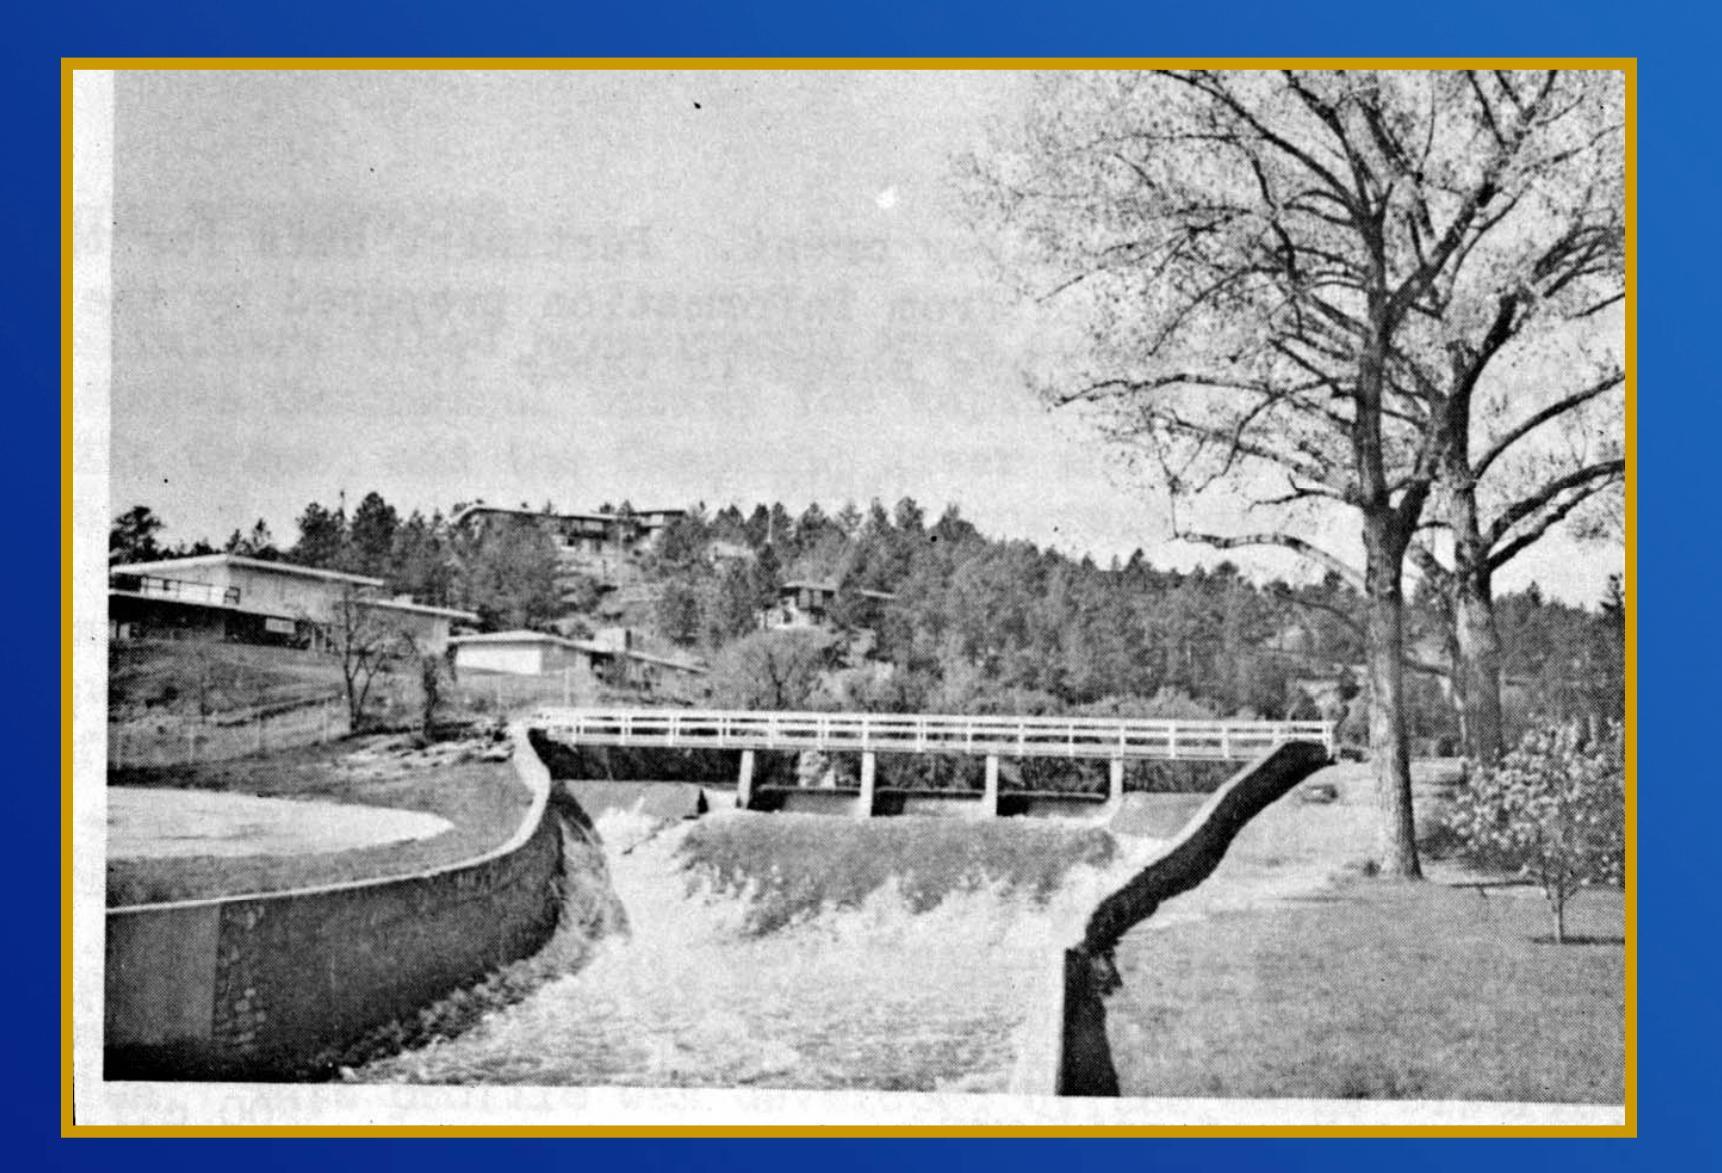
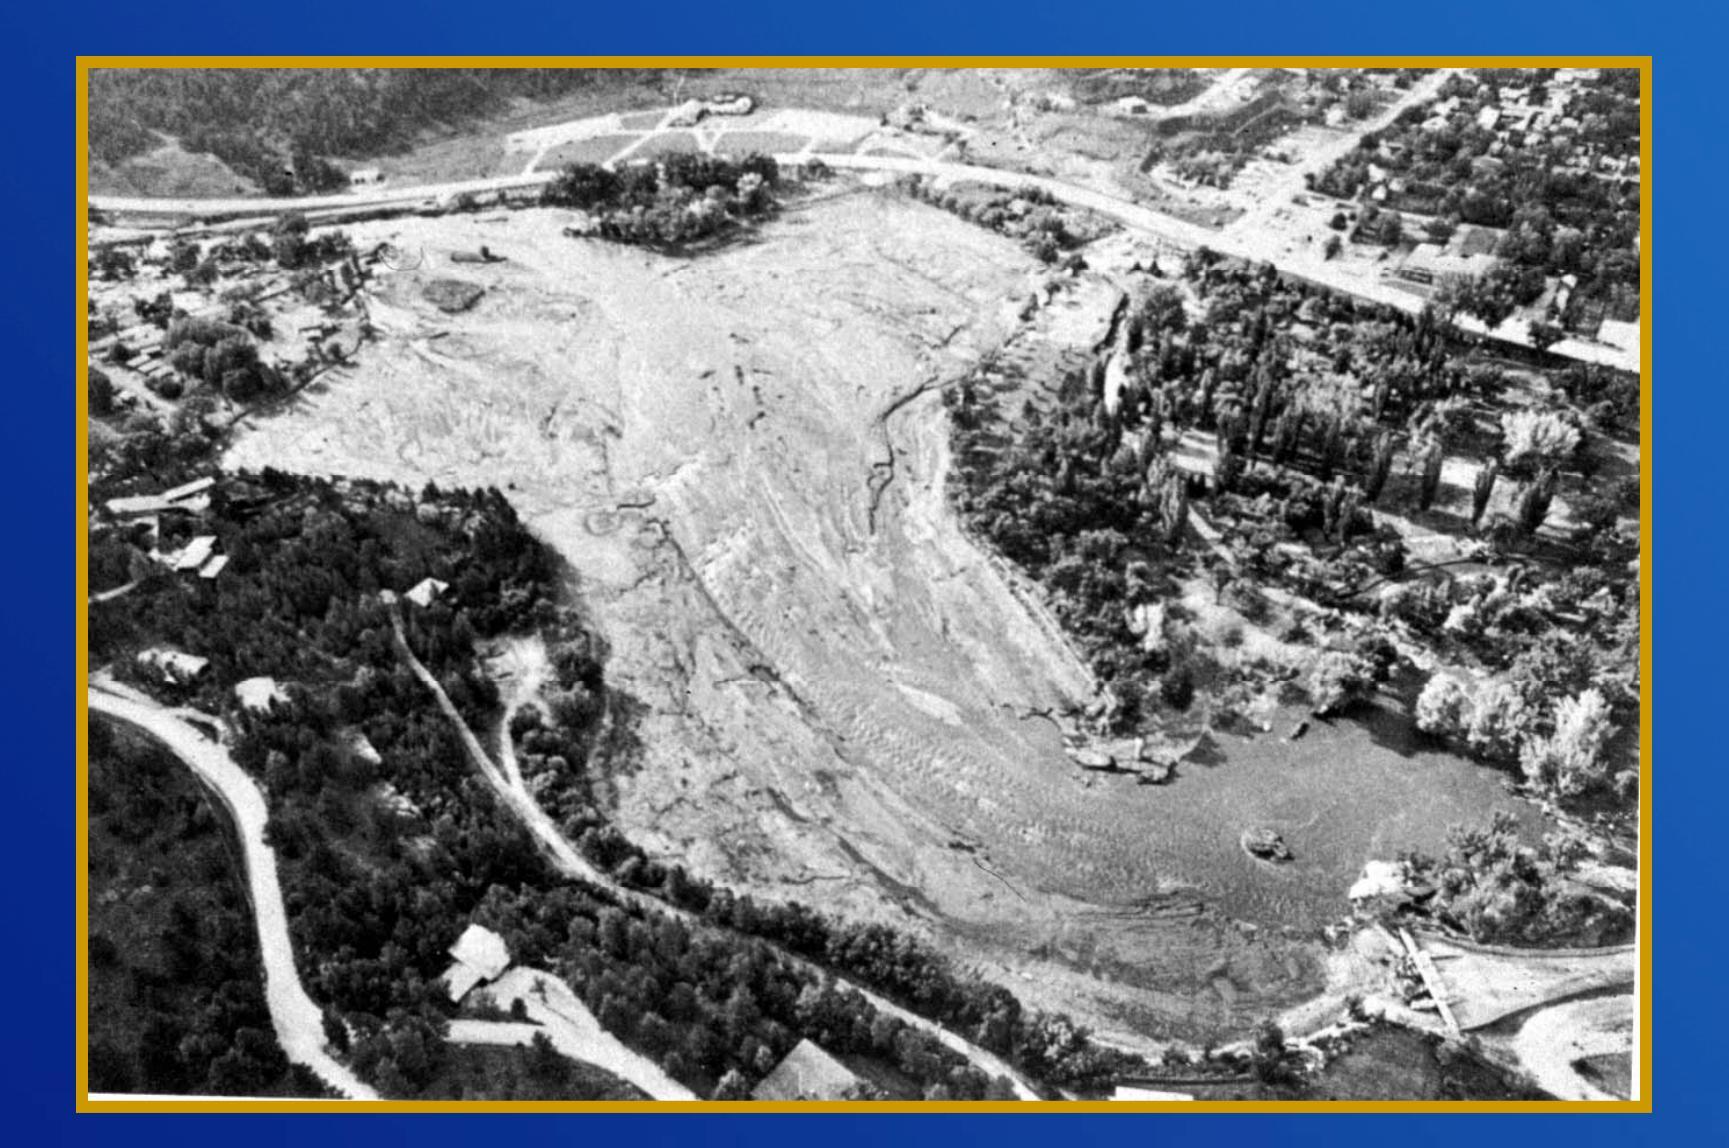
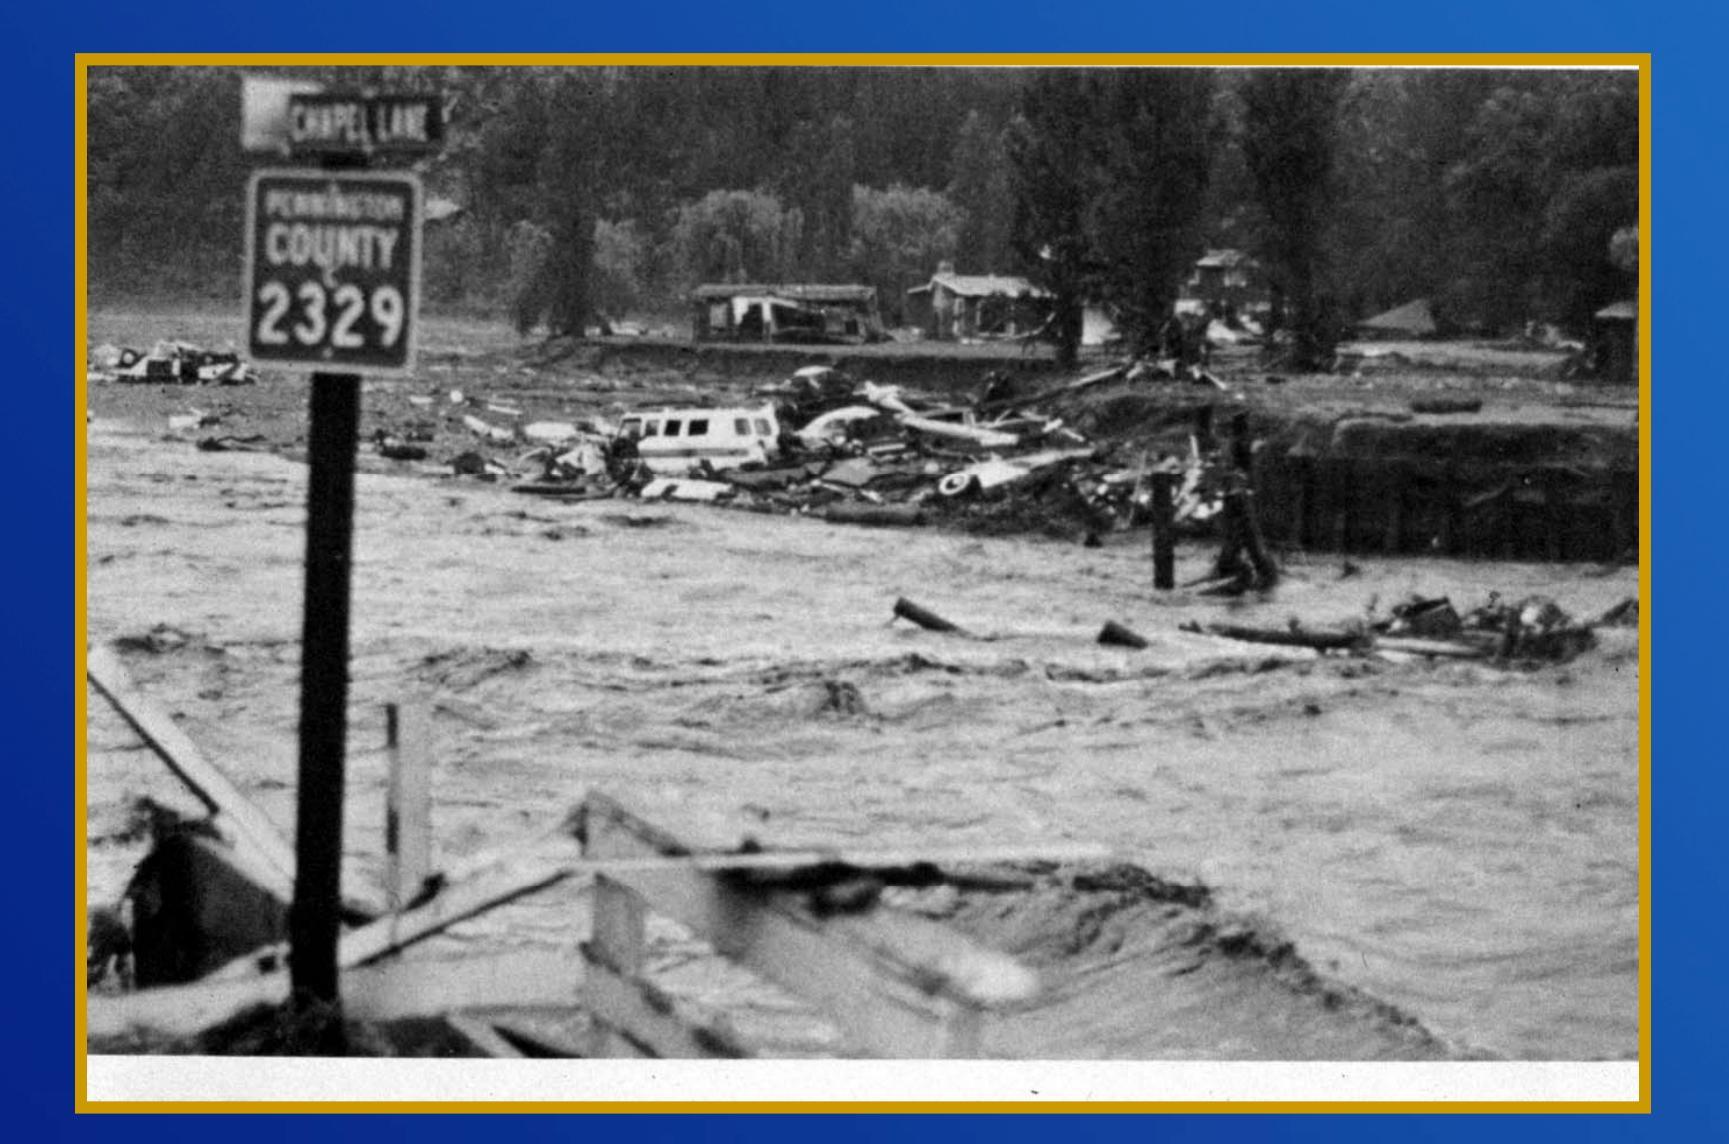
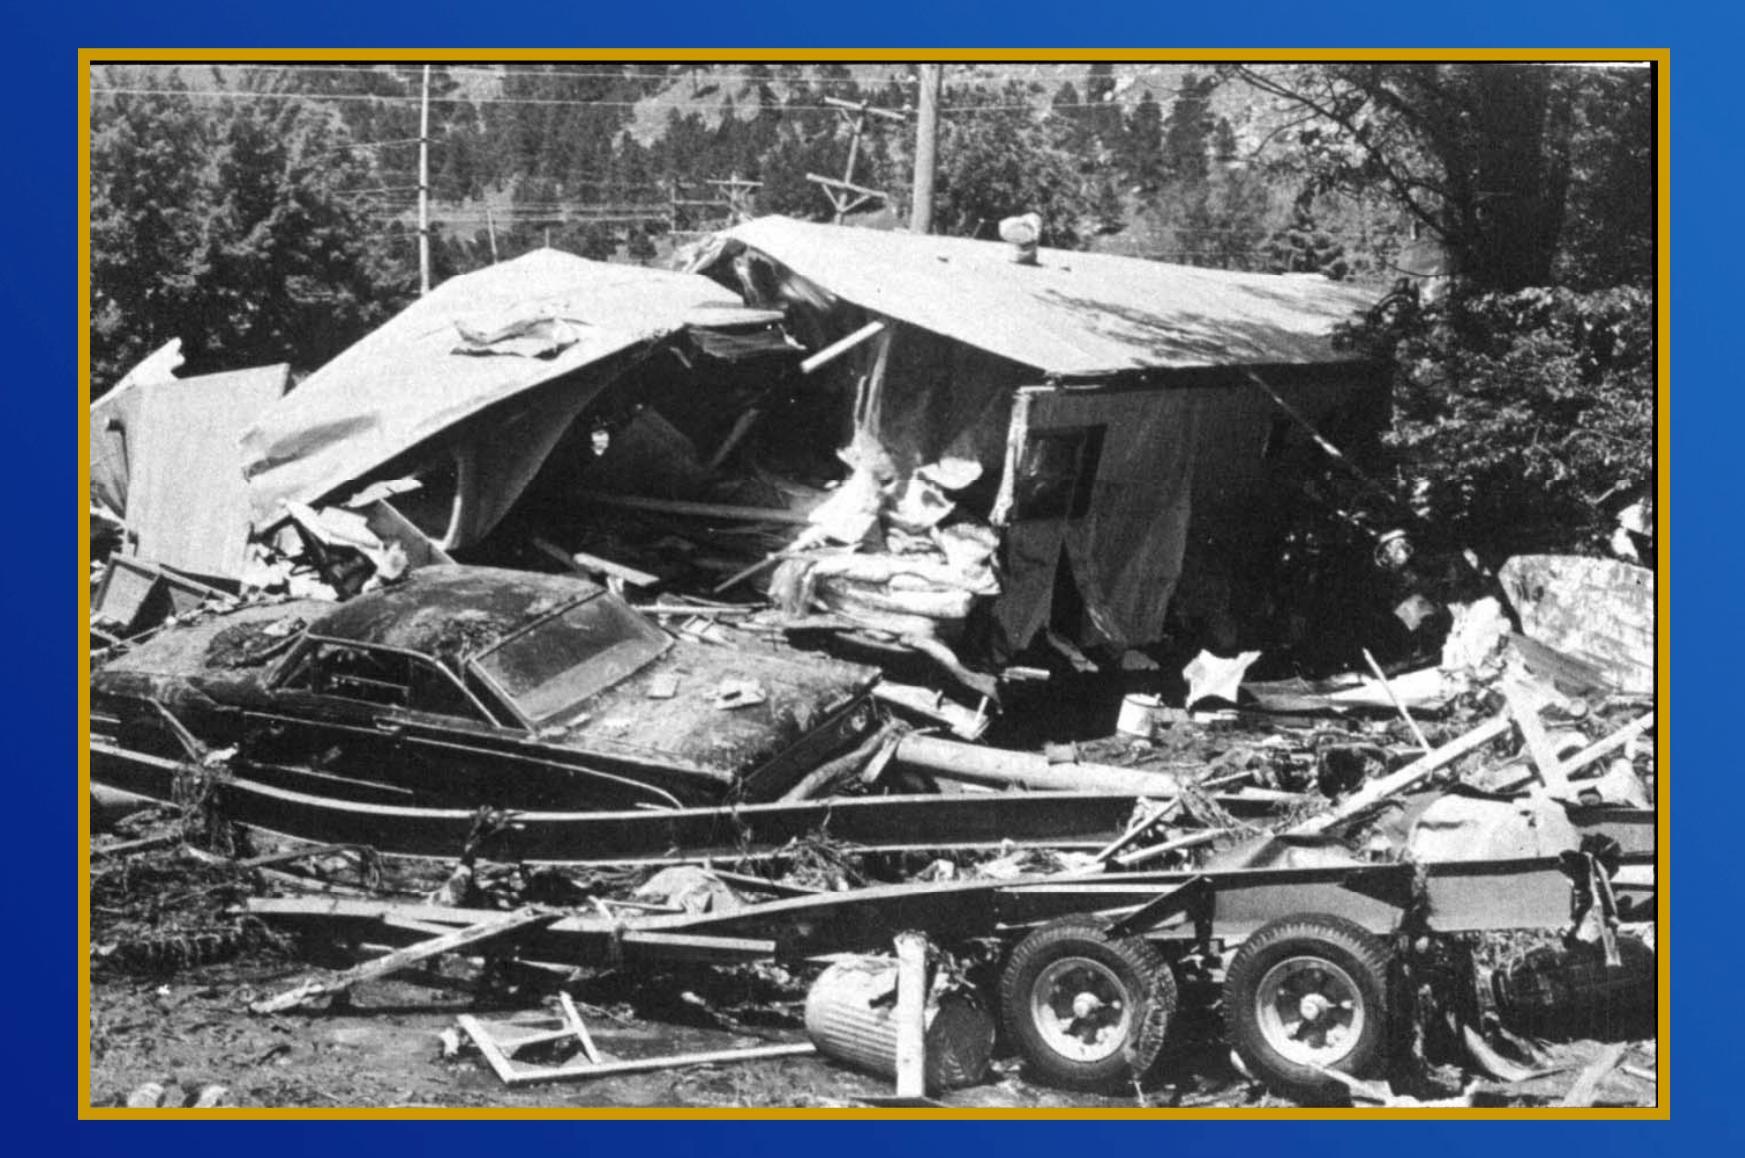
Canyon Lake Dam at Rapid City (2nd Largest City in South Dakota)

- 20 feet high
- Earthfill
- Failed June 9, 1972 between 10:45 and 11:30 p.m.
- Failed due to overtopping.
- No concerted effort to warn of dam failure prior to failure.
- Approximately 165 fatalities downstream from the dam; contribution resulting from dam failure not known.
