A Synopsis of Notable U.S. Dam Failures

1874 to present

U.S. Department of the Interior Bureau of Reclamation

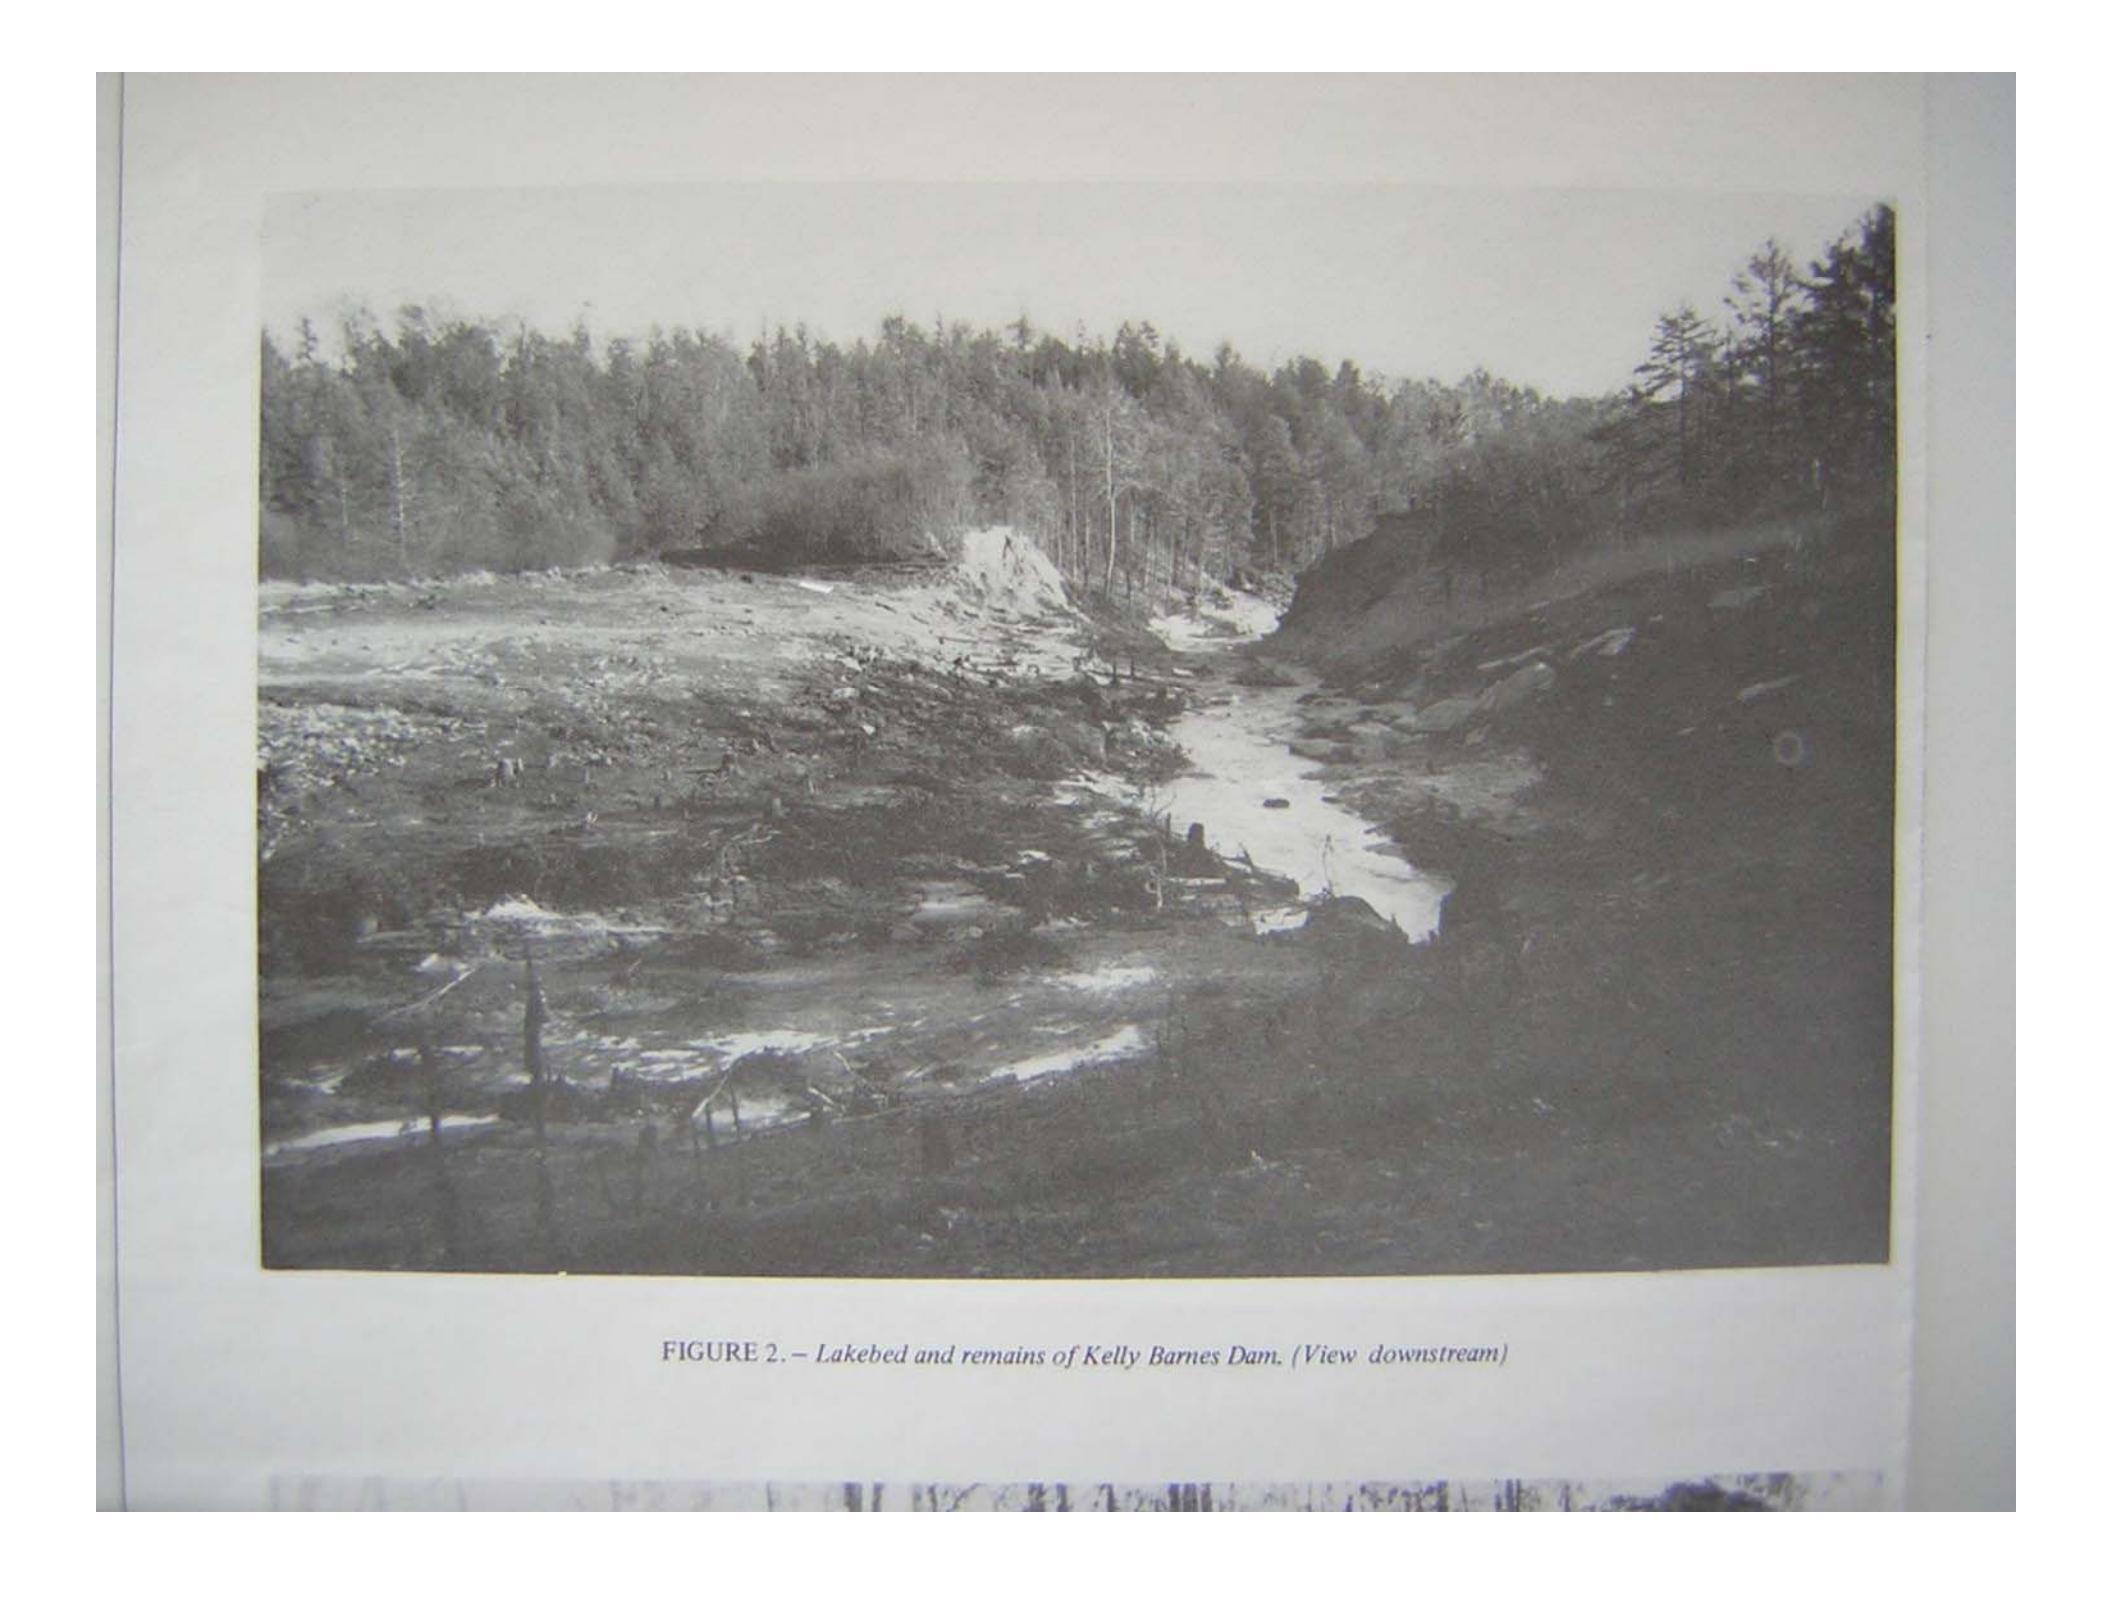
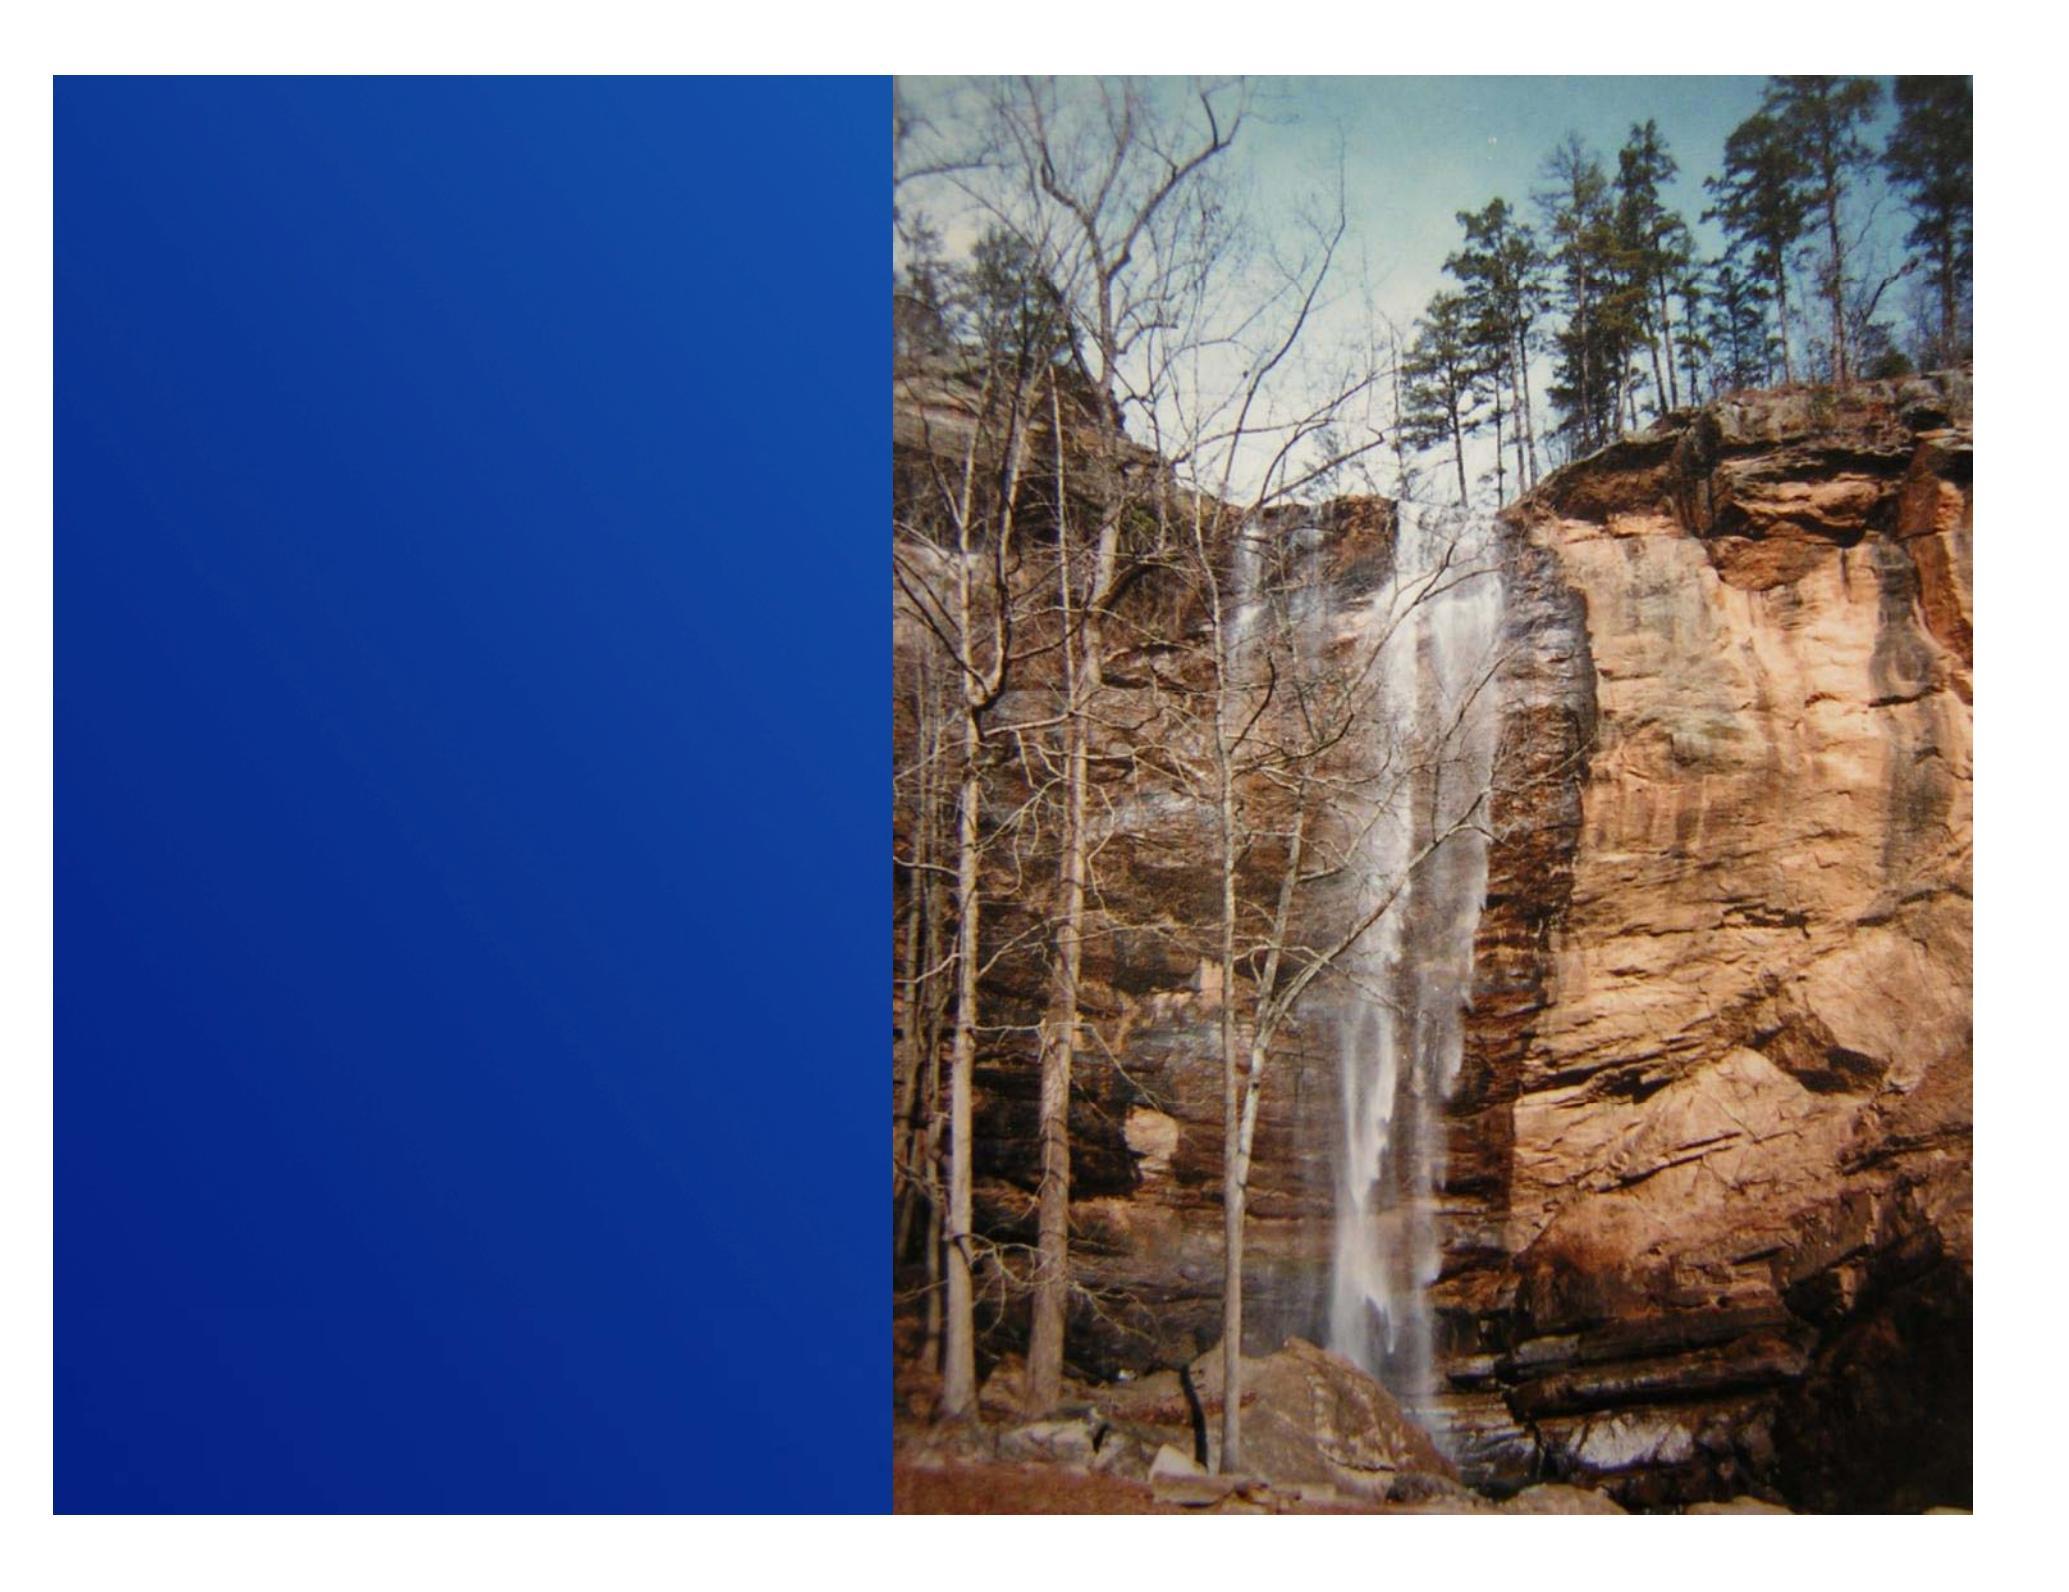
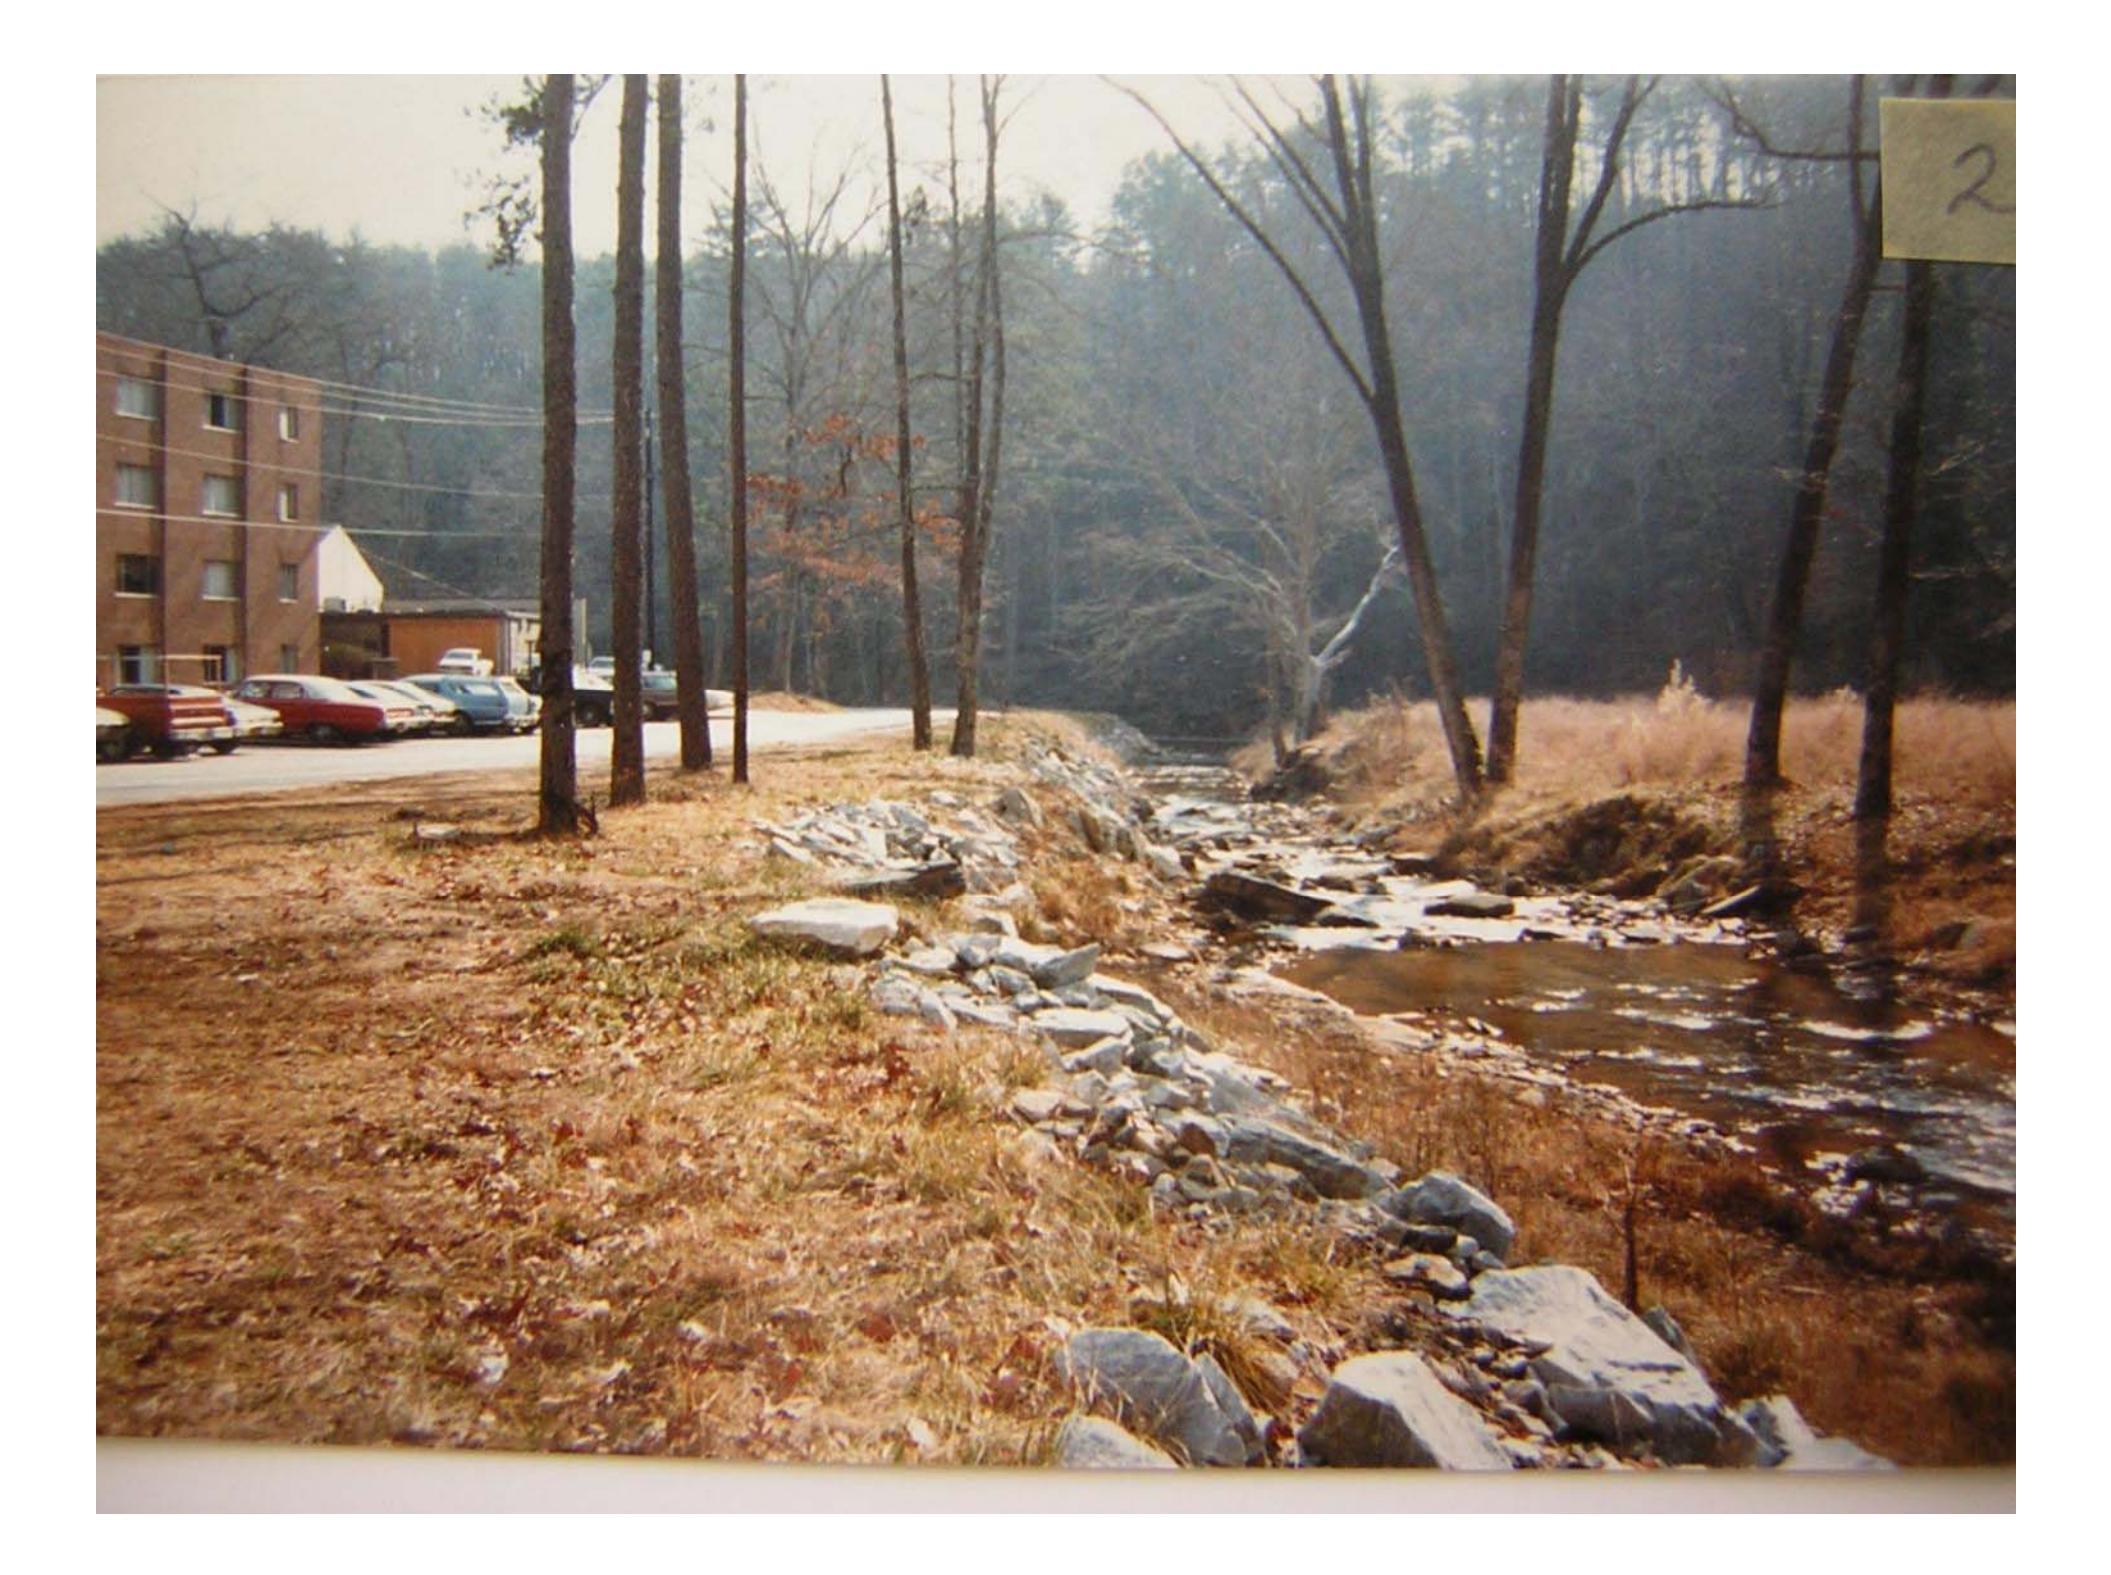
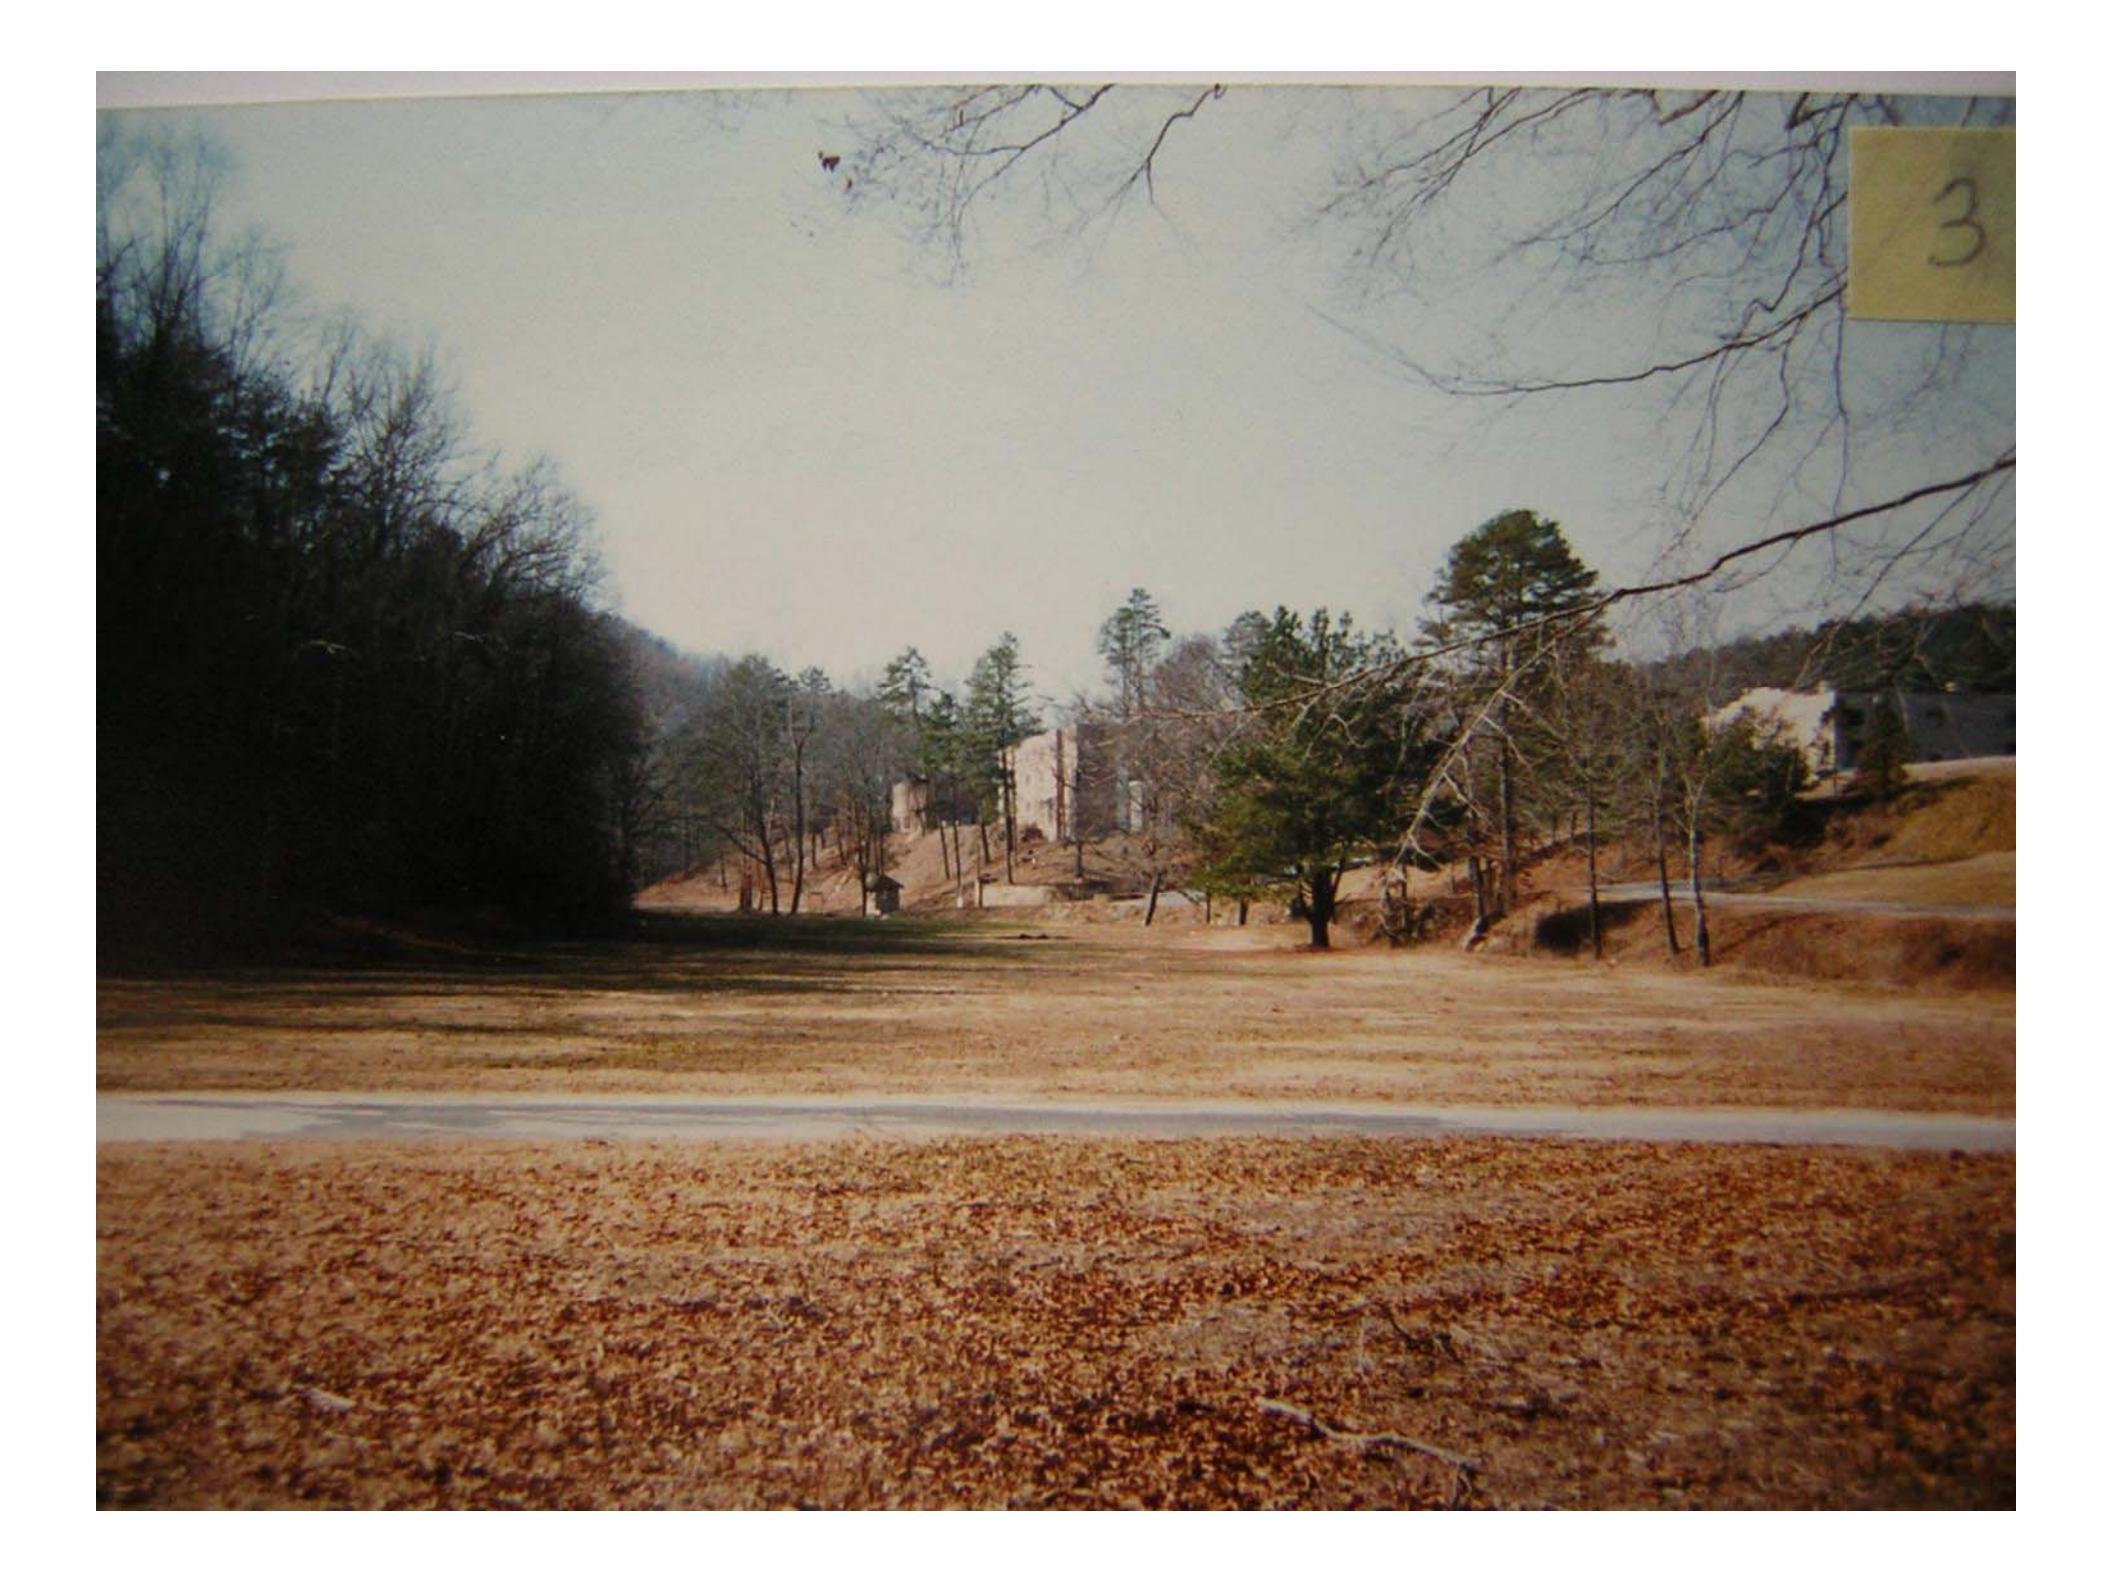
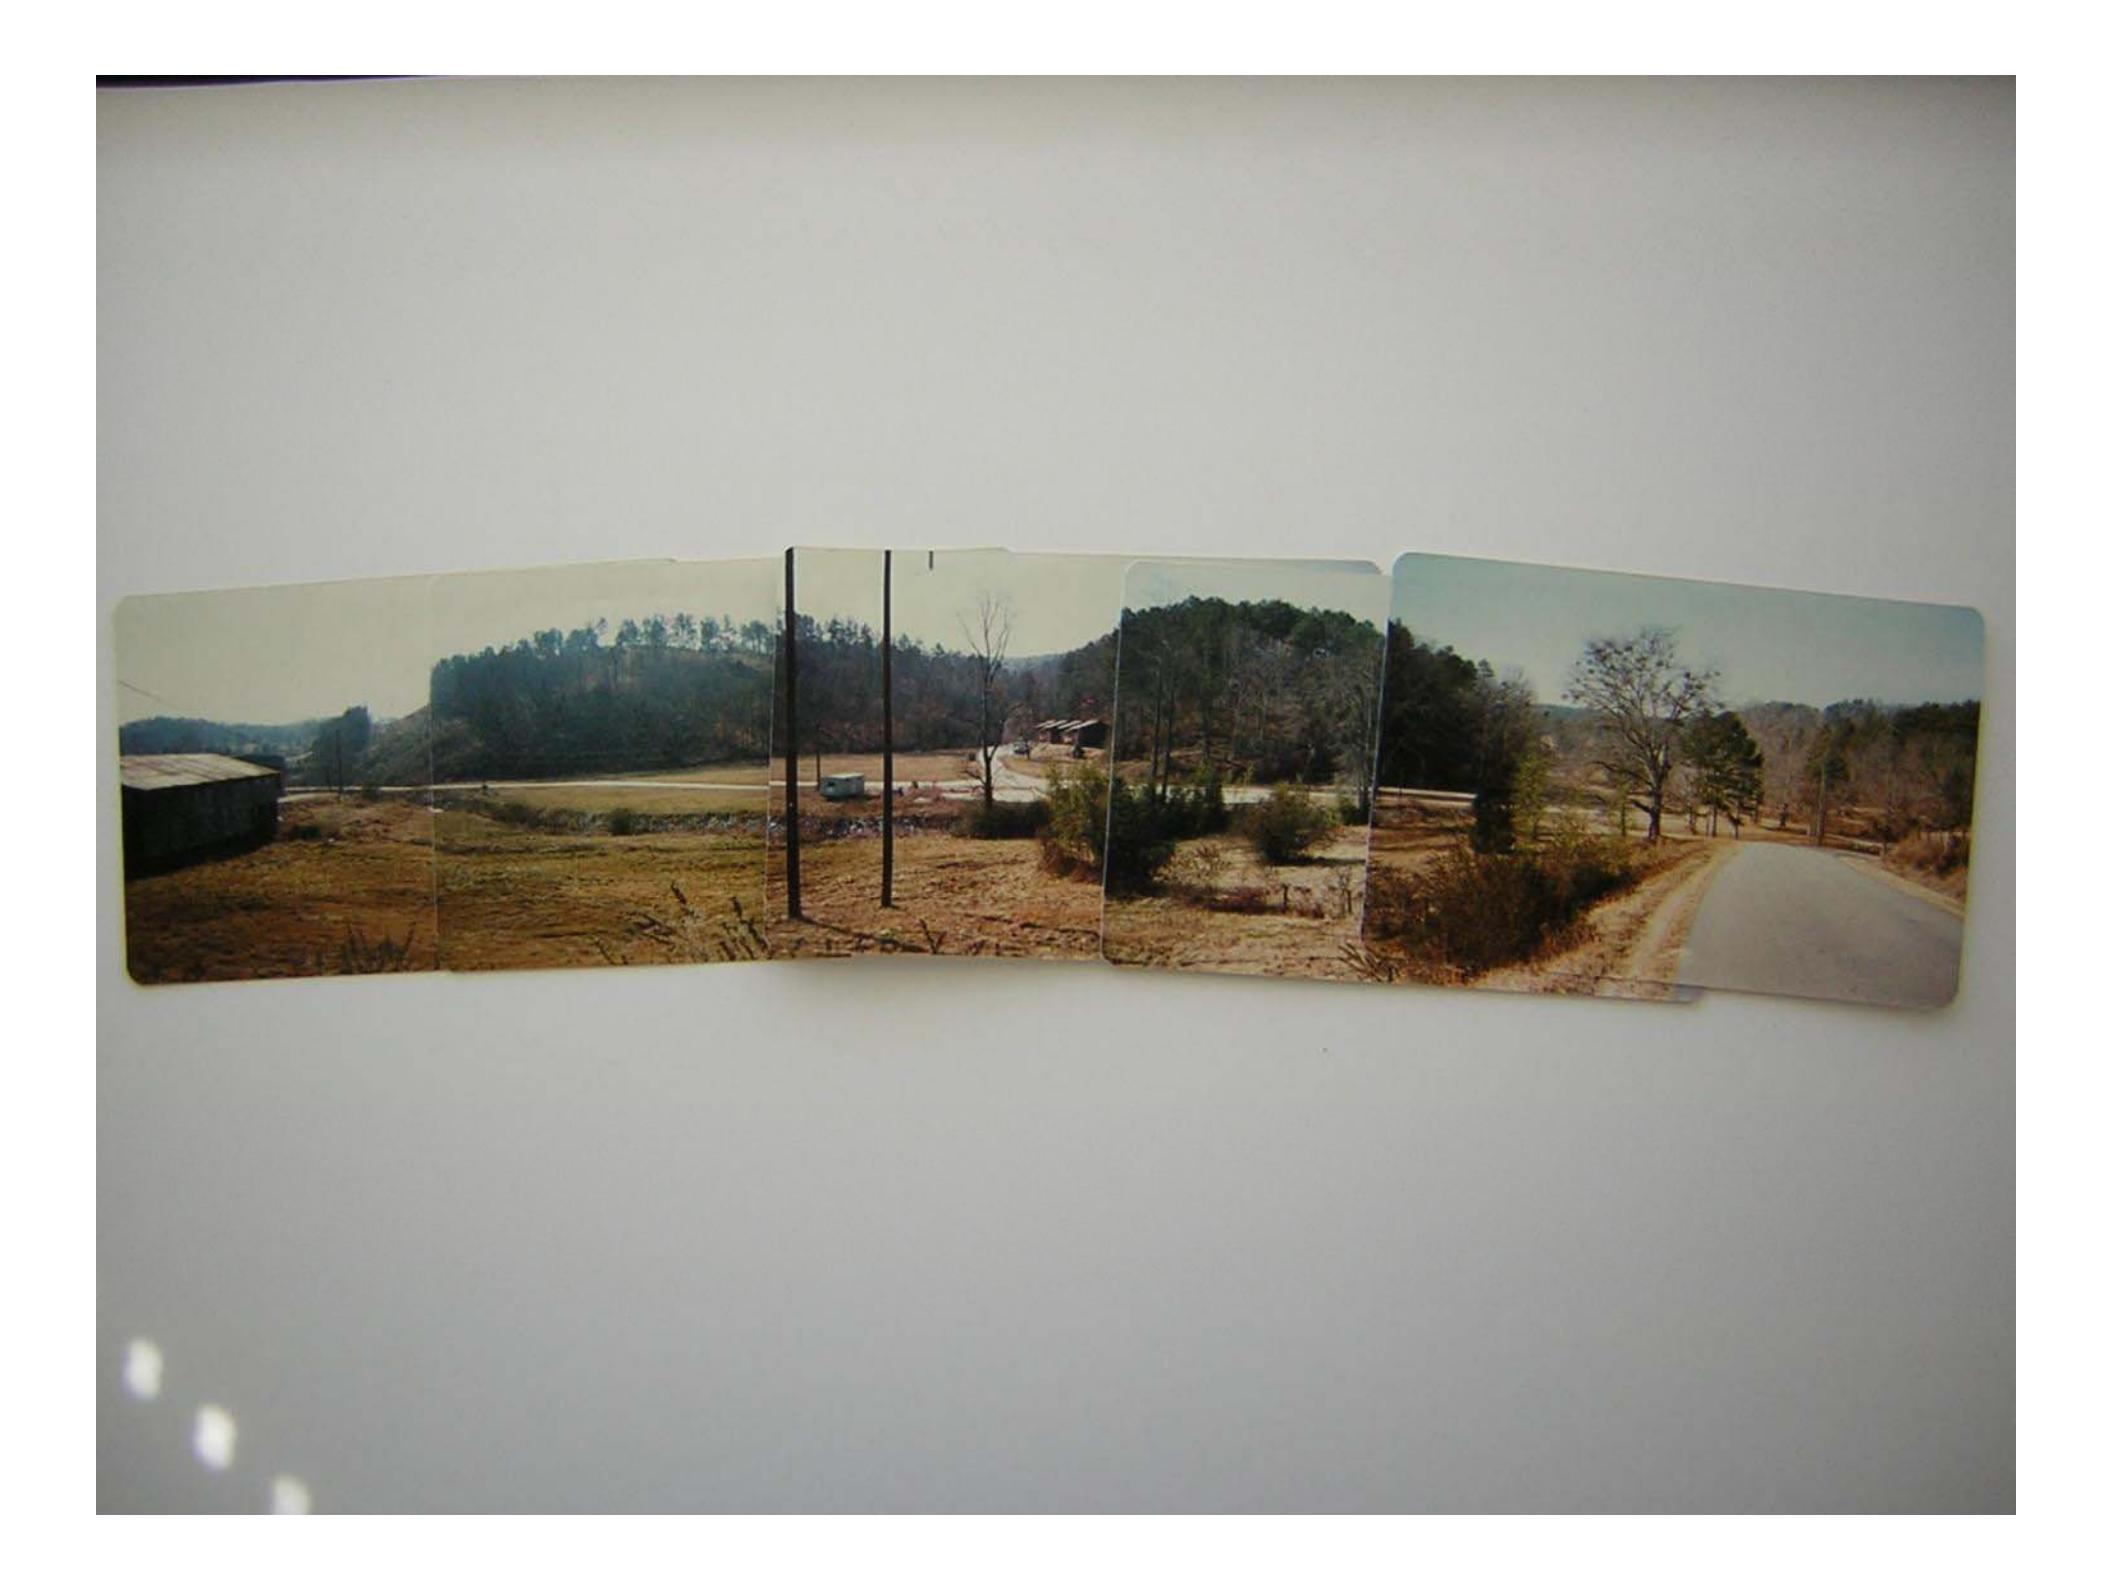
Kelly Barnes Dam near Toccoa, Georgia

- 40 Feet High
- Earthfill
- Failed on November 6, 1977 at 1:20 a.m.
- Failed due to downstream slope failure during heavy rains (and a 10-year flood?)
