A Synopsis of Notable U.S. Dam Failures

1874 to present

U.S. Department of the Interior Bureau of Reclamation

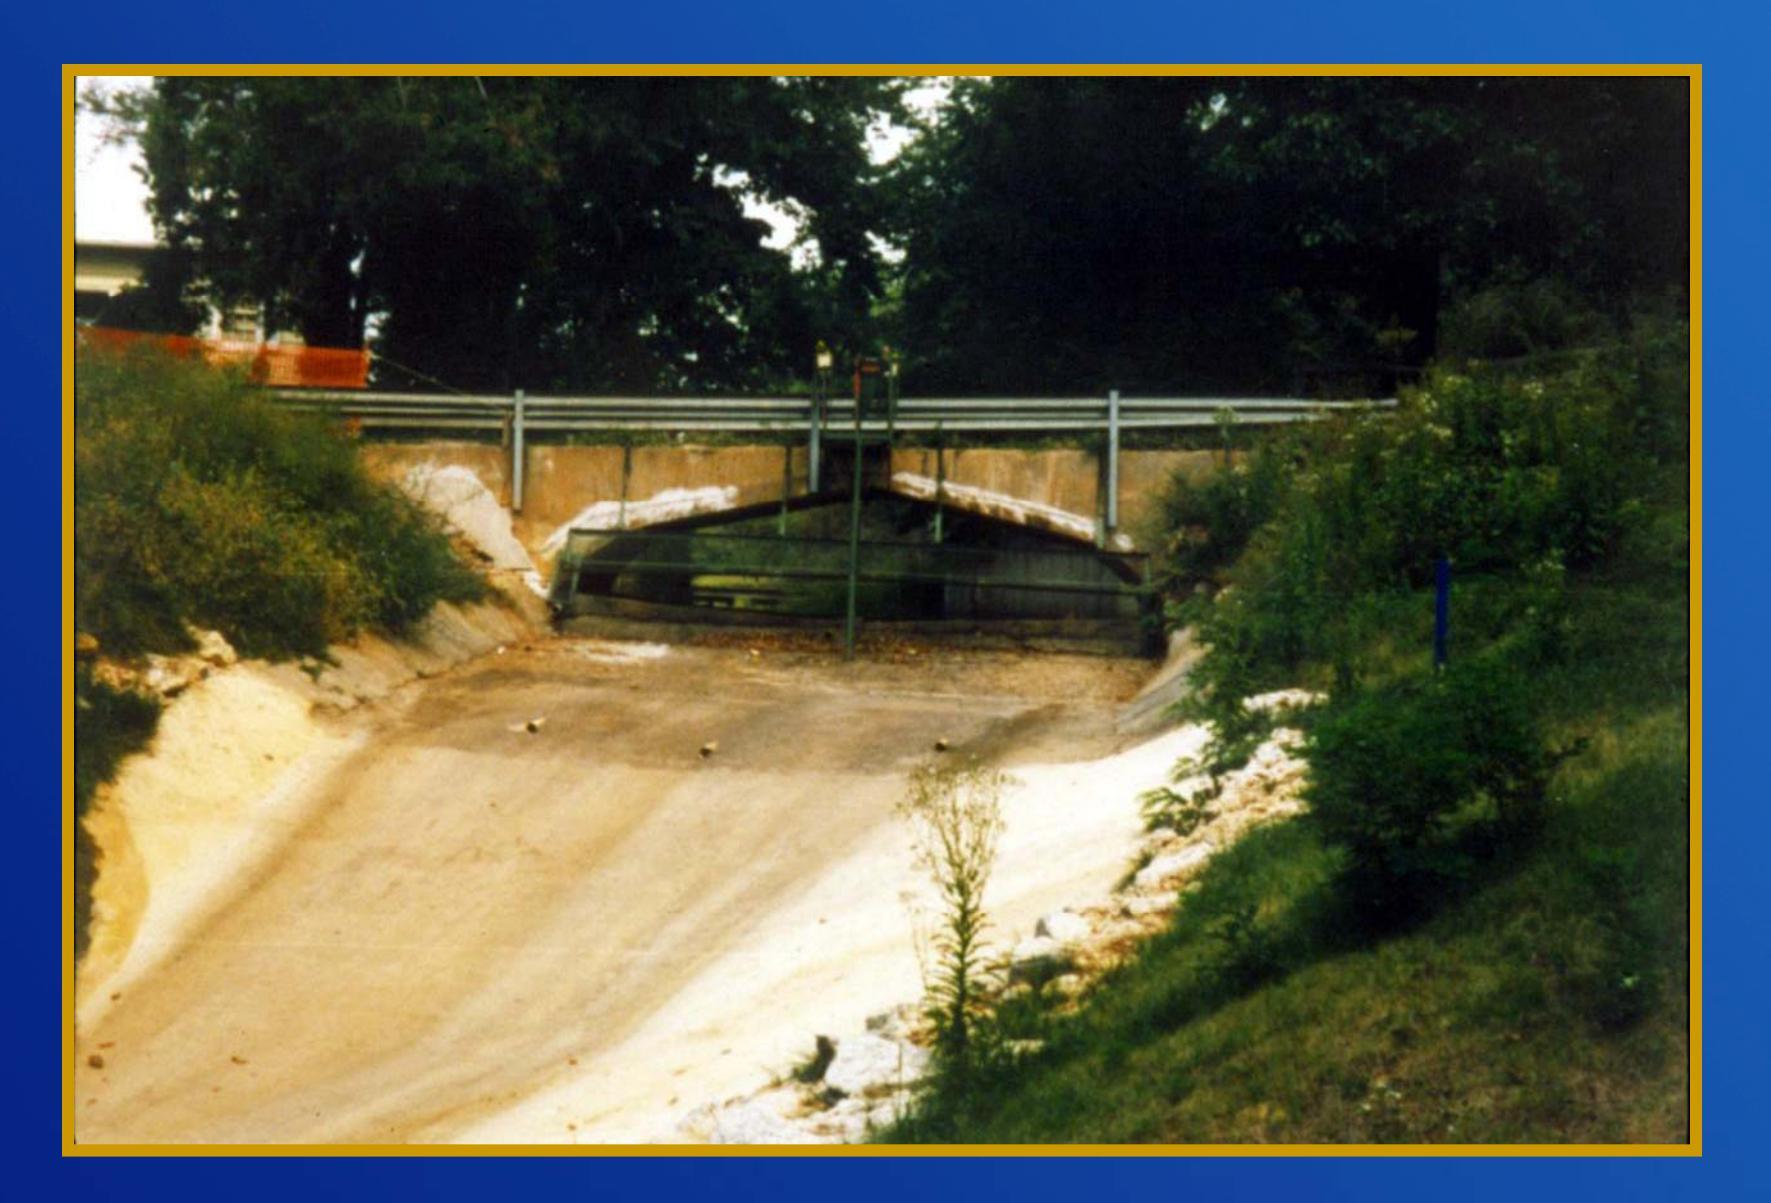
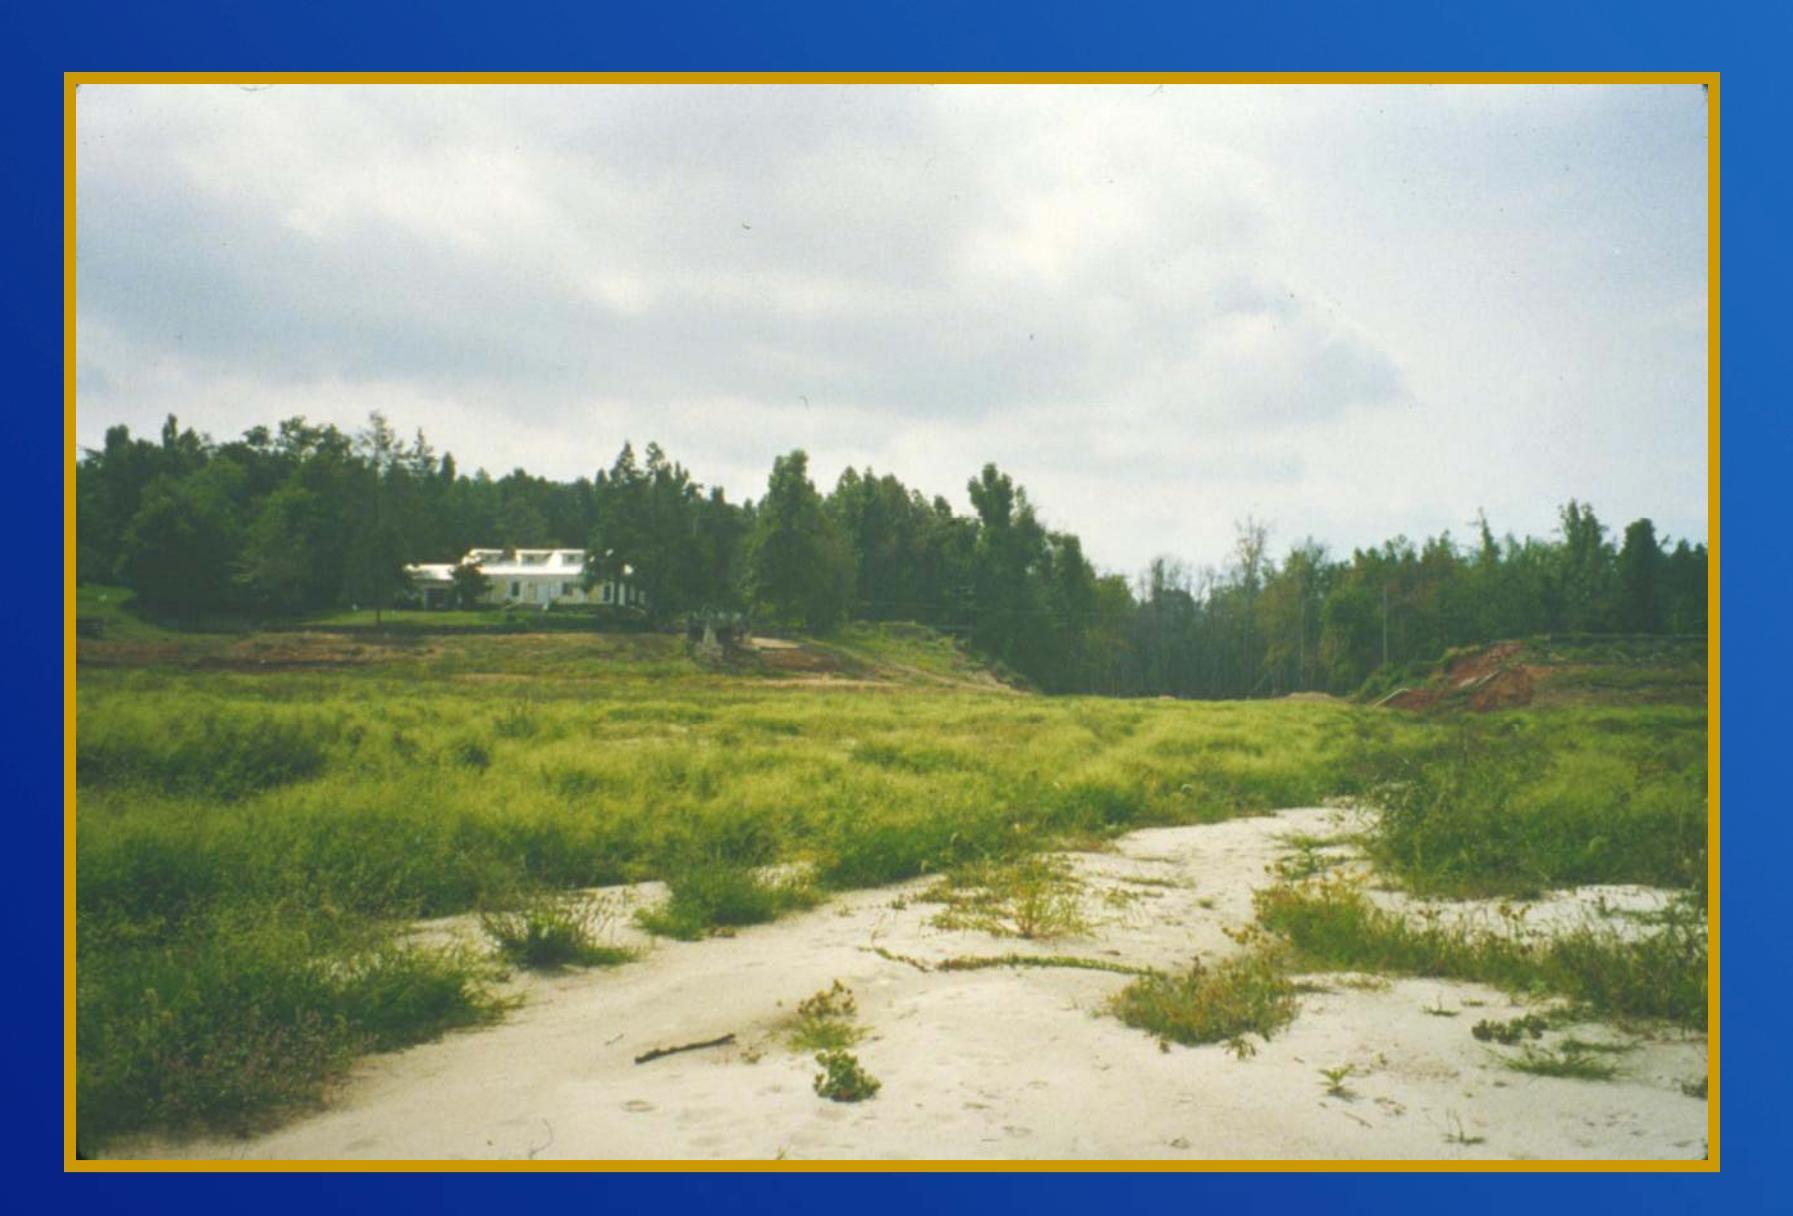
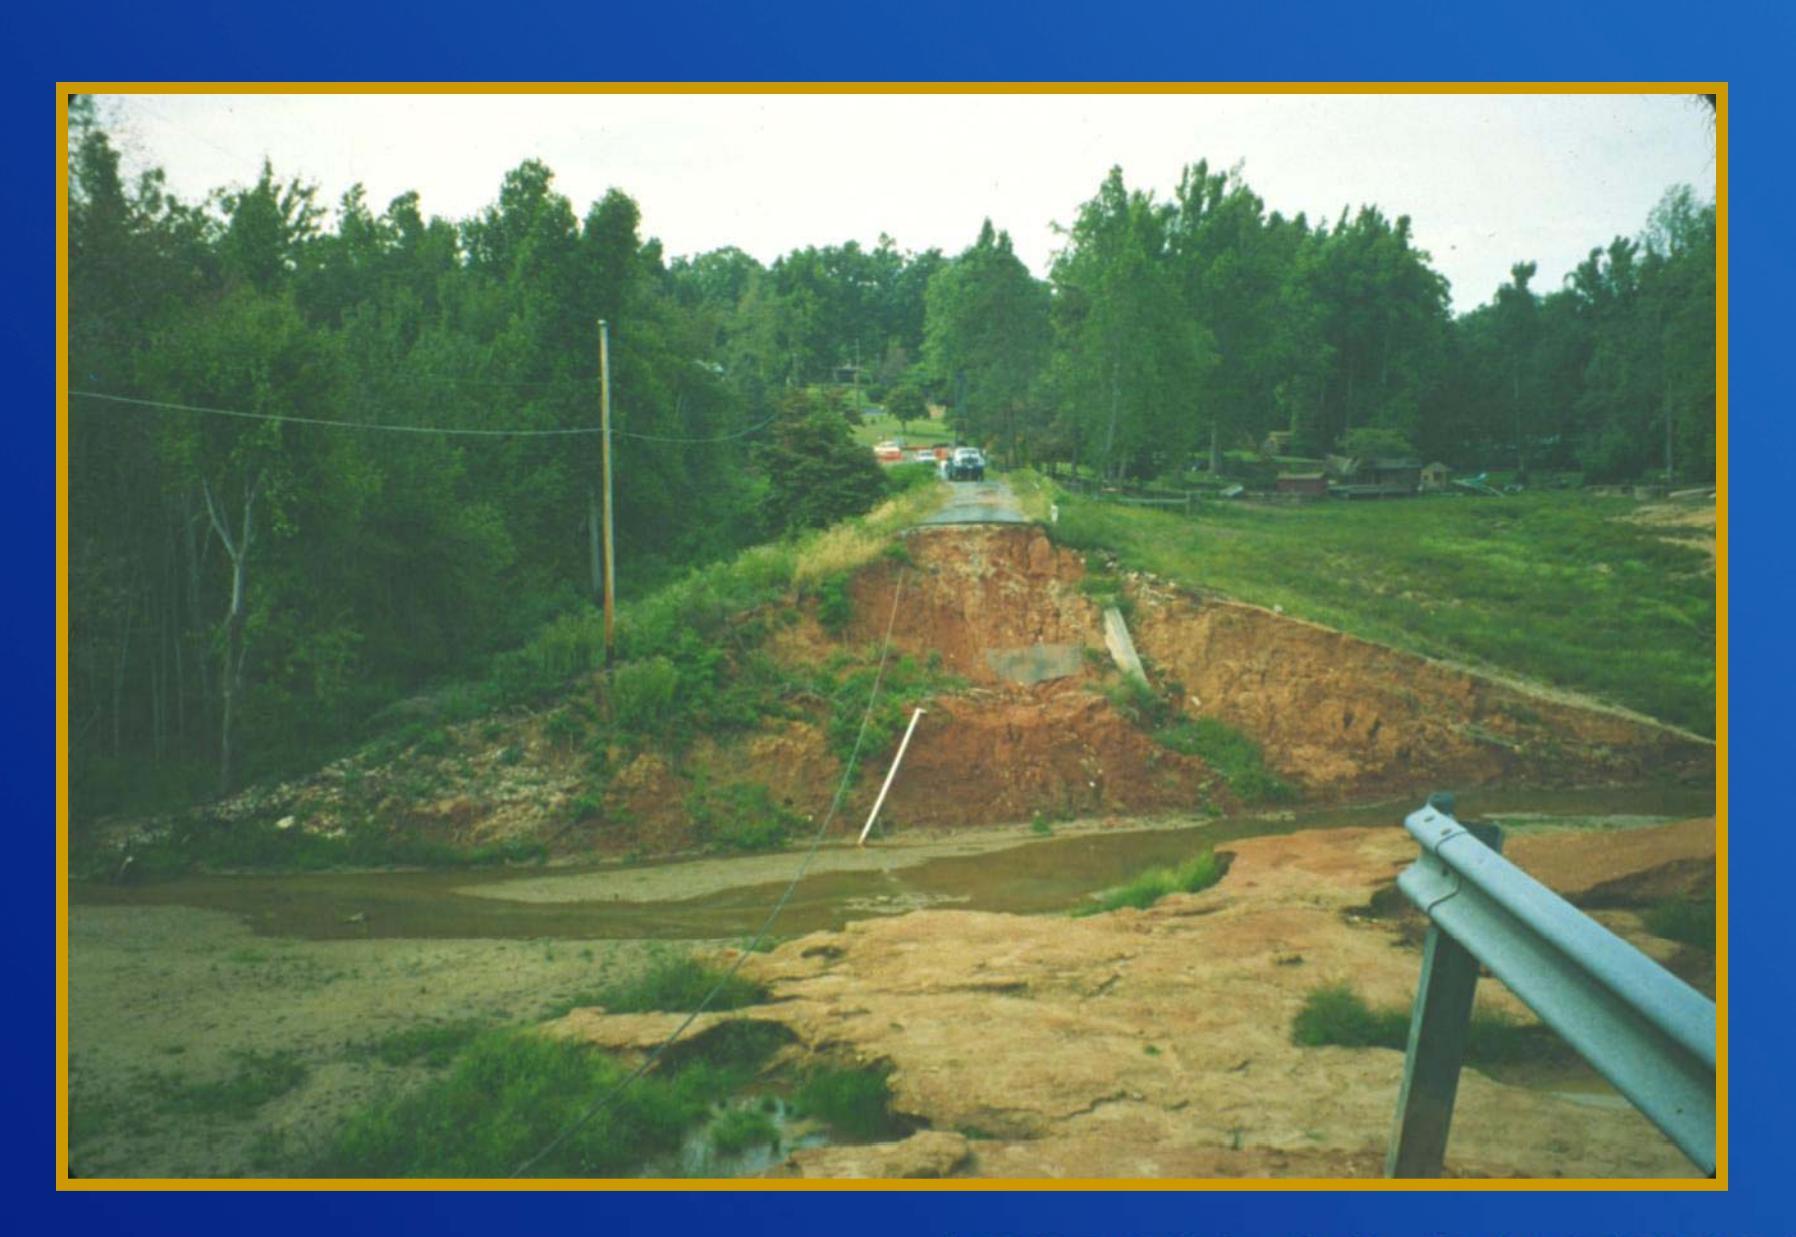
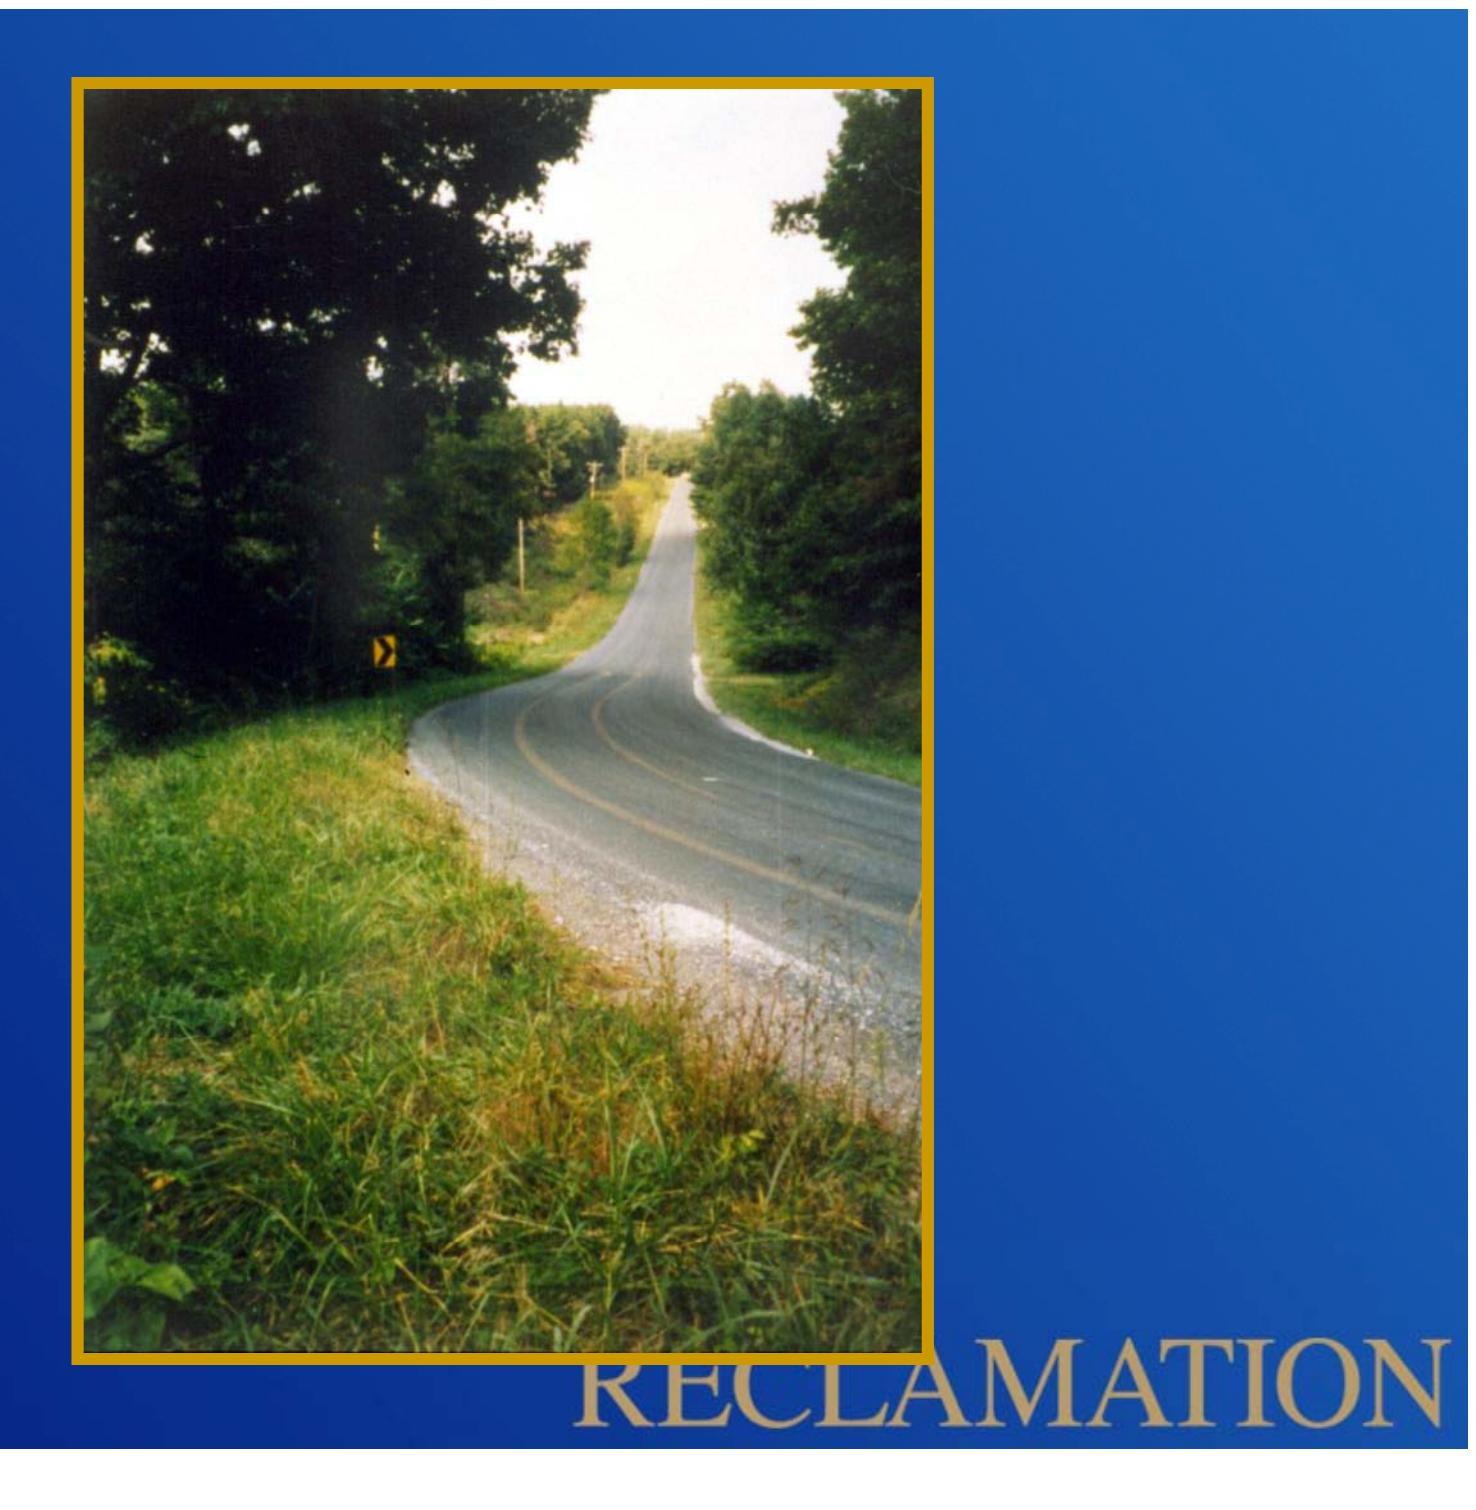
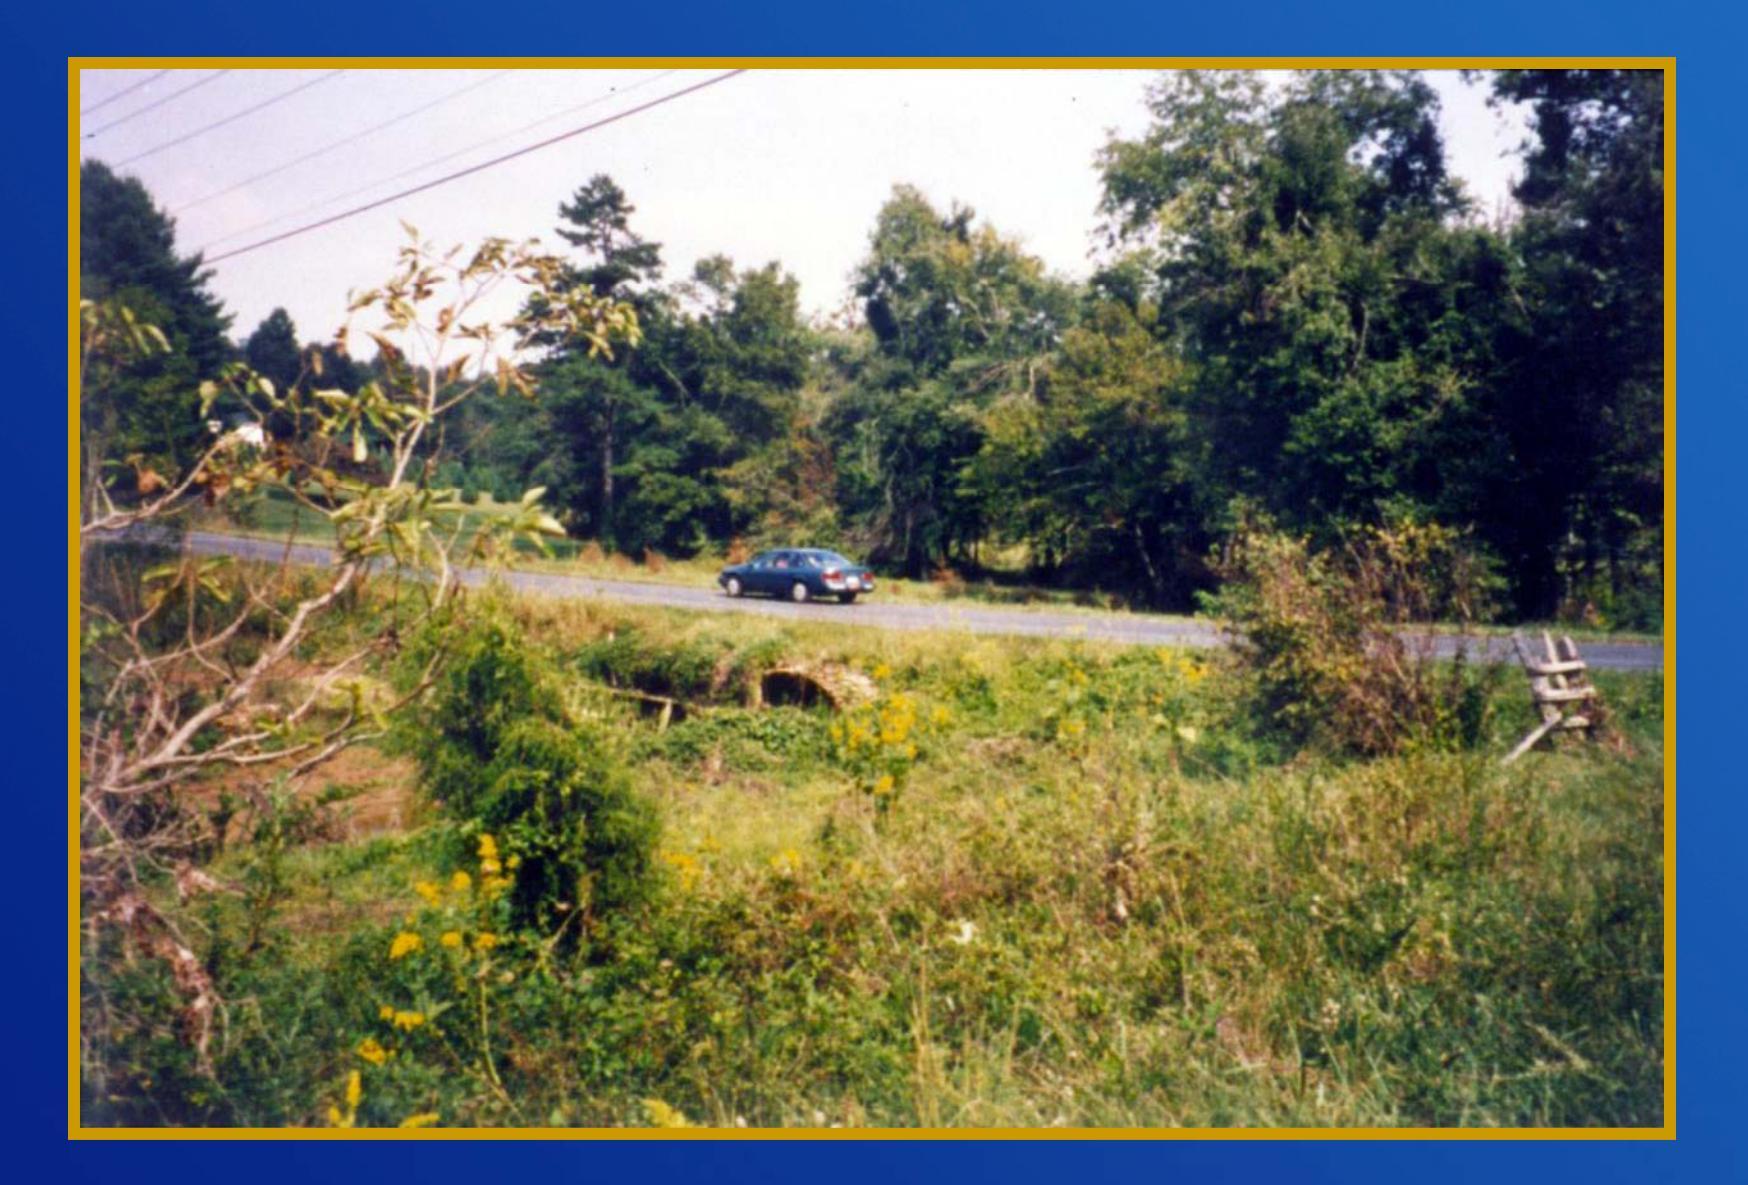
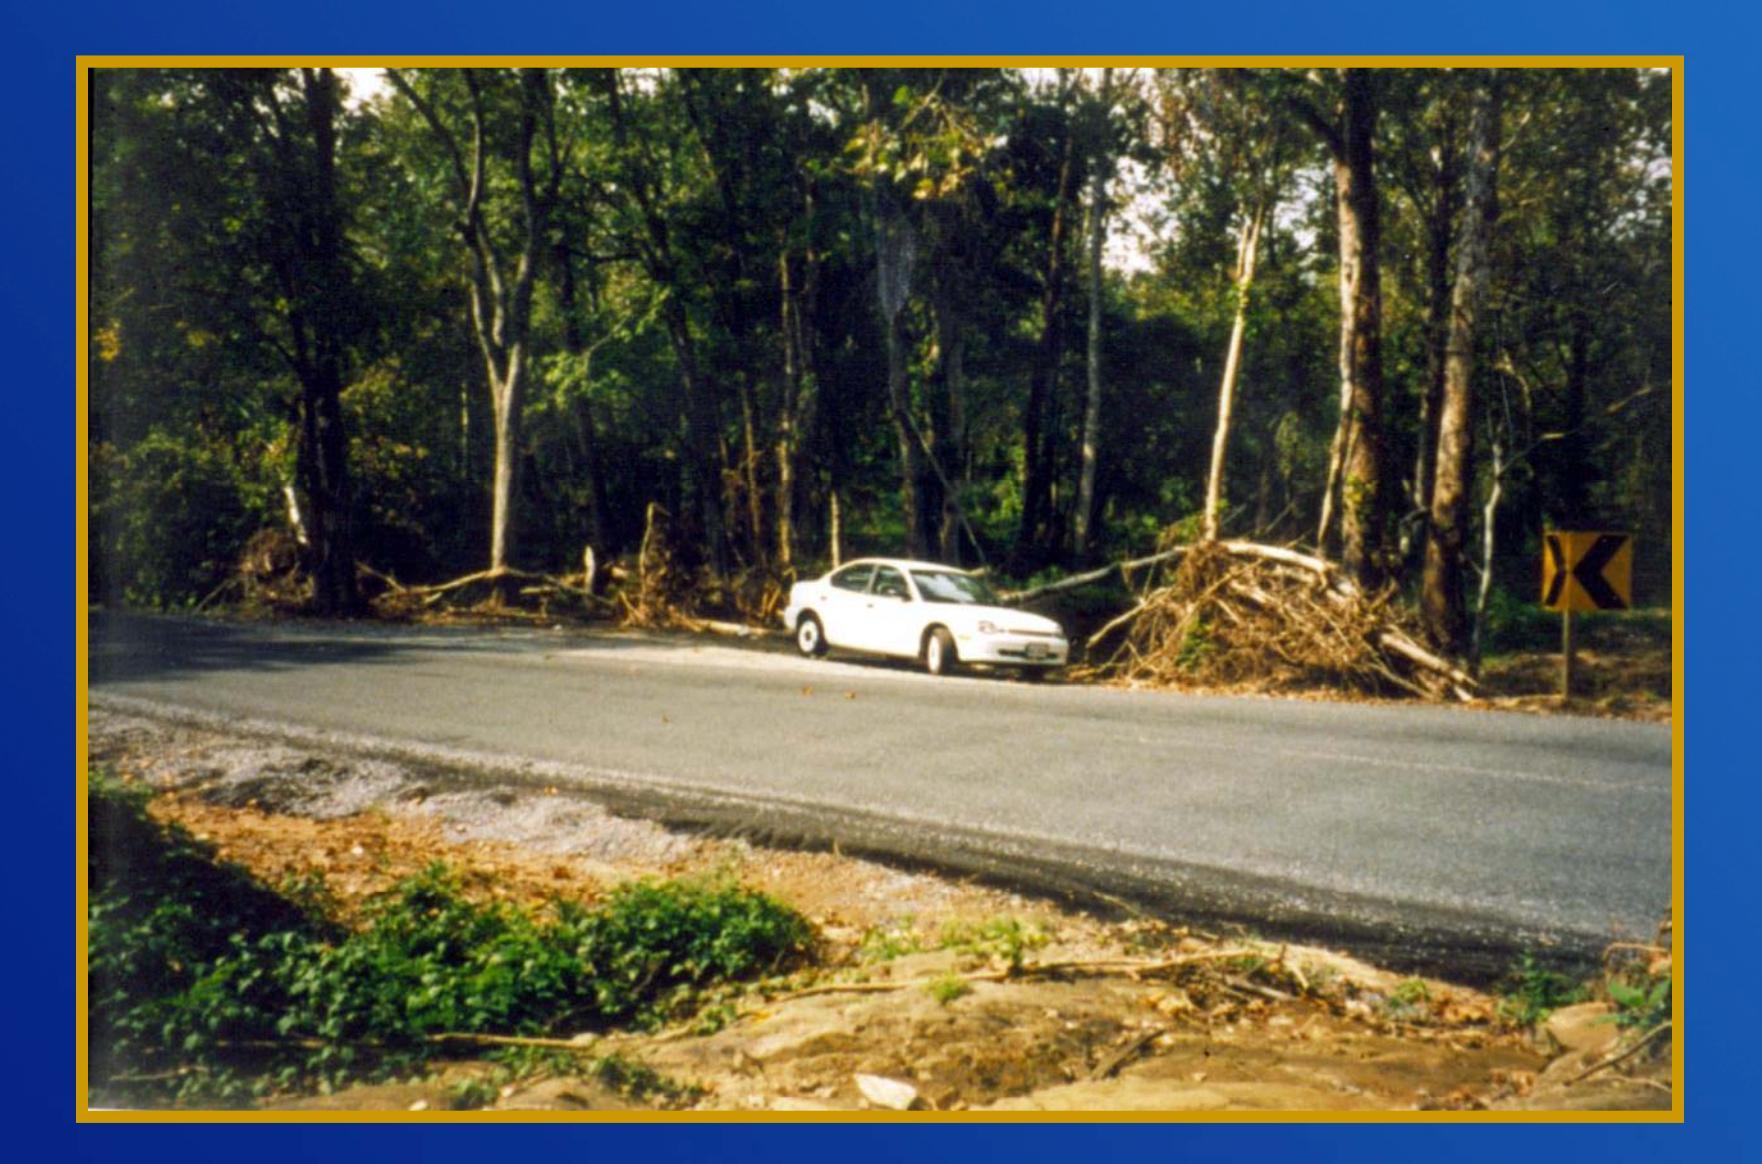
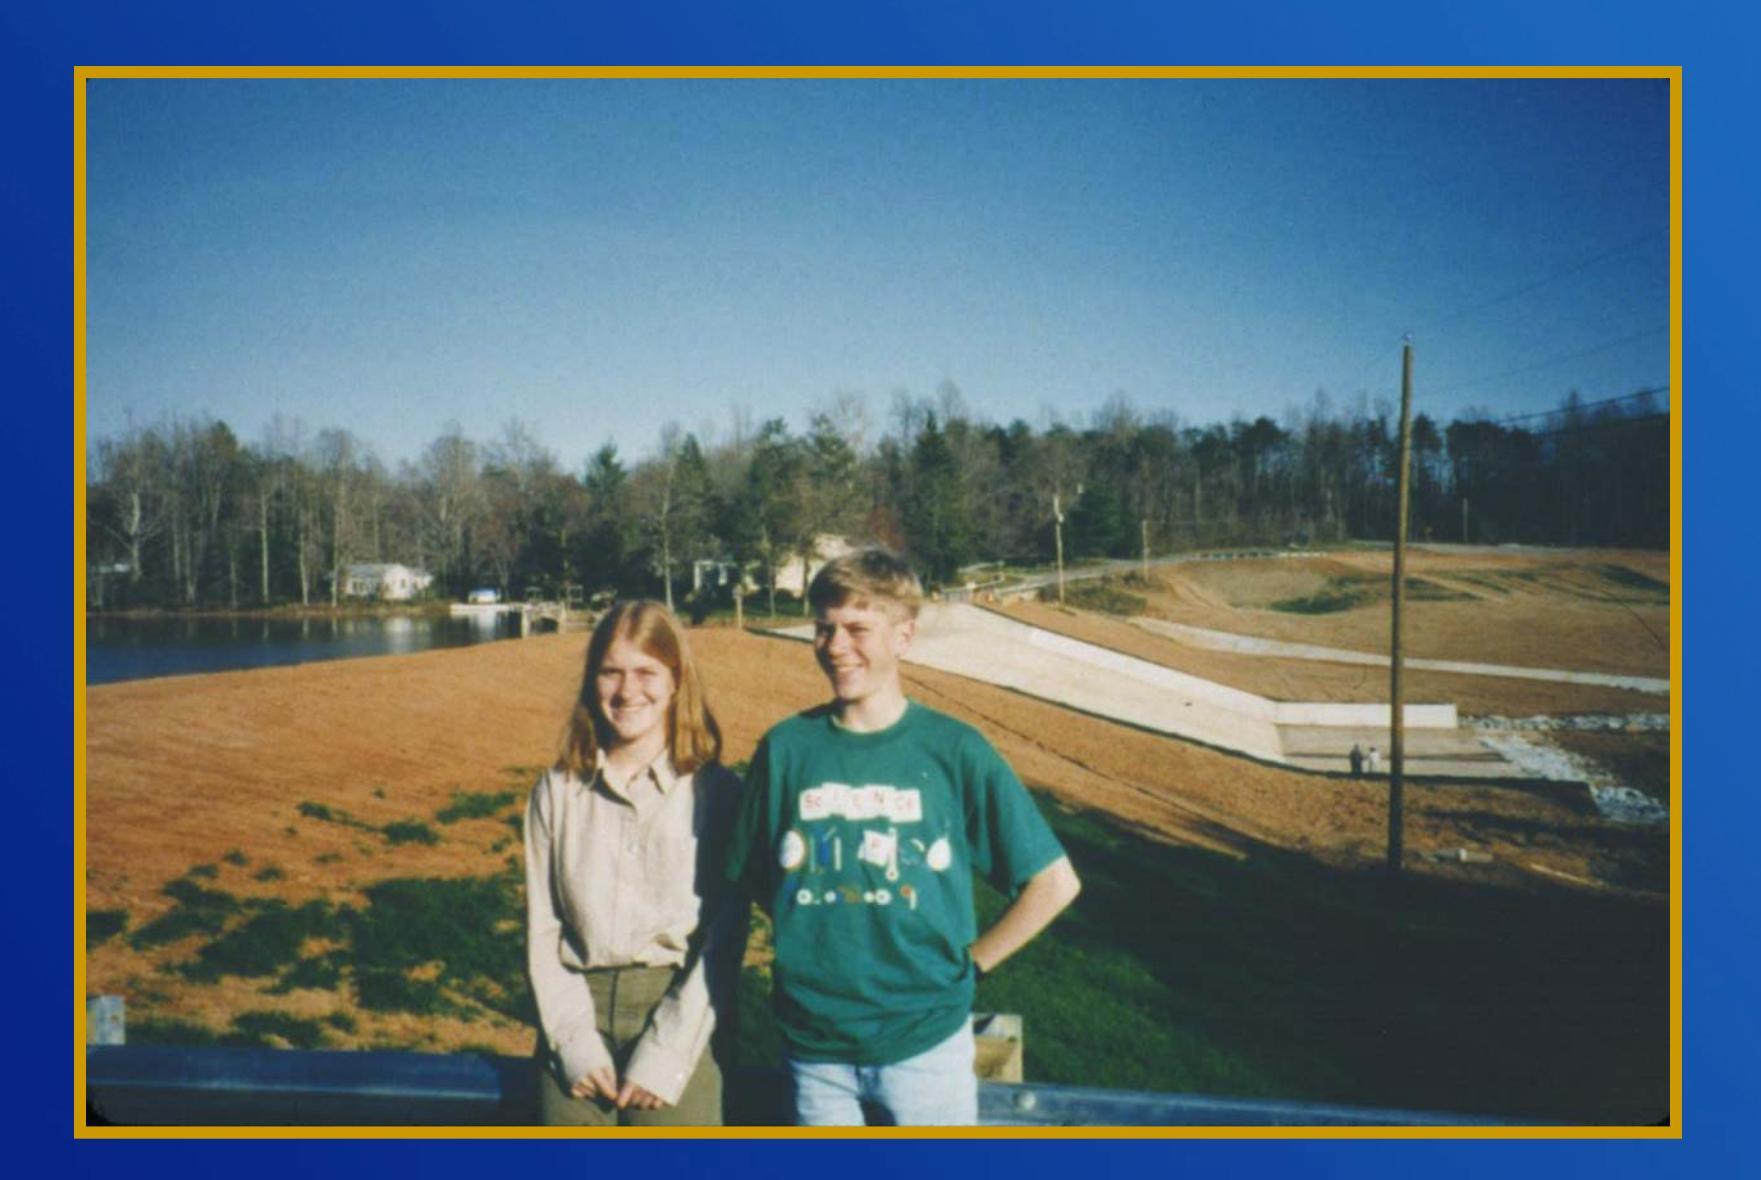
Timberlake Dam near Lynchburg, Virginia

- 33 Feet High
- Earthfill
- Failed June 22, 1995 at 11 p.m.
- Failed due to overtopping
- No warnings were issued before dam failure.
- 2 Fatalities
