A Synopsis of Notable U.S. Dam Failures

1874 to present

U.S. Department of the Interior Bureau of Reclamation

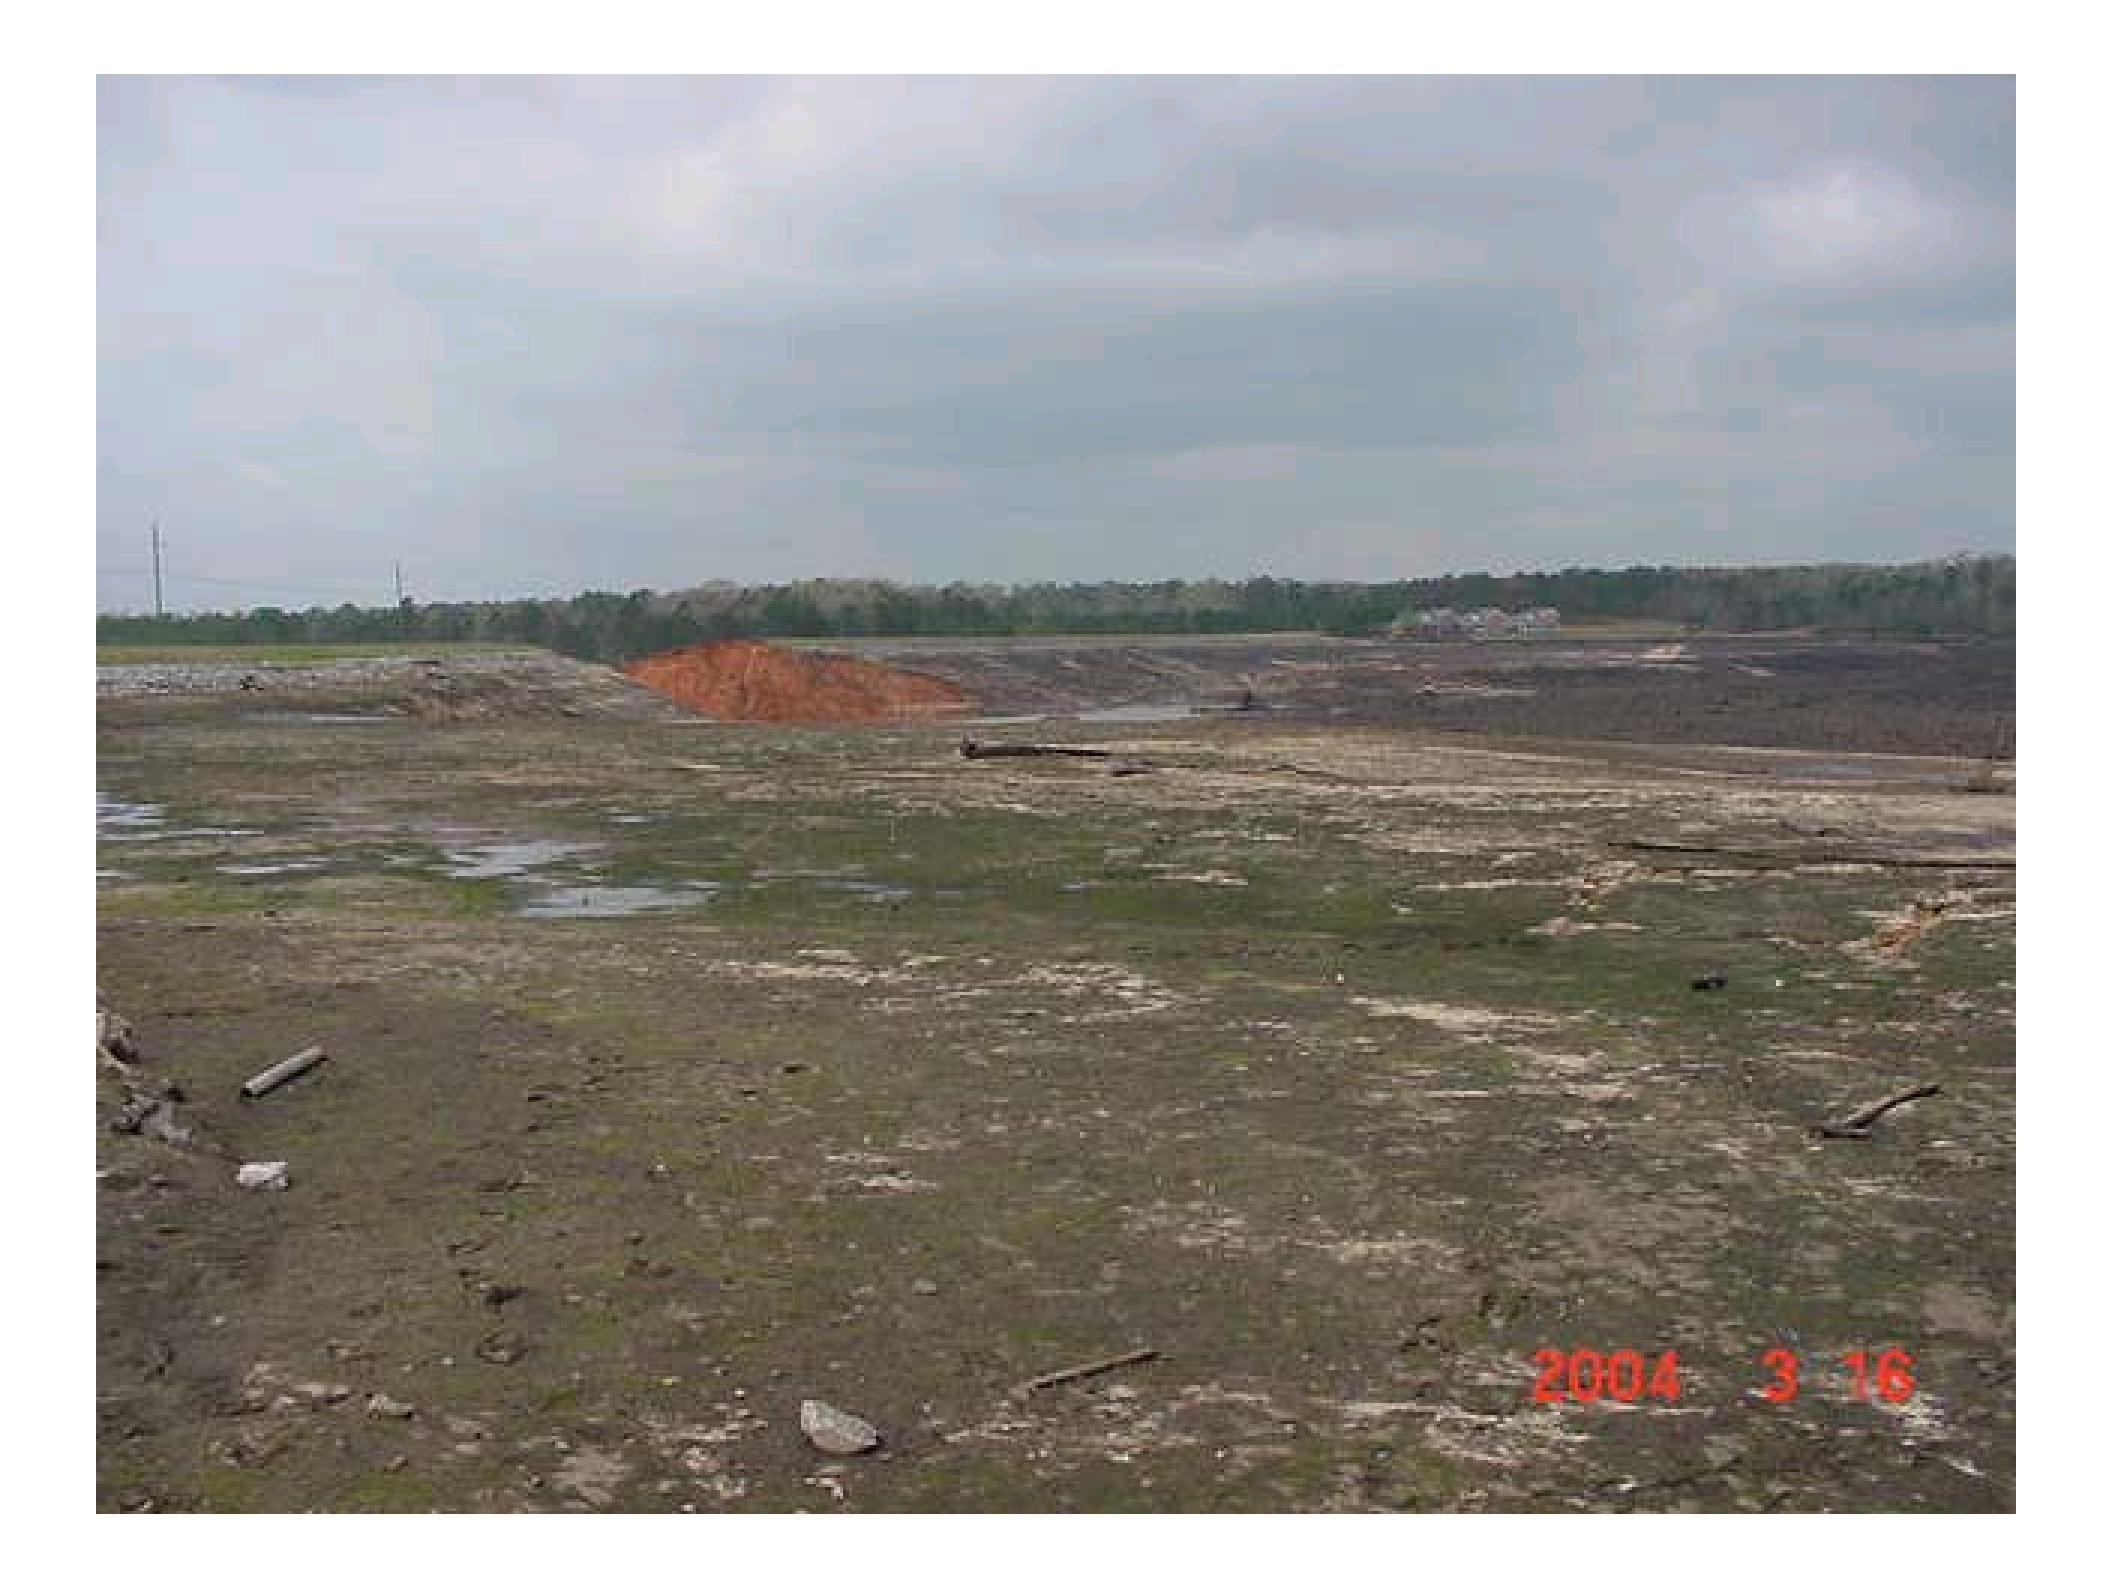
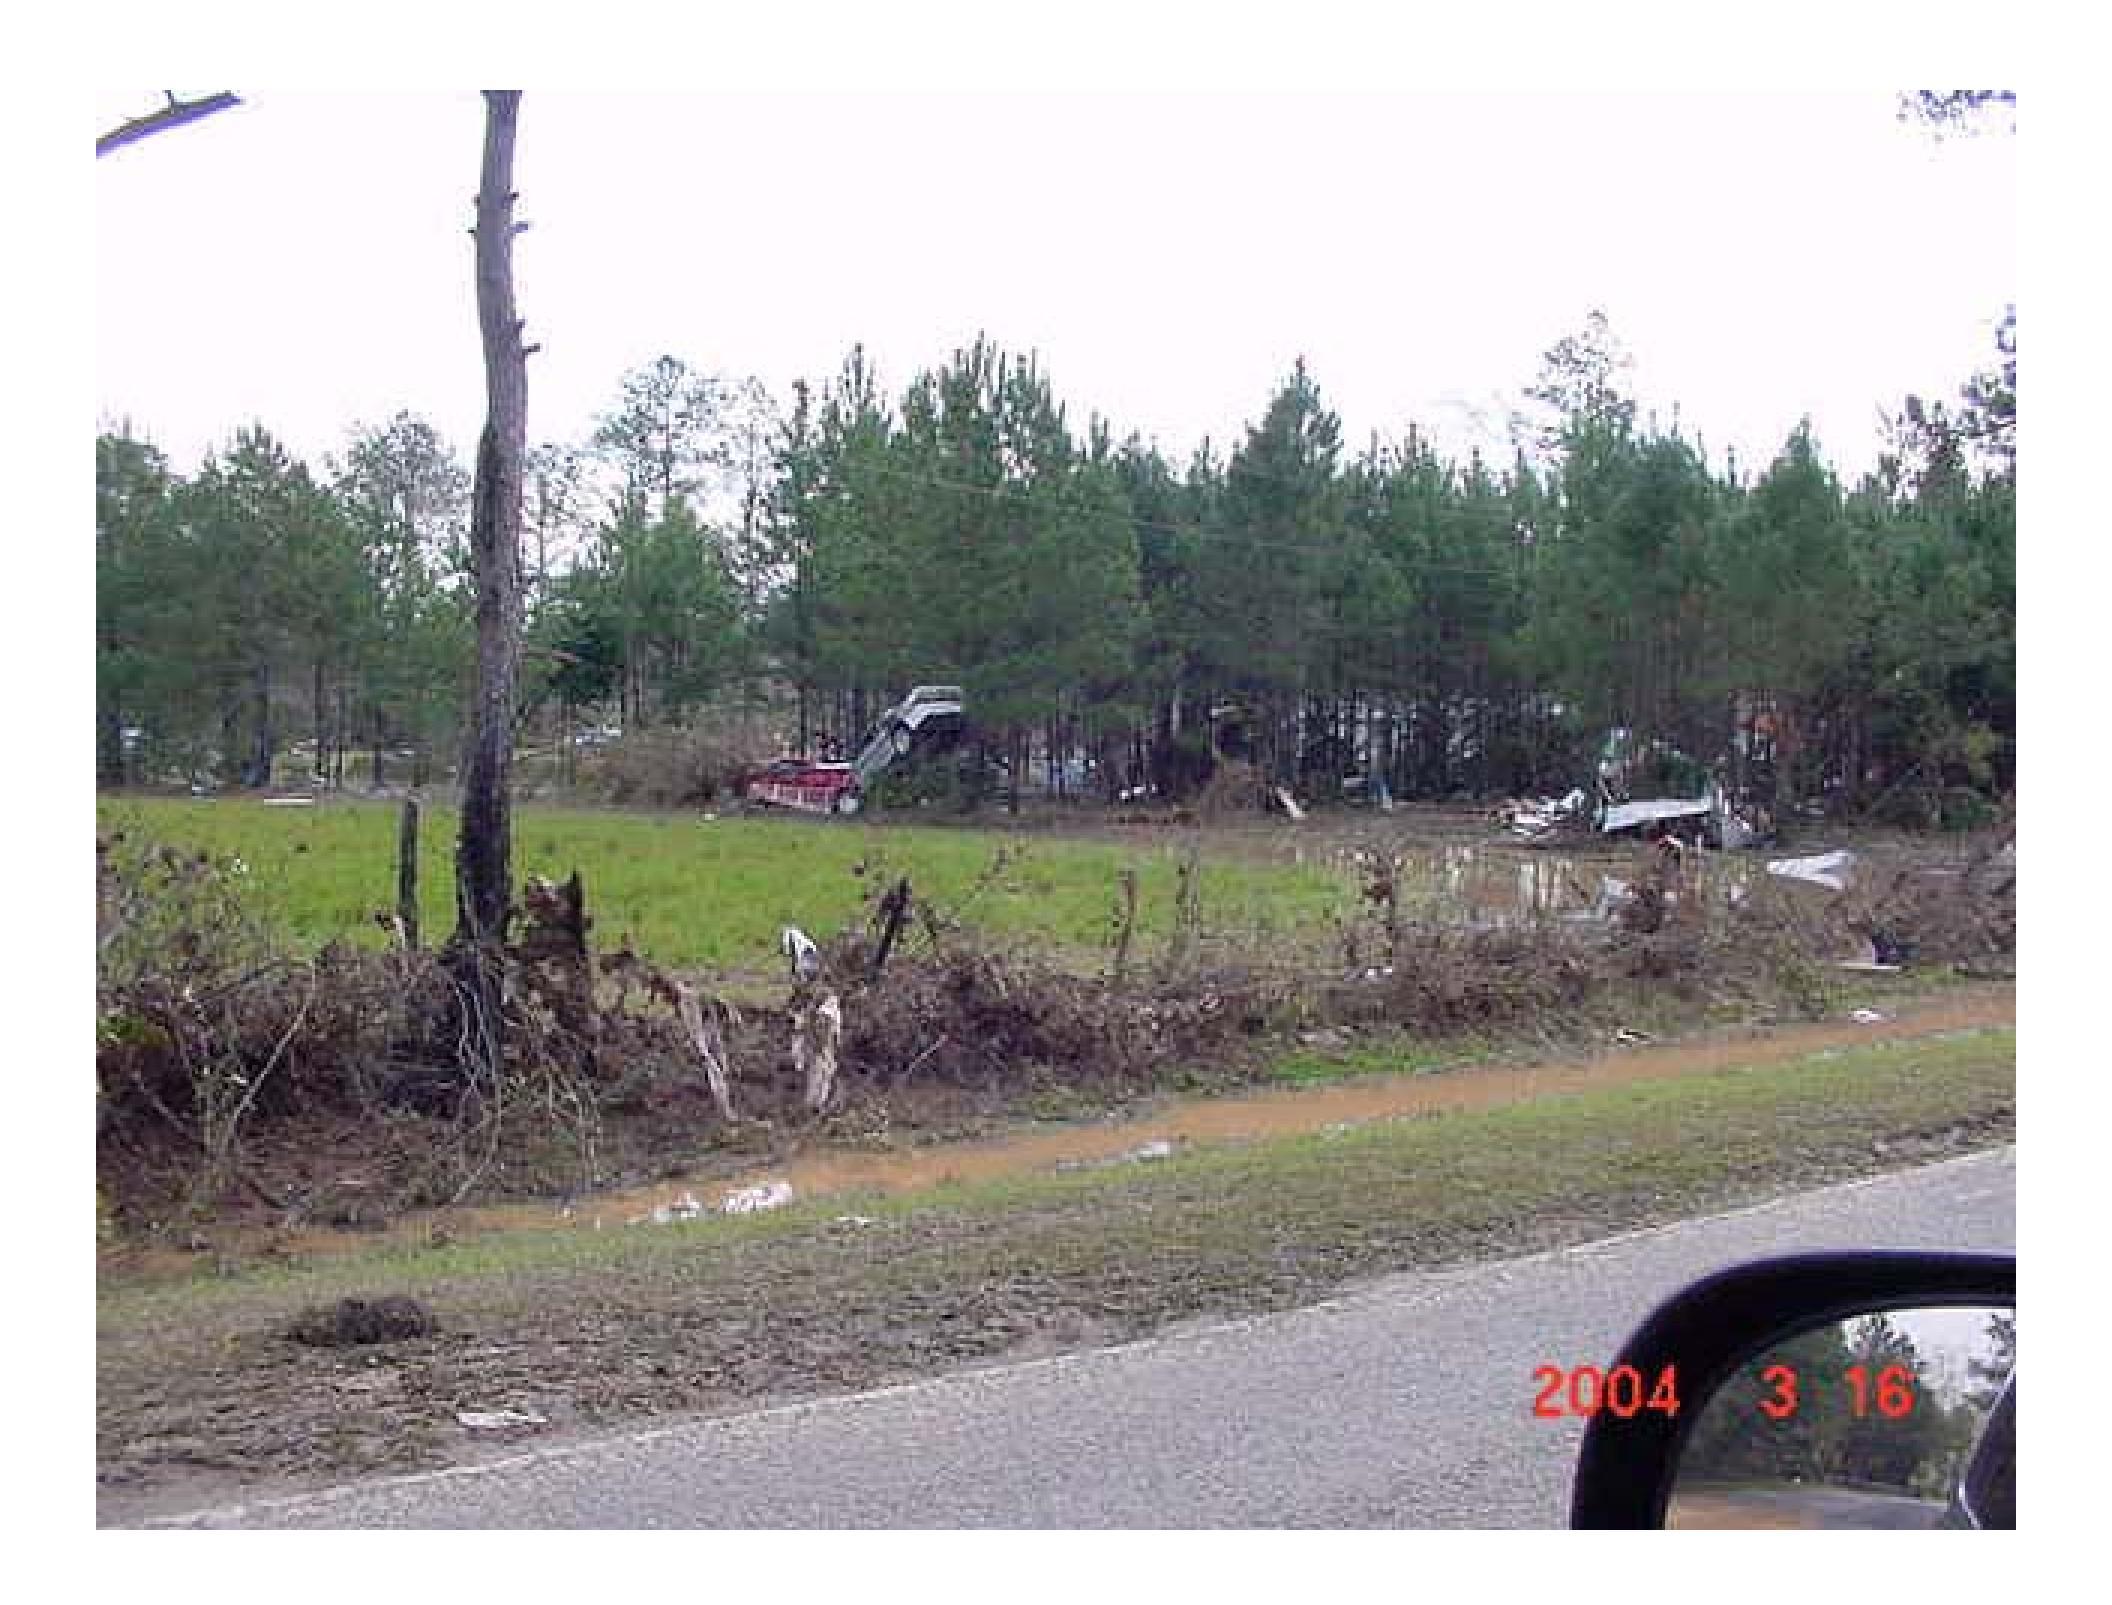
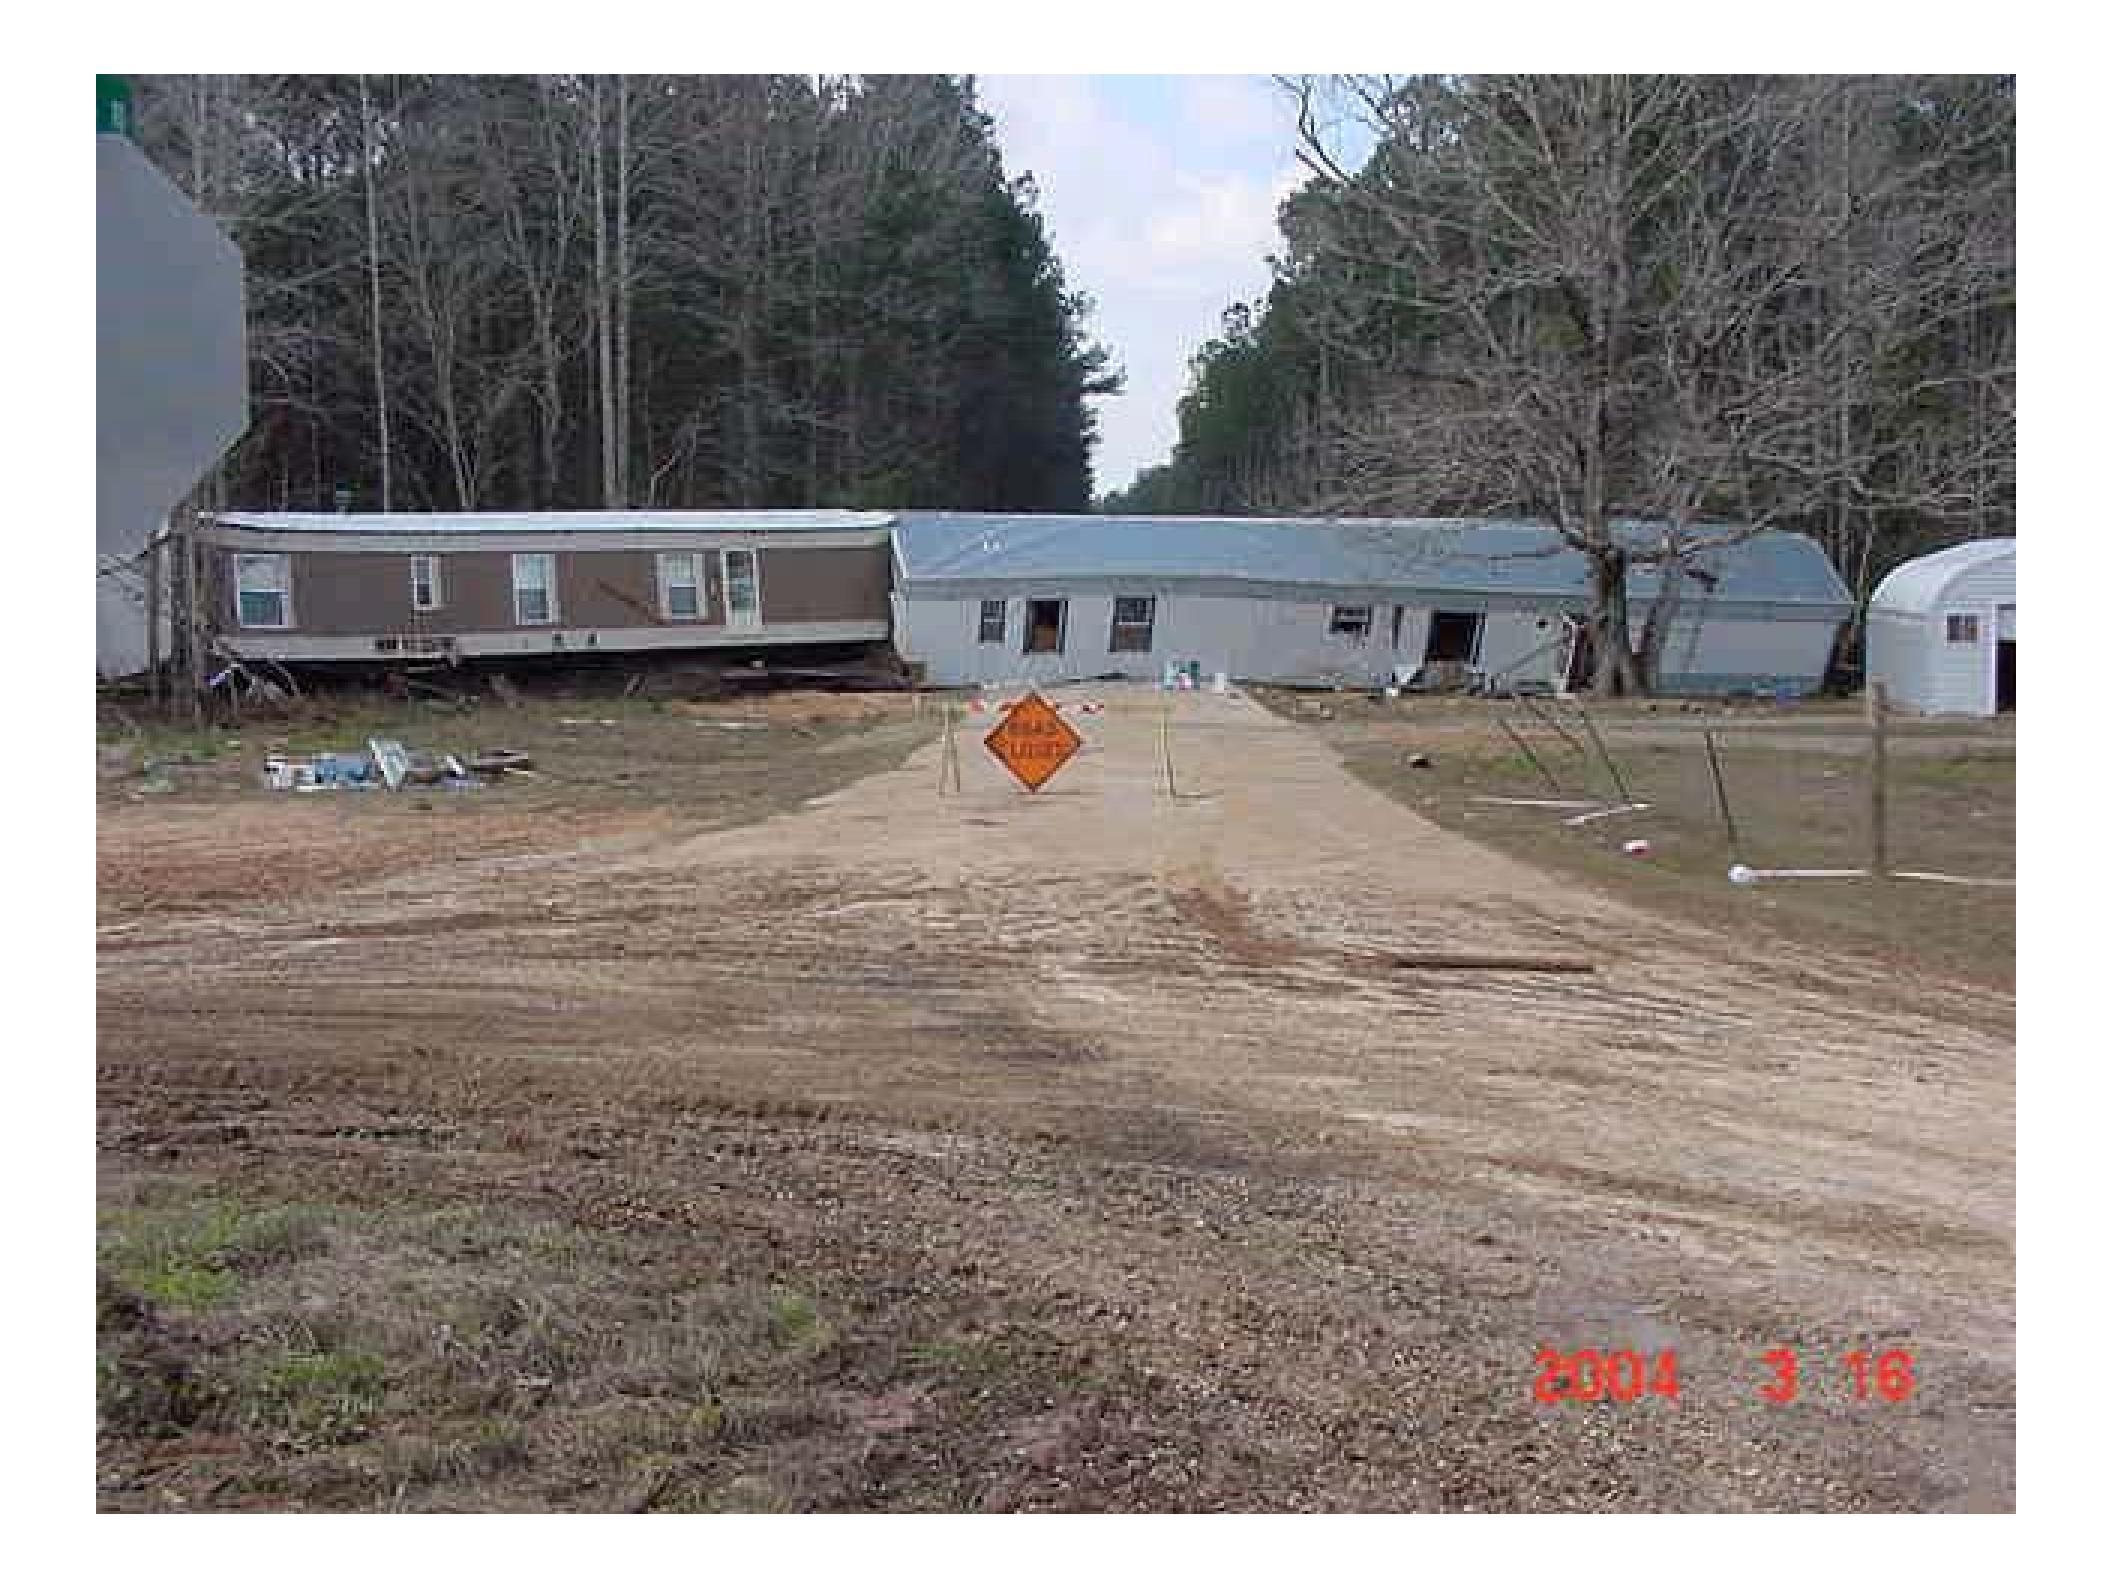
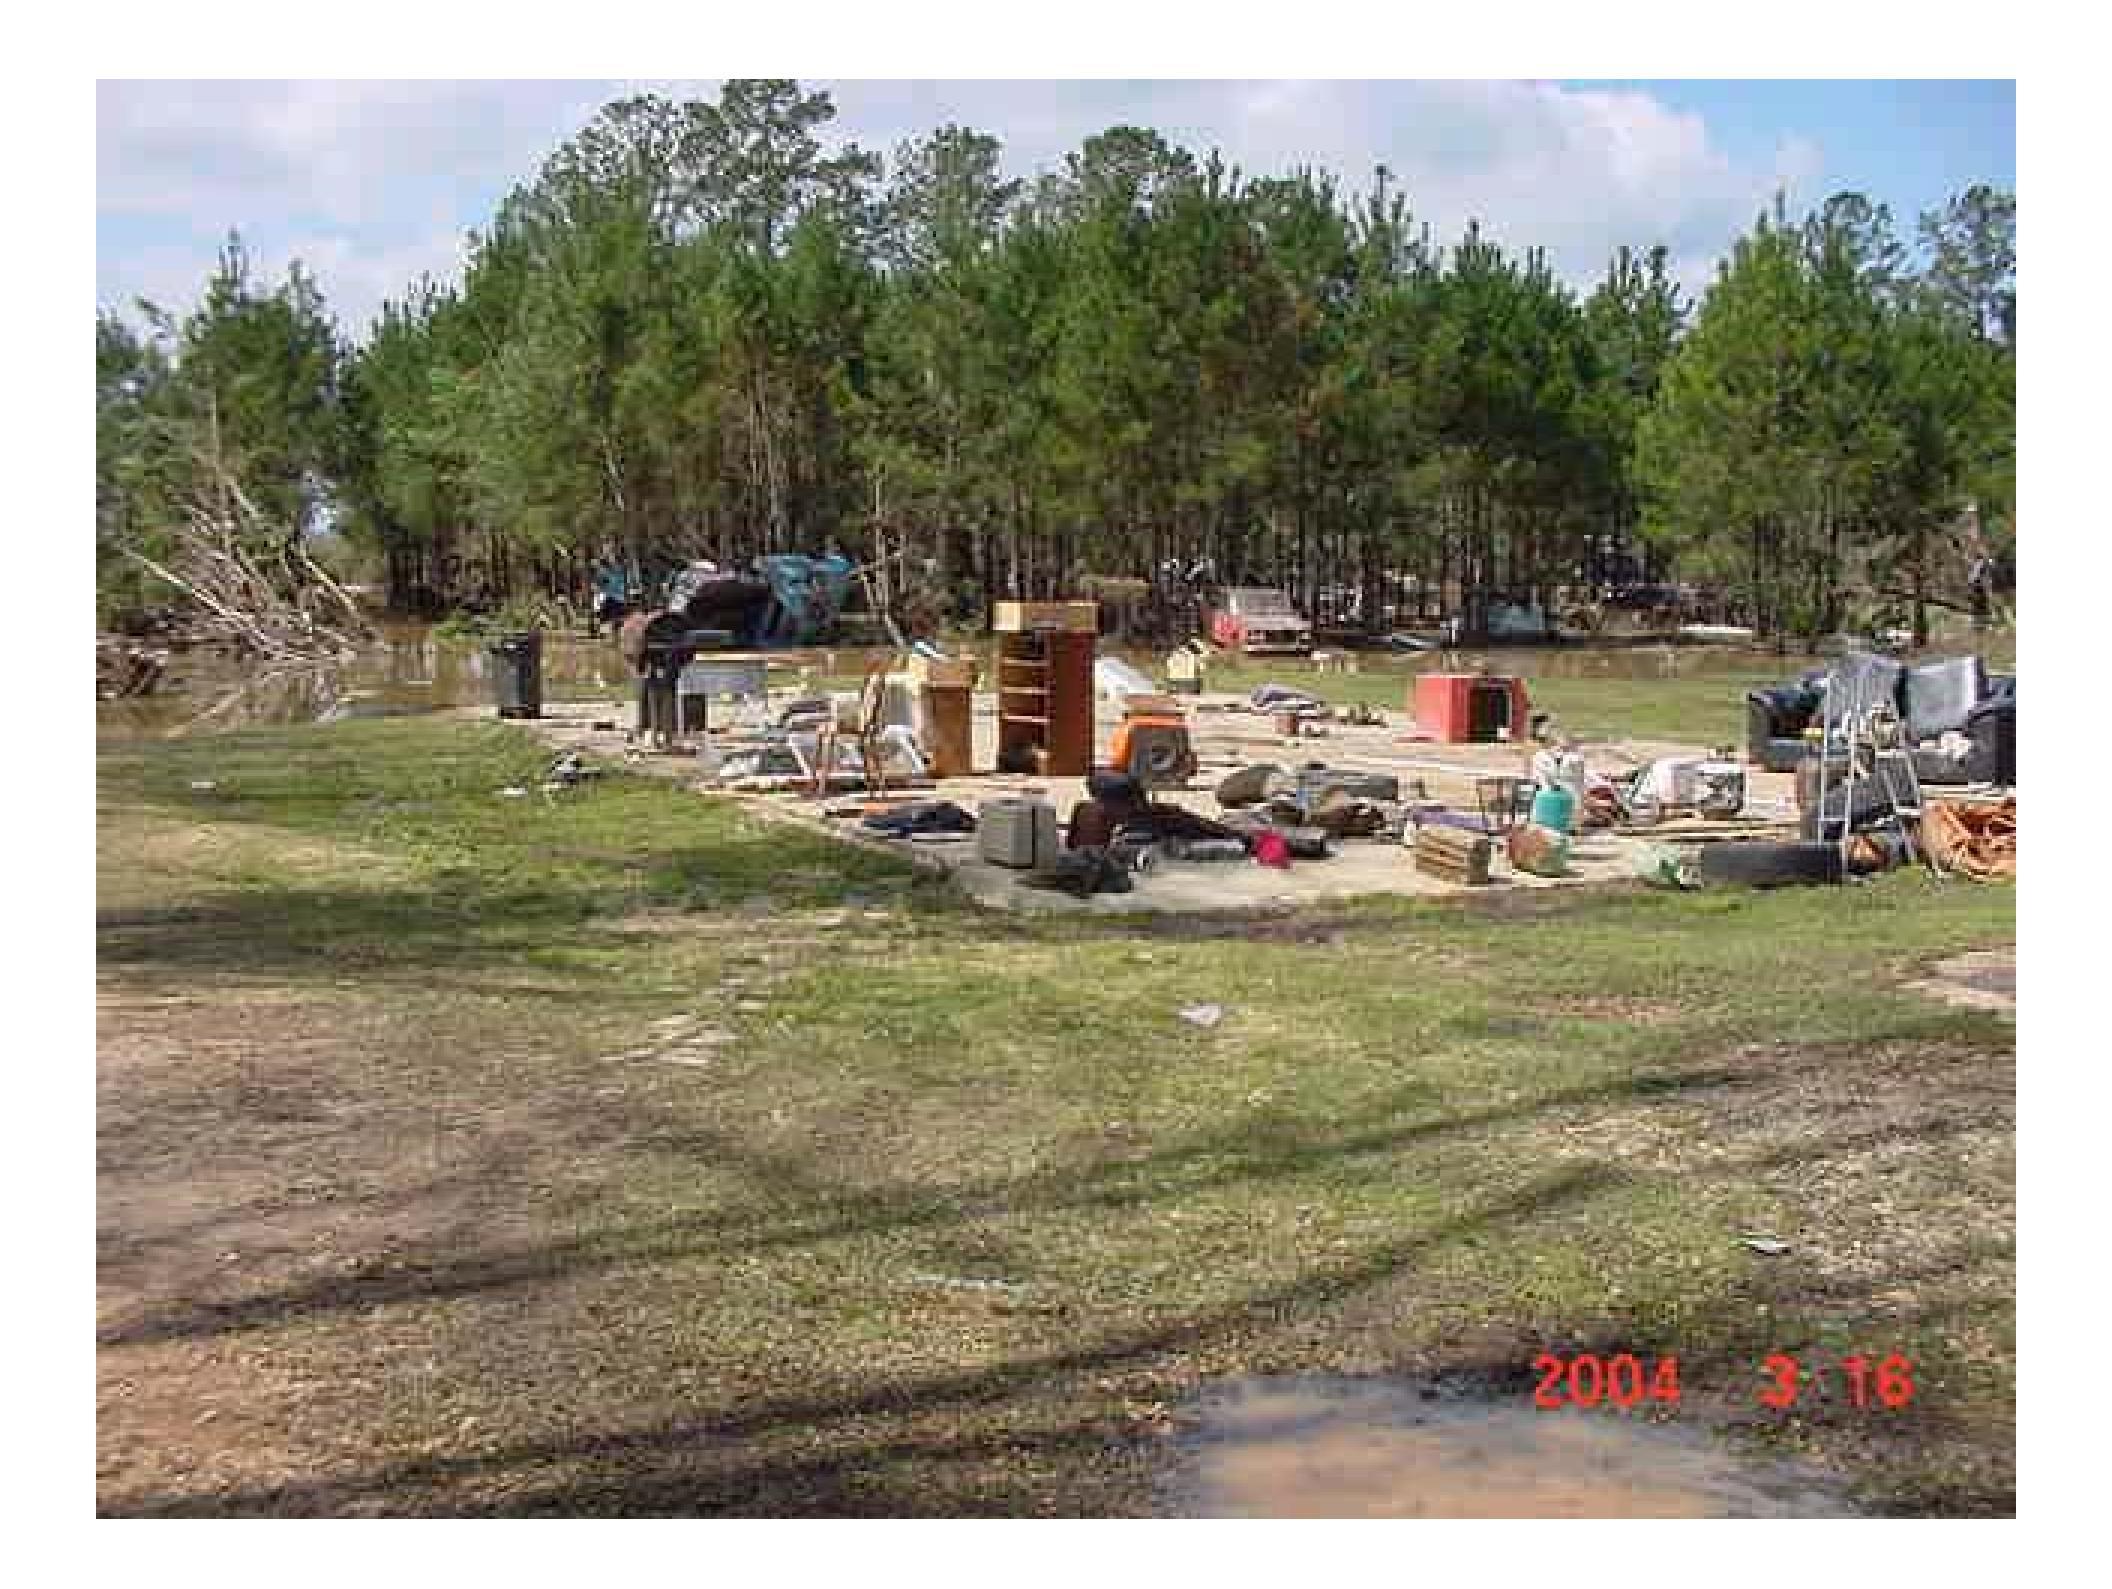
Big Bay Lake Dam Mississippi

- 57 Feet High
- Earthfill
- Failed March 12, 2004 at 12:20 p.m.
- Failed due to piping during normal weather
- Warnings were issued simultaneously with breach formation
- Destructive flood with no fatalities

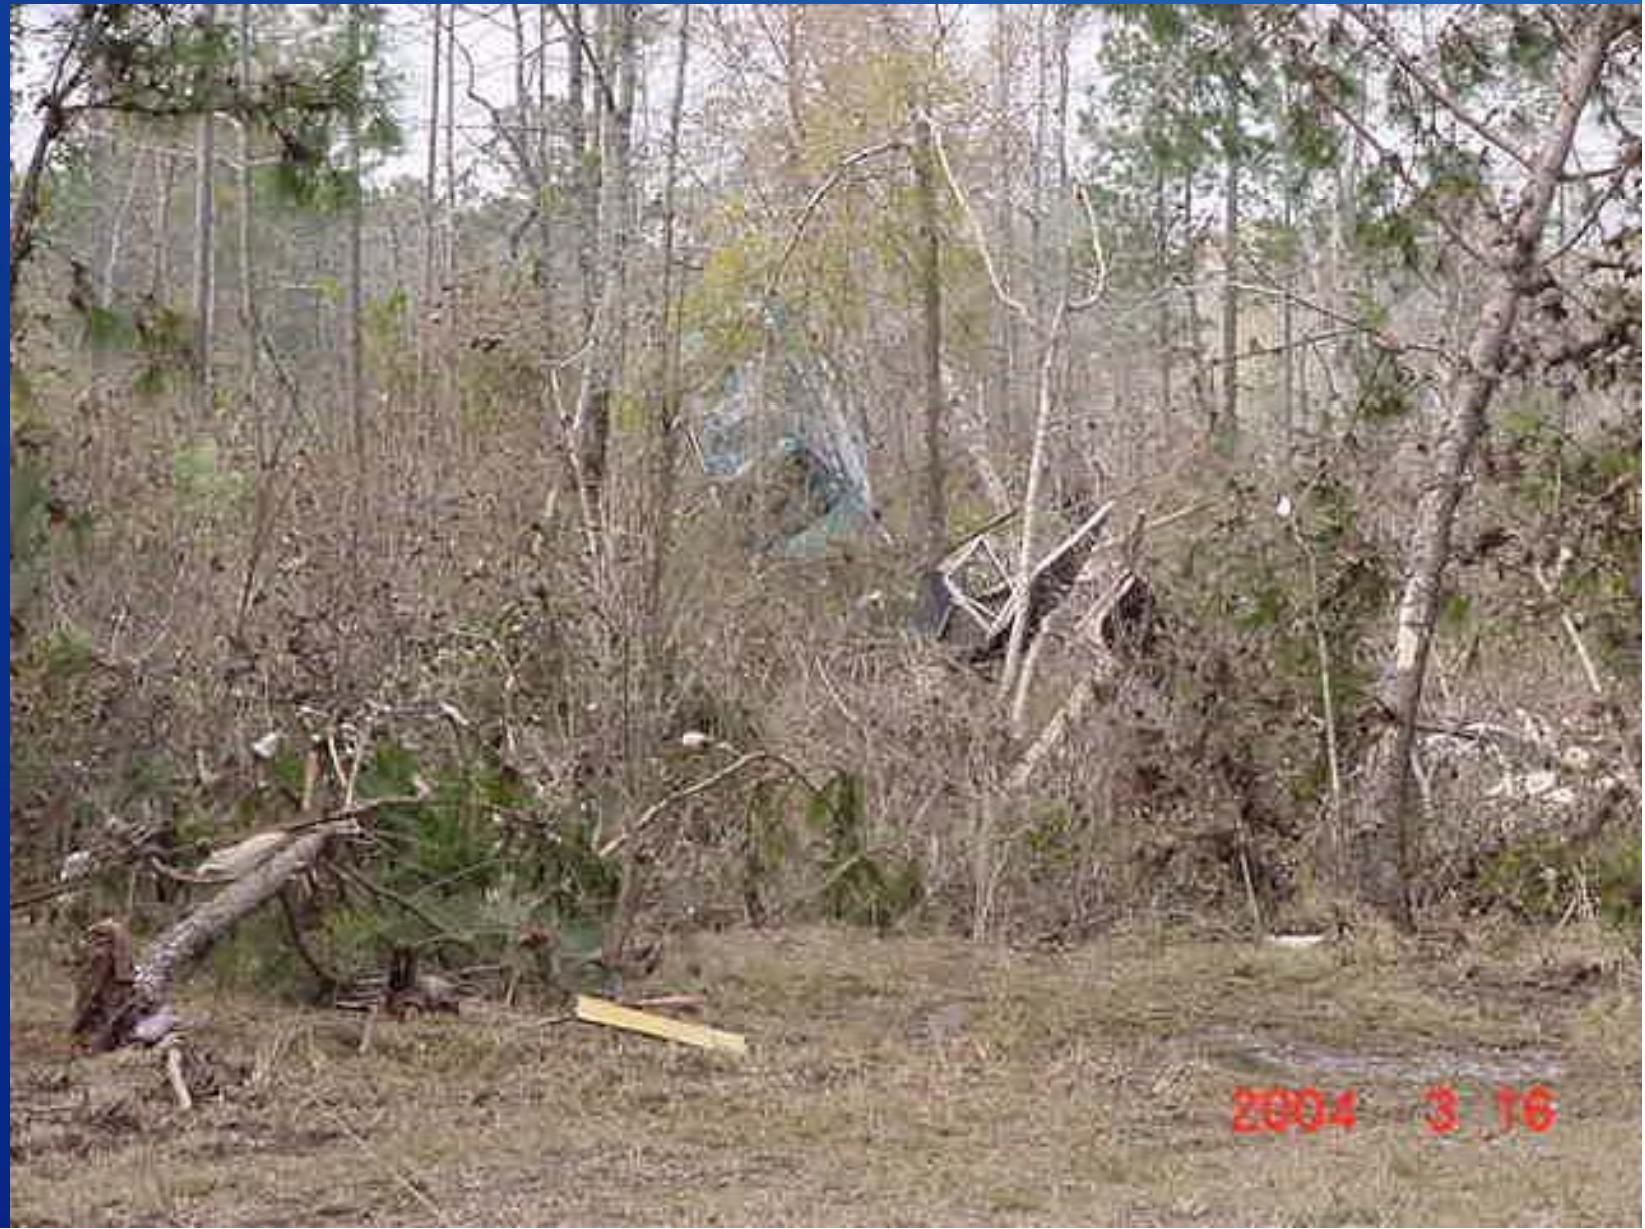
Many vehicles were swept one-quarter mile into the woods

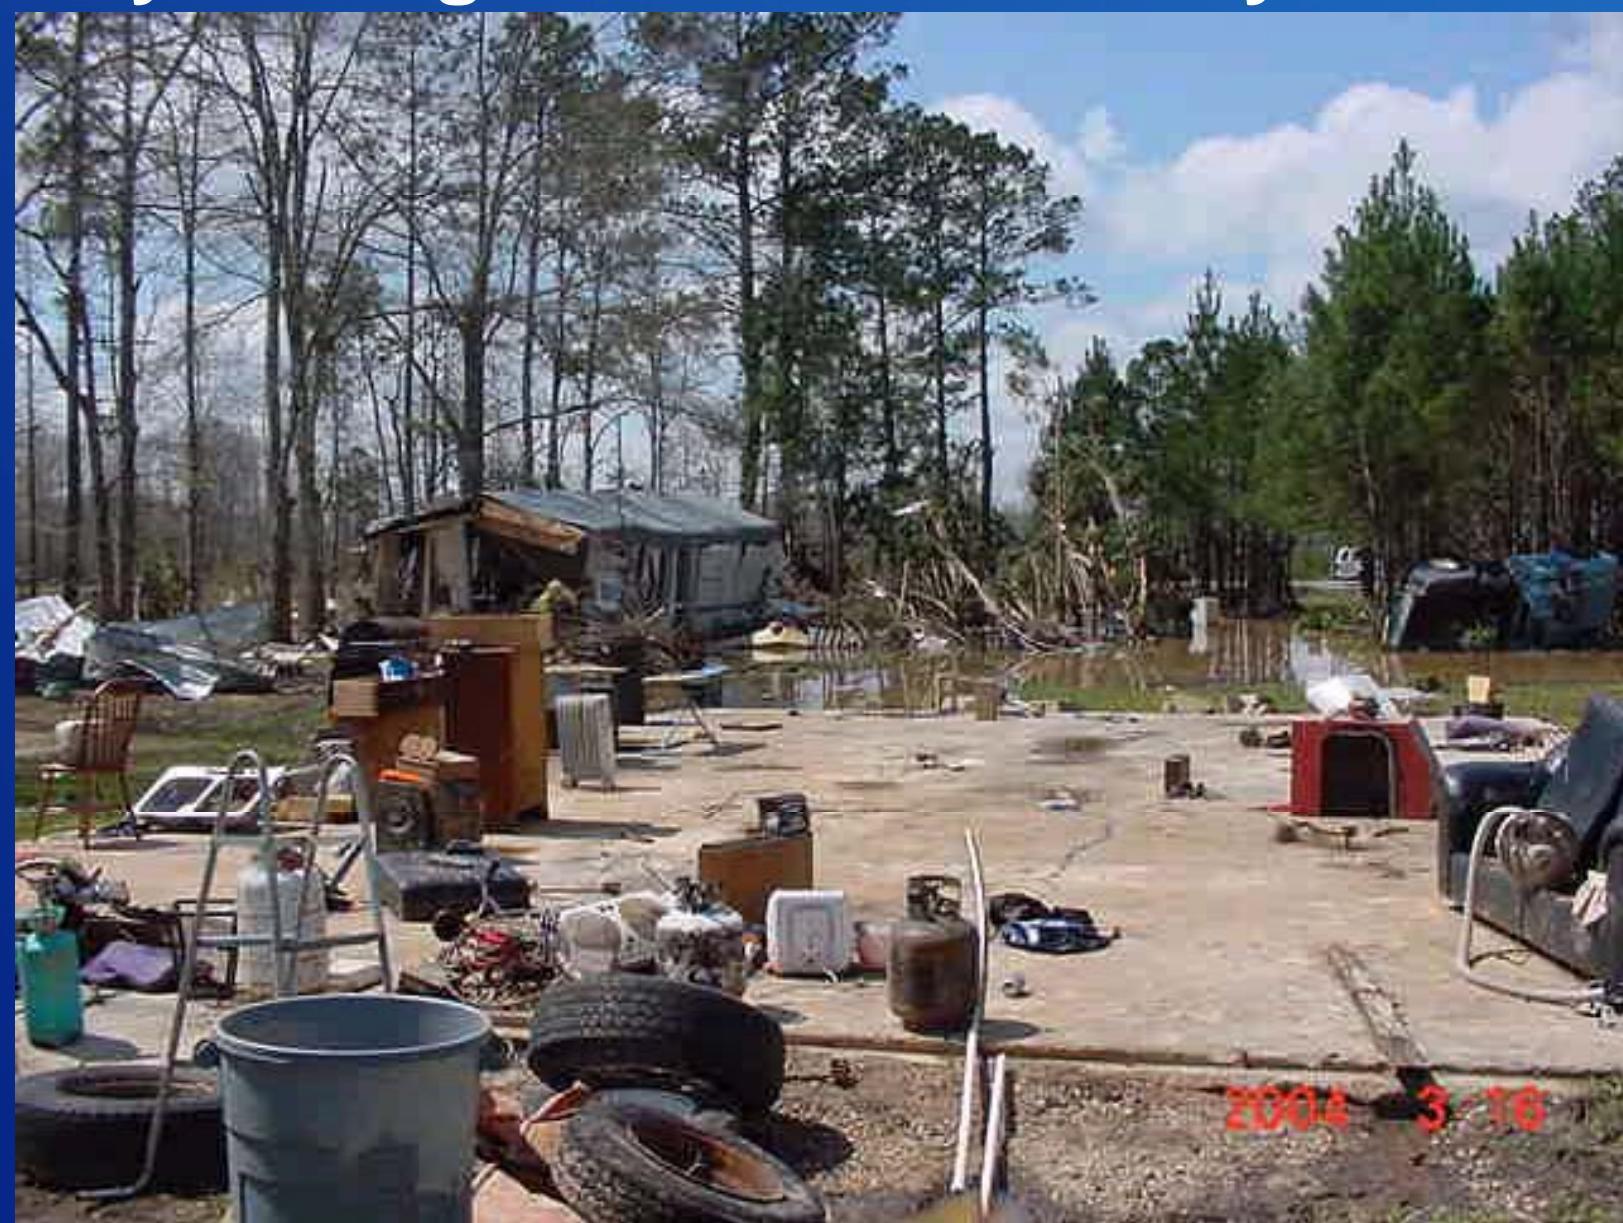
Many homes on Robbins Road Were Severely Damaged or Washed Away
