A Synopsis of Notable U.S. Dam Failures

1874 to present

U.S. Department of the Interior Bureau of Reclamation

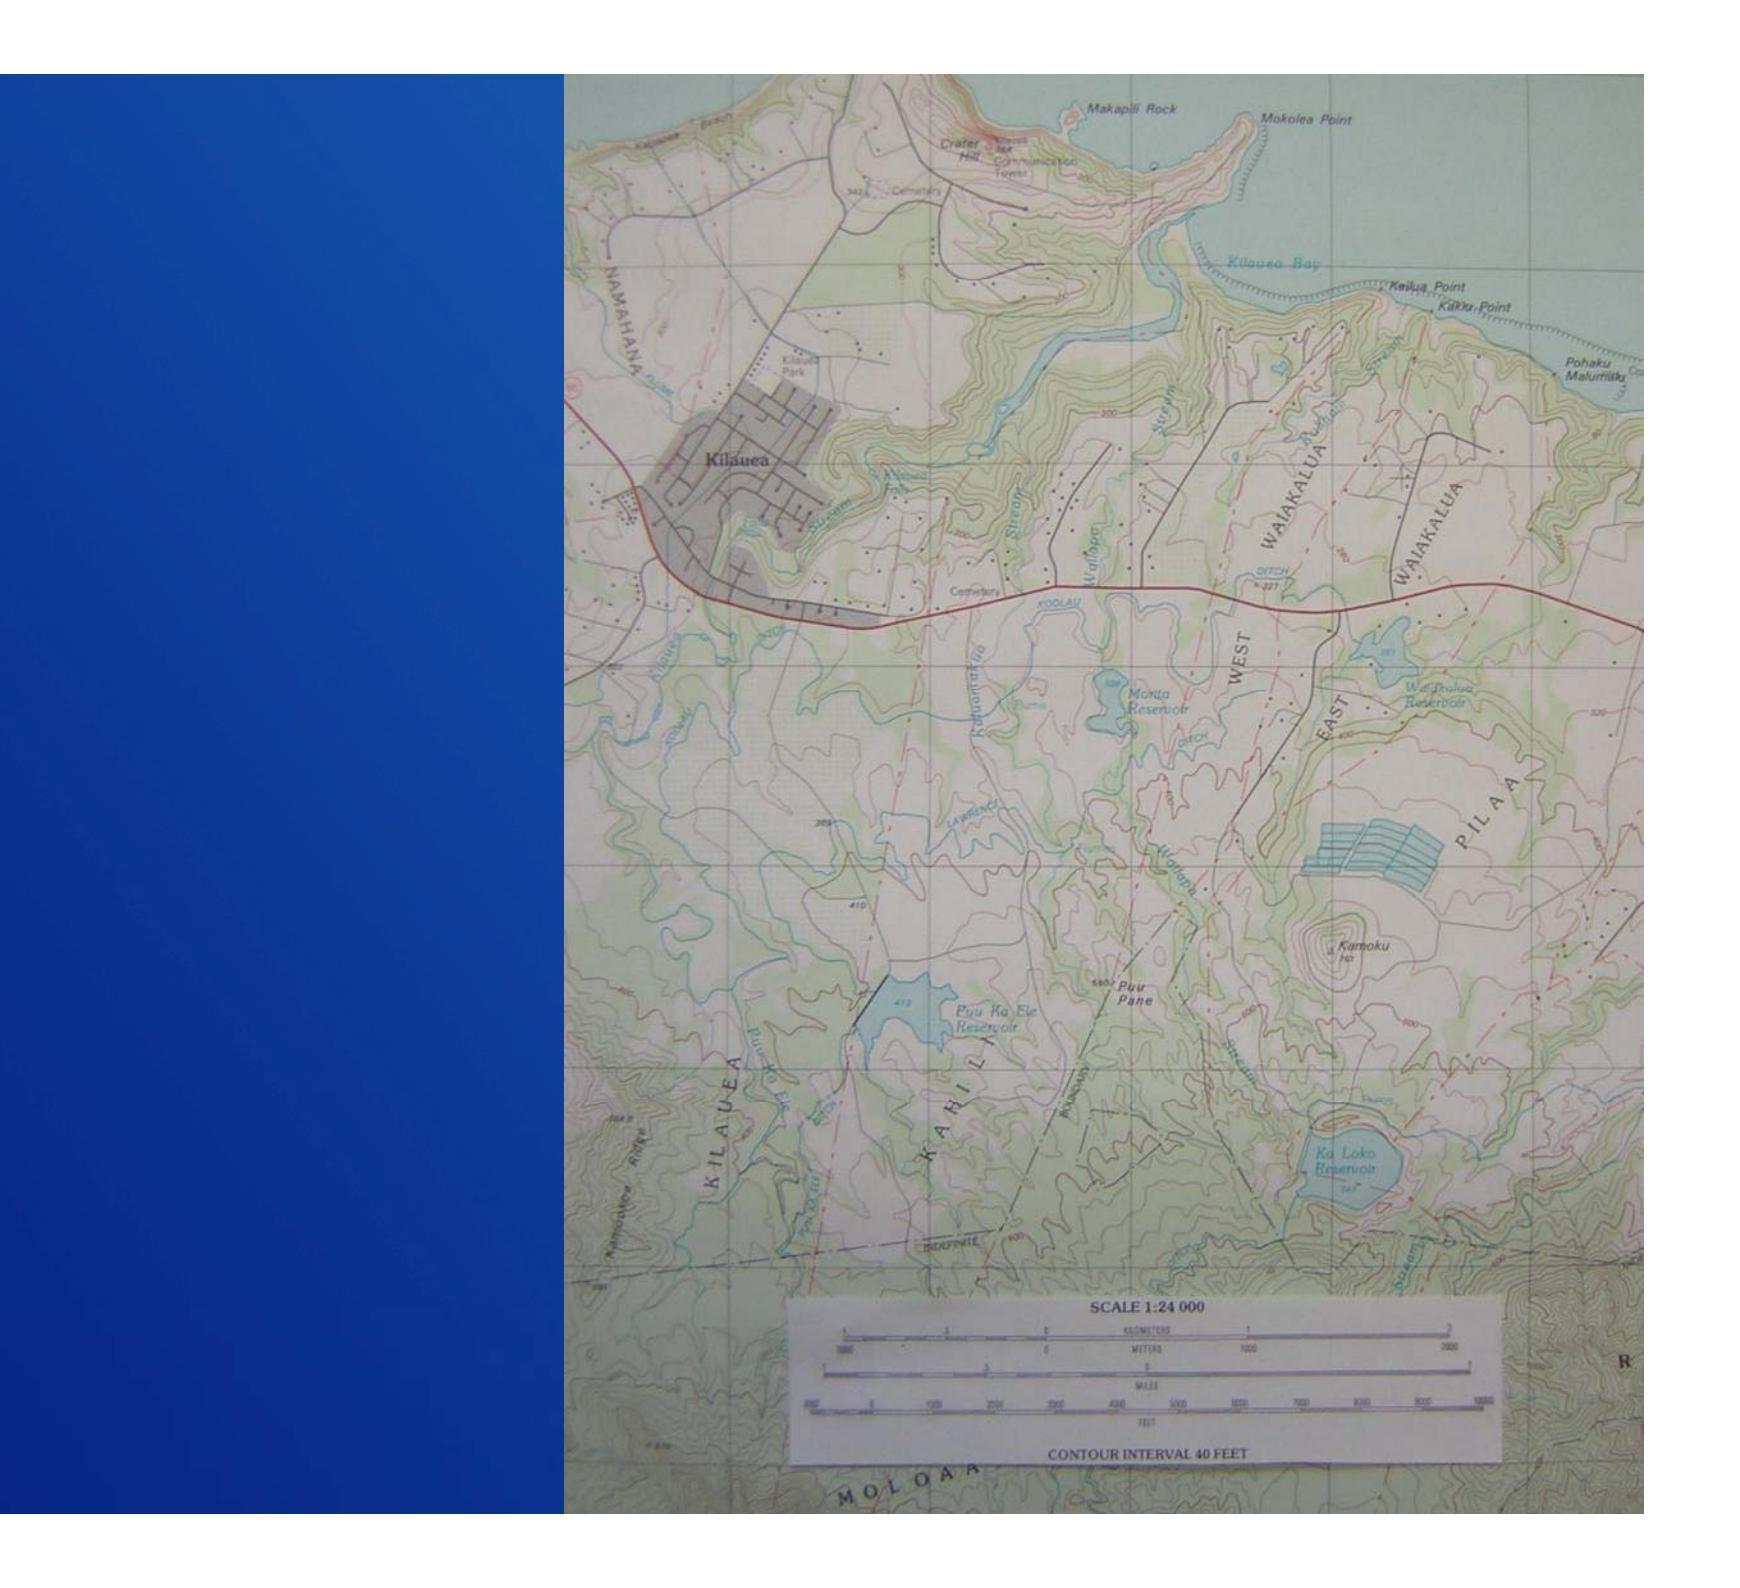
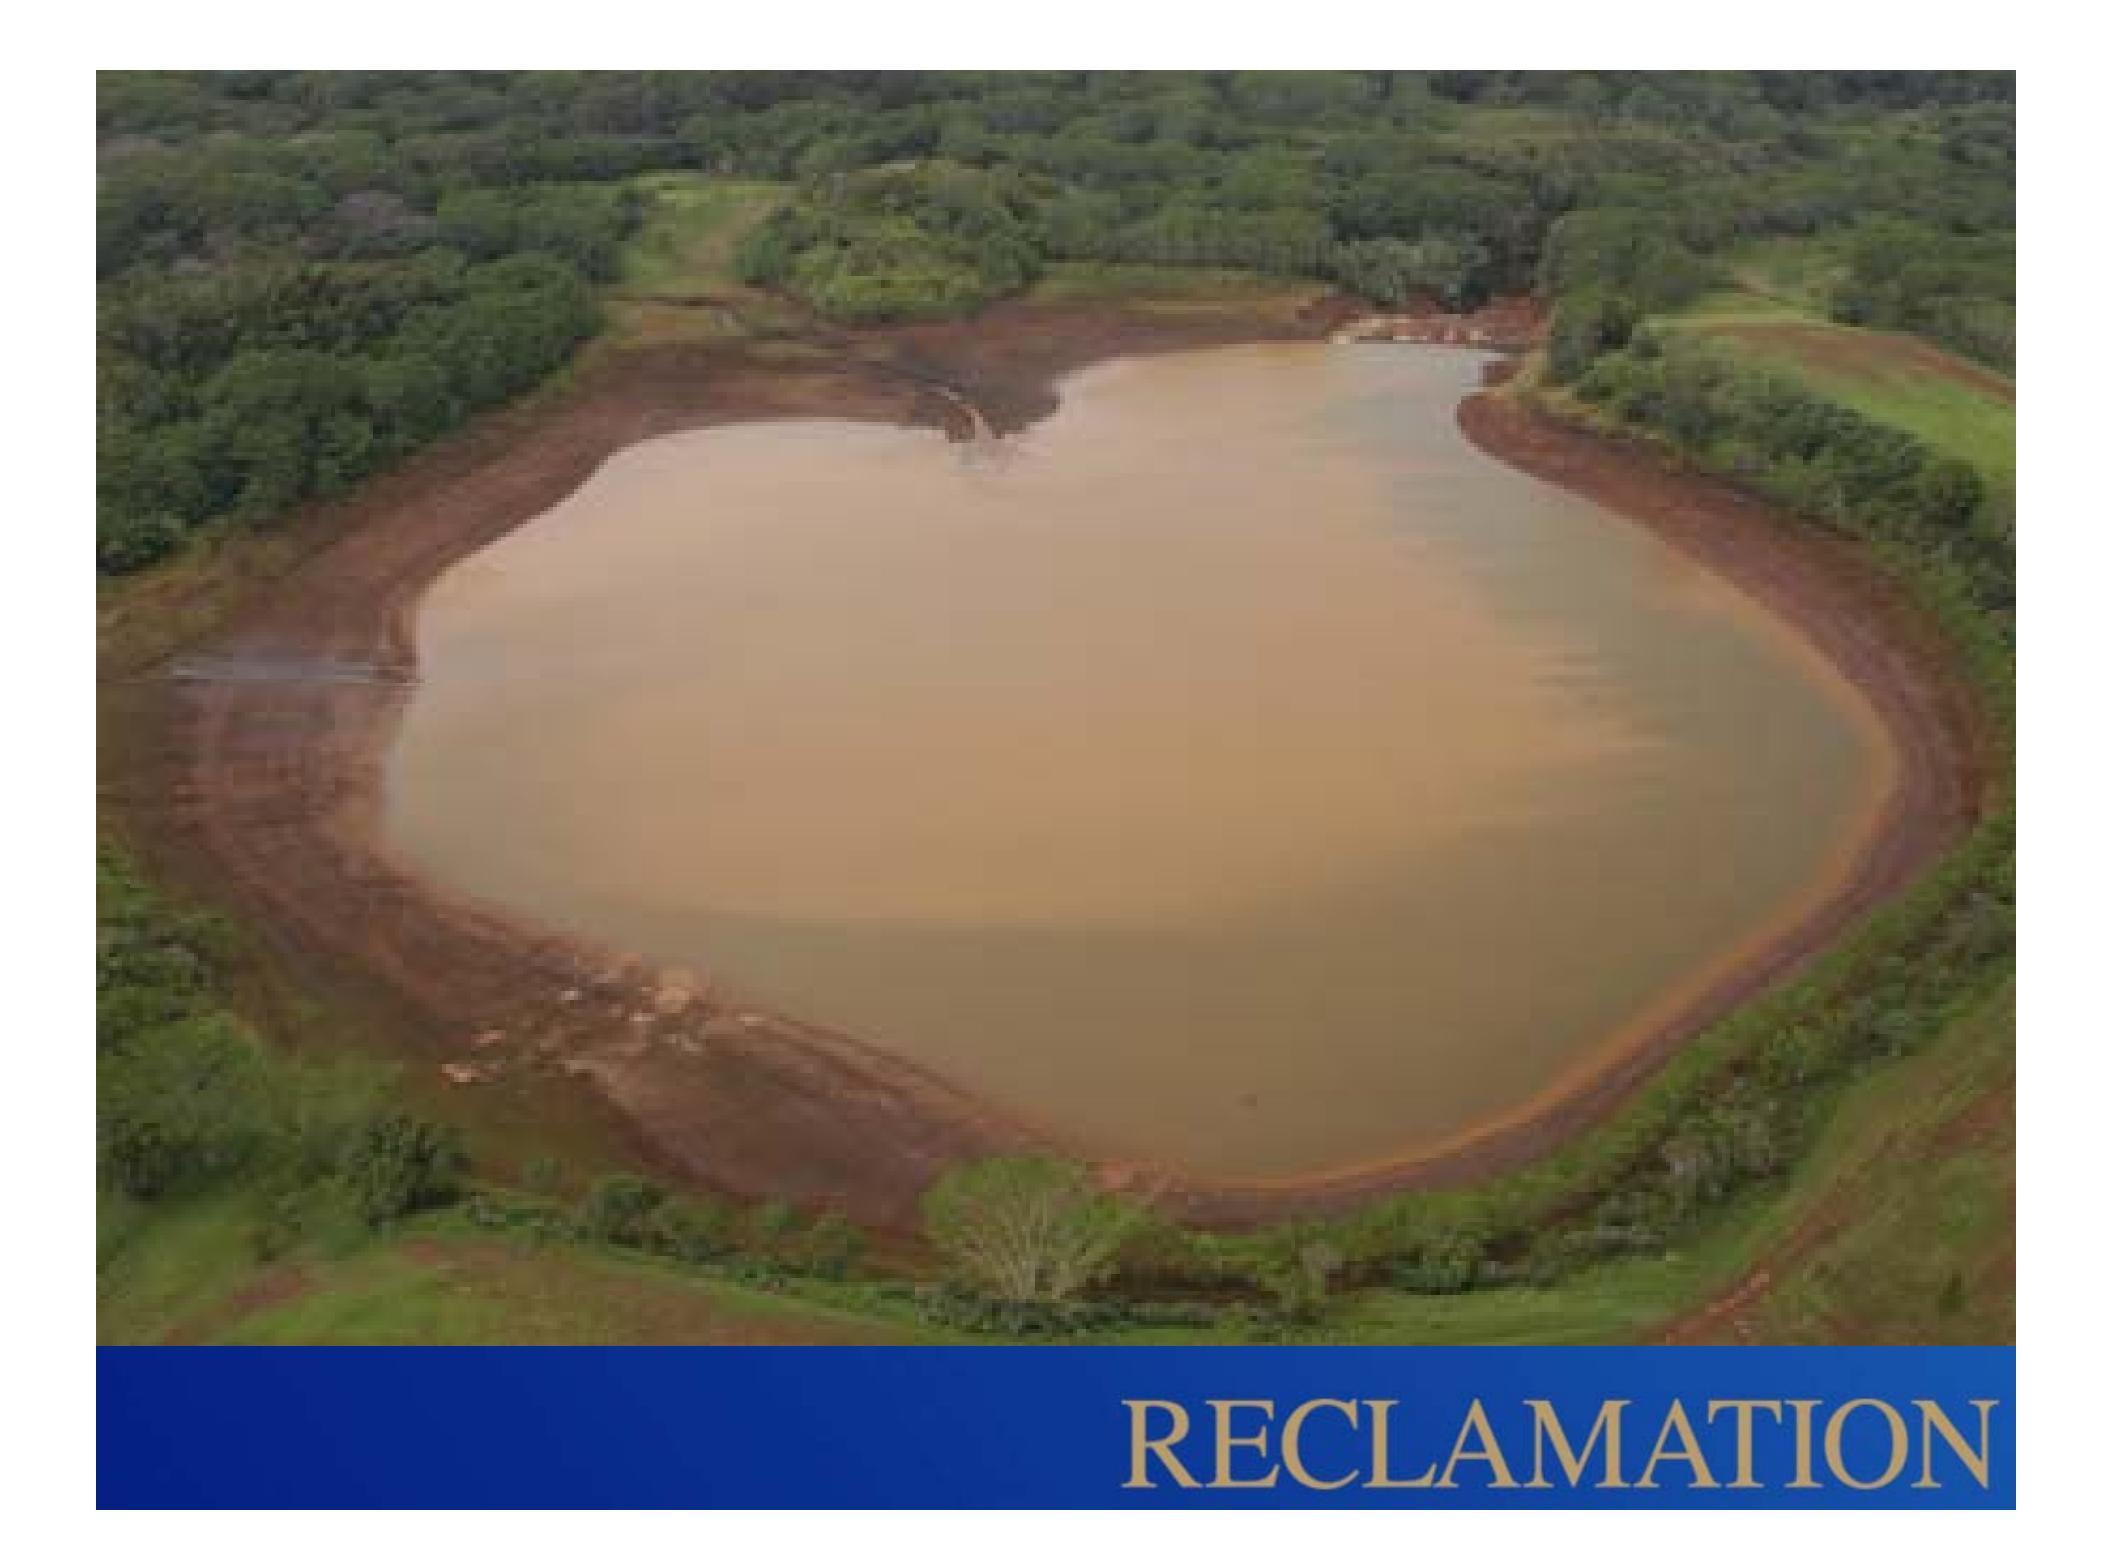
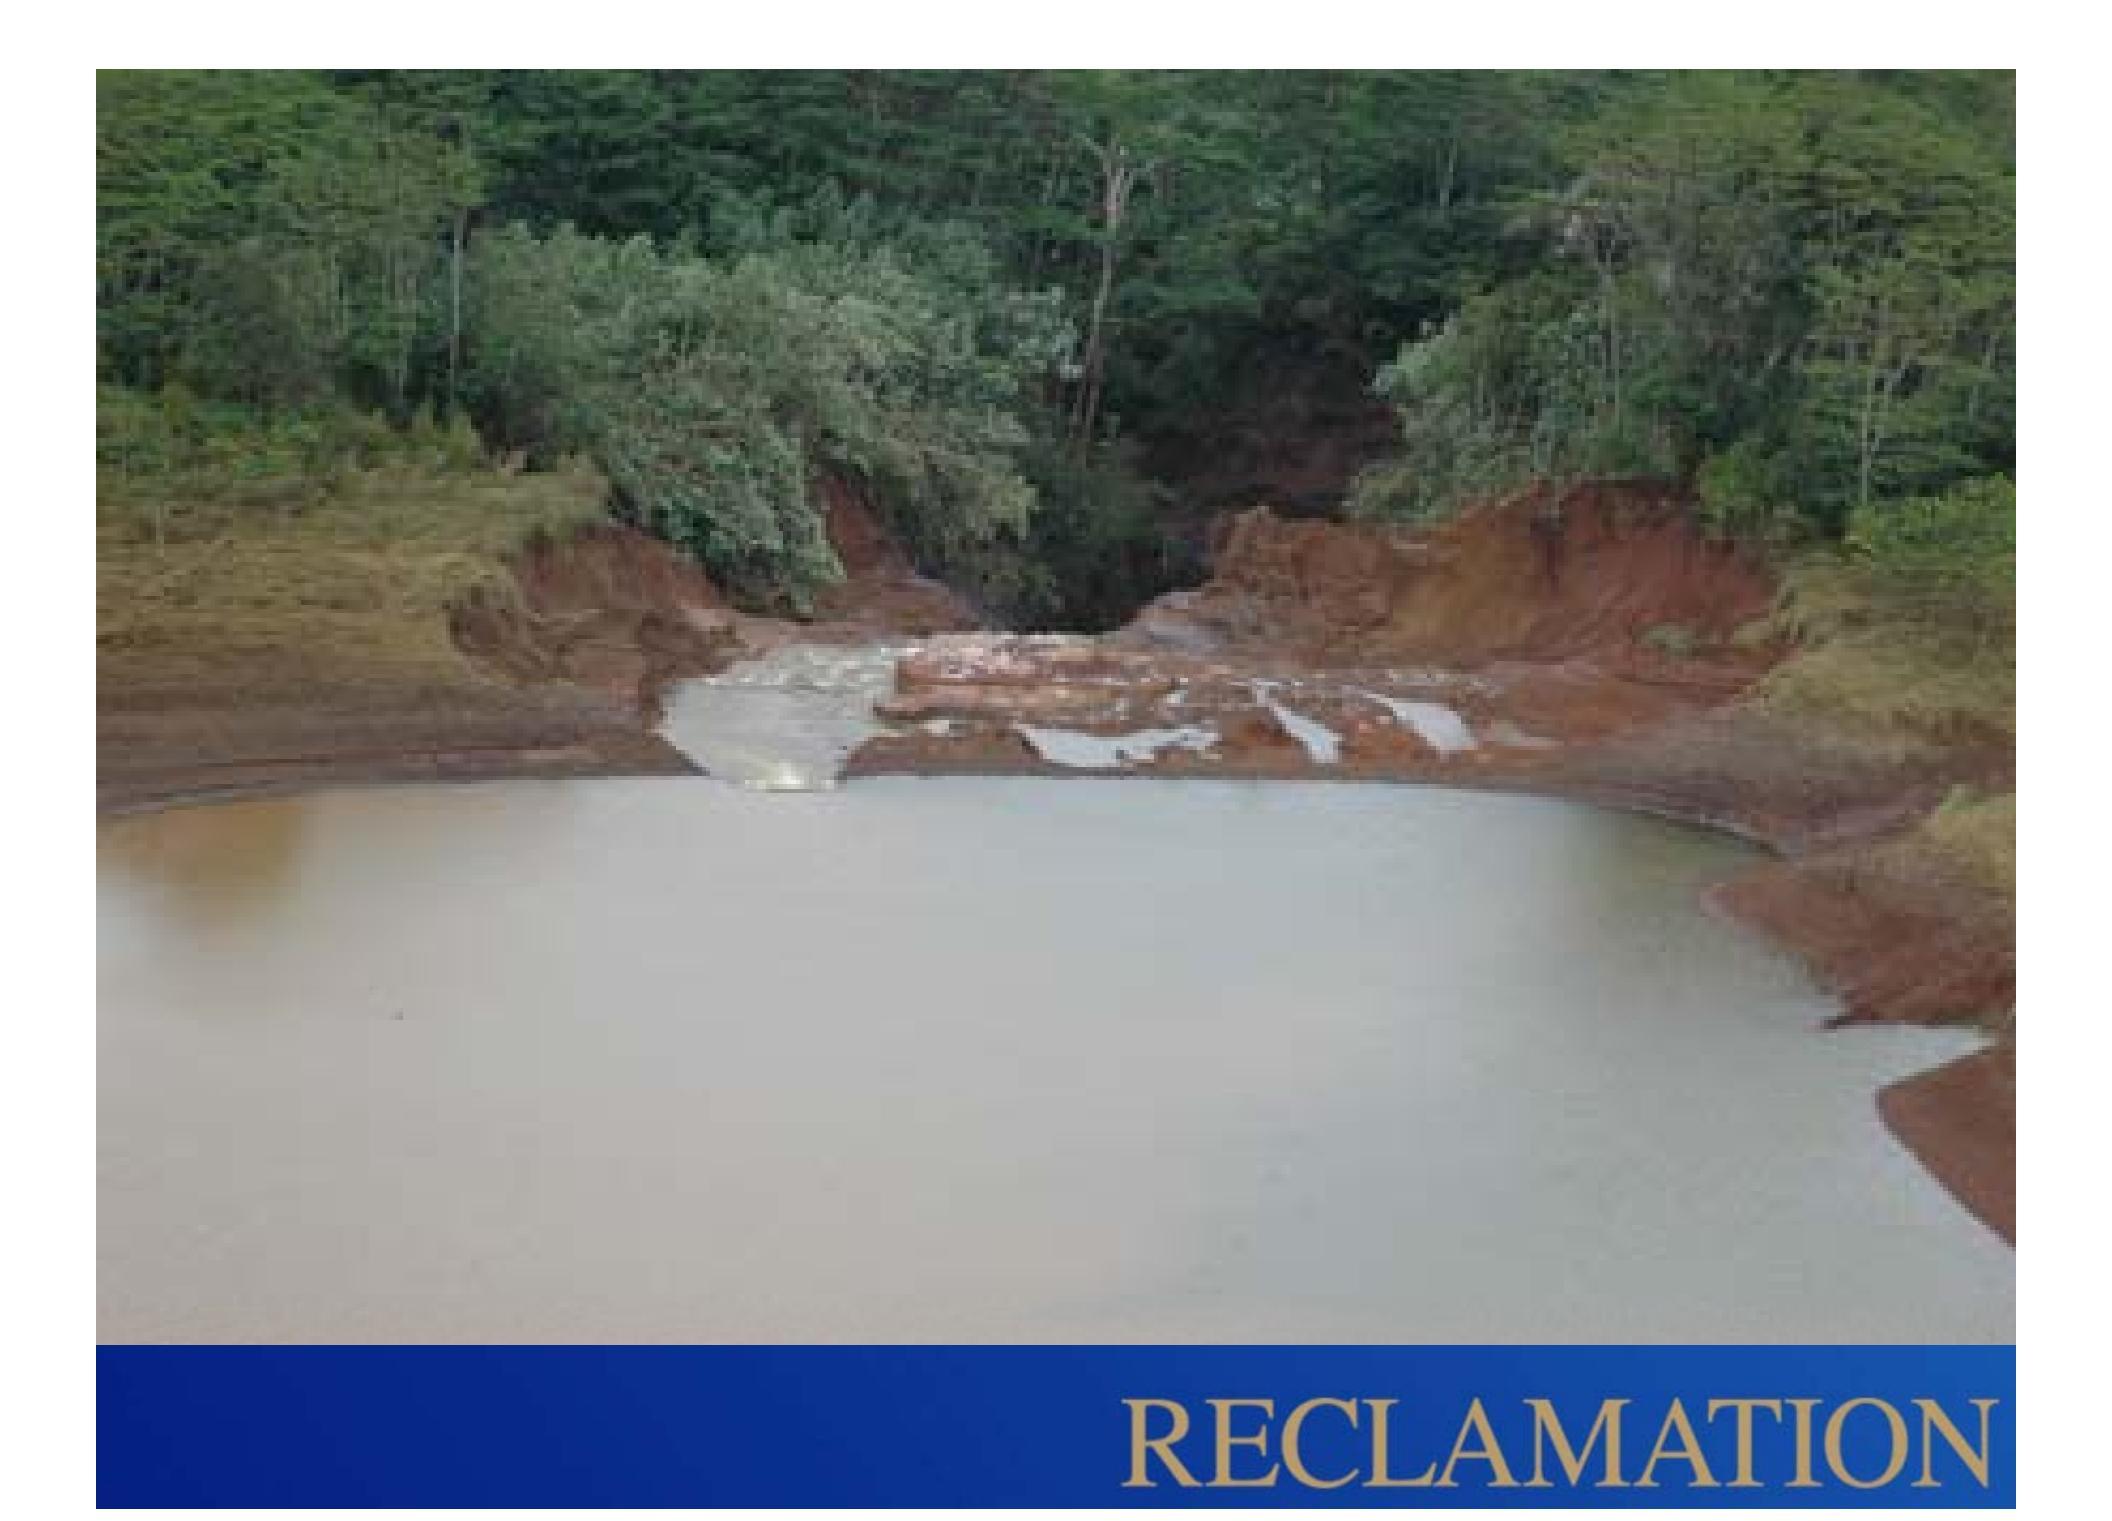
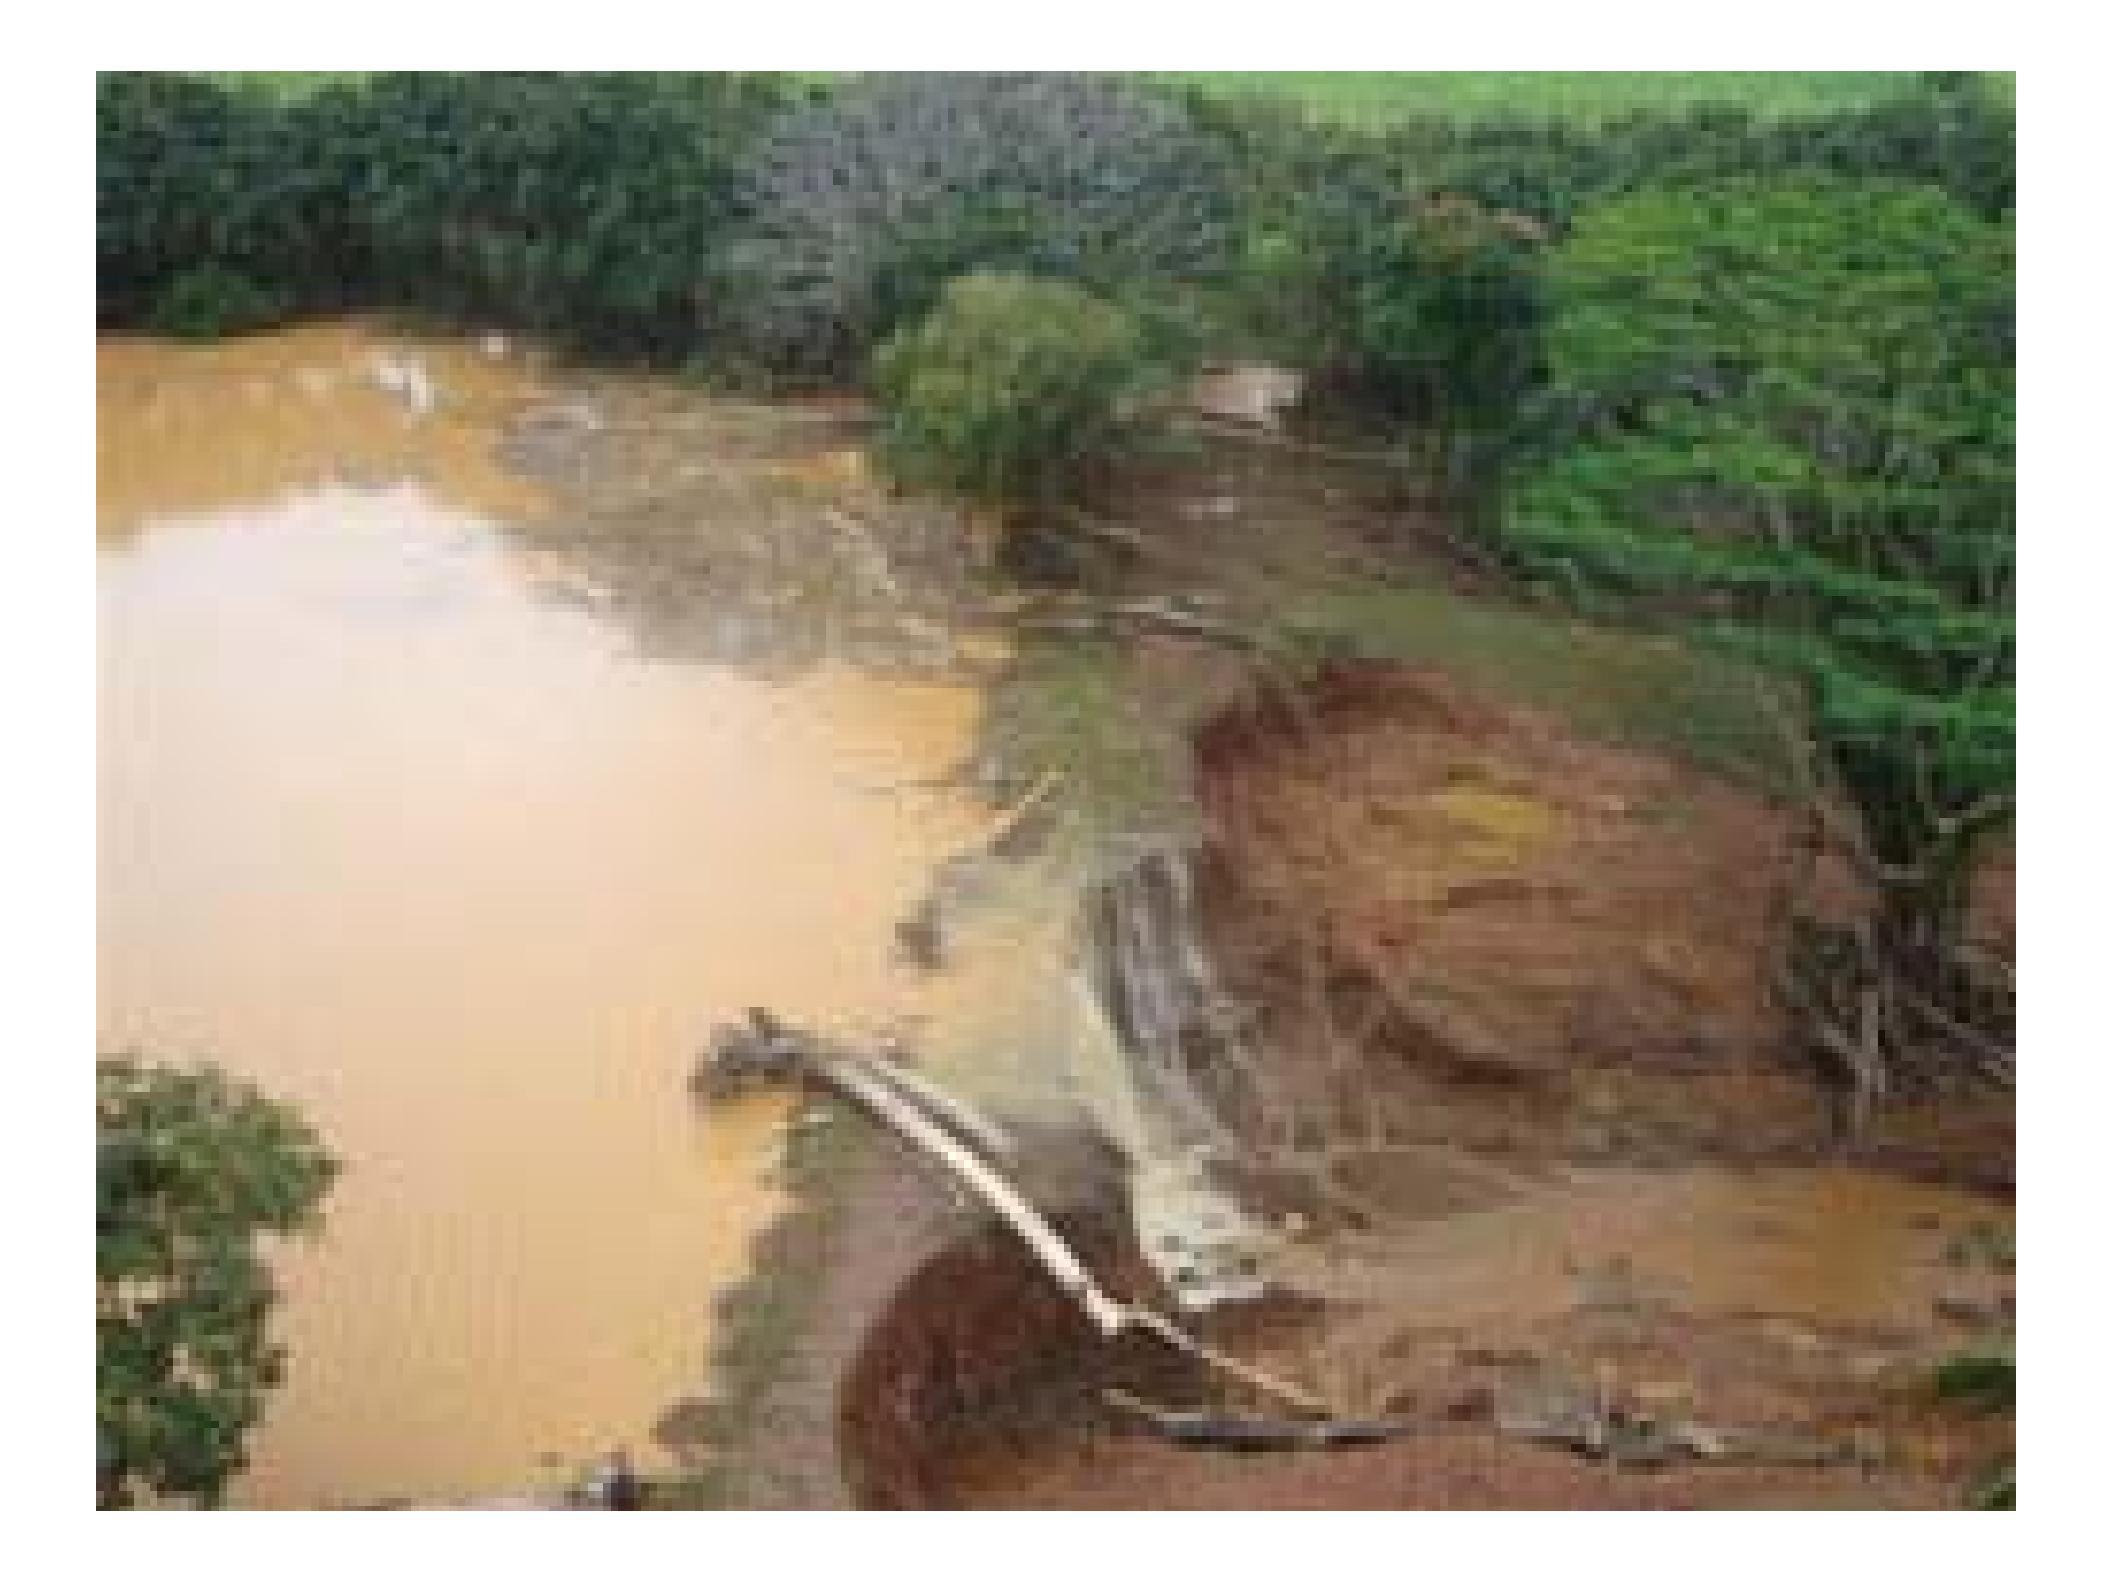
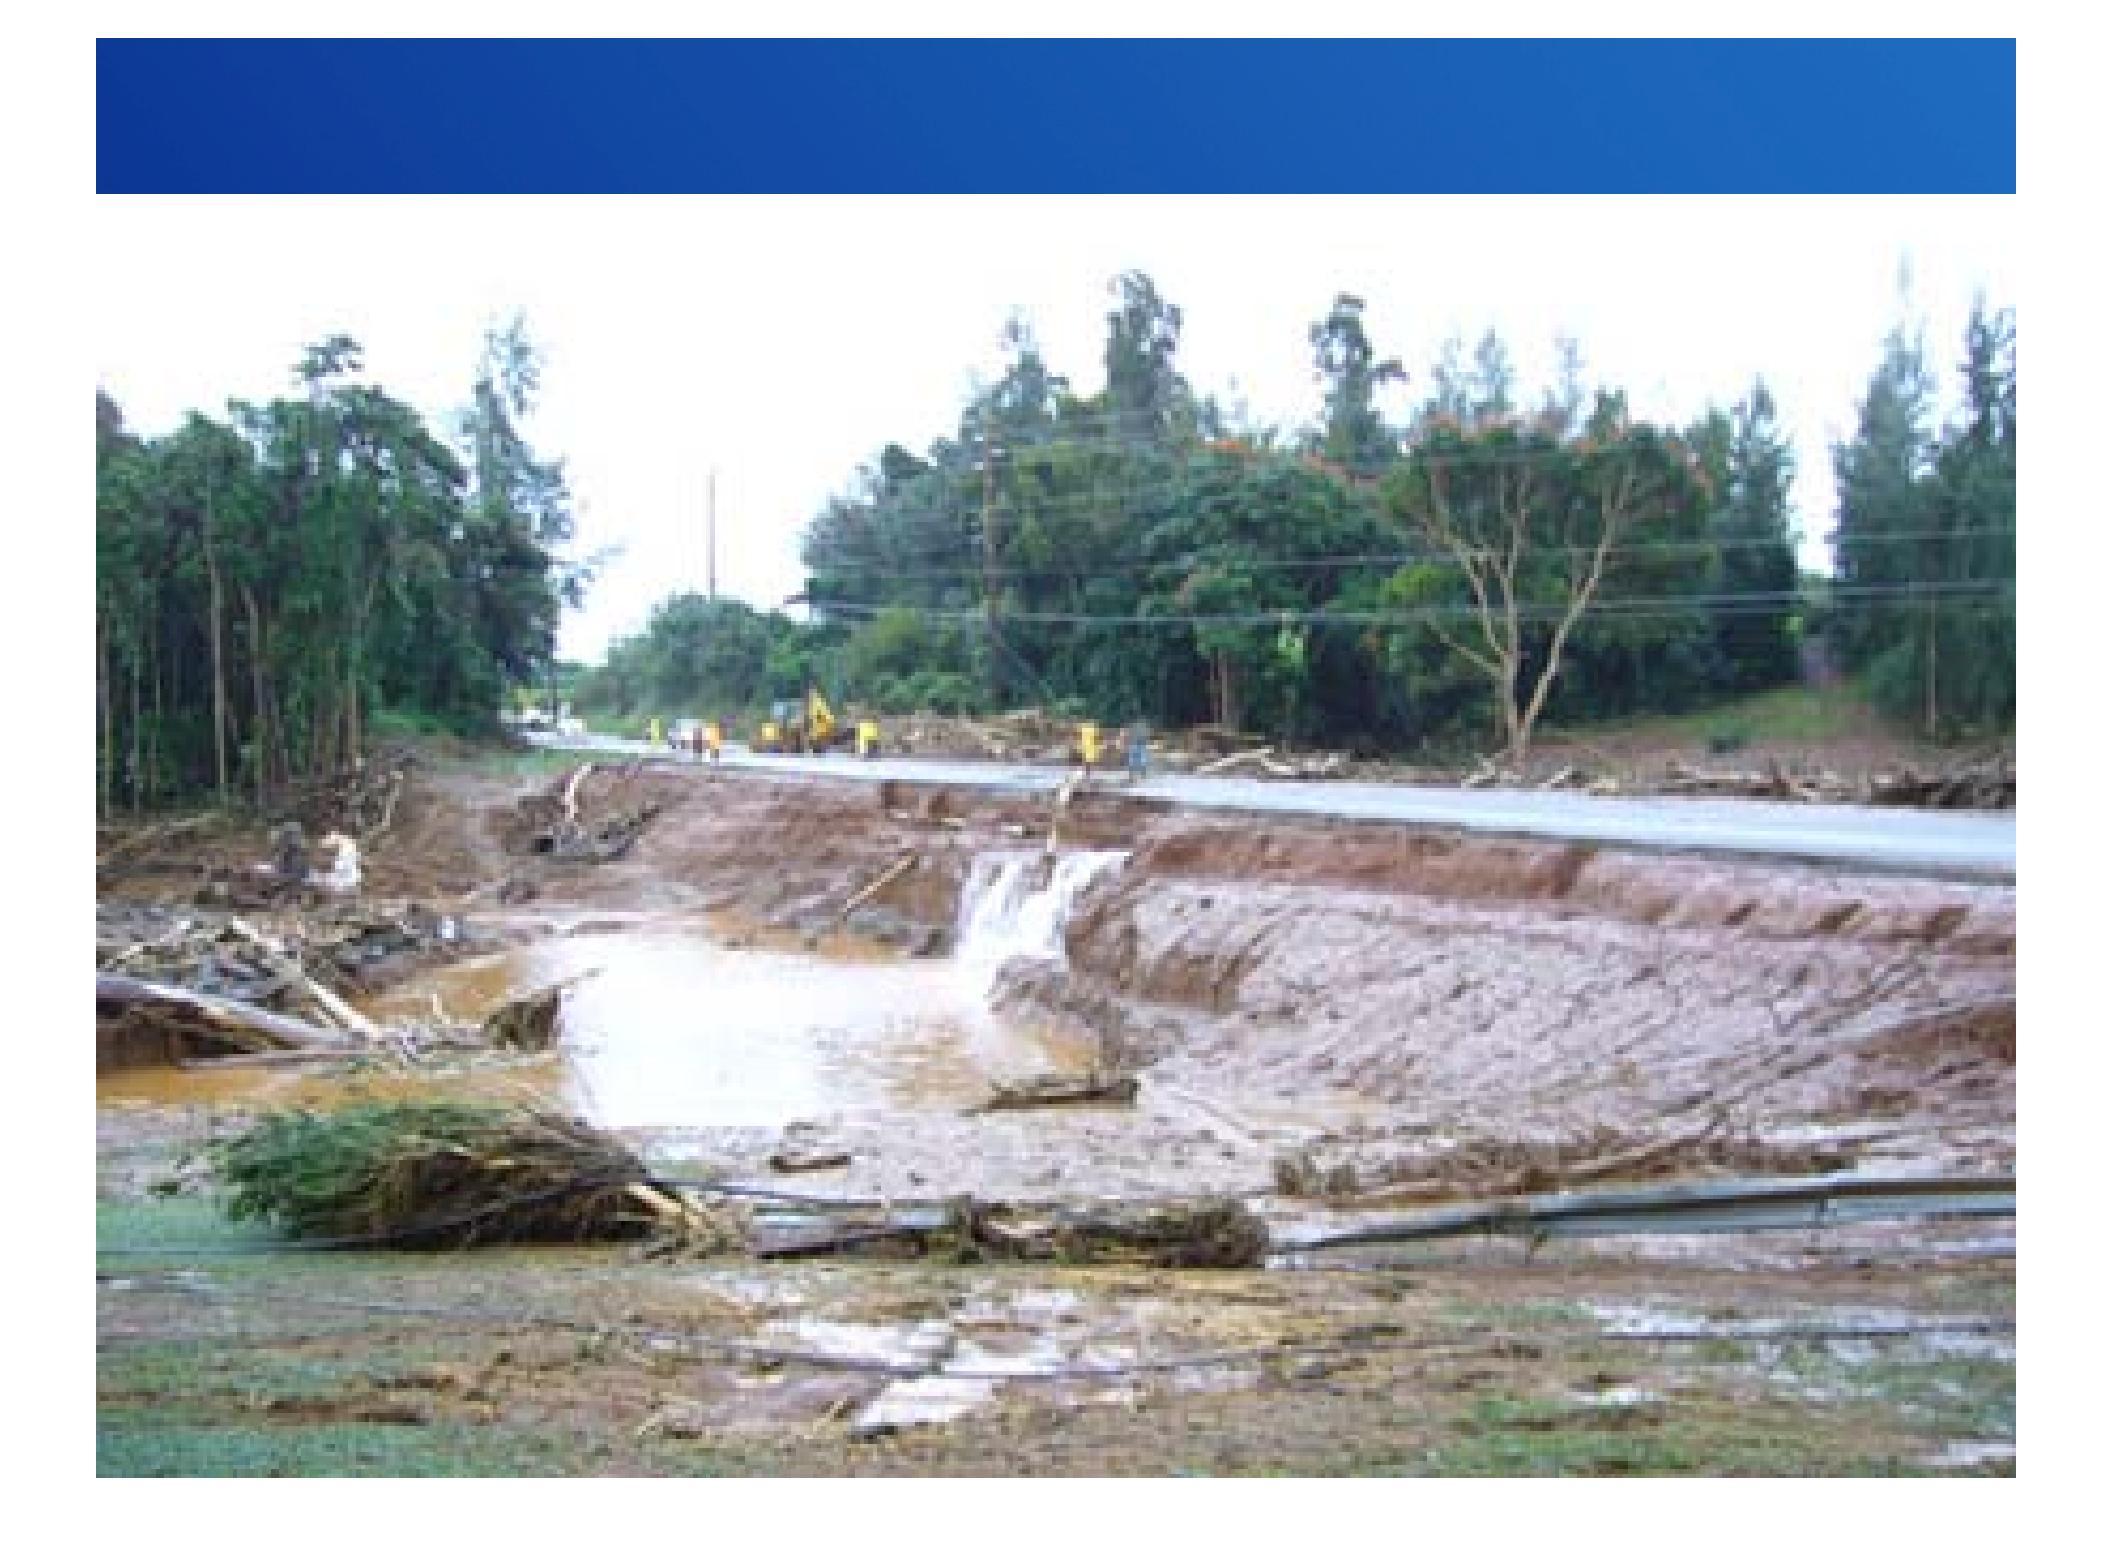
Ka Loko Dam Island of Kauai, Hawaii

- 44 Feet High
- Earthfill
- Failed March 14, 2006 at 5:30 a.m.
- Failed due to probable overtopping
- No warnings were issued before dam failure.
- 7 Fatalities

- Night
- No one lived near dam
- No dam monitoring
- Destroyed structure(s) very close to stream
- Steep gradient with high velocity floodwater
- No plans for warning or evacuation
