# TAILINGS DAMS RISK OF DANGEROUS OCCURRENCES

*Lessons learnt from practical experiences*

**Bulletin 121**

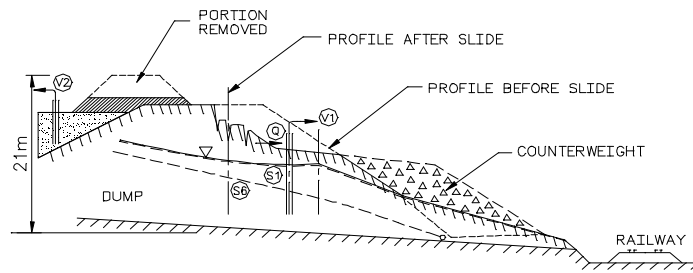
Figure 12. Section of starter dam formed by an existing dump.

S1 = PHREATIC LINE 1 DAY BEFORE SLIDE  
 S6 = PHREATIC LINE 6 DAYS BEFORE SLIDE  
 Q = WATER ESCAPING FROM HIDDEN COARSE LAYER  
 V1 = WELLPOINTS FOR REMOVAL OF POREWATER FROM DAM BODY  
 V2 = WELLPOINTS FOR REMOVAL OF POREWATER FROM SEDIMENTED TAILINGS

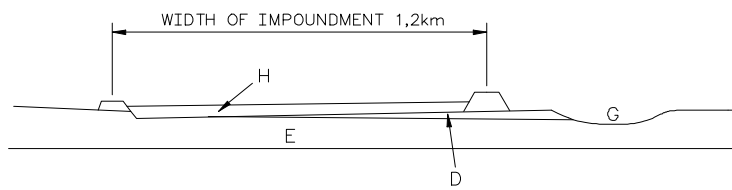
Figure 13. Section of Aznalcóllar Tailings Dam.

There were no eye witnesses because failure developed during the night, but there was some evidence to suggest that the main dam failed north of the dividing dam, prior to the bodily movement of the main dam adjacent to and south of the dividing dam, on a shear plane deep in the marl, as indicated by Fig.13. In addition to the physical conditions at the breach, the river flow measurements showed two peaks, one at 03.25 hours with a second at 08.30, indicating that failure occurred in two

stages. Subsequently piezometric heads in the marl were found to be above dam crest, as indicated by Fig.13. This may have been due to the high density of the impounded tailings producing construction pore pressures in the heavily overconsolidated marl that had migrated horizontally towards the river and come underneath the dam. Deep boreholes have disclosed an aquifer 80 m below the dam, showing a head of 80m, that would have restricted drainage from the marl. According to Eriksson and Adamek (2000) the cause of the failure was a fault in the marl 14 m below ground surface. Bodily movement of the marl, carrying with it the intact dam towards the river, would be assisted by the reduction of effective stresses on the horizontal feature caused by the high pore pressure. Several eminent geotechnical engineers have expressed the view that such behaviour would have been extremely difficult to predict.

- A WASTE ROCKFILL.
- B EARTHFILL.
- C SLURRY TRENCH CUT-OFF.
- D ALLUVIAL SAND AND GRAVEL ABOUT 4m THICK.
- E BLUE MARL 60m THICK.  $k = 10^{-11}$  to  $10^{-12}$  m/s.
- F SLIP SURFACE.  $c' = 0$ ,  $\phi' = 16^\circ$
- G RIVER
- H TAILINGS.  $\gamma = 28 \text{ kN/m}^3$

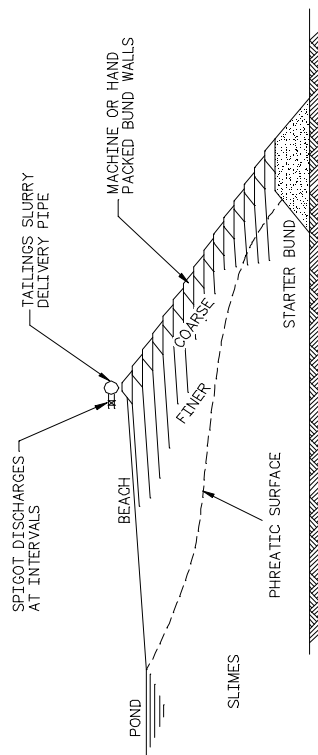
a dam being built by the upstream method, is indicated by Fig.14. By maintaining a wide beach, the pool of visible water is kept well away from the longitudinal axis and crest of the dam and there is more opportunity for the coarse fractions from the tailings to settle out on to what is becoming the body of the dam; only the finest fraction being carried into the settling pool. The rate of settlement depends on size of particle, its specific gravity, and its activity: an assessment can be obtained from Stoke's Law. The rate of clearance, i.e. the time for the smallest particles to sink below the surface to leave some clear water, can be so small that a large area of pond is needed to cater for the volume of tailings being discharged into the impoundment, and a compromise has to be reached between the area of the surface of the pond, and its closeness to the dam crest.

Figure 14. Upstream method of construction with spigots.

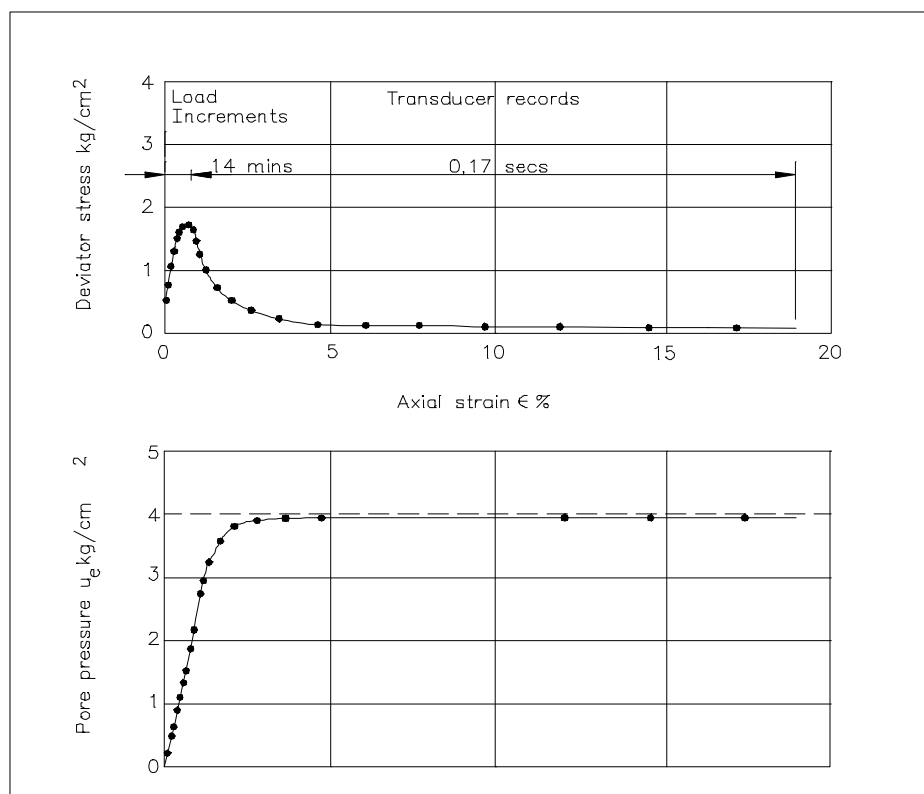
Very loose, normally consolidated saturated material as are tailings in an impoundment, exhibit a peak strength higher than the residual strength at greater strains, when tested in apparatus using strain control. This effect is shown more vividly in stress controlled tests, i.e. tests in which the shearing force is applied by weights: an example given by Castro (1969) is shown by Fig.17. The tests were made on a fine uniform sand with a  $D_{10}$  size of 0.1 mm at a relative density of 29% using a confining pressure of 400 kN/m<sup>2</sup>. Load was applied in small increments and peak deviator stress was reached in 14 minutes at a strain of 1%, during which time the pore pressure increased to half the confining pressure. But once the peak strength had been reached the strain increased to 19% in 0.17 seconds. The pore pressure climbed to almost the value of the confining pressure and as a consequence the strength fell to almost nothing. This is the mechanism of a flow slide.

Figure 17. Stress-strain curve for stress controlled consolidated undrained test on saturated loose sand.

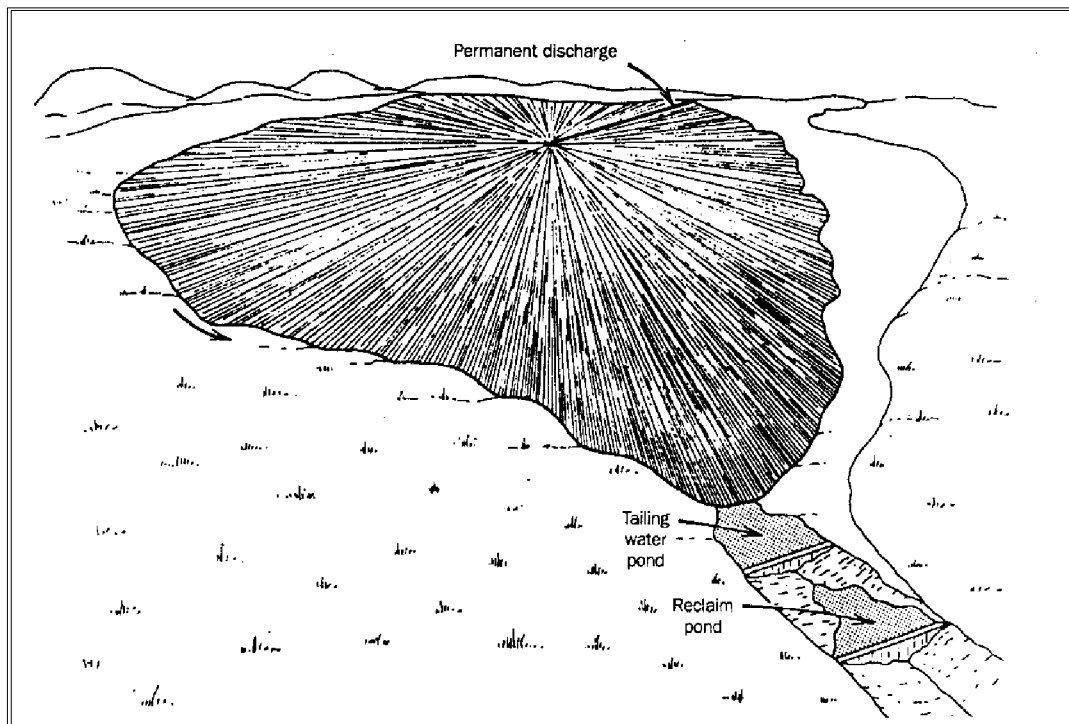
Example. The Thickened Tailings Disposal (TTD) System has been used at the Peak Gold Mine at Cobar, New South Wales. This underground mine, established in 1992, produces gold together with copper, lead, zinc, but mainly  $0.3 \times 10^6$  tonnes of fine tailings a year. The absence of any significant amount of waste rock from the underground mine made the idea of an impoundment requiring no large dams particularly attractive, and the central discharge avoids the considerable work of having to move the discharge points as required during the construction of the other types of tailings dams. The general arrangement for the storage is shown by Fig.18.

Figure 18. Tailings storage using the Thickened Central Discharge Method.  
(Reprinted from Robinski 1979)
