## Brown Bridge Dam – Temporary Dewatering Structure

### Root Cause Analysis of the October 6, 2012, Failure Incident

June 2014

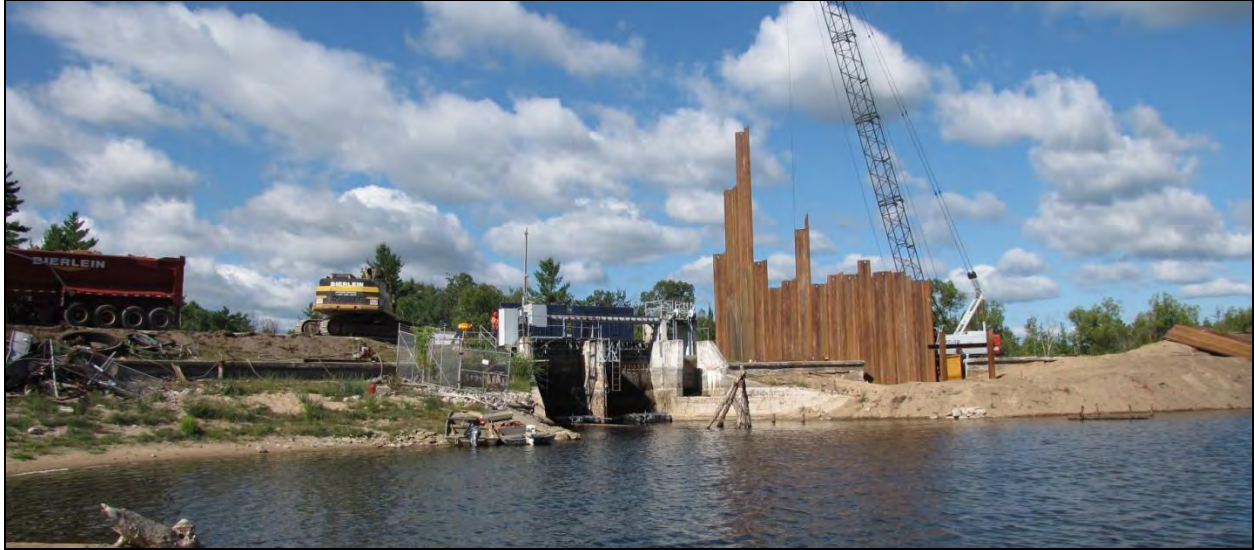
**Figure II-2.** Photo of the dam during TDS construction  
*Photo courtesy of AMEC*

During construction of the TDS, a steel sheetpile headwall was installed at the inlet to prevent flow into the structure. Embankment material was then excavated from between the TDS walls, and construction of the control structure and downstream channel was completed in early October. Testing of the structure and continuation of the drawdown was scheduled to begin on Saturday, October 6, 2012. A photographic diagram of the completed TDS structure is shown in Figure II-3 below.

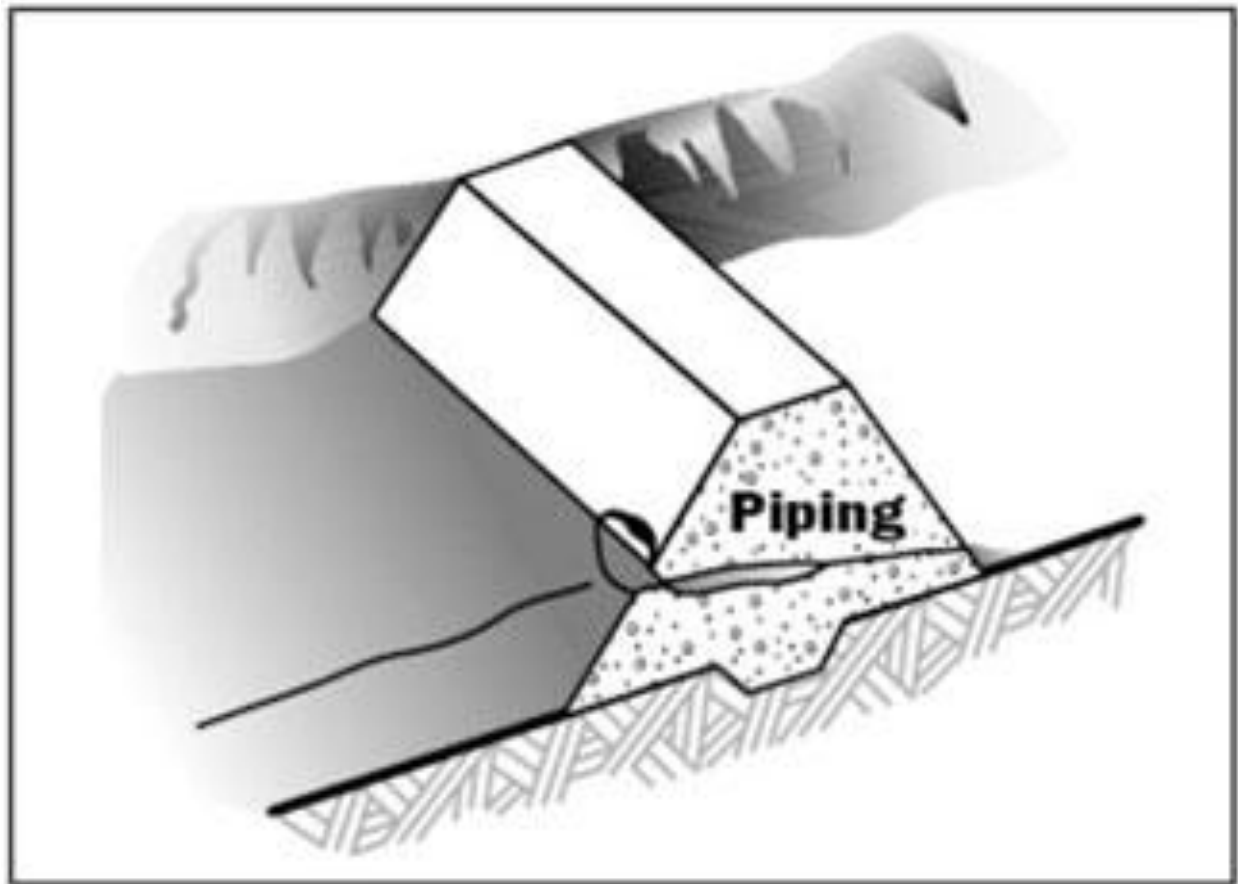
**Figure III-1.** Diagram of a pipe forming in an embankment dam

Upon considering the verbal accounts of project personnel onsite at the time of the TDS failure, reviewing photographs of the incident, and conducting onsite investigations and exploratory excavations; it became apparent that the failure of the TDS was caused by internal erosion (piping) of earthen embankment material in the vicinity of the TDS, causing undermining of the structure and breaching of the embankment section between the TDS and former spillway structure. Piping occurs when seepage waters begin to transport soil particles from the dam embankment, in this case the TDS foundation.

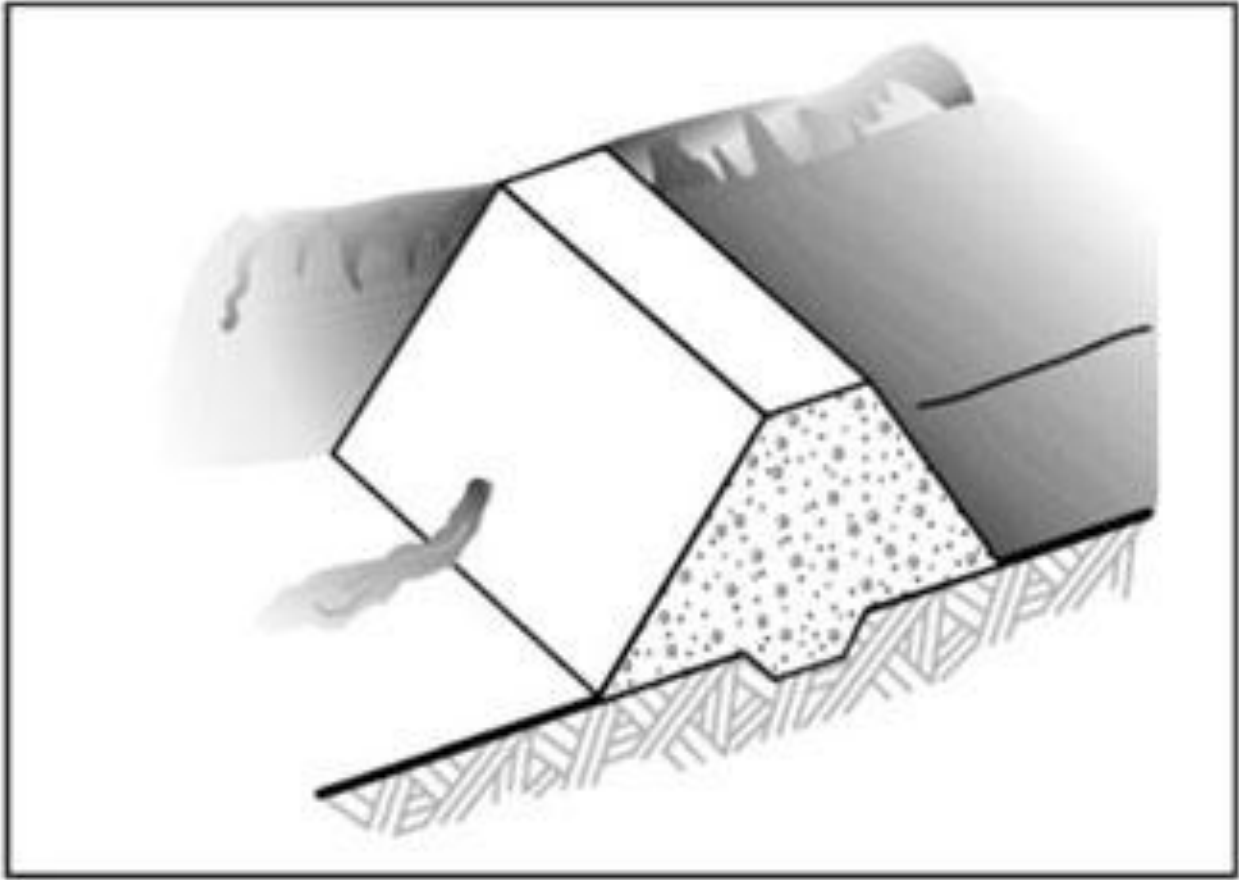
**Figure III-2.** Diagram of a pipe after formation, unrestricted flow  
*Source: Dam Safety: An Owner's Guidance Manual*

If uncorrected, piping of embankment materials can progress to the point where an open conduit forms through the embankment soils. At this time, flow is unrestricted through the embankment, causing severe erosion and eventual collapse of the embankment. The analyses contained in this report were designed to determine the root cause of this piping and predict the development of the failure as it progressed.

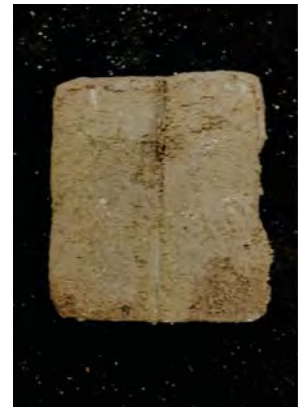
Boring number: GB-3  
Sample Number: 3  
Depth (ft): 13.5'-15.5'

Specimen After Test

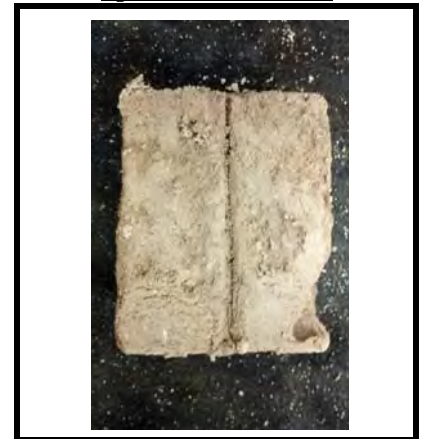
**ND1**  
**Non- Dispersive**

**Specimen After Test**

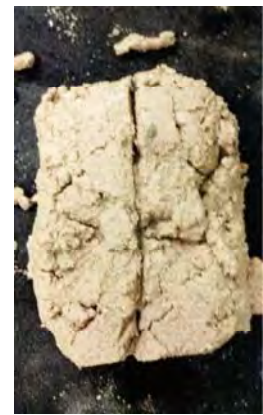
**ND3**  
**Slightly-**  
**Dispersive**

Specimen After Test
