# *REPORT OF THE COMPTROLLER GENERAL OF THE UNITED STATES*

## **Actions Needed To Increase The Safety Of Dams Built By The Bureau Of Reclamation And The Corps Of Engineers**

GED-77-85

JUNE 3, 1977

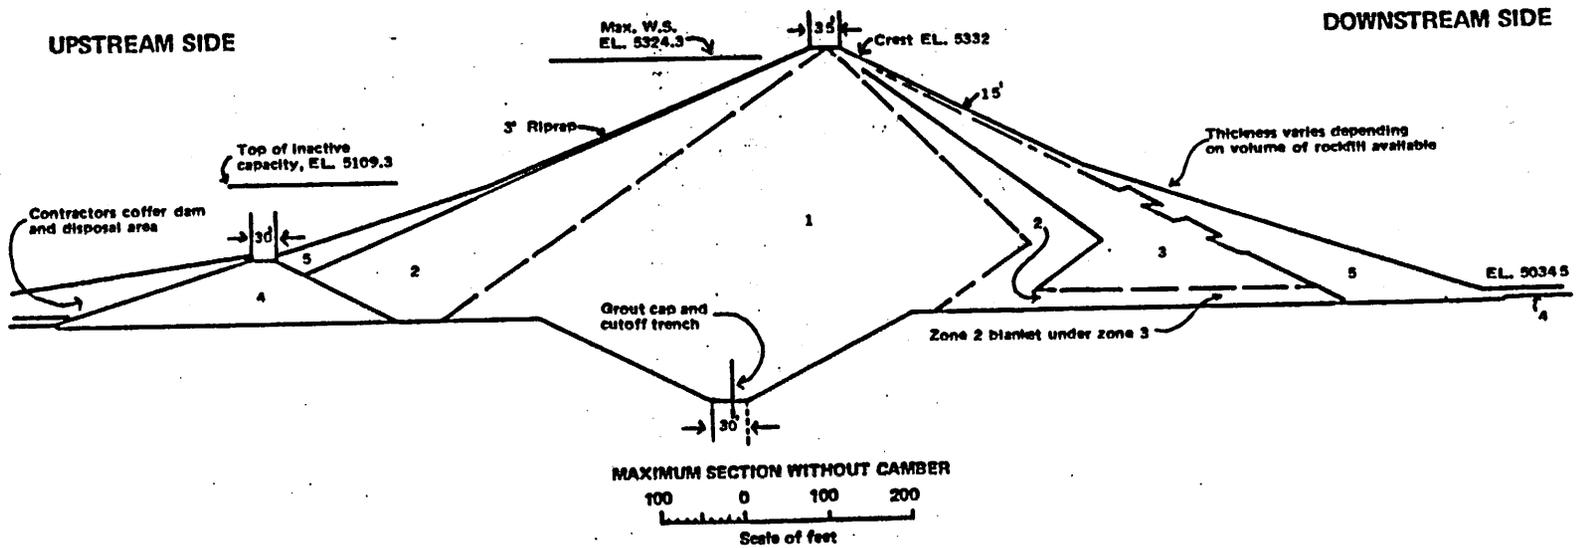
## EMBANKMENT EXPLANATION

- 1 Selected clay, silt, sand, gravel, and cobbles compacted by tamping rollers to 6-inch layers.
- 2 Selected sand, gravel, and cobbles compacted by crawler-type tractors to 12-inch layers. Acted as filters.
- 3 Miscellaneous material compacted by rubber-tired rollers to 12-inch layers.
- 4 Selected silt, sand, gravel, and cobbles compacted by rubber-tired rollers to 12-inch layers.
- 5 Rockfill placed in 3-foot layers.

protection from wave action. Zones 1 and 2 were the most significant zones from the standpoint of leakage.

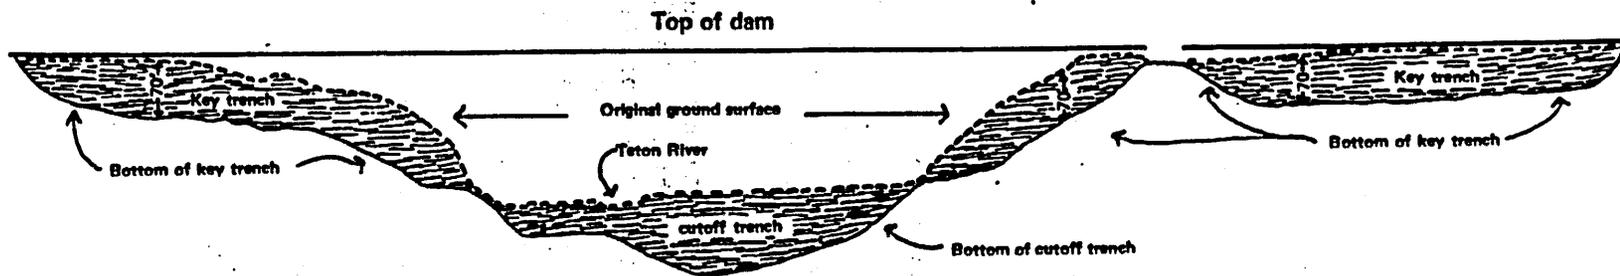
PROFILE OF KEY AND CUTOFF TRENCHES

Bureau designers concluded it would be more economical to remove the upper 70 feet of rock on the abutments rather than try to seal or grout the cracked rock there. As the result, the Teton design called for the excavation of a deep trench--key trench--into the rock on both abutments. As shown on the drawing on page 30, the key trench was to be constructed about 70 feet into the abutment walls, with a base width of 30 feet and steeply sloping sides. Bureau designers told us that the key trench was contained within the cutoff trench. They told us the cutoff trench in the abutments was only excavated a few feet into the rock. The key trench was backfilled with the silt material to provide a seepage barrier.

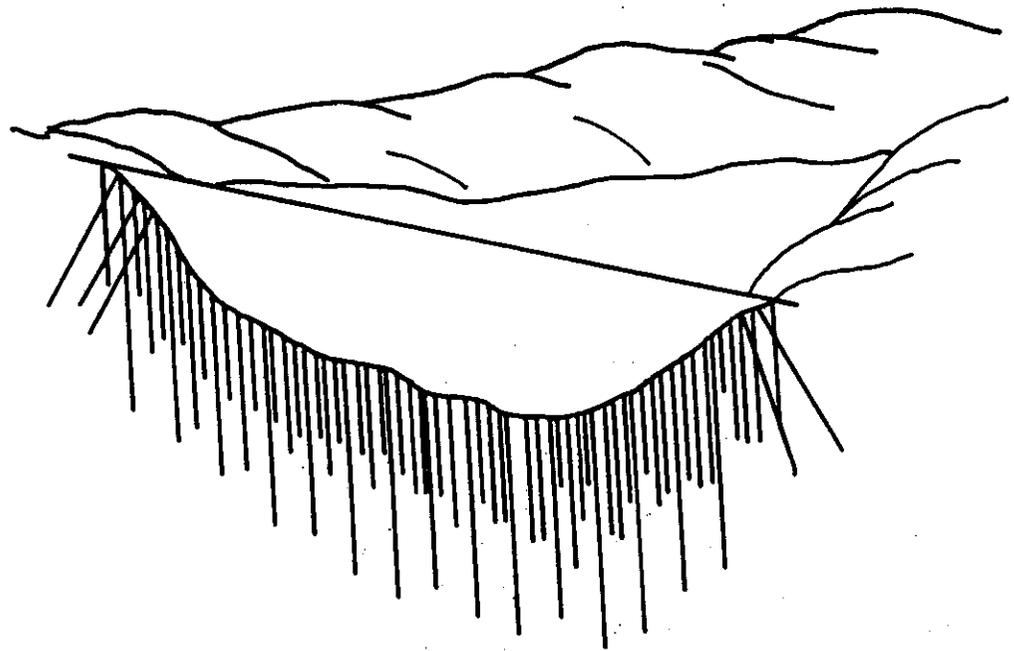
**GROUT CURTAIN**

and other materials into the foundation at a cost of about \$4 million. Yet, the grout curtain may not have been effective in controlling seepage as intended. The Independent Panel concluded from its postfailure tests that water could pass through the grout curtain at several locations. Thus, it concluded that the grout curtain may not have been fully effective in controlling seepage in the critical key trench area. The Independent Panel questioned the adequacy of the design of the grout curtain as well as the heavy reliance placed on it to control seepage. In addition, there is a question whether additional measures should have been taken to test the adequacy of the grout curtain after it had been constructed.

The Independent Panel concluded that the construction of multiple grout curtains at Teton would have been justifiable in light of the known rock conditions. Although the Bureau generally used three rows of grout holes at Teton, only the center row of holes was intended to form a water barrier. As such, the Panel concluded that only a single grout curtain was constructed. In addition to the construction of multiple grout curtains, the Panel concluded that closer spacing of grout holes and drilling the holes at cross angles, instead of in one direction, may have been warranted to better ensure the formation of a water-tight barrier.

However, the Bureau did not test the adequacy of the grout curtain after it had been constructed, either through instrumentation (discussed in ch. 5) or by other means such as drilling into the constructed grout curtain and water testing for leaks. While we were told that postconstruction
