GEI Consultants, Inc.

**FORENSIC INVESTIGATION
MEADOW POND DAM
ALTON, NEW HAMPSHIRE**

New Hampshire Department of Environmental Services

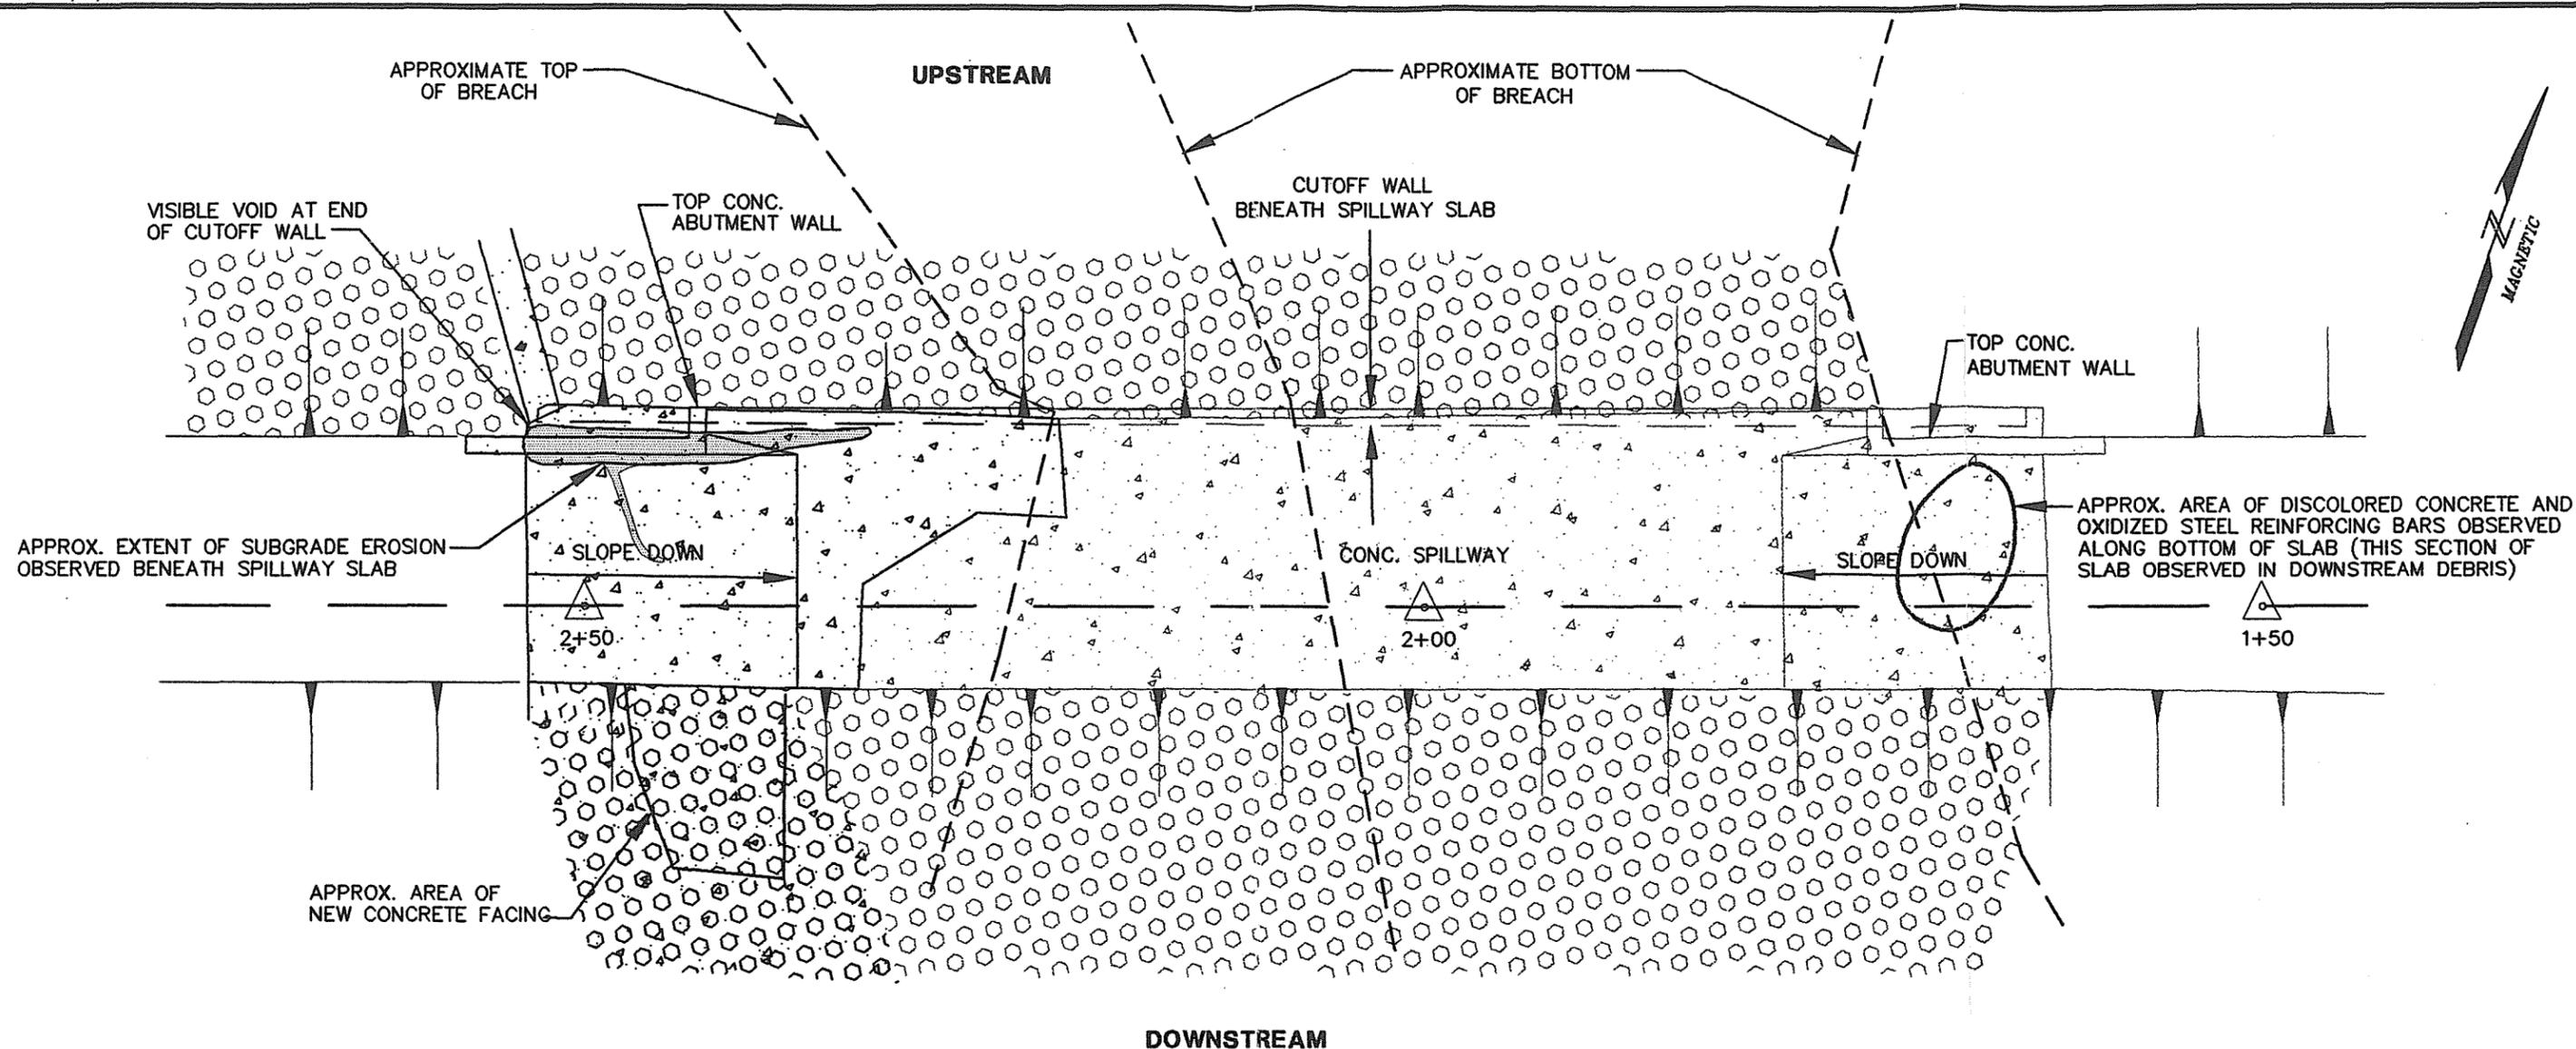
GEI Consultants, Inc.	Project 96069	June 1996 Fig. 2

- A void was observed at the right end of the spillway cutoff wall. During the removal of the spillway slab, the void was observed to continue along the downstream side of the cutoff wall, near the intersection of the cutoff wall and the spillway slab. Based on observations of the soil along the bottom of the void, it appears that the void was caused by erosion and piping. Evidence of erosion was also observed on the subgrade for the sloping portion of the spillway slab, downstream of the cutoff wall. The approximate extent of the void and apparent subgrade erosion is shown on Figure 2.

- Heavily rusted steel reinforcing bars and staining of the concrete were observed on the underside of a portion of the concrete slab from the left side of the spillway (in debris pile). The approximate area of the staining and heavily rusted reinforcing bars is shown on Figure 2.

The abutment wall along the right side of the breach was observed to begin about 5.6 feet right of the horizontal portion of the spillway. In other words, the abutment wall started within the sloping slab (see Figure 2).

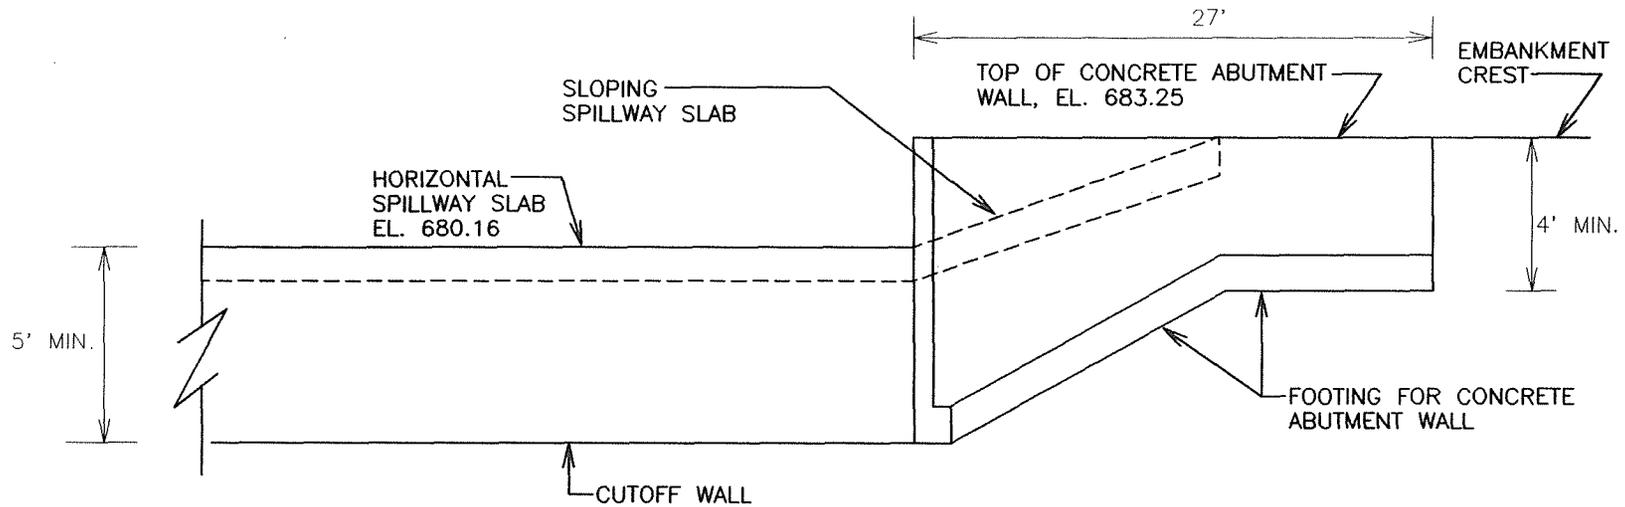
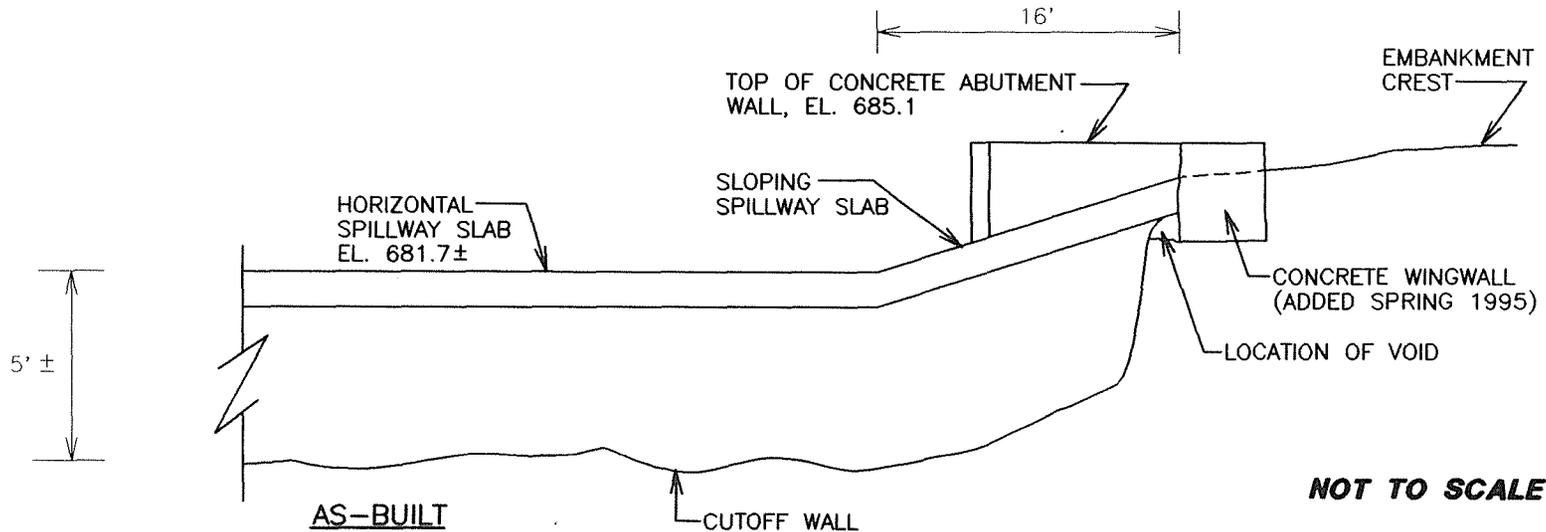
NHDES Water Resources Division Concord, New Hampshire GEI Consultants, Inc.	Forensic Evaluation Meadow Pond Dam Alton, New Hampshire	ELEVATION - RIGHT END OF SPILLWAY	
	Project 96069	June 1996	Fig. 3

The as-built configuration of the spillway and embankment was compared with that indicated in the design drawings and the sketches prepared by Rivers on December 11, 1992 (NHDES files). The as-built conditions of the right end of the spillway and portions of the embankment on either side of the breach are shown on Figure 2 and on Civil Consultants' survey drawings provided in Appendix C. Figure 2 also shows the inferred configuration of the portions of the spillway and embankment that were destroyed during failure. Differences between the design and as-built configuration of the spillway and embankment are discussed below:

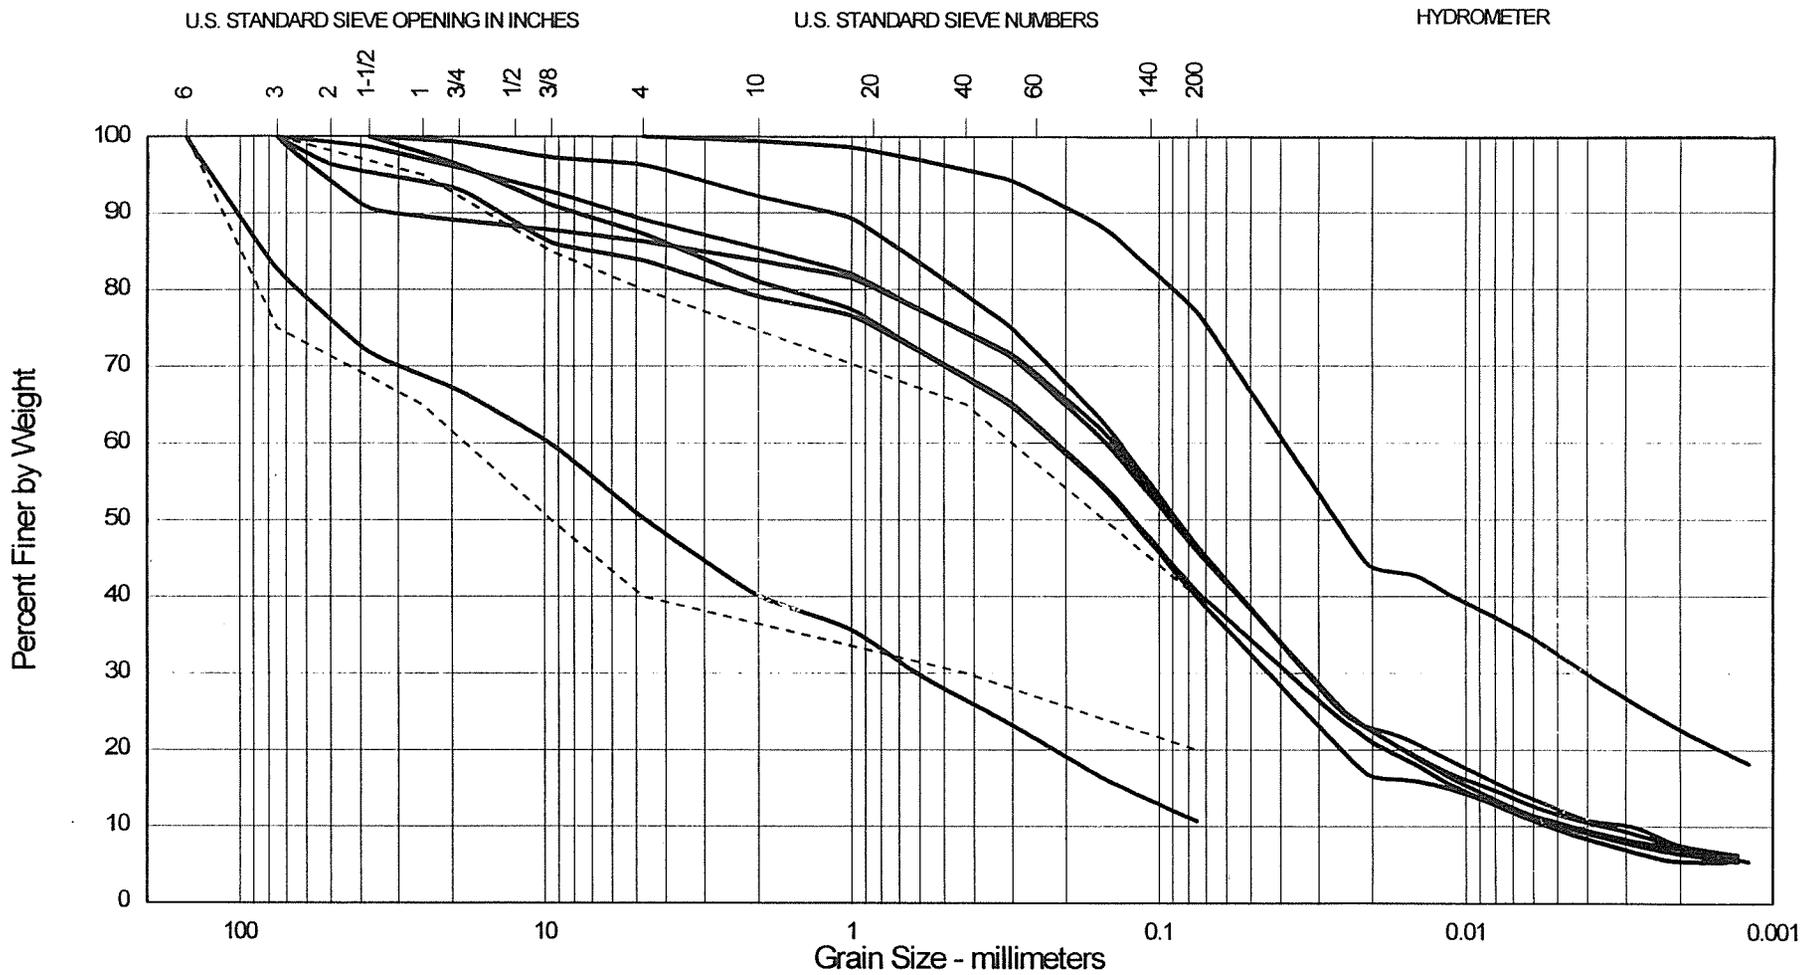
GEI Consultants, Inc.	Project 96069	June 1996	Fig. 4

Gradation tests were performed on seven samples of the core obtained during the post failure investigations. As shown in Figure 4 none of the samples fully meets the gradation range in the specifications. Six of the seven samples are finer than specified throughout the full gradation range. Although no permeability tests were performed as part of this investigation, it is our opinion that six of the seven samples tested for gradation are likely to have a permeability below the specified upper limit of 10^{-5} cm/sec and the seventh sample would be close to 10^{-5} cm/sec. In our opinion, the core material used in the construction of the dam was of adequate gradation and permeability.

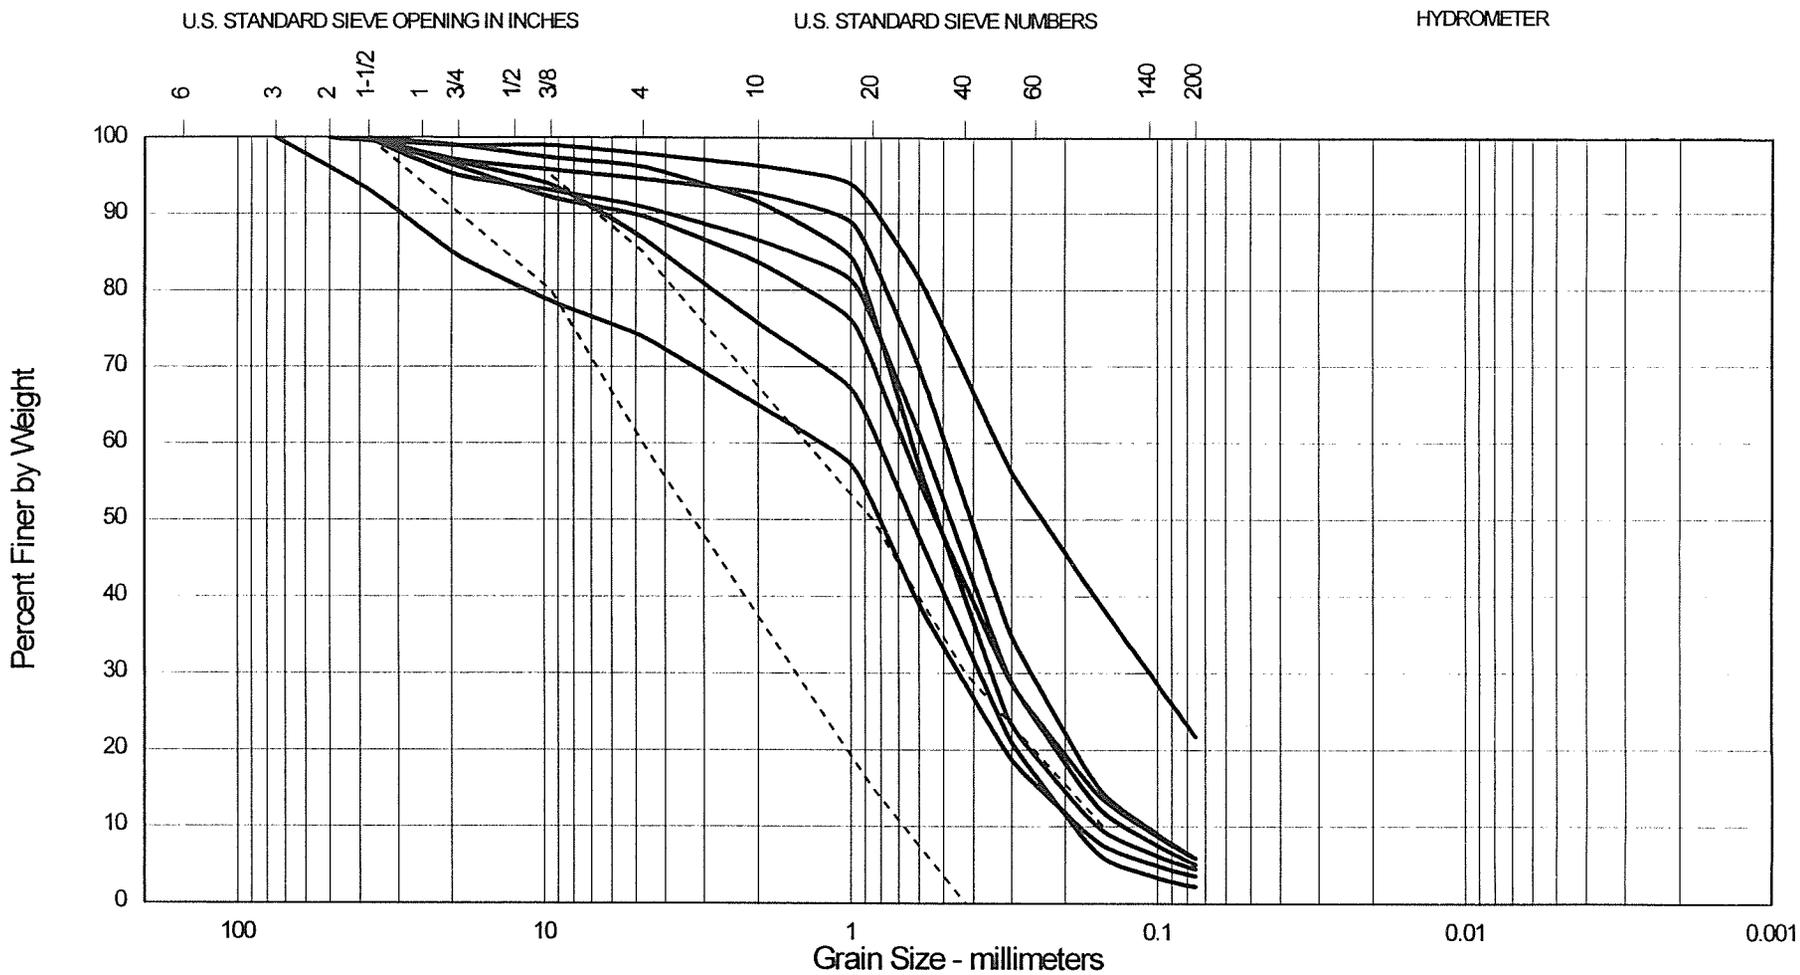
GEI Consultants, Inc.	Project 96069	June 1996 Fig. 5

Gradation tests were made on seven filter sand samples obtained from the chimney and blanket drains during the post failure investigations. As shown on Figure 5, none of the samples fully meets the gradation specifications. For the filter sand application, the most important aspect of the gradation is the percentage of finer particles because it determines the permeability and the ability to filter the base soils. The percentage passing the No. 100 sieve (the finest sieve in the specified gradation) exceeds the specification range of 0 to 10% for four of the seven samples. A permeability test performed on sample with about 10% passing the No. 100 sieve indicated a permeability of approximately 10^{-3} cm/sec, i.e., at the lower limit of acceptability according the specifications. The four samples that had a higher percentage passing the No. 100 sieve are likely to have lower permeabilities.

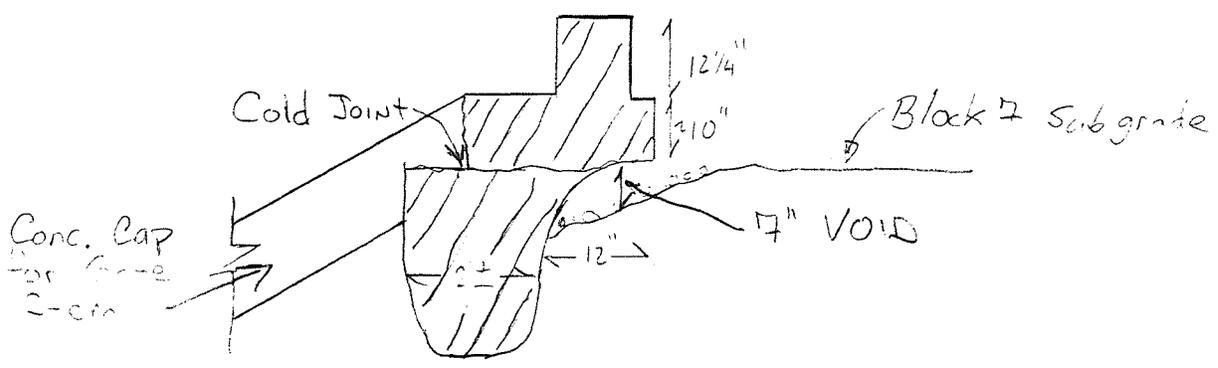
SECTION A-A'

Fine to Coarse Gravel
was observed on
the surface of the void

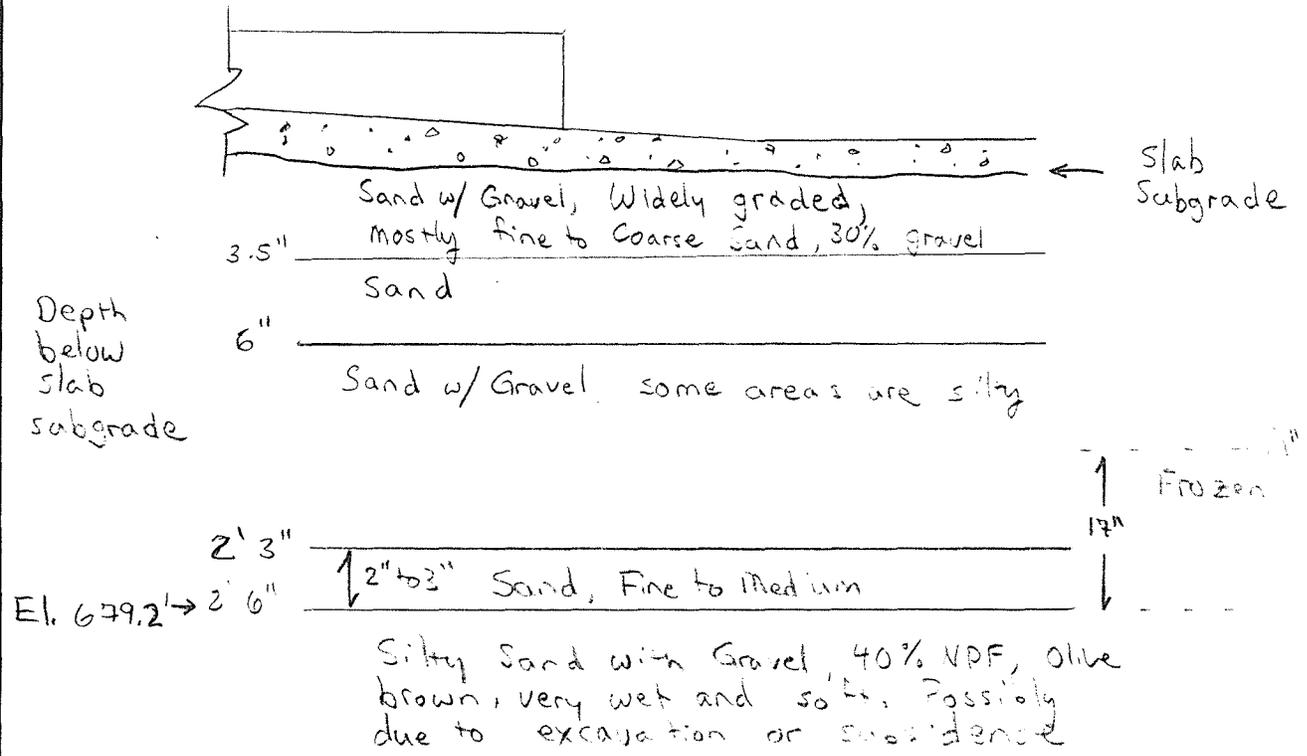
FIGURE 7

A test pit was excavated parallel to the crest of the dam, 4' downstream from the spillway wall on the right side of the breach. The location of the excavation and a soil profile are shown in Figure 6. After increasing the length and width of the excavation, the second soil profile was logged at five locations, as shown in Figure 7.

Silty Sand with Gravel, 40% NPF, olive brown, very wet and soft. Possibly due to excavation or subsidence

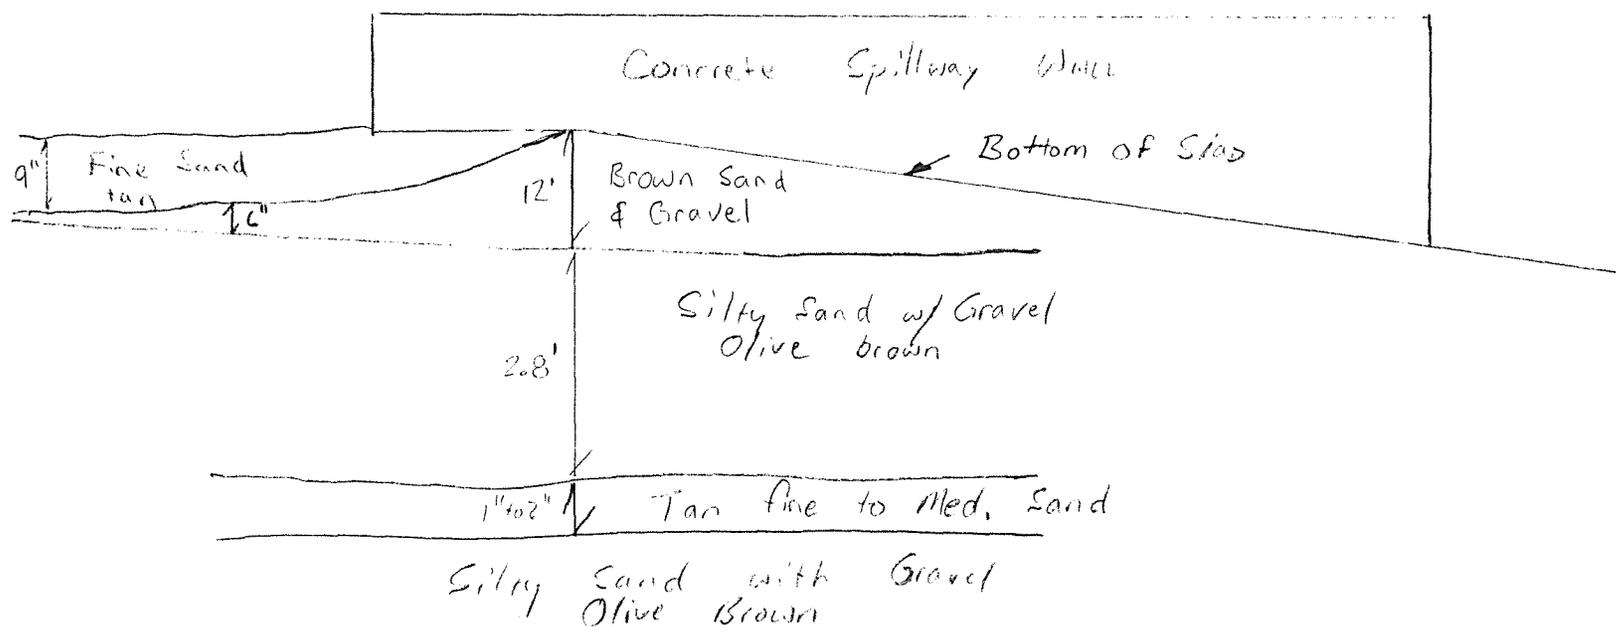
FIGURE 1

The excavation begun on the previous day beneath the spillway slab was continued. The lower sand layer observed in the soil profiles logged previously (Figures 6 and 7 of Field Observation Report 5) continued 14' downstream. The excavation proceeded upstream to within approximately 2' of cutoff wall. The soil profile is shown in Figure 1.

SOIL PROFILE
DOWN STREAM of ABUTMENT WALL

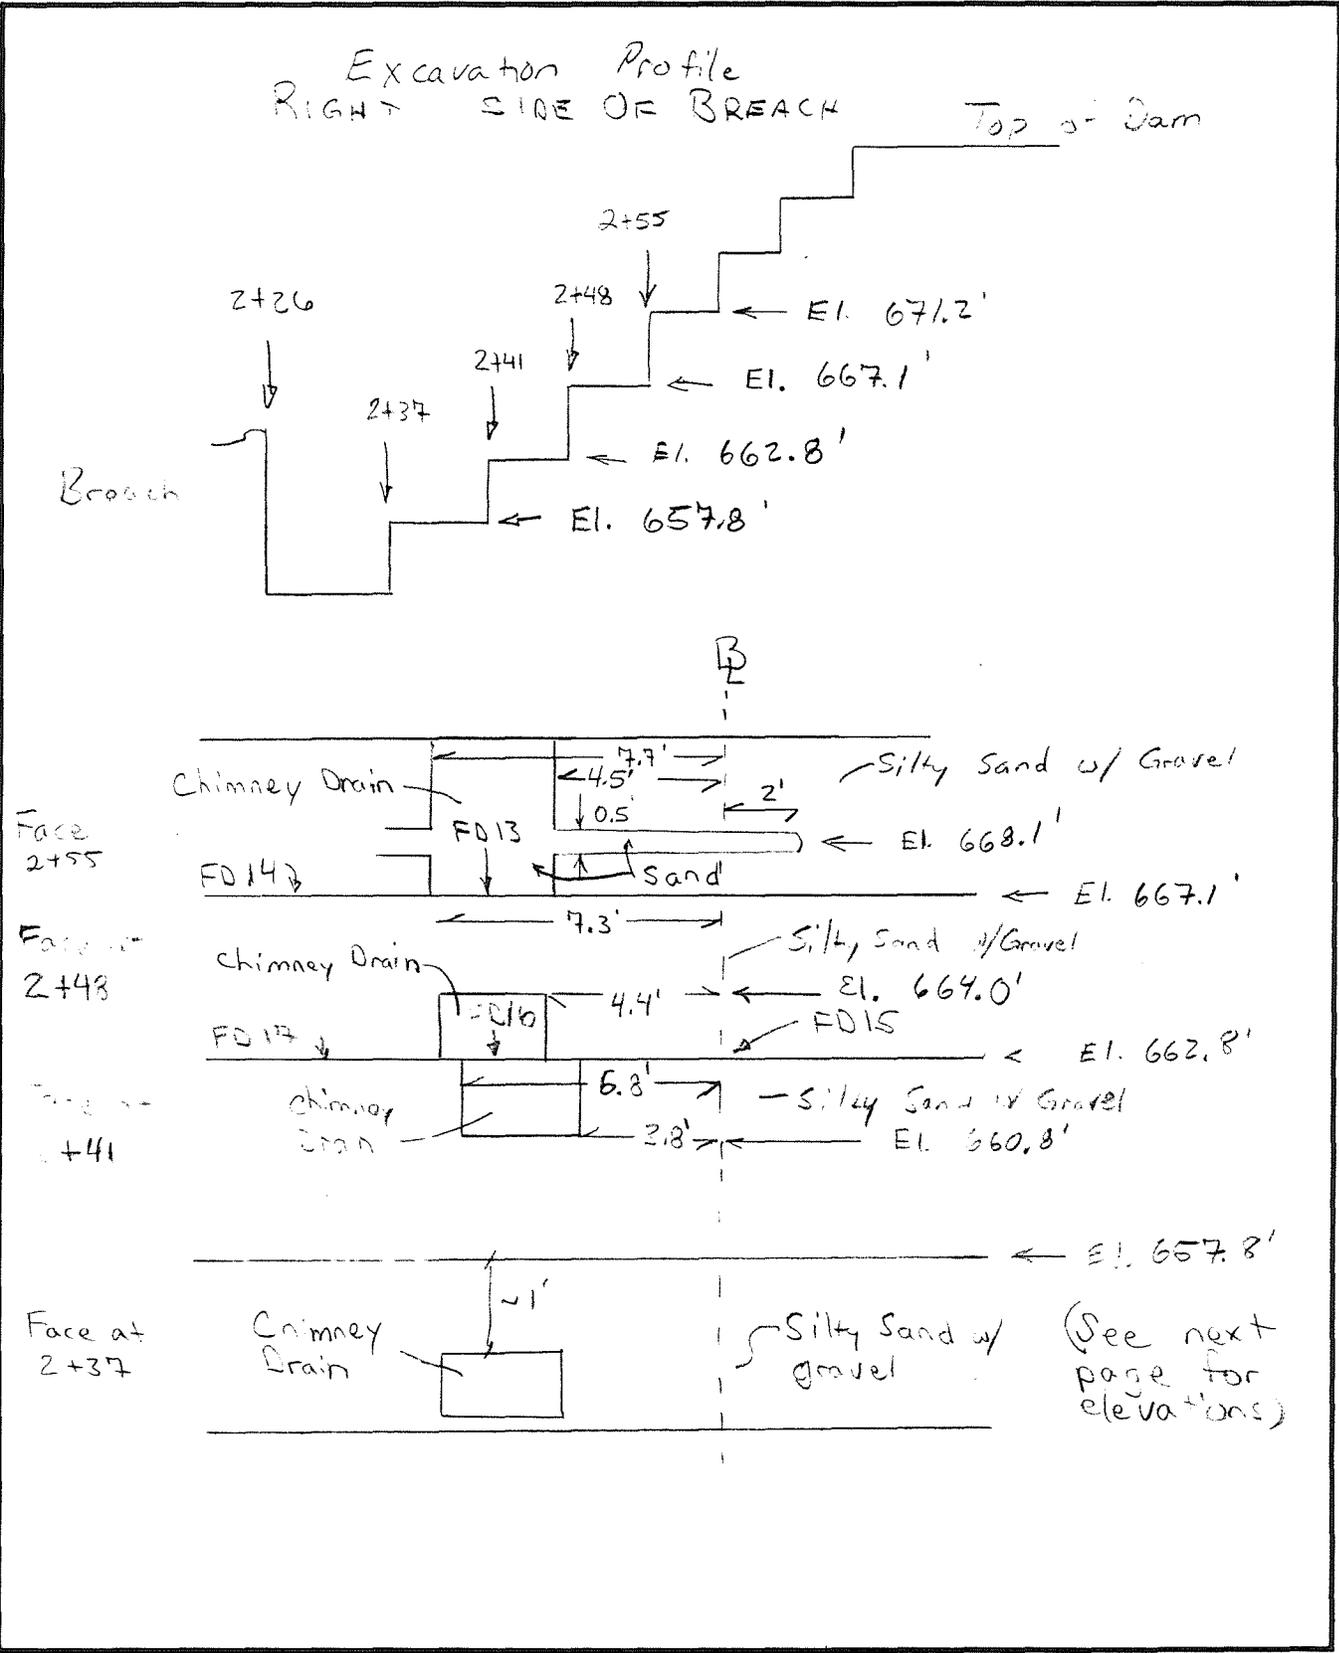
FIGURE 2

Excavation of the benches in the embankment along the right side of the breach continued. The soil profile logged at each bench is shown in Figure 2. The results of the field density testing conducted at each bench are summarized at the end of this report. The field density testing was generally conducted in the core upstream of the chimney drain, in the chimney drain, and in the core down stream of the chimney drain. A soil sample was not collected from the location of FD18 because the test was found to be conducted within two different types of soils (filter sand from chimney drain and core material).

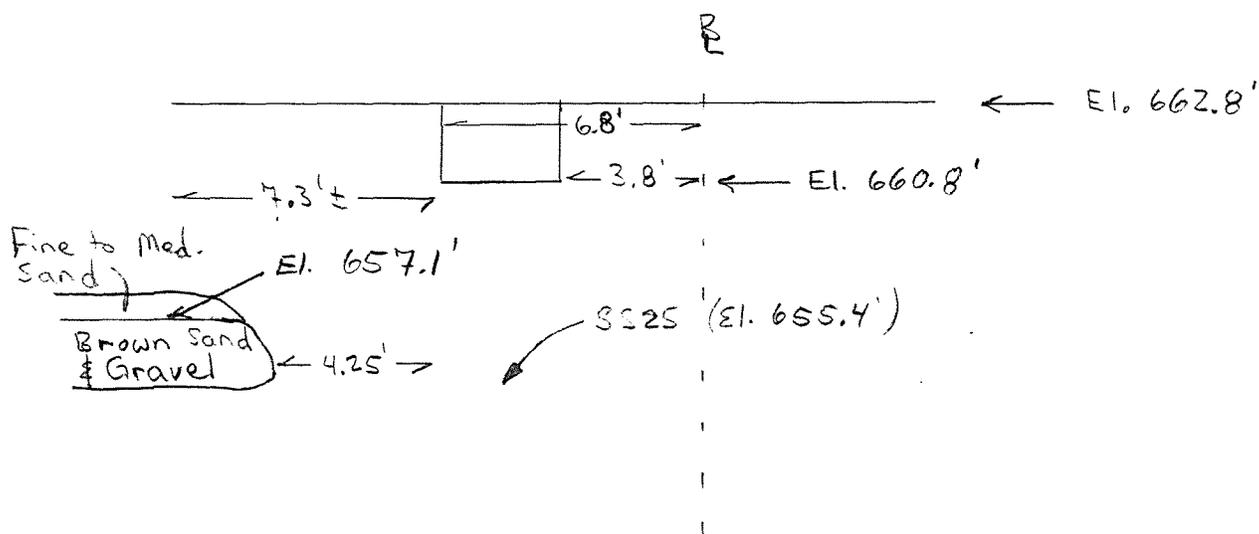
CROSS SECTION
Station 2+41

The face at 2+41 was deepened by excavation of the bench at 2+37. As shown in Figure 3, the blanket drain was observed below and downstream of the bottom of the chimney drain. The upstream edge of the blanket drain was located about 4.3' downstream of the downstream side of the chimney drain. The top of the sand and gravel layer in the blanket drain was about 3.7' lower than the bottom of the chimney drain.

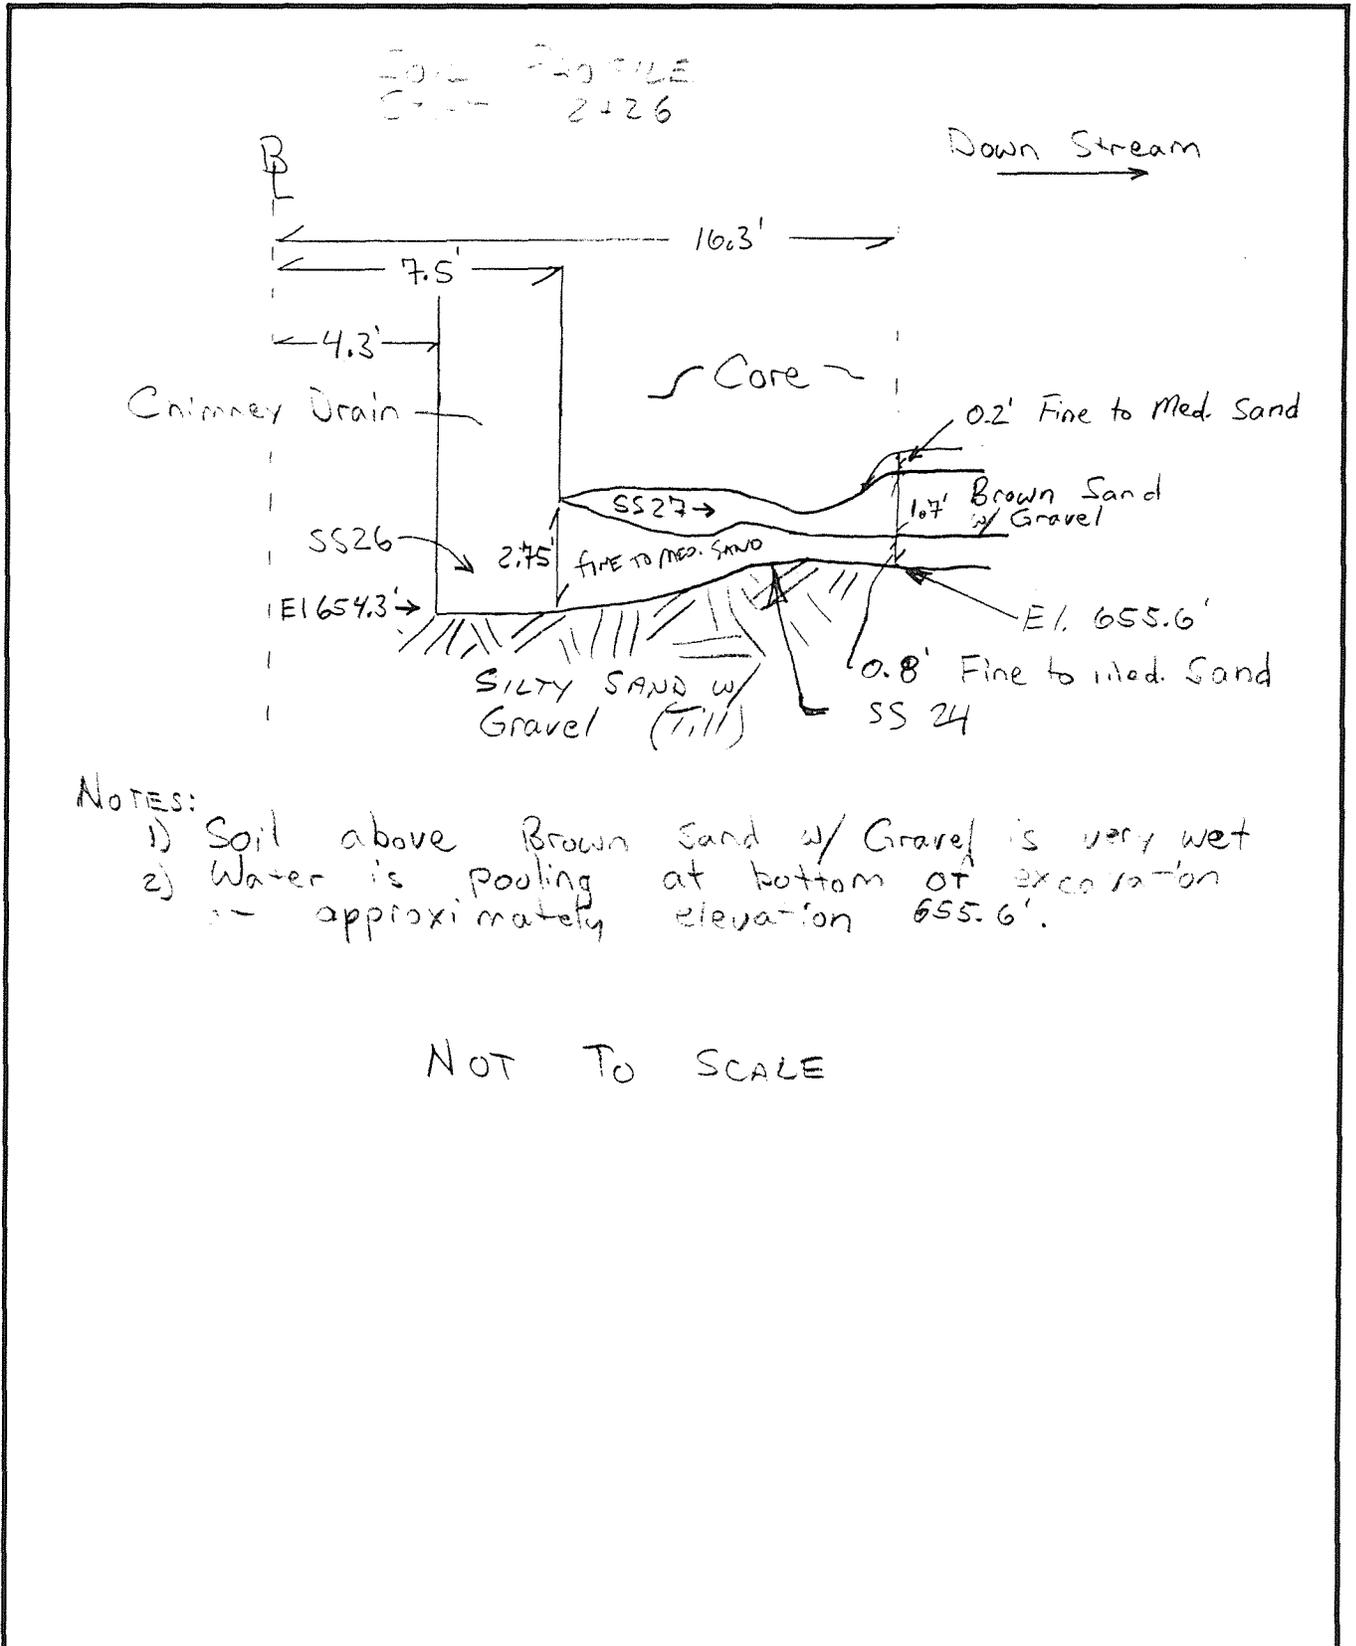
Deepened Face AT 2+41
by excavating bench AT 2+37

The chimney drain was observed to be discontinuous at the faces of benches at stations 2+48, 2+41, and 2+37 (see Figure 4). The discontinuities were zones about 3' to 4' high in which silty sand with gravel core material were in place of the filter sand in the chimney drain. It appears as though the trench excavated for the chimney drain had partially caved in at these locations during backfilling with filter sand.

The chimney drain was observed to connect to the blanket drain at the excavated face at about station 2+26 (looking left) (Figure 4). However, on the face of the excavation at station 2+37 (looking right), the bottom of the chimney drain was observed at less than one foot above the glacial till foundation soils in the bottom of the excavation, but the blanket drain was not observed.

As shown in Figure 4, the layers in the blanket drain on the face at station 2+26 were irregular and varied in thickness. The upper filter layer was absent from the downstream side of the chimney drain to about 8.8' downstream the downstream side of the chimney drain (16.3' downstream of the baseline). Where observed, the thickness of the upper filter sand layer was about 0.2'. The sand and gravel layer ranged from about 0 to 1.7' thick and consisted of brown sand and gravel similar to that observed along the left side of the breach. The lower filter sand layer ranged in thickness from about 0.8 to 2.75'. The bottom of the blanket drain was underlain by the glacial till foundation soils, consisting of silty sand with gravel. Numerous cobbles and boulders were observed on the surface of the till. In some locations, thin pockets of organic soils were observed between the cobbles and boulders.

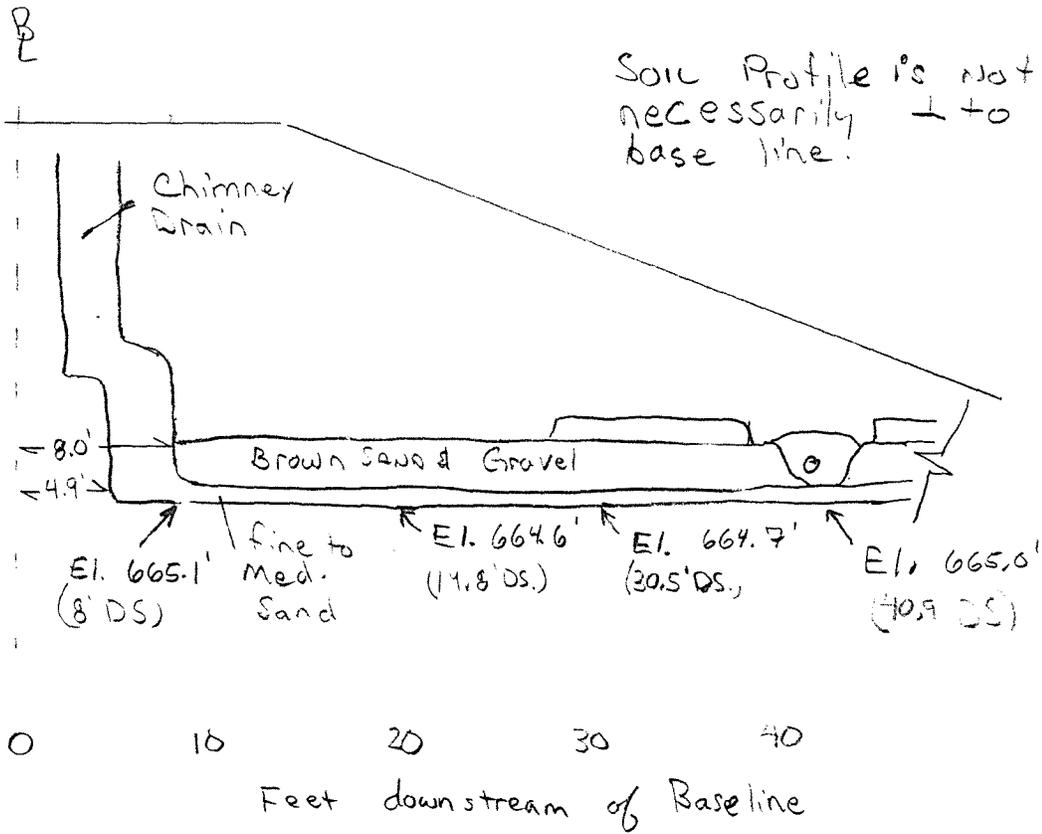
FIGURE 1

Elevations on the left side of the breached section of the dam were obtained. The elevations and soil profile are shown in Figure 1.

SOIL PROFILE LEFT EMBANKMENT OF BREACH

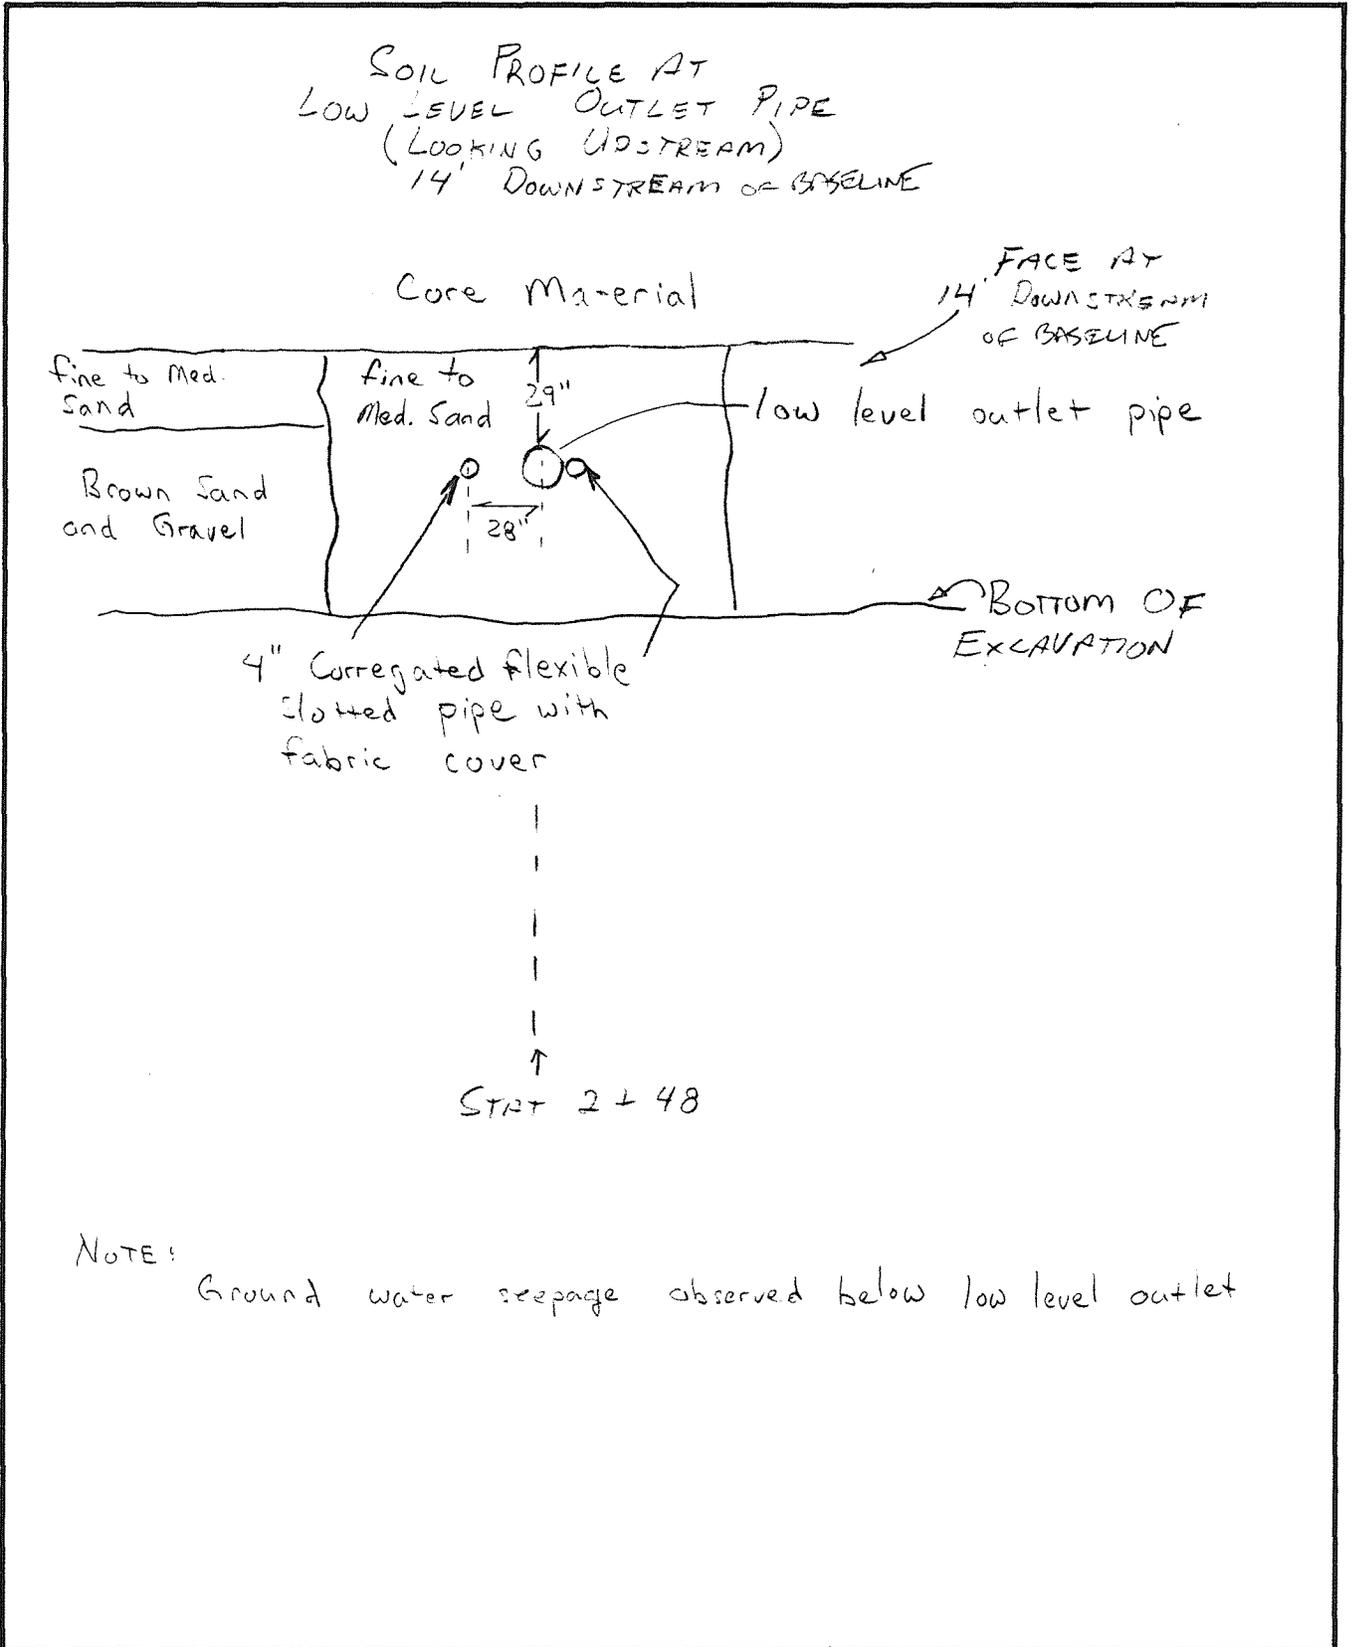
FIGURE 2

- A 2' to 3' diameter boulder was removed from the foundation of the dam at the location of the irregular profile shown in Figure 6 of Field Observation Report No. 7 (April 5, 1996).
- The low level outlet pipe was observed at about station 2+48, 14' downstream of the baseline (see Figure 2). The low level outlet pipe is a 12-inch-diameter plastic corrugated pipe and was observed within a layer of filter sand. Two 4-inch-diameter corrugated, slotted plastic pipes (wrapped in geotextive filter fabric) were observed to run alongside the low level outlet pipe. The elevation of the top of low level outlet pipe was about 654' to 655'. Water was observed to seep out of the sand below the pipes.

The blanket drain was observed to the right (upstation) of the low level outlet pipe, at about the same elevation. At an excavation face at 2+55, the blanket drain was observed to consist of an approximately 0.8'-thick layer of filter sand over an approximate 2'-thick layer of brown sand and gravel. The excavation was not deepened to observe the lower filter sand layer. The elevation of the top of the sand and gravel layer at 2+51, 14' downstream of the baseline, was approximately 656.7'.

- The excavation was advanced upstream to locate the antiseep collar. The antiseep collar was observed at about station 2+51, just U.S. of the chimney drain. At this location, the bottom of the chimney drain was about 5.9' above the top of the low level outlet pipe.
- The excavation was advanced further to the right to see if the chimney drain connected to the blanket drain on the right side of the low level outlet. The excavation was advanced to about elevation 652' at station 2+63. While the connection of the chimney drain to the blanket drain was not observed, it was noted that the elevation of the bottom of the chimney drain decreased as the excavation proceeded up station (to the right). Among the engineers on-site, it was speculated that the contractor may have intentionally excavated a shallow trench for the chimney drain in this area to avoid disturbance to the low level outlet.

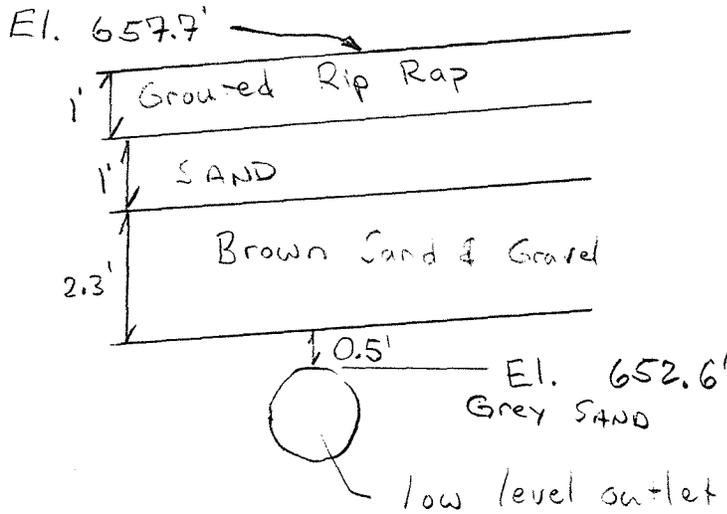
TP2 2-26, 70' Down Stream

Test pit TP2 was excavated at station 2+26, 70' downstream, perpendicular to the low level outlet. As shown in the soil profile in Figure 4, the top of the low level outlet pipe was about 4.8 feet below the grouted riprap at the test pit location. The soils in the test pit consisted of varying thicknesses of sand, brown sand and gravel and gray fine to medium sand. The soil profile on Figure 4 shows logging at one location on the test pit wall. More thorough logging was not possible due to test pit instability. A 4-inch-diameter corrugated slotted drainage pipe was observed in the west side of the test pit, approximately 1' below the grouted rip rap at about station 2+26, 80' downstream. This pipe was probably part of the toe drain.

This figure provides the soil profile at one location. The types and thicknesses of materials encountered varied widely. More accurate logging of the soil profile was not possible due to the instability of the excavation and water seepage.

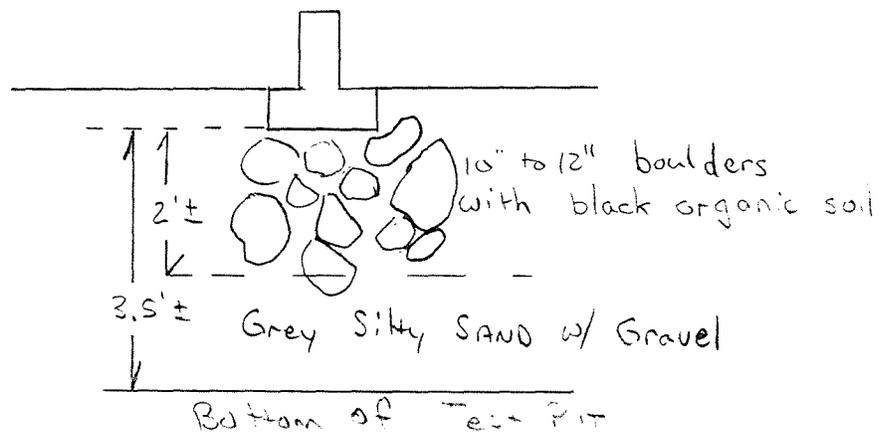
TP 4
At east end of intact portion of baffle wall

Test pit side walls collapsing due to groundwater.

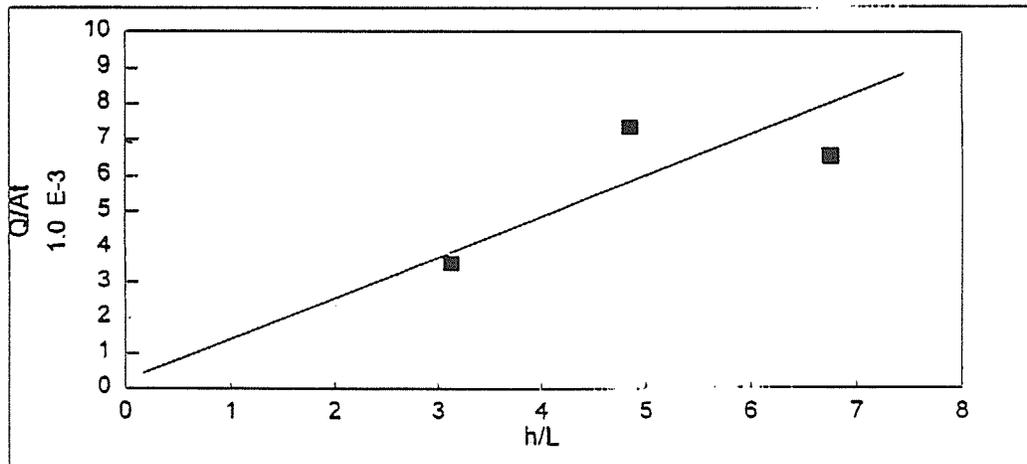
k = 1.2E-03 cm/s
