GEI Consultants, Inc.

**FORENSIC INVESTIGATION
MEADOW POND DAM
ALTON, NEW HAMPSHIRE**

New Hampshire Department of Environmental Services

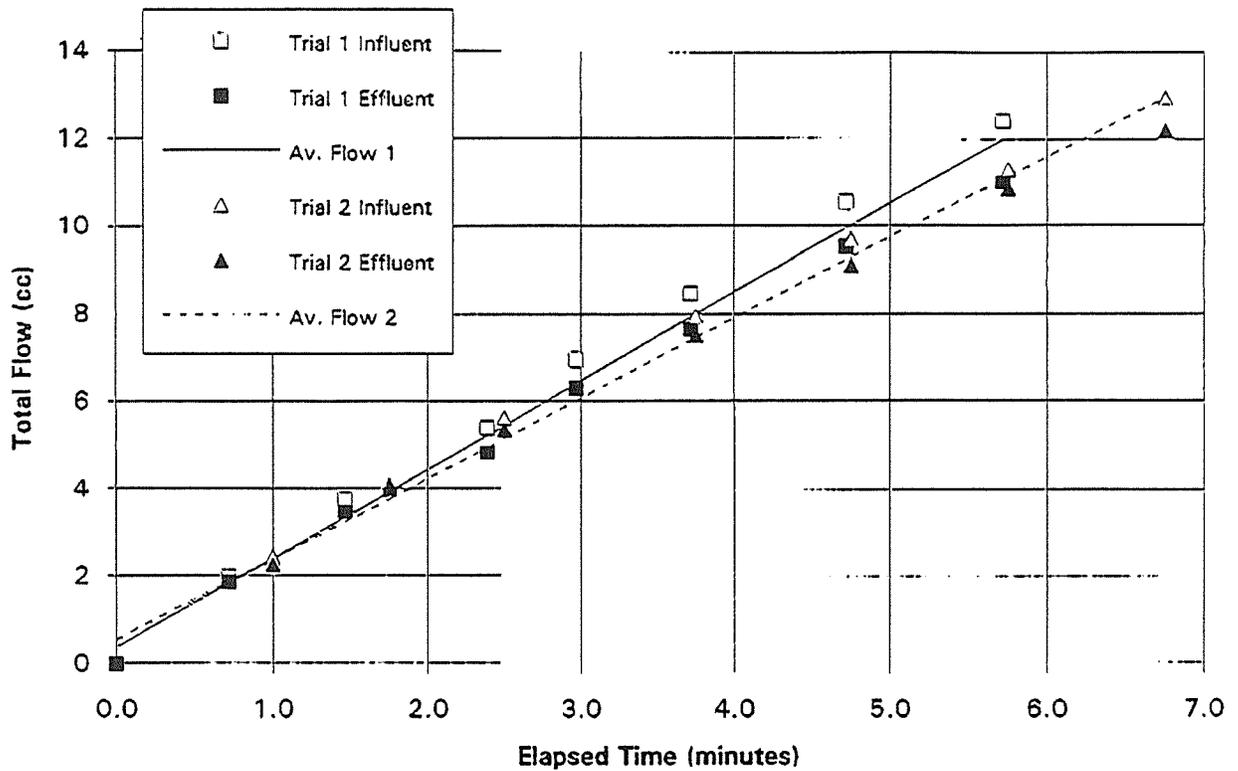
PERMEABILITY : 1.1×10^{-4} cm/sec

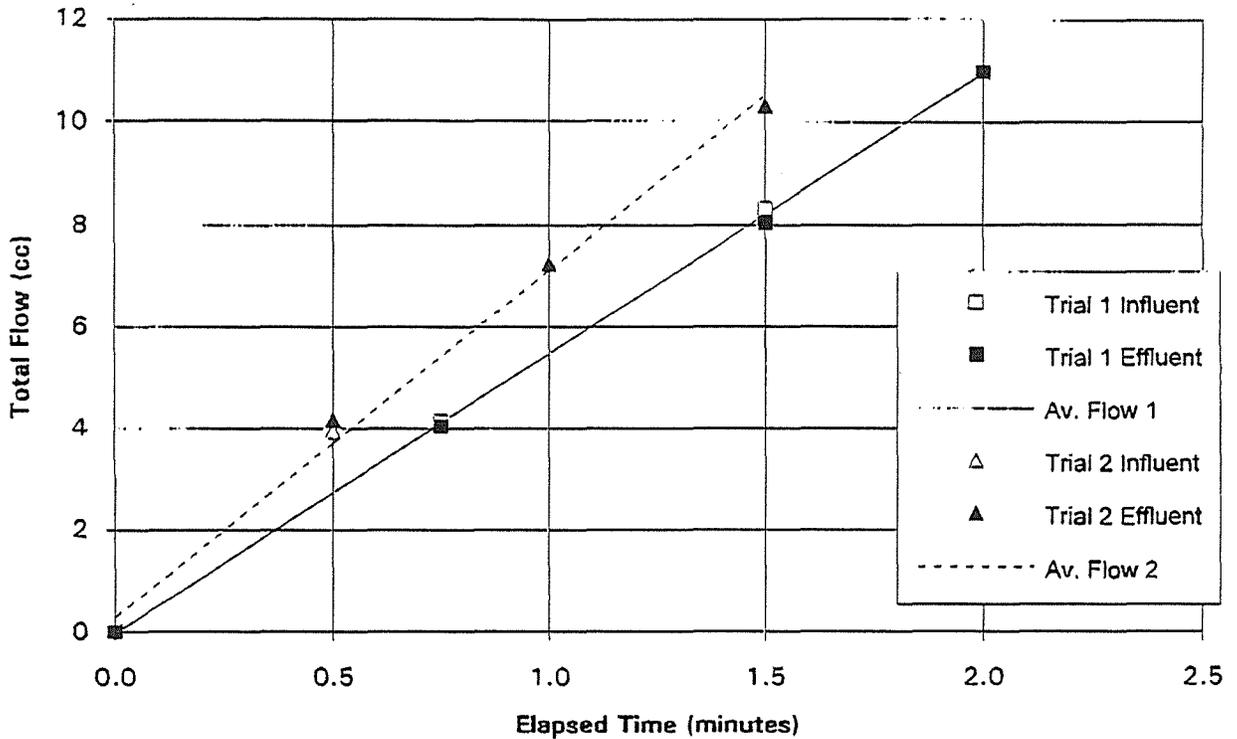
State of New Hampshire Dept. of Environmental Services	Forensic Evaluation Meadow Pond Dam Alton, NH	TRJAXIAL PERMEABILITY TEST FD1, "Gravel Blanket"
	Project 96069	May-96

PERMEABILITY : 7.8×10^{-4} cm/sec

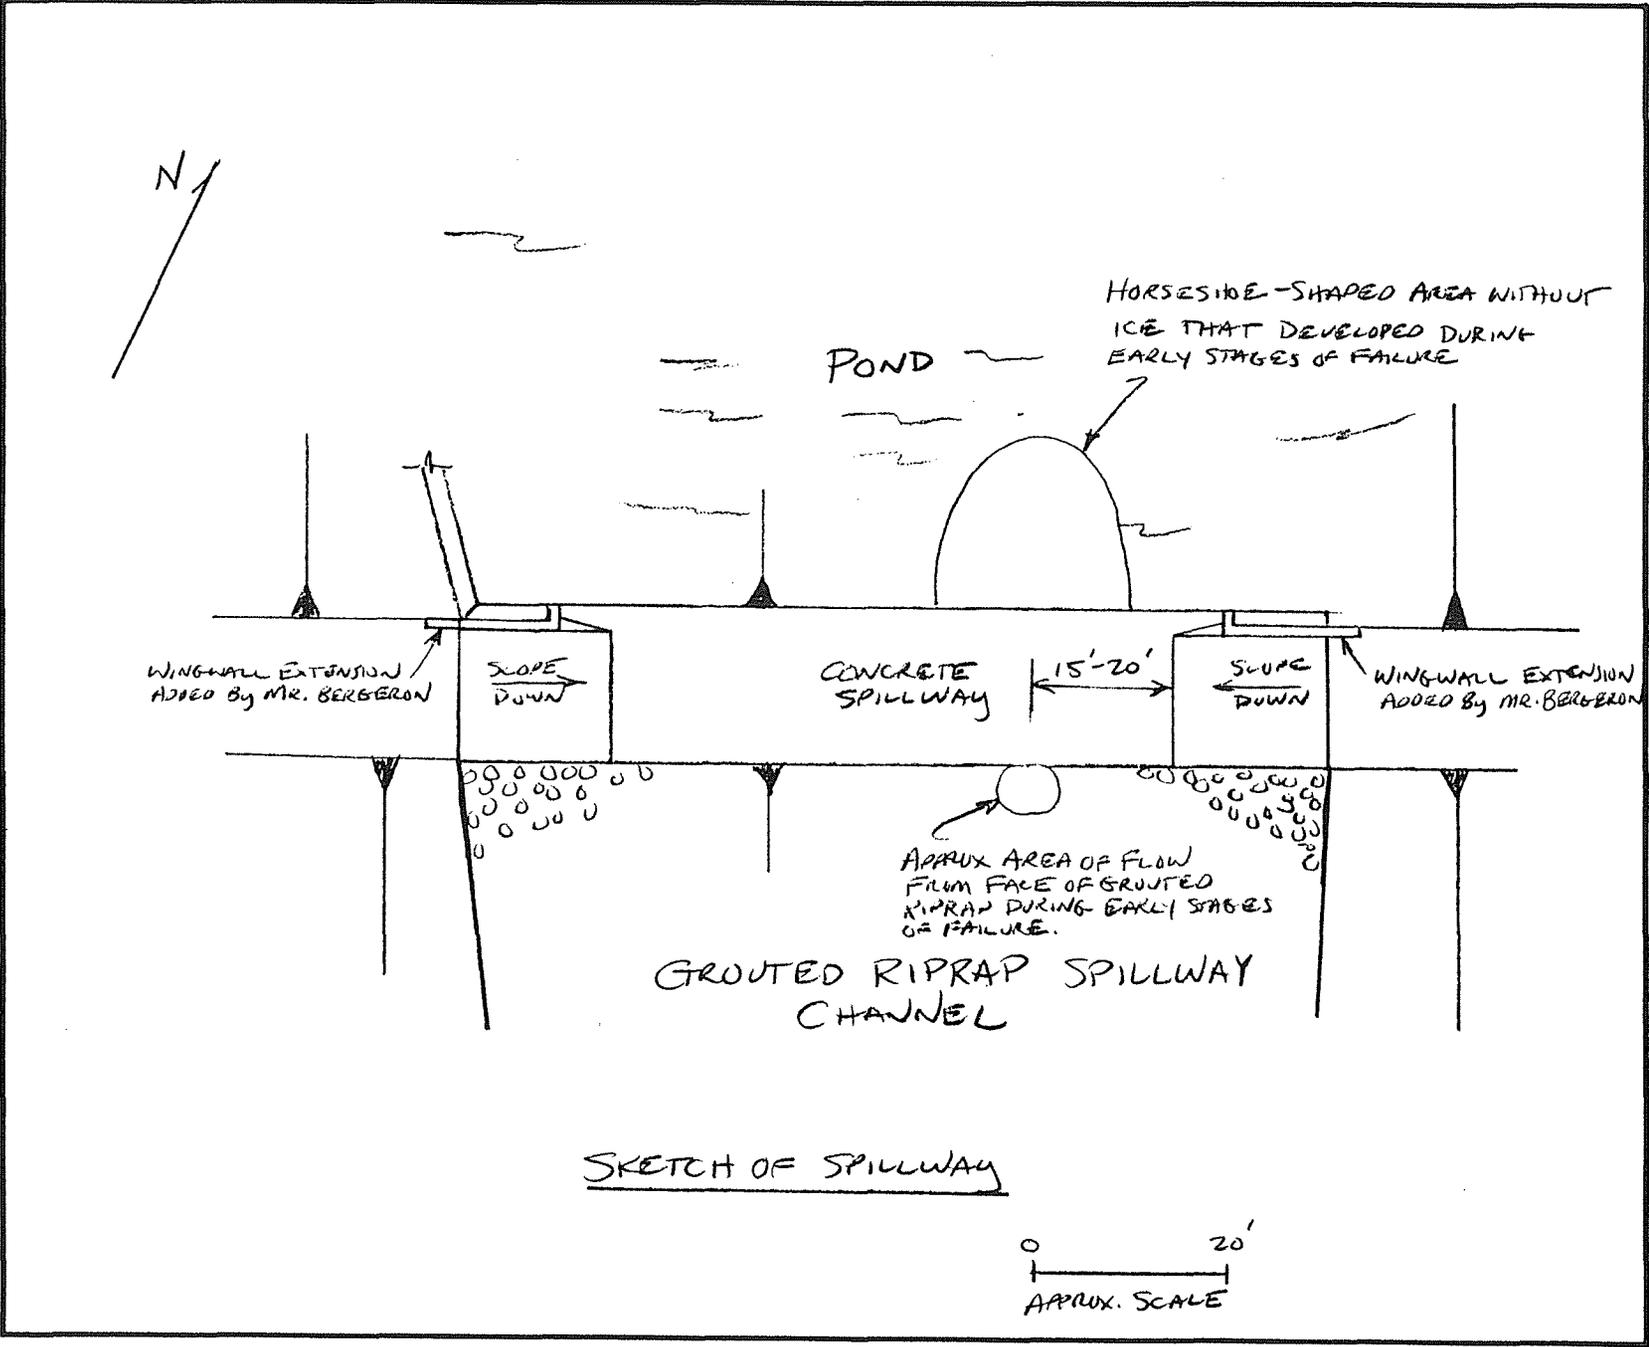
SKETCH OF SPILLWAY

- Shortly after the pond was filled, three cracks formed in the concrete spillway. The cracks were of hairline width and were located on the flat portion of the spillway, near the right end (looking downstream). Mr. Bergeron pulled riprap away from the leading edge of the concrete to further expose the cracks and filled visible portions of the cracks with caulking in the spring of 1995. Filling of cracks is consistent with the maintenance procedures suggested by the State. A sketch of the spillway is shown on the attached figure.

- In the spring of 1995, Mr. Bergeron built concrete wingwalls at both ends of the spillway to protect the portions of the earthen embankment adjacent to the spillway from splashing water that could cause erosion. The wingwalls are about 4 feet long, and are flush with the tops of the parapet walls on either end of the spillway. The locations of the wingwalls are shown on the attached figure.

- In the spring of 1995, Mr. Bergeron also regouted portions of the grouted riprap spillway, as was consistent with maintenance procedures suggested by the State. One concrete truck load of grout was used to fill holes and cracks along the upper approximately one-third of the grouted riprap (within reach of the concrete truck chutes) and to fill a space that was left after removal of a concrete form board from the downstream edge of the concrete spillway structure. Grout was also used to raise the sides of the grouted spillway to reduce the potential for overflow during high flow periods. Some grout was applied on the lower approximately two-thirds of the grouted riprap (beyond the reach of the concrete truck chutes) by transporting the grout in buckets.

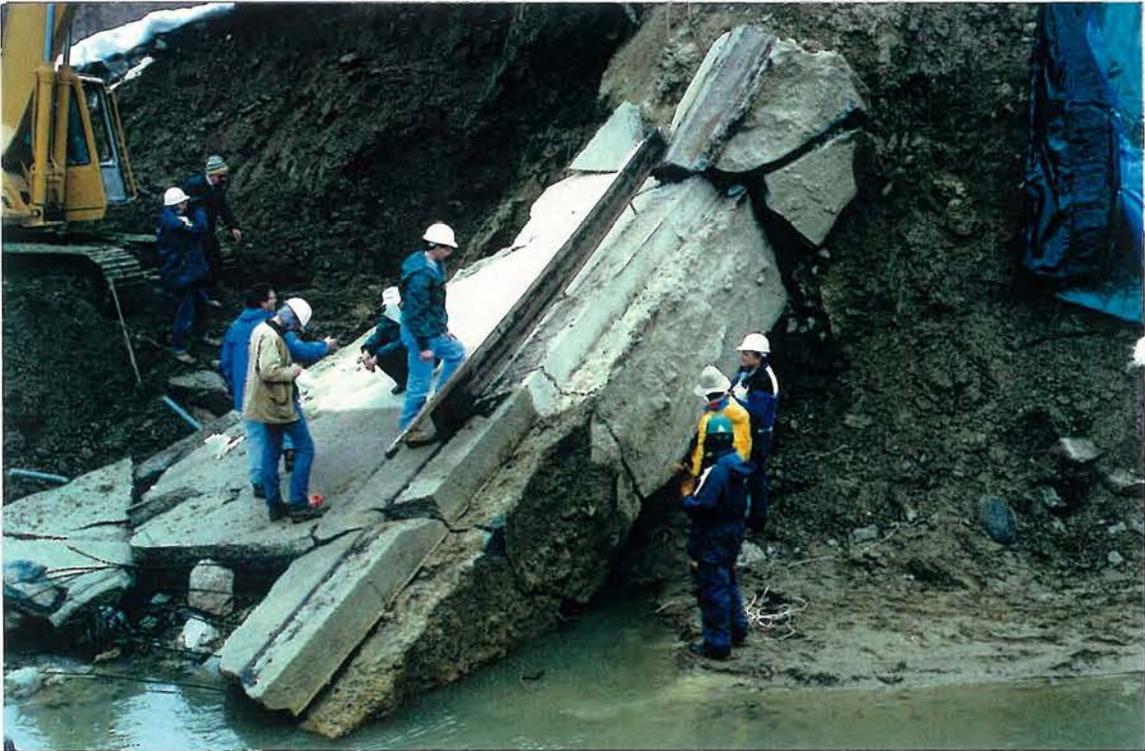
Concrete spillway section in dam breach. Note cold joint between slab and cutoff wall at lower left of photo. (3/20/96)

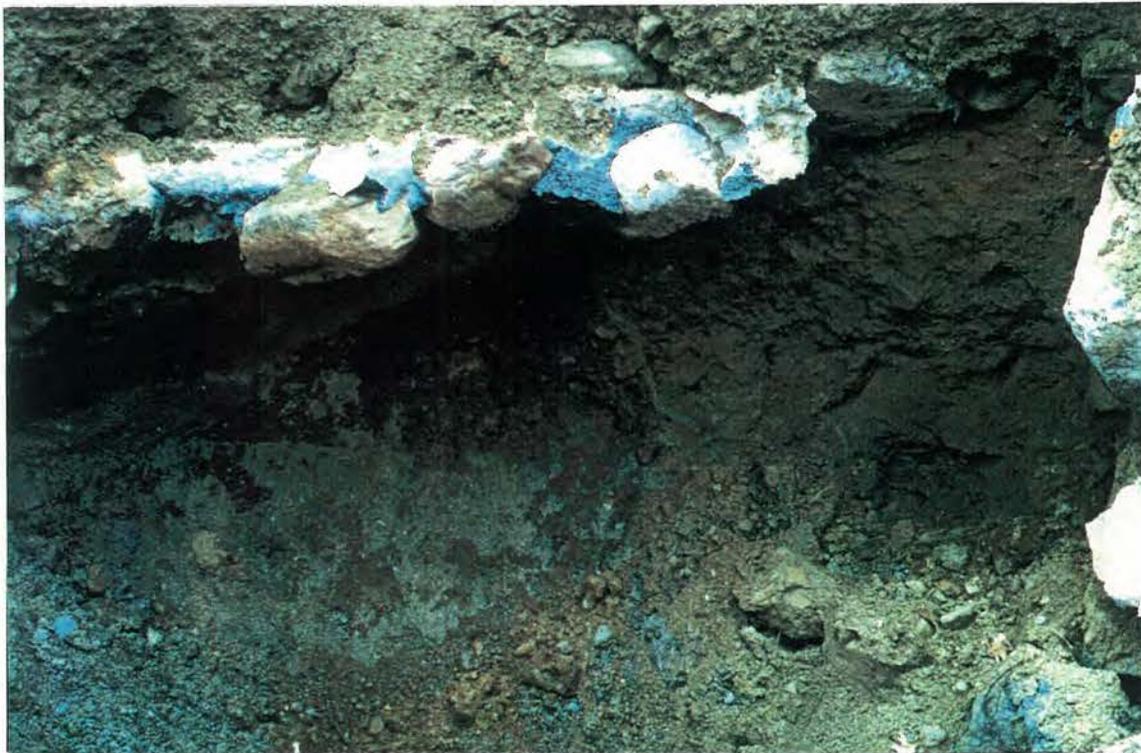
Soil beneath grouted riprap on downstream side of spillway. (4/5/96)

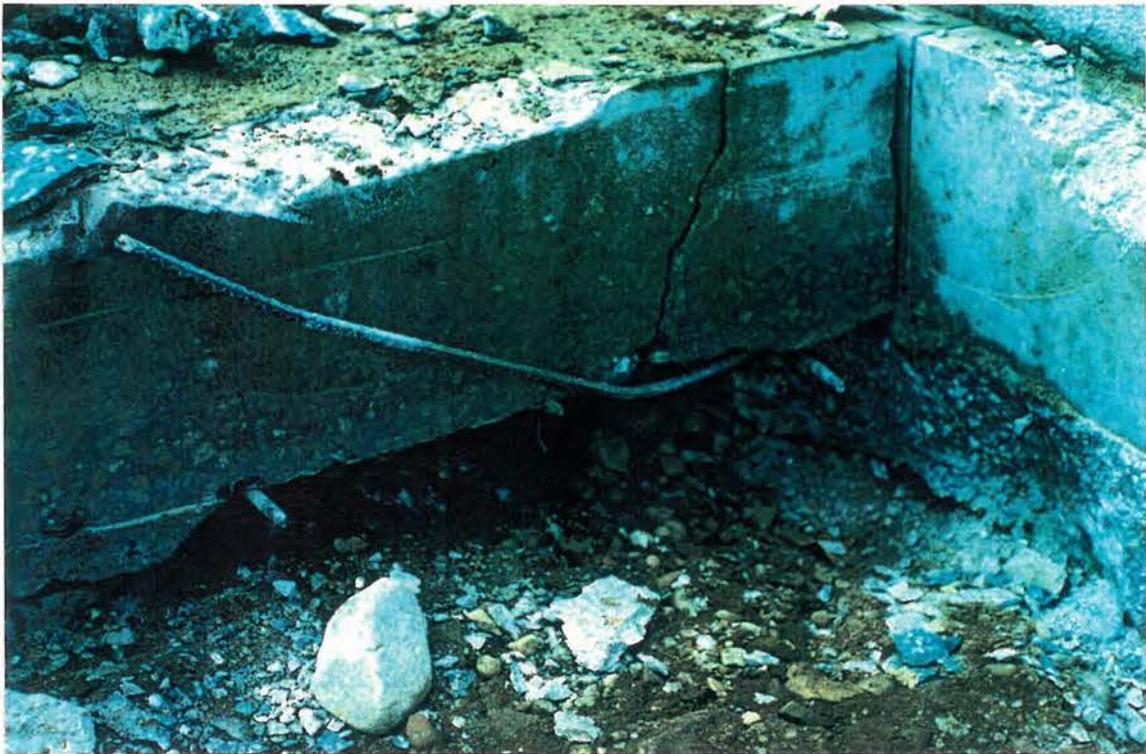
Void beneath spillway slab. (4/2/96)

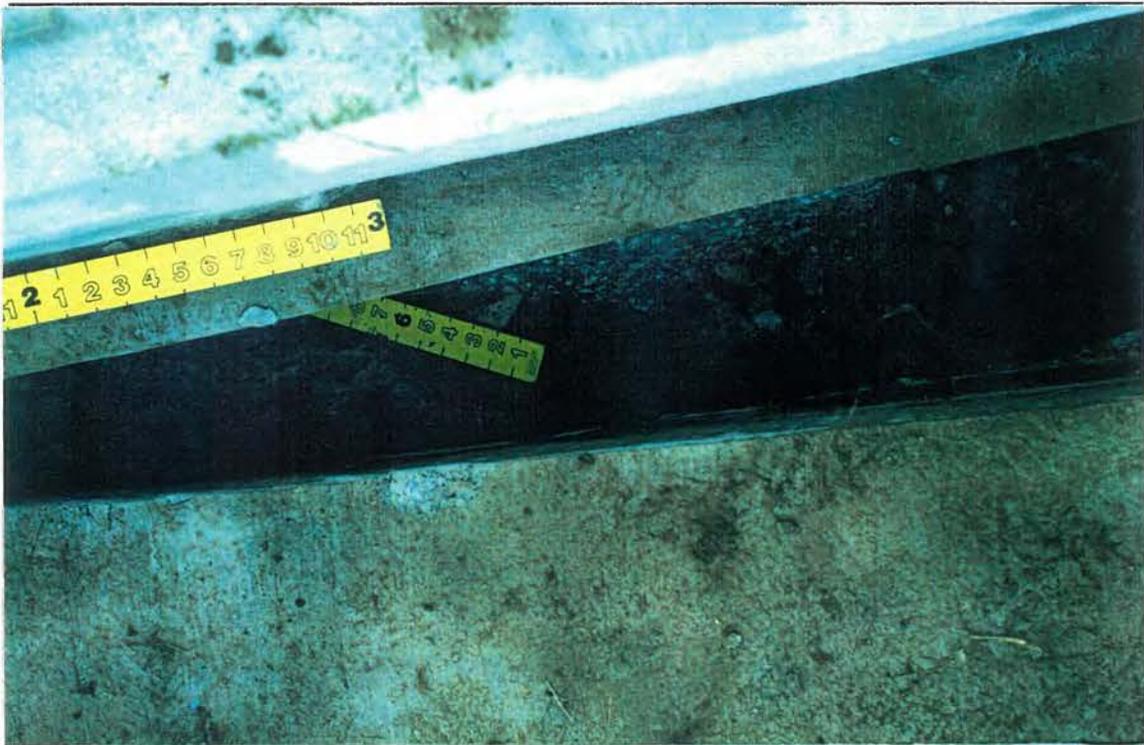
Saw cut slab moved away from abutment wall. Ruler on slab subgrade inserted from upstream side of void at right end of cutoff wall. (4/2/96)

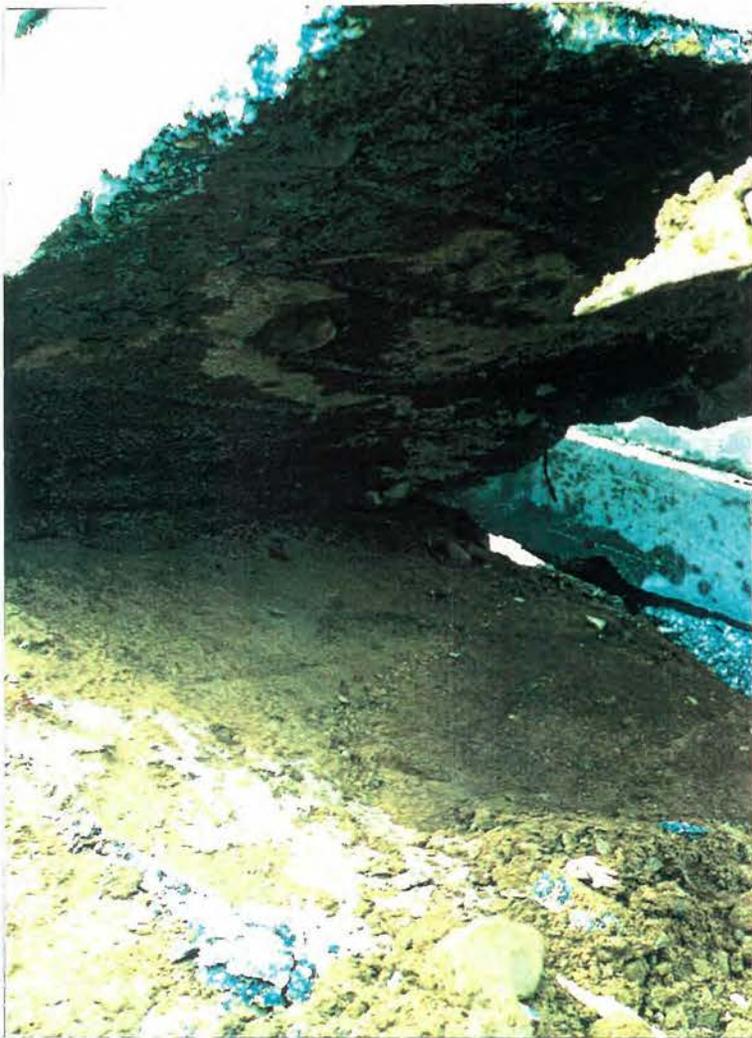
Left: Subgrade beneath sloped portion of spillway slab. Note void at far edge of subgrade, area of protruding gravel on subgrade (indicating erosion) and corresponding dry area on bottom of slab. (4/2/96)

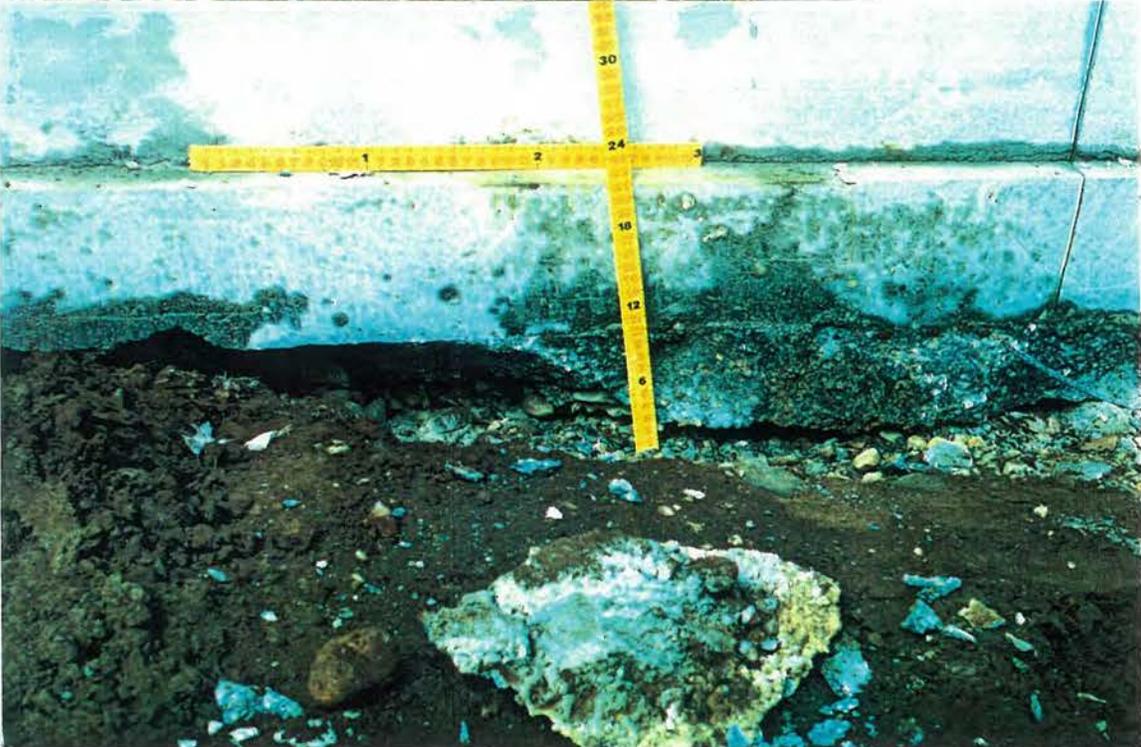
Below: Void beneath spillway slab. (4/2/96)

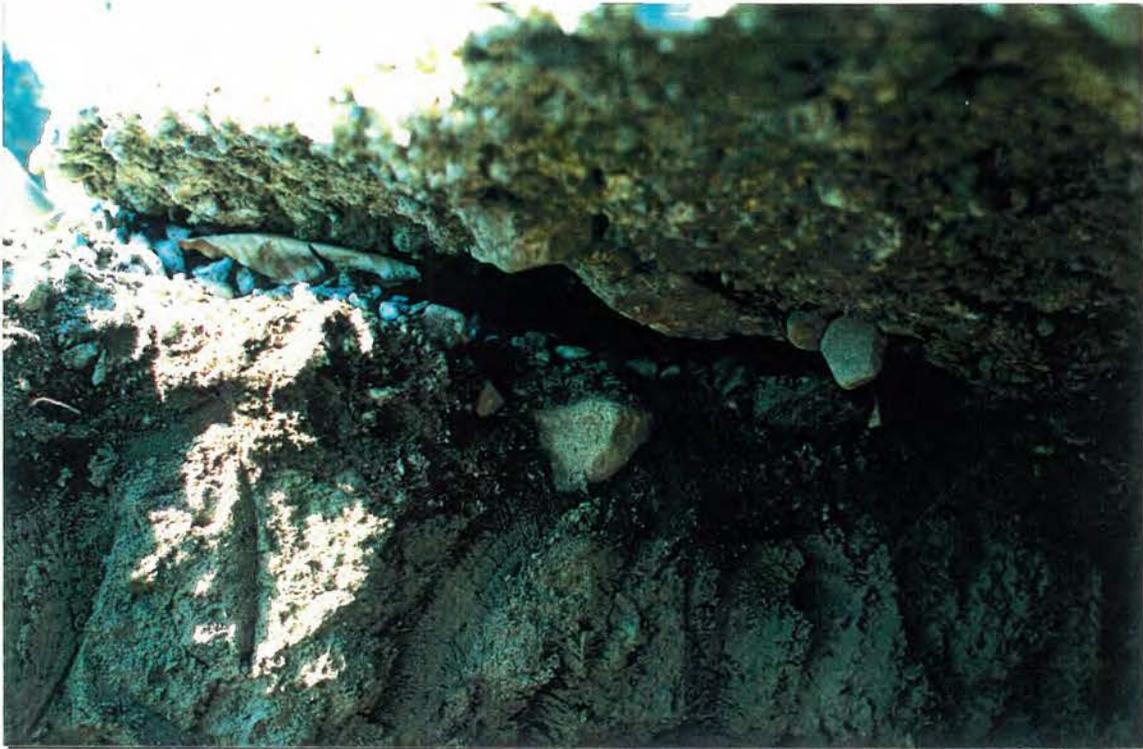
Void beneath spillway slab. (4/2/96)

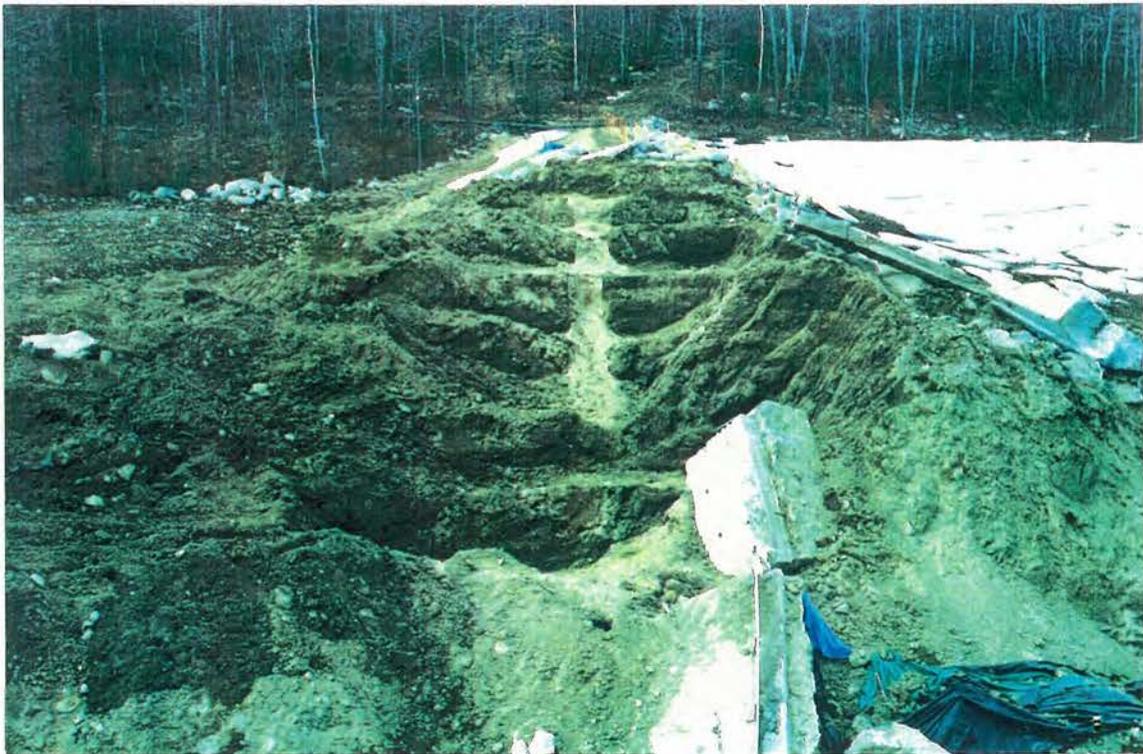
Right side of breach after field investigations. (4/5/96)
