GEOLOGICAL SURVEY CIRCULAR 667

West Virginia's Buffalo Creek Flood:
A Study of the Hydrology and
Engineering Geology

By William E. Davies, James F. Bailey,
and Donovan B. Kelly

First printing 1972

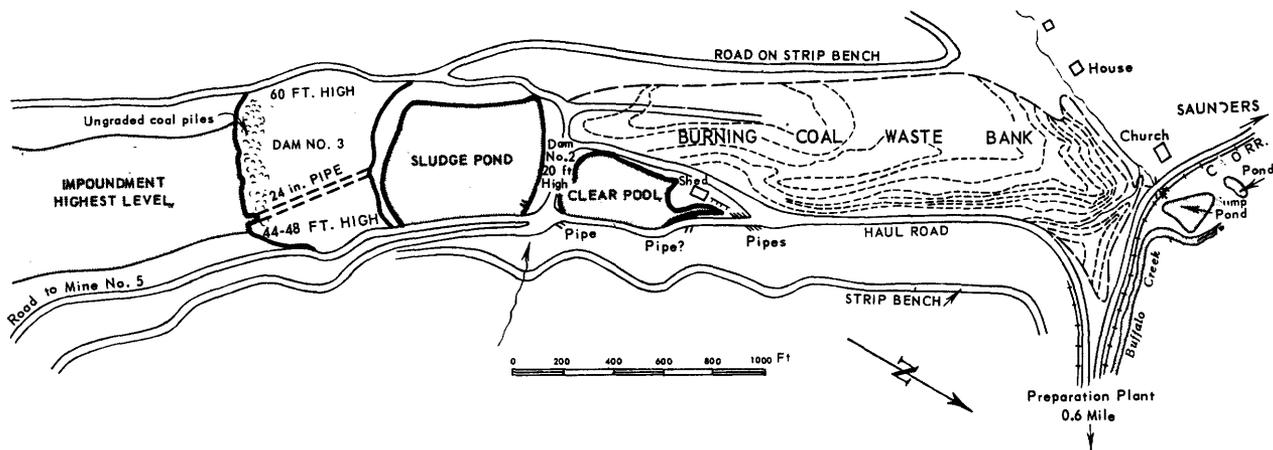
FIGURE 3.—Sketch map of Middle Fork, February 1972, before dam broke.

In their coal-mining operations, the Buffalo Creek Mining Co. had built three major coal-waste banks by dumping waste rock and coal in the narrow valley of Middle Fork (fig. 3). Coal-waste bank No. 1 was located at the mouth of the Middle Fork. Banks No. 2 and 3 were upstream 600 and 1,200 feet from bank No. 1 and served as dams prior to the flood. Part of the purpose of the dams was to reduce stream pollution by impounding the waste-water from the coal washing plant, thus allowing most of the sediment to settle. The porous nature of the coal-waste dams allowed most of the water normally to filter through the dam and this clear water was recycled to the washing plant from decanting basins downstream.

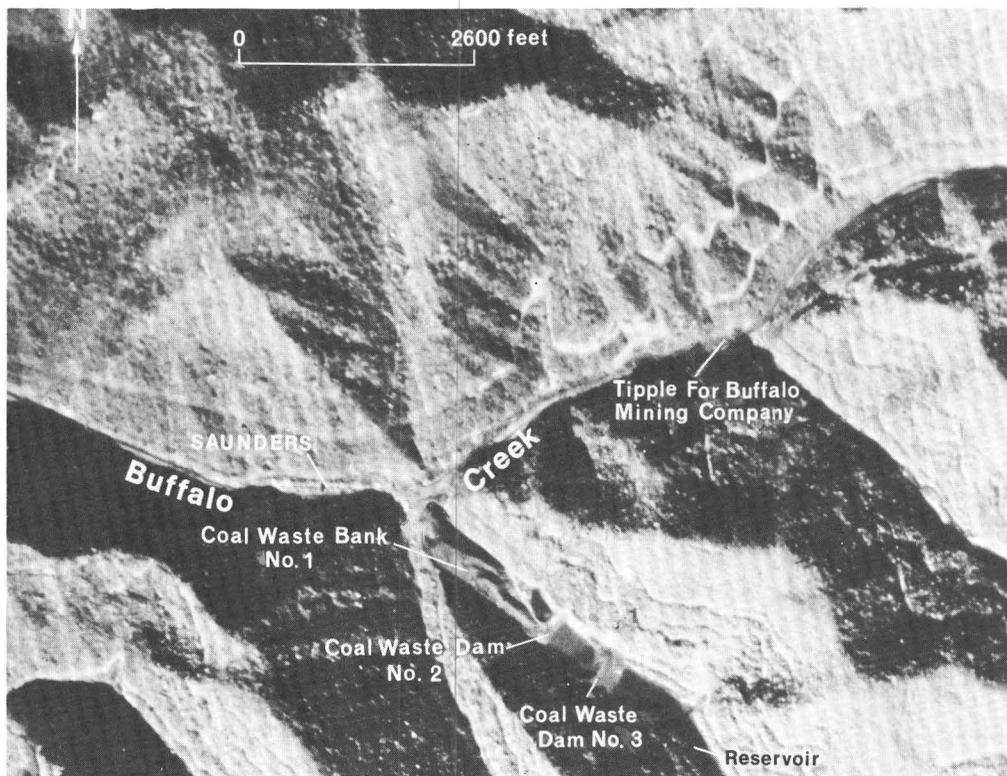
FIGURE 6.—Buffalo Creek area, West Virginia, Nov. 3, 1971. (Aerial photograph by Appalachian Regional Commission.)

back sloped 32° , the angle of repose for such material where dumping was modified by impounded water. The front (northwest) face of the dam, based on an aerial photograph taken November 3, 1971 (fig. 6), was concave in plan and contained four small concave hollows. The rear face was nearly straight, except near the right abutment where a reentry cut diagonally into the dam.

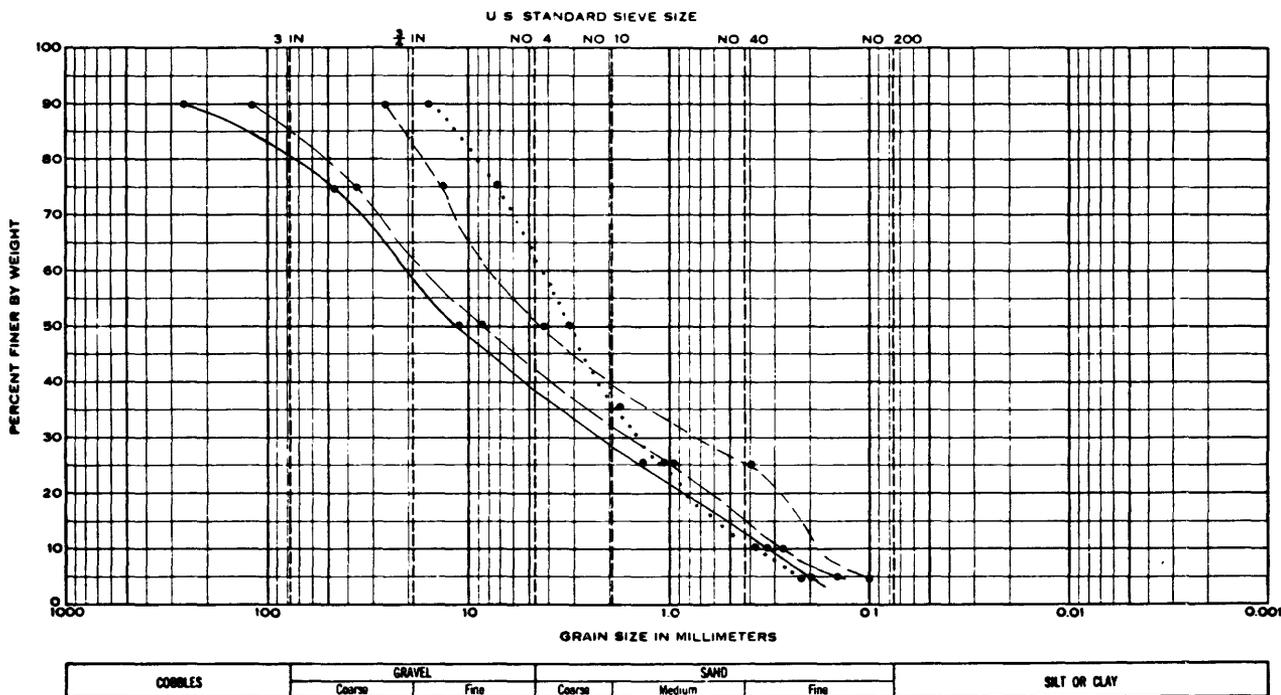
GRADATION CURVES, COAL WASTE DAM NO. 3, SAUNDERS, WEST VIRGINIA

Slabs and chips of shale and coal were bonded by clay in the right abutment. This material was high in sulfides, and a light-gray efflorescence of sulfates was deposited along fractures and on faces of slabs and chips.

The material remaining in the left abutment of dam No. 3 was bonded by clayey material but was relatively low in sulfates. Only thin, discontinuous effluorescences were present on the upper part of this abutment. The shale in both abutments was slaking rapidly and breaking down to chips and flakes less

- Sample 1, right abutment, front side, 15 feet above base.
- Sample 2, left abutment, rear side, 37 feet above base.
- · - · - Sample 3, left abutment, rear side, 10 feet above base.
- Sample 4, mound at former front toe, near left abutment.

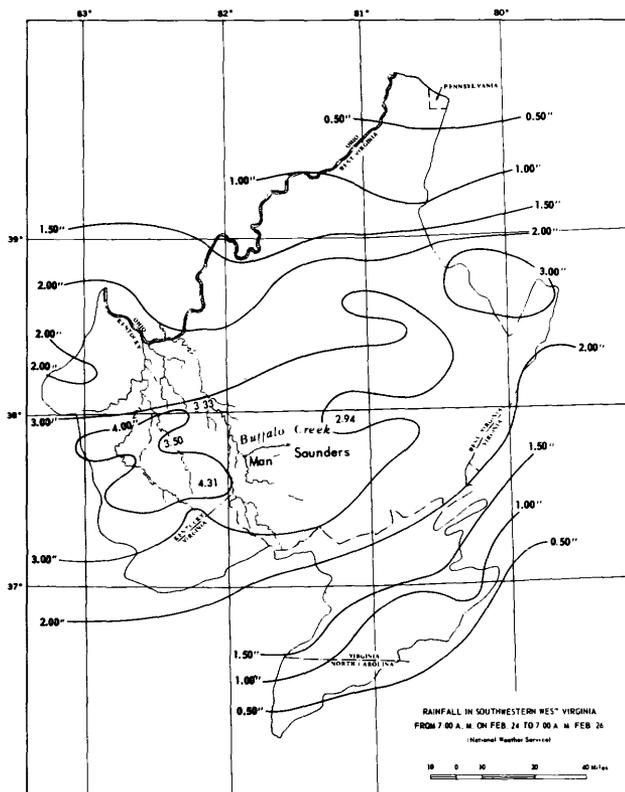
FIGURE 8.—Rainfall in southwestern West Virginia, Feb. 24 to Feb. 26, 1972.

During the 72-hour period immediately preceding the flood, precipitation averaged 3.7 inches at Logan and at other stations 15-20 miles south and east of Buffalo Creek, according to the National Weather Service (fig. 8). About half of the rainfall (1.9 in.) at Logan fell in the 24 hours that preceded the flood. Precipitation tapered off to the north during the 3-day period, measuring 2.35 inches in Charleston. Maximum precipitation during the storm was 4.5 inches produced at Williamson, 22 miles west of Buffalo Creek. A bucket sur-

vey in the Buffalo Creek hollow conducted by field parties during the week following the flood revealed no catchment of precipitation in open cans and other available containers that exceeded 3.7 inches recorded at Logan.

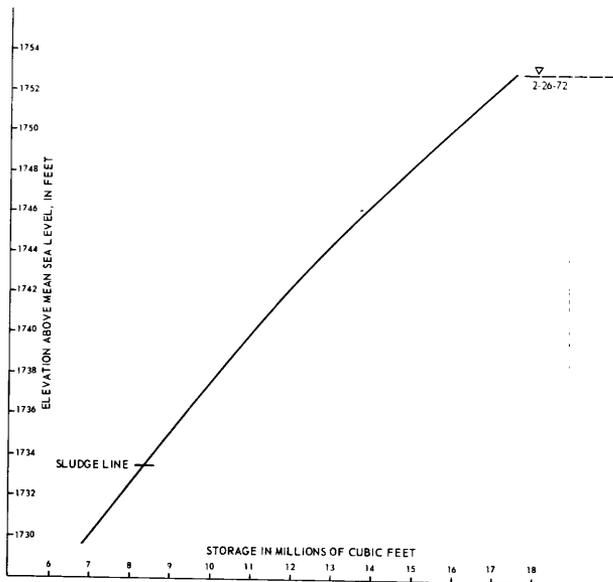
Information on inflow and characteristics of the pool behind coal-waste dam No. 3 were determined from field surveys and interviews with local residents. The pool reached its maximum volume, about 17.6 million cubic feet of water and sludge, around 8:00 a.m. on Saturday, February 26 (fig. 9). At that time the water-surface elevation had risen to 1,753.1 feet above mean sea level, and the depth of water in the pool just upstream of the coal-waste dam was 47.3 feet. The surface area of the pool at the time of the dam failure was 14.2 acres (fig. 10), and the pool extended 2,100 feet up the Middle Fork valley.

FIGURE 9.—Height of the pool behind coal-waste dam No. 3 rose to a maximum of 1,753.1 feet.

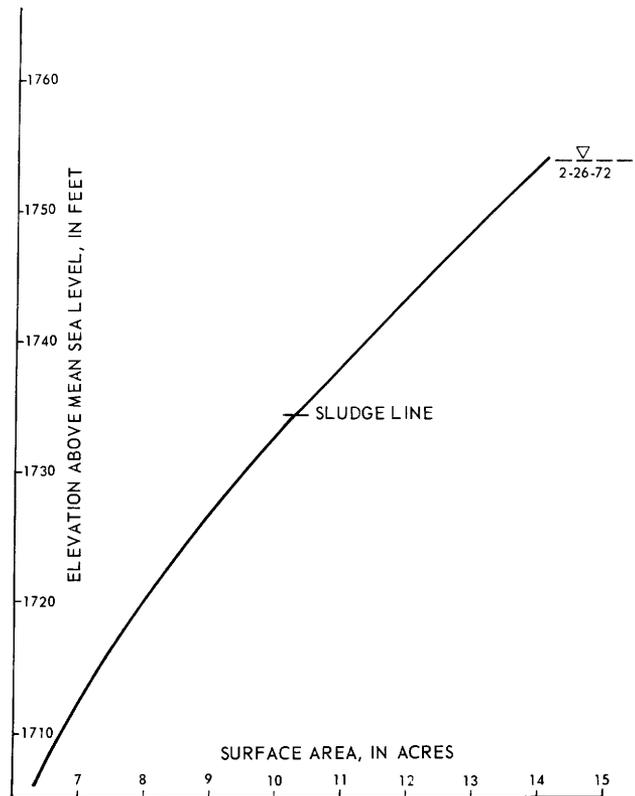
FIGURE 10.—The pool behind dam No. 3 covered a maximum of 14.2 acres at the time the dam collapsed.

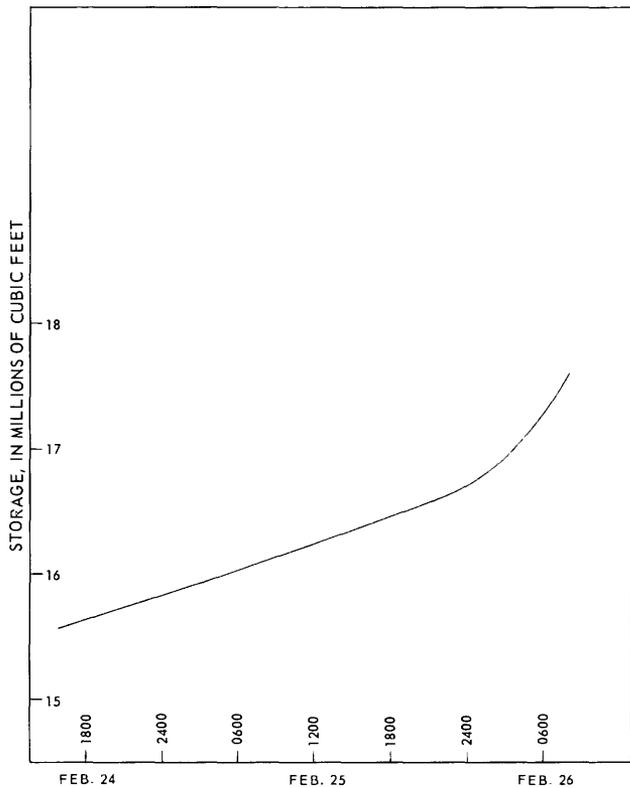
At 4:00 p.m. Thursday, February 24, a local mining-company employee placed a measuring stick on the lowest point of the back (upstream) side of coal-waste dam No. 3 so that the top of the stick was approximately 1 foot below the compacted part of the dam. This employee visited the dam frequently between 4:00 p.m. Thursday and 4:30 a.m. Saturday, observing the rate of rise of the pool. Analysis of the observations indicate a rise of slightly less than 1 inch per hour on Thursday afternoon, increasing to about 3 inches per hour by 3:00 a.m. Saturday. Using the stage-volume curve shown in figure 9 and the observations made on the measuring stick, the rate of rise of the pool is shown in figure 11.

FIGURE 11.—The volume of water in the pool behind coal-waste dam No. 3 increased steadily between February 24-26.

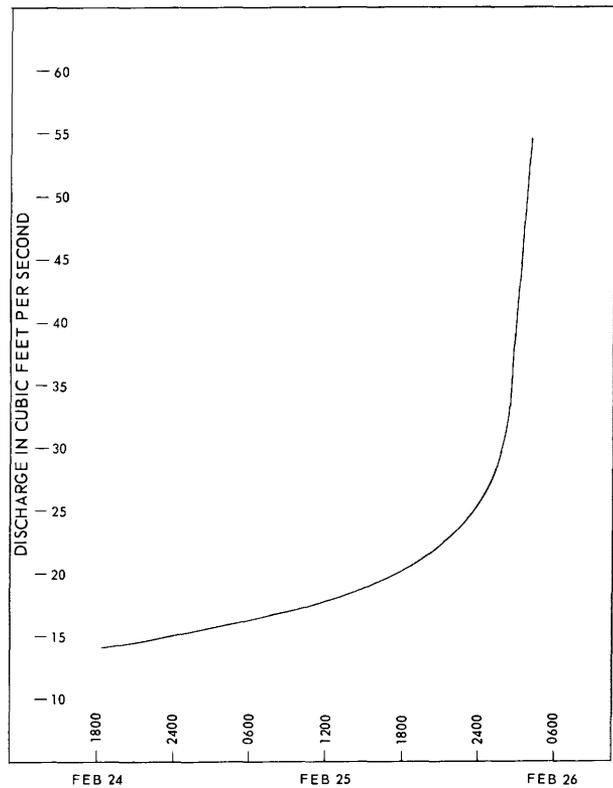
Using the rate of change in contents relation developed in figure 11 and adjusting for outflow, the inflow graph shown in figure 12 was developed for the period 4:00 p.m. Thursday, February 24, to 4:00 a.m. Saturday, February 26, when observations on the elevation of the impounded water were discontinued. The inflow curve does not include seepage through the dam. Maximum seepage, estimated at less than 10 cfs (4,500 gpm), would have occurred just prior to failure when the hydraulic gradient through the dam was the greatest.

FIGURE 12.—Inflow to the pool behind coal-waste dam No. 3 from 6:00 p.m. Thursday, February 24, to 4:00 a.m. Saturday, February 26.

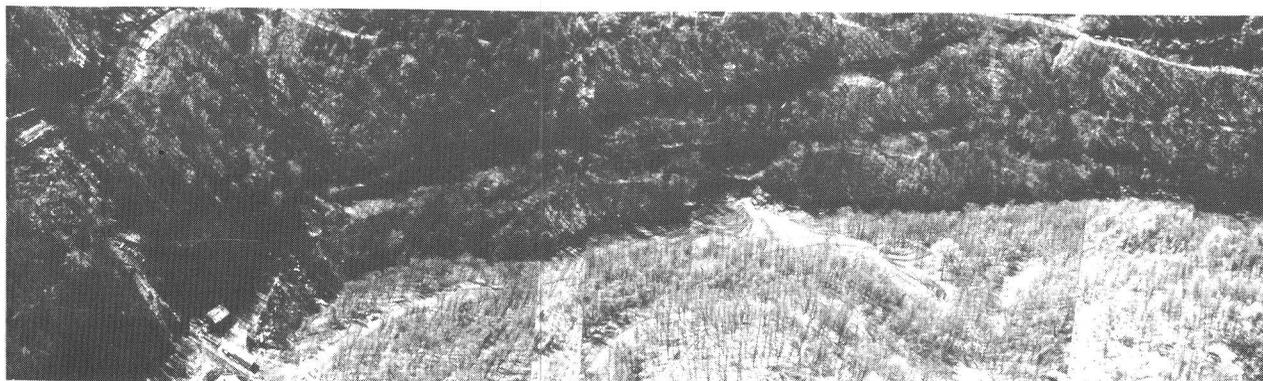
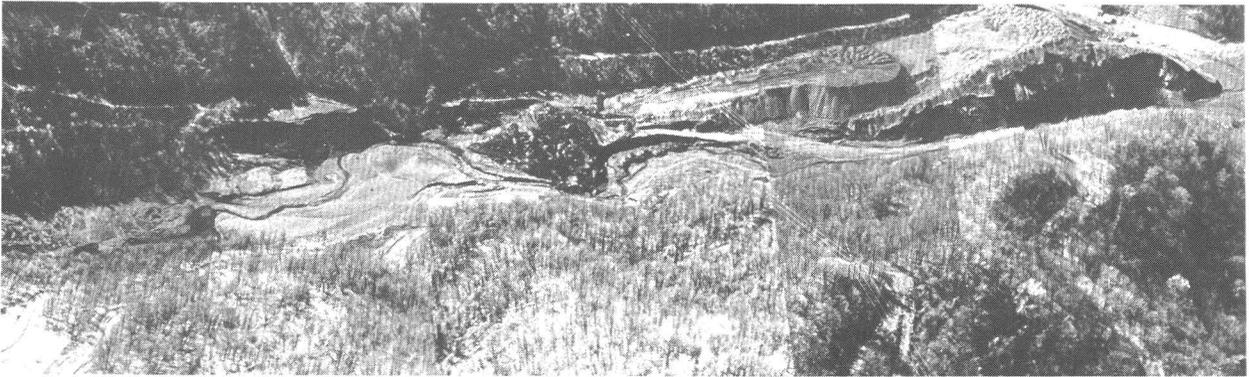
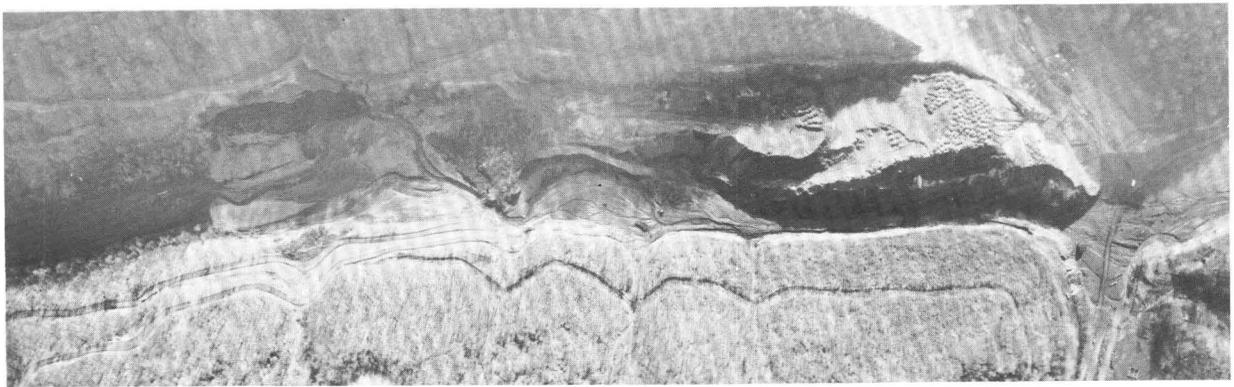
FIGURE 26.—Middle Fork, panoramic view (A), mine No. 5 to Buffalo Creek, March 5, 1972. Vertical aerial photograph (B), dam No. 3 to Buffalo Creek, February 28, 1972.

About 6 million cubic feet of coal waste and other debris was carried downstream from the breach at dam No. 3 (figs. 26A and 26B). Some of this debris was deposited as slumps in pool No. 2 in front of dam No. 3. Practically none was left in the clear pool, and over 90 percent of the debris was carried into Buffalo Creek valley and deposited as far downstream as Pardee, 2 miles below Middle Fork (fig. 27).

SITE OF
DAM NO. 2
↓
CLEAR POOL

BURNING COAL WASTE BANK
NW
BUFFALO CREEK

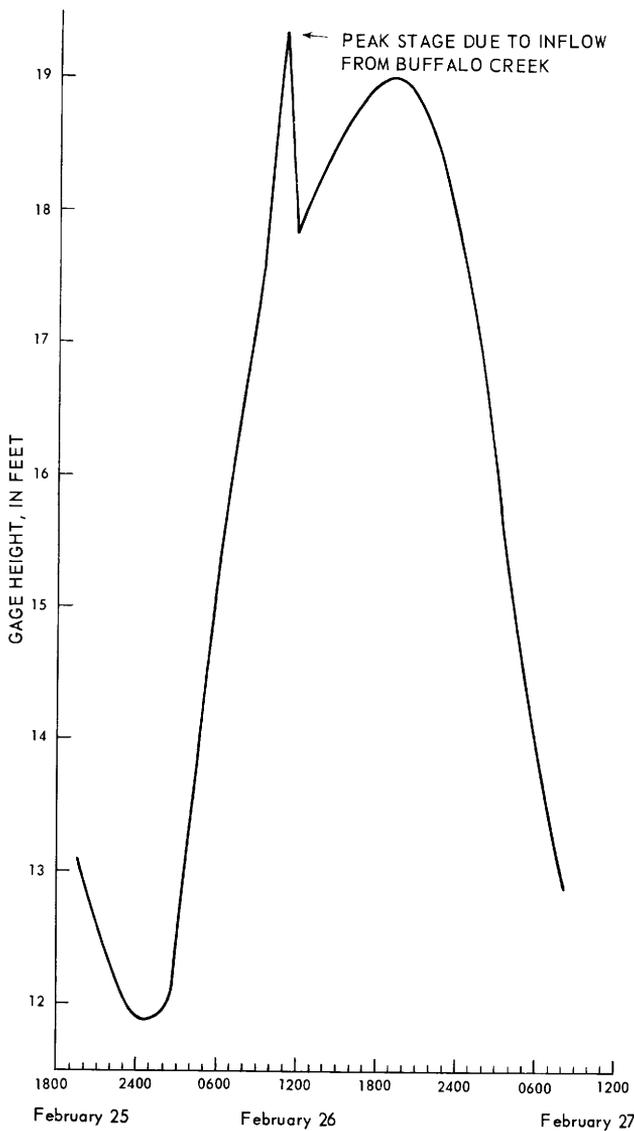
of the dam on Middle Fork (fig. 28). The peak discharge of 31,600 cfs (14 million gpm) related to this stage may not be reliable due to variable backwater. The peak discharge of 30,700 cfs (13.7 million gpm) occurring at gage height 19.02 was the result of natural drainage.

FIGURE 28.—The flood inflow from Buffalo Creek produced a sudden high peak of 19.34 feet on the gaging station record for Guyandotte River at Man at 11:00 a.m., February 26. Peak discharge was 31,600 cubic feet per second.

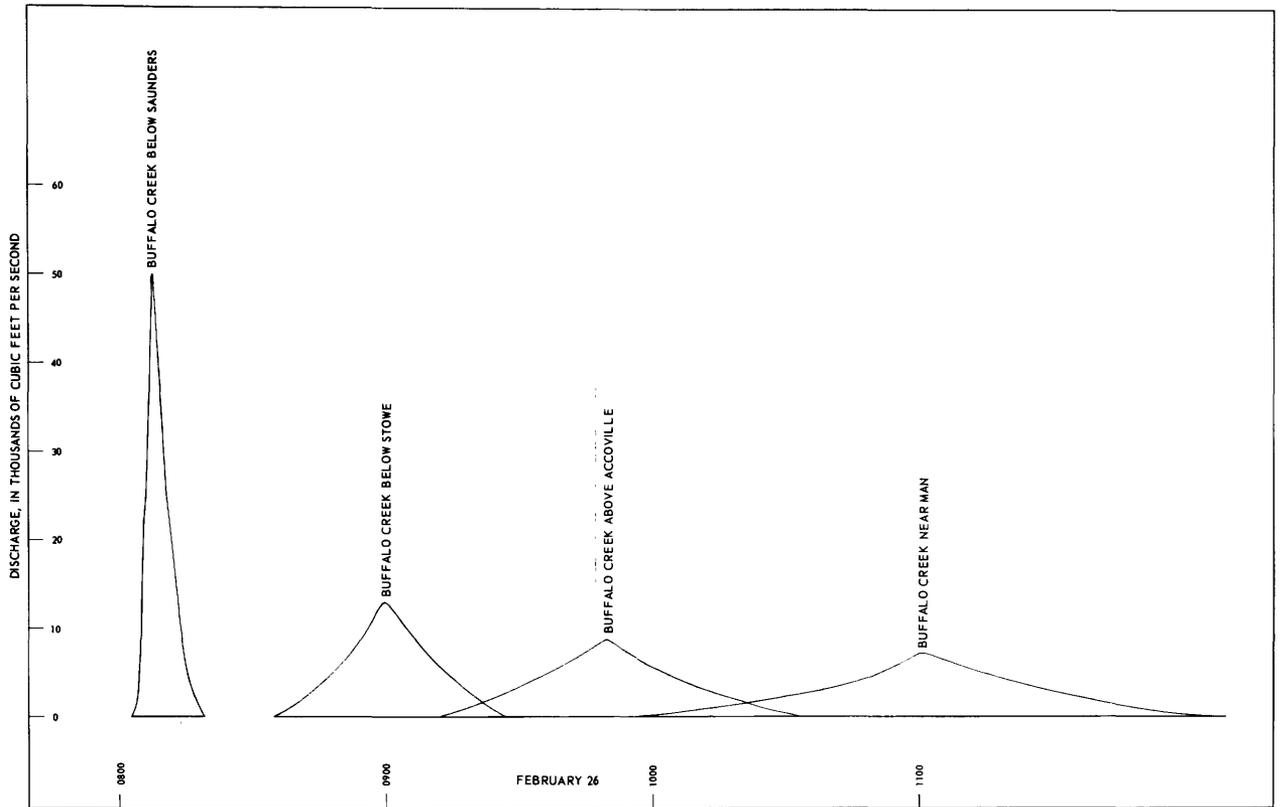
FIGURE 29.—Estimated flood hydrographs for Buffalo Creek below Saunders, below Stowe, above Accoville, and near Man on February 26, 1972.

Peak discharges were greatly reduced due to valley storage as the flood wave moved downstream. This effect is shown in figure 29, where flood hydrographs were estimated on the basis of peak flow information obtained at indirect measuring sites and from flow duration information furnished by local residents. Attenuation due to valley storage reduced the peak flow to 13,000 cfs (5.8 million gpm) by the time the flood crest reached Stowe 6 miles downstream from the mouth of Middle Fork; although the total discharge past Stowe was slightly greater than the total flow past Saunders, the floodflow took more than three times longer to travel past Stowe. The same attenuating effect from valley storage stretched out the floodflow all the way down Buffalo Creek; the floodflow that took only 15 minutes to pass Saunders took 2 hours to pass Man. Despite the attenuation, peak flow at Stowe was still unusually high, approximately four times that of a naturally occurring 50-year flood.

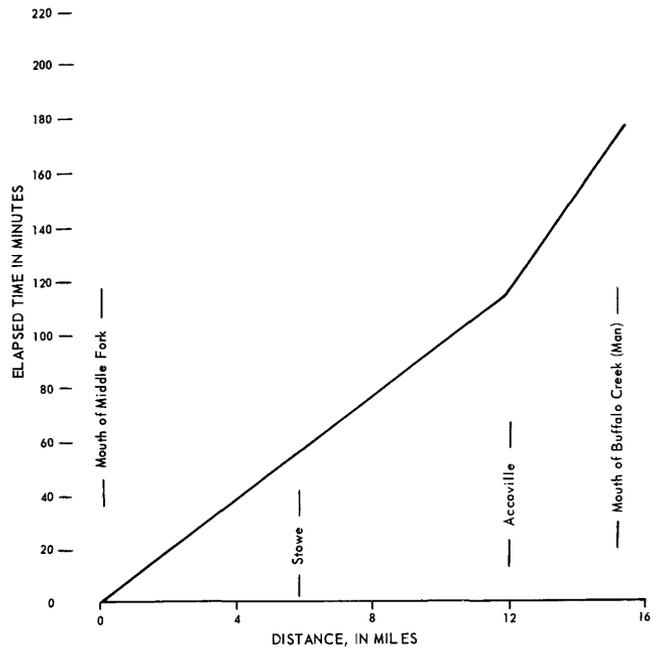
FIGURE 30.—Time of travel of the flood wave down Buffalo Creek from Middle Fork to Man.

hours, reaching the mouth of Buffalo Creek at Man at 11:00 a.m. on February 26. The traveltime versus distance relation for the flood wave is shown in figure 30.

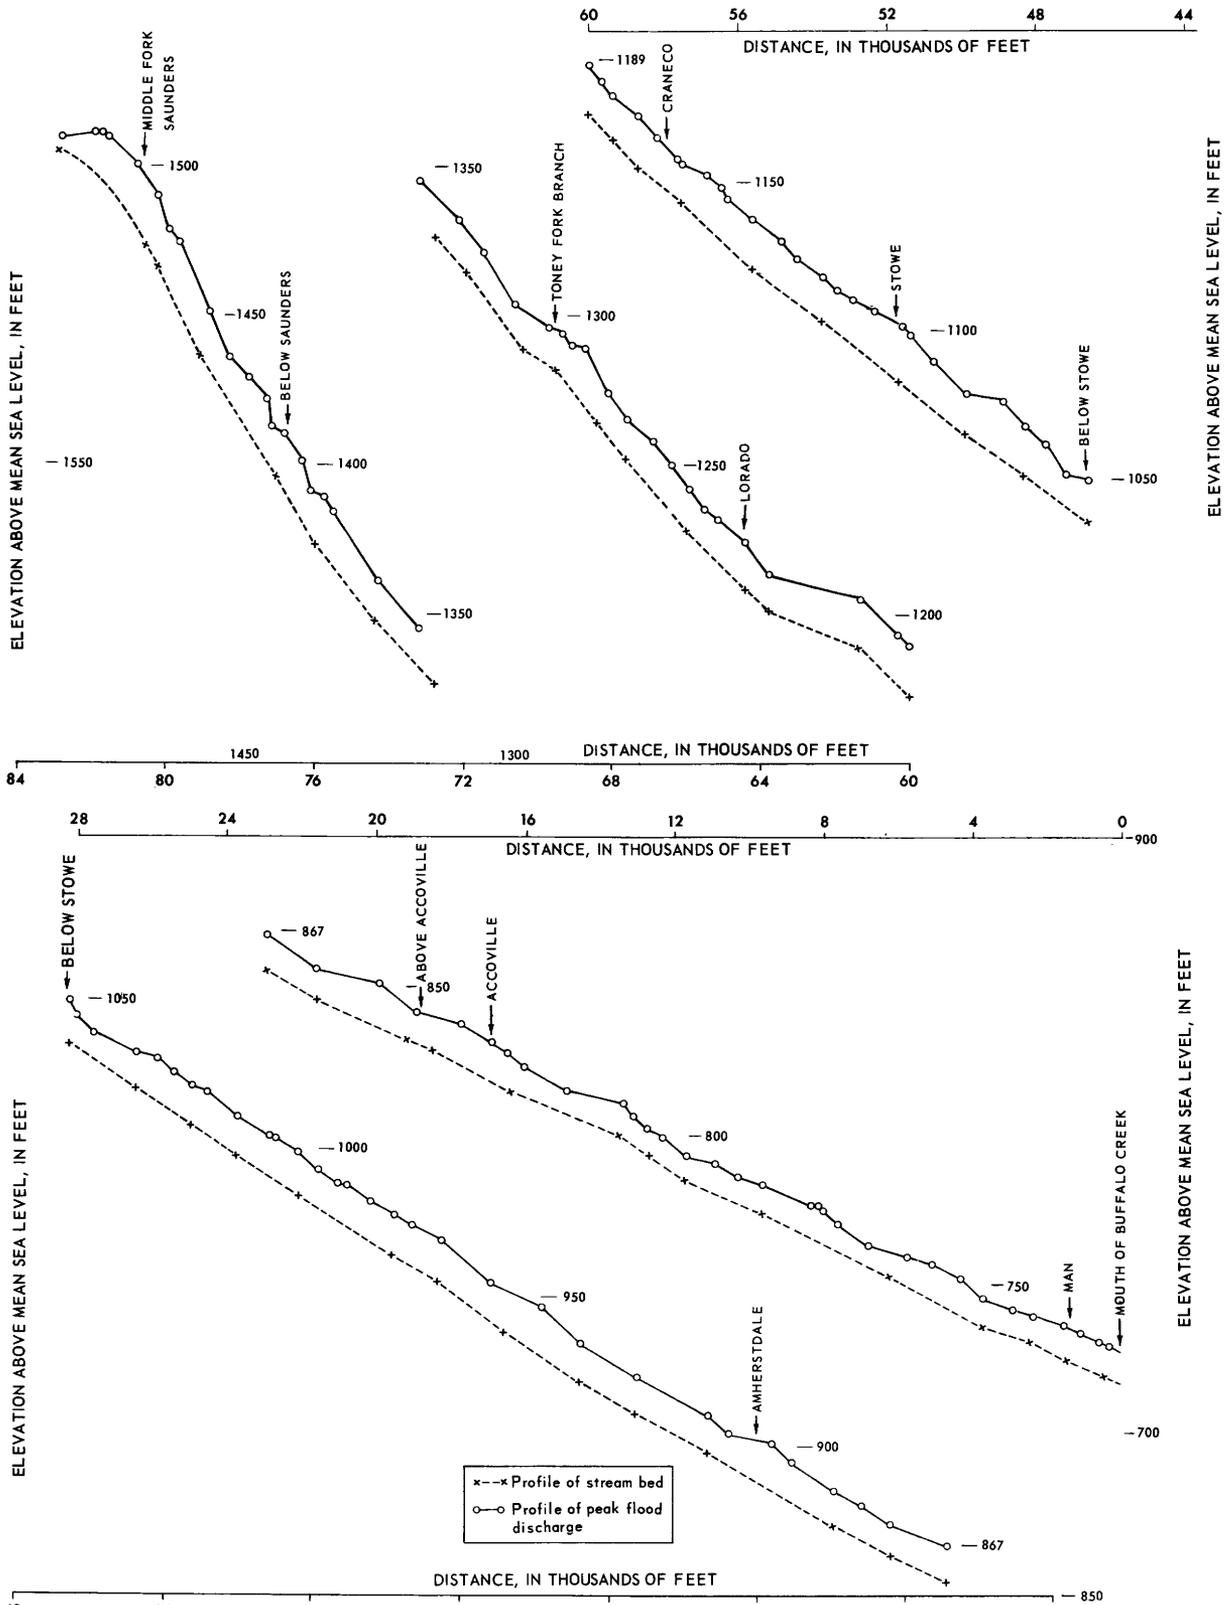
FIGURE 31.—Profile of the peak flood discharge and of the streambed, Buffalo Creek, Middle Fork to Man.

Profiles of the flood wave and of the streambed were obtained for the 15-mile reach of Buffalo Creek from the mouth of Middle Fork to Man, from a survey of high-water marks at many sites throughout the reach (fig. 31). The fall, or total drop in elevation, from Saunders to Man is approximately 750 feet. The slope of the flood profile ranges from an average of 96 feet per mile in the reach from Saunders to Pardee to 33 feet per mile in the reach from Accoville to Man.

The depth of flow in the stream channel at points along Buffalo Creek can be estimated from figure 31 by subtracting the bed elevation from the flood profile. The flood plain of Buffalo Creek ranges from 200 to 500 feet wide throughout the reach from Saunders to Man. Ground elevations on this flood plain can be determined by surveying to selected points on the flood plain from nearby bench marks. The depth of flooding on the flood plain can then be estimated by subtracting the ground elevation from the flood profile shown in figure 31. At the time of the peak, the depth of flow on the flood plain was approximately 12-10 feet deep from Saunders to Lorado, 9-6 feet deep from Craneco to Latrobe, and 5-2 feet deep from Robinette to Kistler.
