I am transmitting herewith my report on the failure of the Mammoth Dam.

REPORT ON THE FAILURE OF THE MAMMOTH DAM

The Mammoth dam is situated on the southwest quarter of Section 6, T. 13 S., R. 6 E., twelve miles east of Fairview, Utah, and is owned by the Price River Irrigation Company of Salt Lake City. The officers of the company are

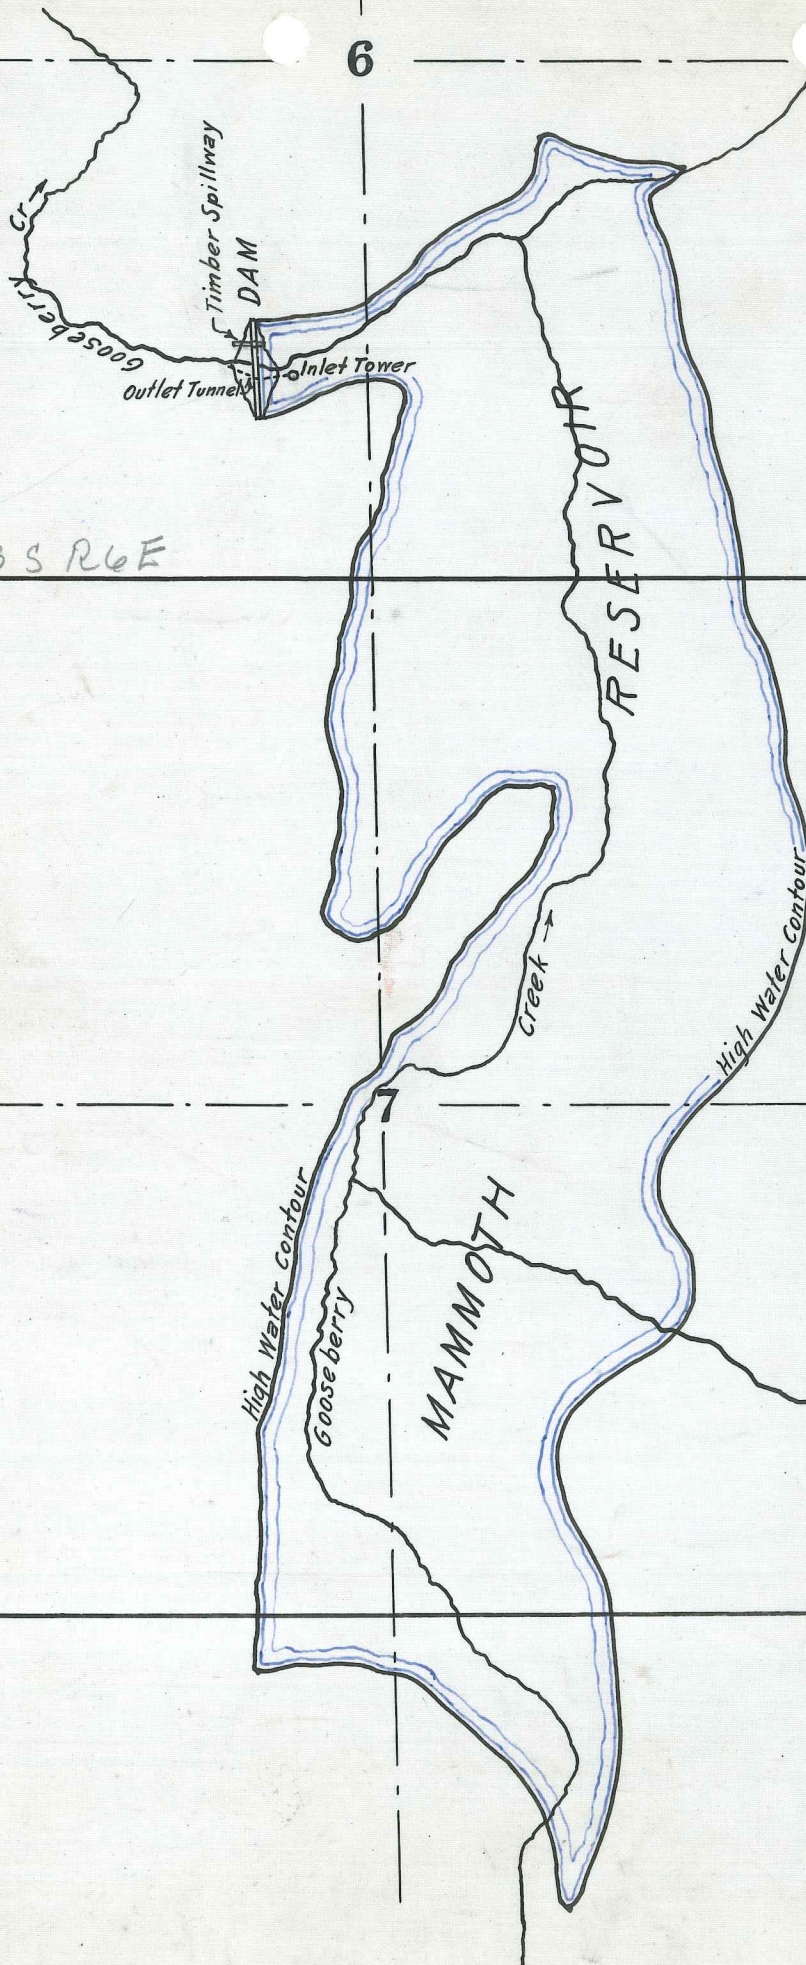
A review of the situation shows that this dam failed, first; because the flume portion of the spillway was improperly and inadequately constructed, second; because the horizontal

reinforcement in the core wall had been stopped twelve feet above the base instead of being carried to the top of the core, third; the first section of core wall to fail sheared off at a point five feet below the top, indicating that the bond between the older section of the wall and the five-foot raise made last year was not what it should have been, and fourth; because the management deliberately permitted the level of the water in the reservoir to rise to within ten inches of the top of the core wall contrary to all precedent, and against all engineering practice.

UPSTREAM VIEW OF DAM AFTER BREAK
