MADISON RIVER, MONTANA
REPORT ON
*FLOOD EMERGENCY
MADISON RIVER SLIDE*

*VOLUME I
MAIN REPORT*

U. S. ARMY ENGINEER DISTRICT, OMAHA
CORPS OF ENGINEERS
OMAHA, NEBRASKA
SEPTEMBER 1960

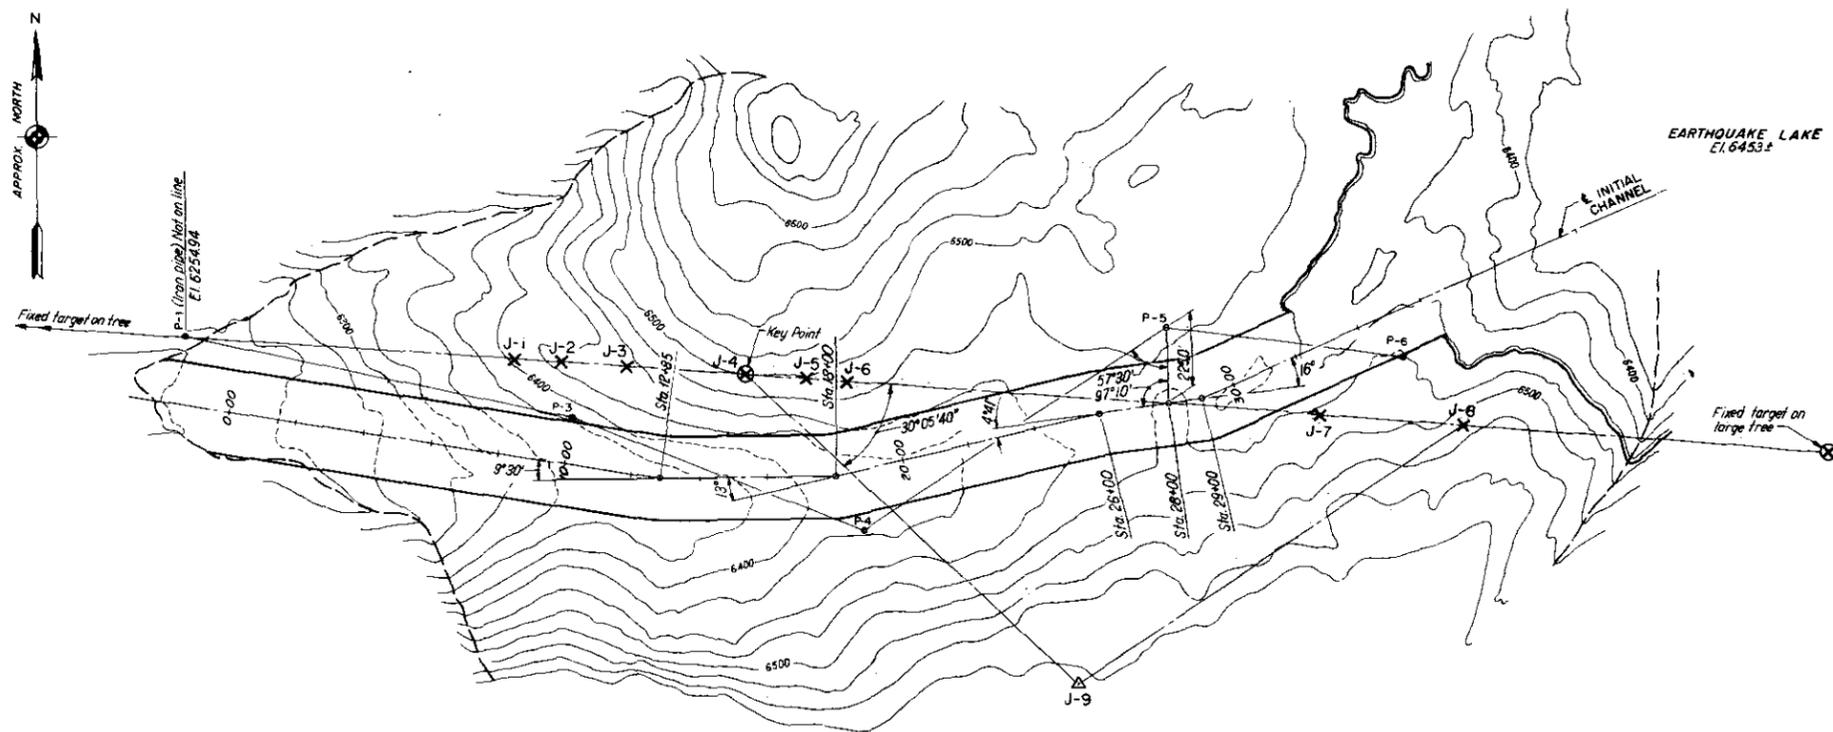
MADISON RIVER, MONTANA
FLOOD EMERGENCY
MADISON RIVER SLIDE
MOVEMENT POINTS
SEPT. 1960

71. Possible additional slides. Safety of the people working on the slide being of paramount importance, extensive studies were made of conditions along the crest of the slide scar and on the slide mass itself, to estimate the probability of additional slides that would endanger personnel or block the spillway channel. Visible cracks behind the crest of the slide ridge showed that two areas held a potential for movement. Sets of strain gages, consisting of pipes driven into the surface and tied together with wires, were installed across these cracked and displaced areas. Distances between the pipes were measured at frequent intervals to detect possible movement. Some of the wires were fitted with flag markers to permit airborne observers to detect any significant movement. Readings of the strain gages and aerial observations during the period from 29 and 30 August, when they were installed, to 19 September indicated that no significant movement had occurred.
