MADISON RIVER, MONTANA
REPORT ON
*FLOOD EMERGENCY
MADISON RIVER SLIDE*

*VOLUME II
APPENDIXES*

U. S. ARMY ENGINEER DISTRICT, OMAHA
CORPS OF ENGINEERS
OMAHA, NEBRASKA
SEPTEMBER 1960

PRELIMINARY STUDIES OF MADISON
CANYON SLIDE AND HEBGEN DAM

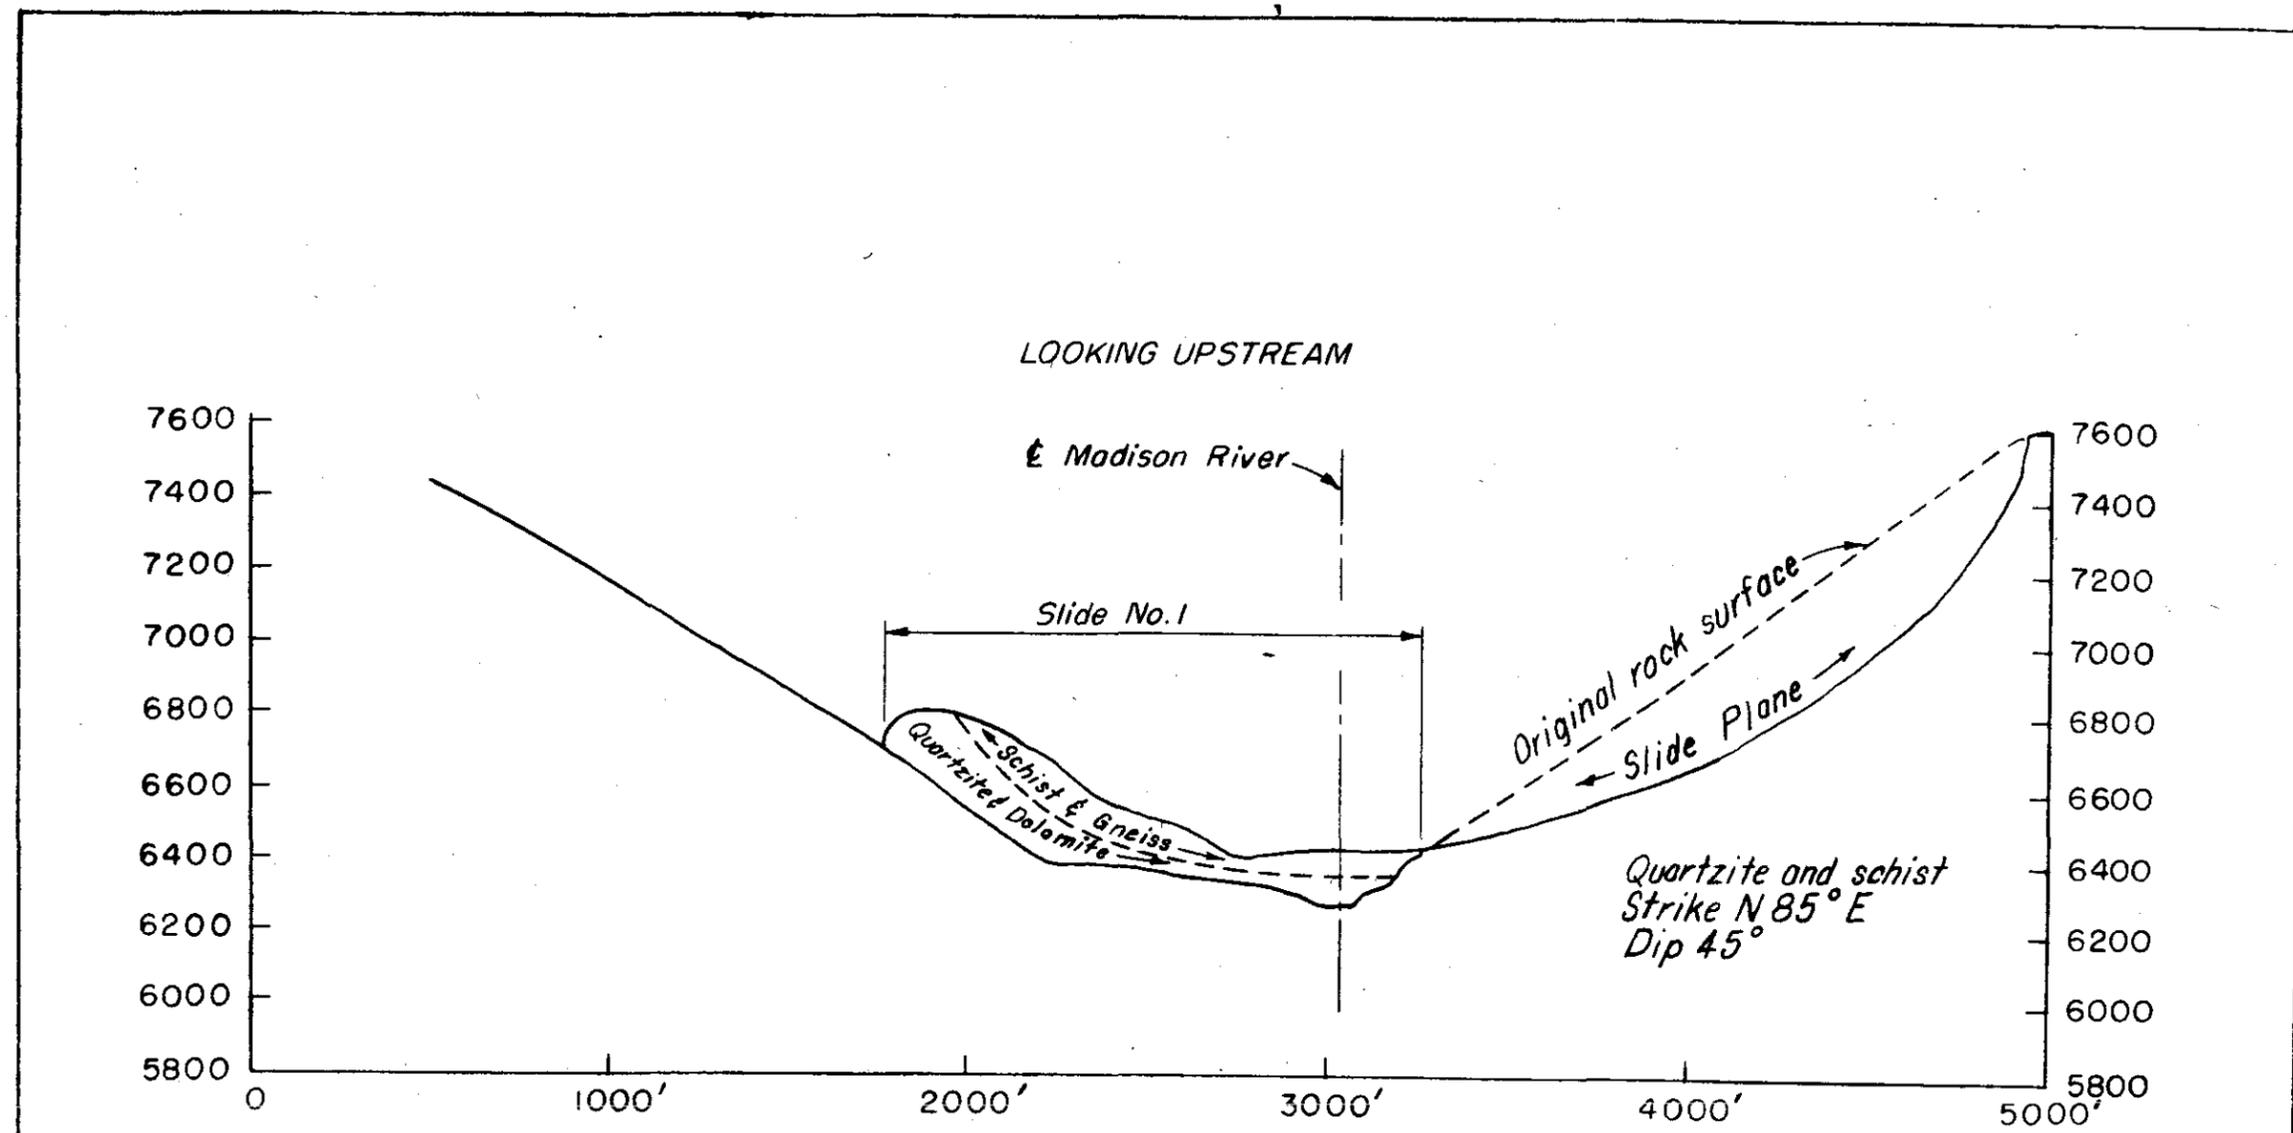
GEOLOGIC SECTION A-A

2. The berm or terrace, composed largely of chlorite schist and illustrated on Plate No. 2 is an incompetent loosely compacted mass. It is recommended that the discharge over the natural dam be diverted from the toe of this material to avoid the possibility of triggering slides. Materials necessary to fill in low areas across the upstream face and top of the rock-filled dam should be derived from the quartzite and dolomite ridge to the north.

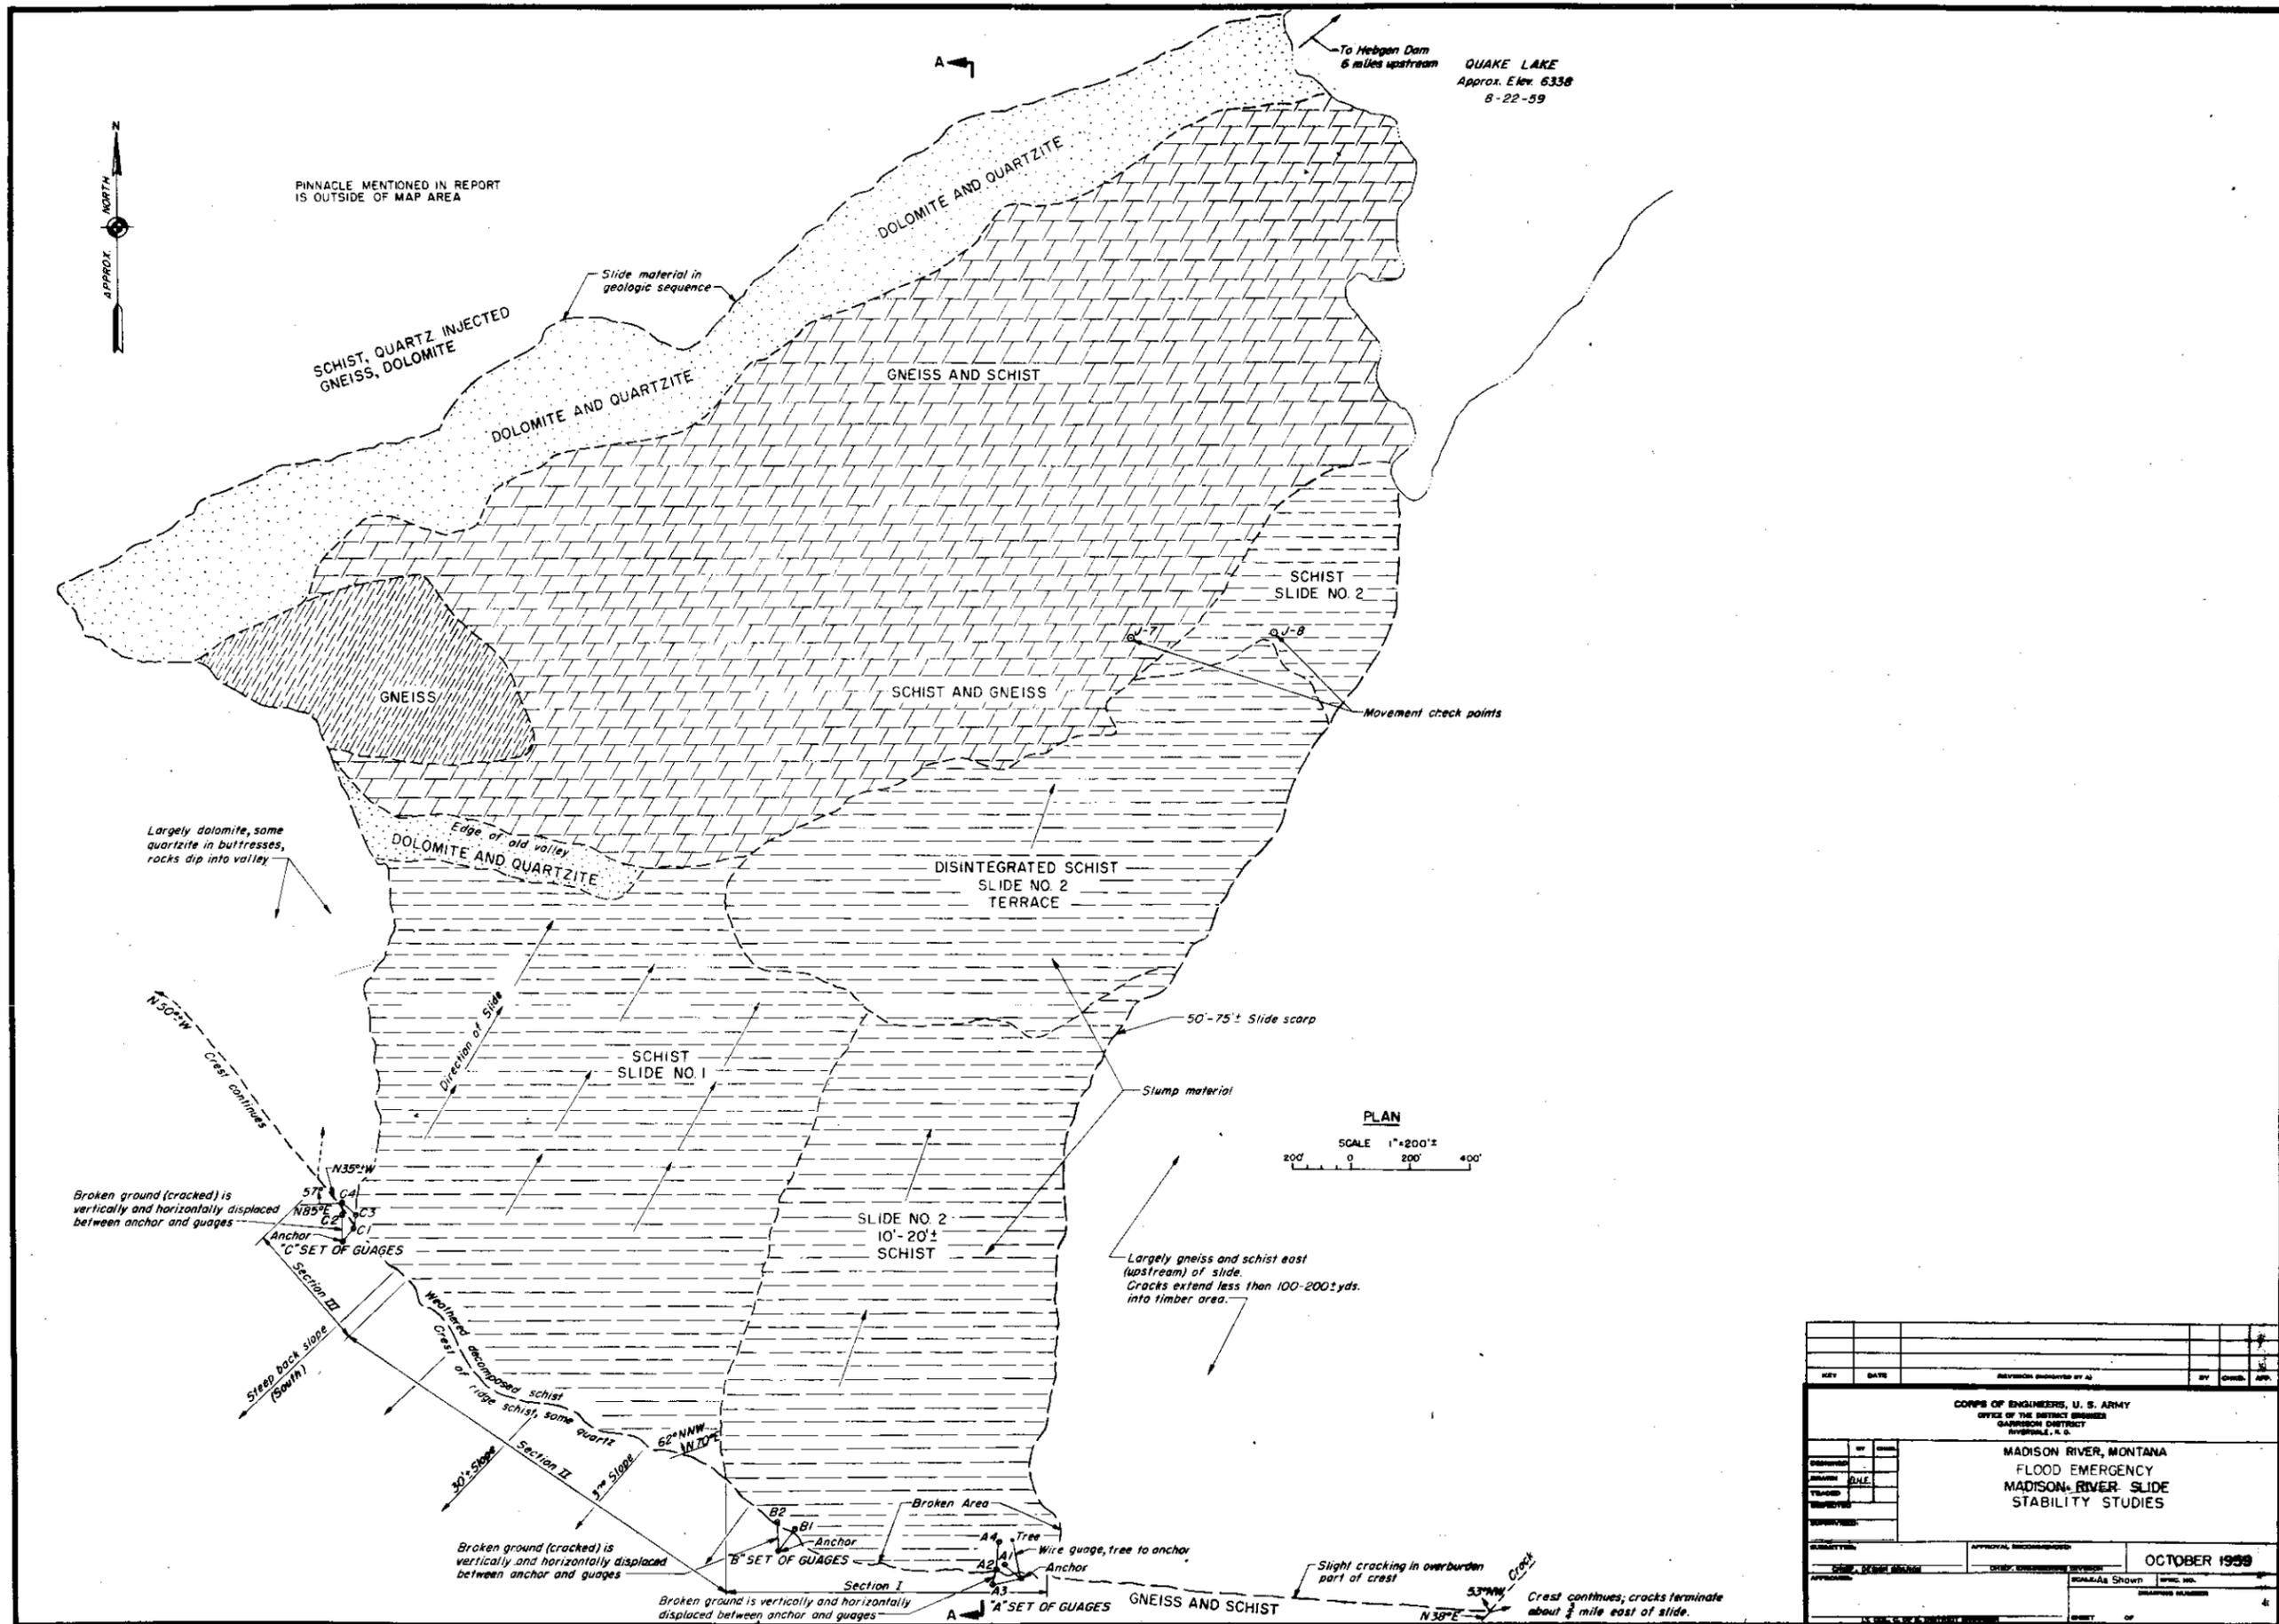
APPENDIX IX KNIGHT-CURTISS REPORT FIG. 1

7. At the west end of the ridge, the volume of material susceptible to sliding has been estimated at slightly over one million cubic yards of material. At the east end (section I on figure 1 and photographs * No. 1, 2, and 3), the material which is already broken loose and lies on the upper portion of the slide face has been estimated at two-thirds of a million cubic yards. The large berm lying at a corresponding location below the east slide area, which would tend to resist the movement of downsliding material, has been estimated at two million yards (see figure 3).

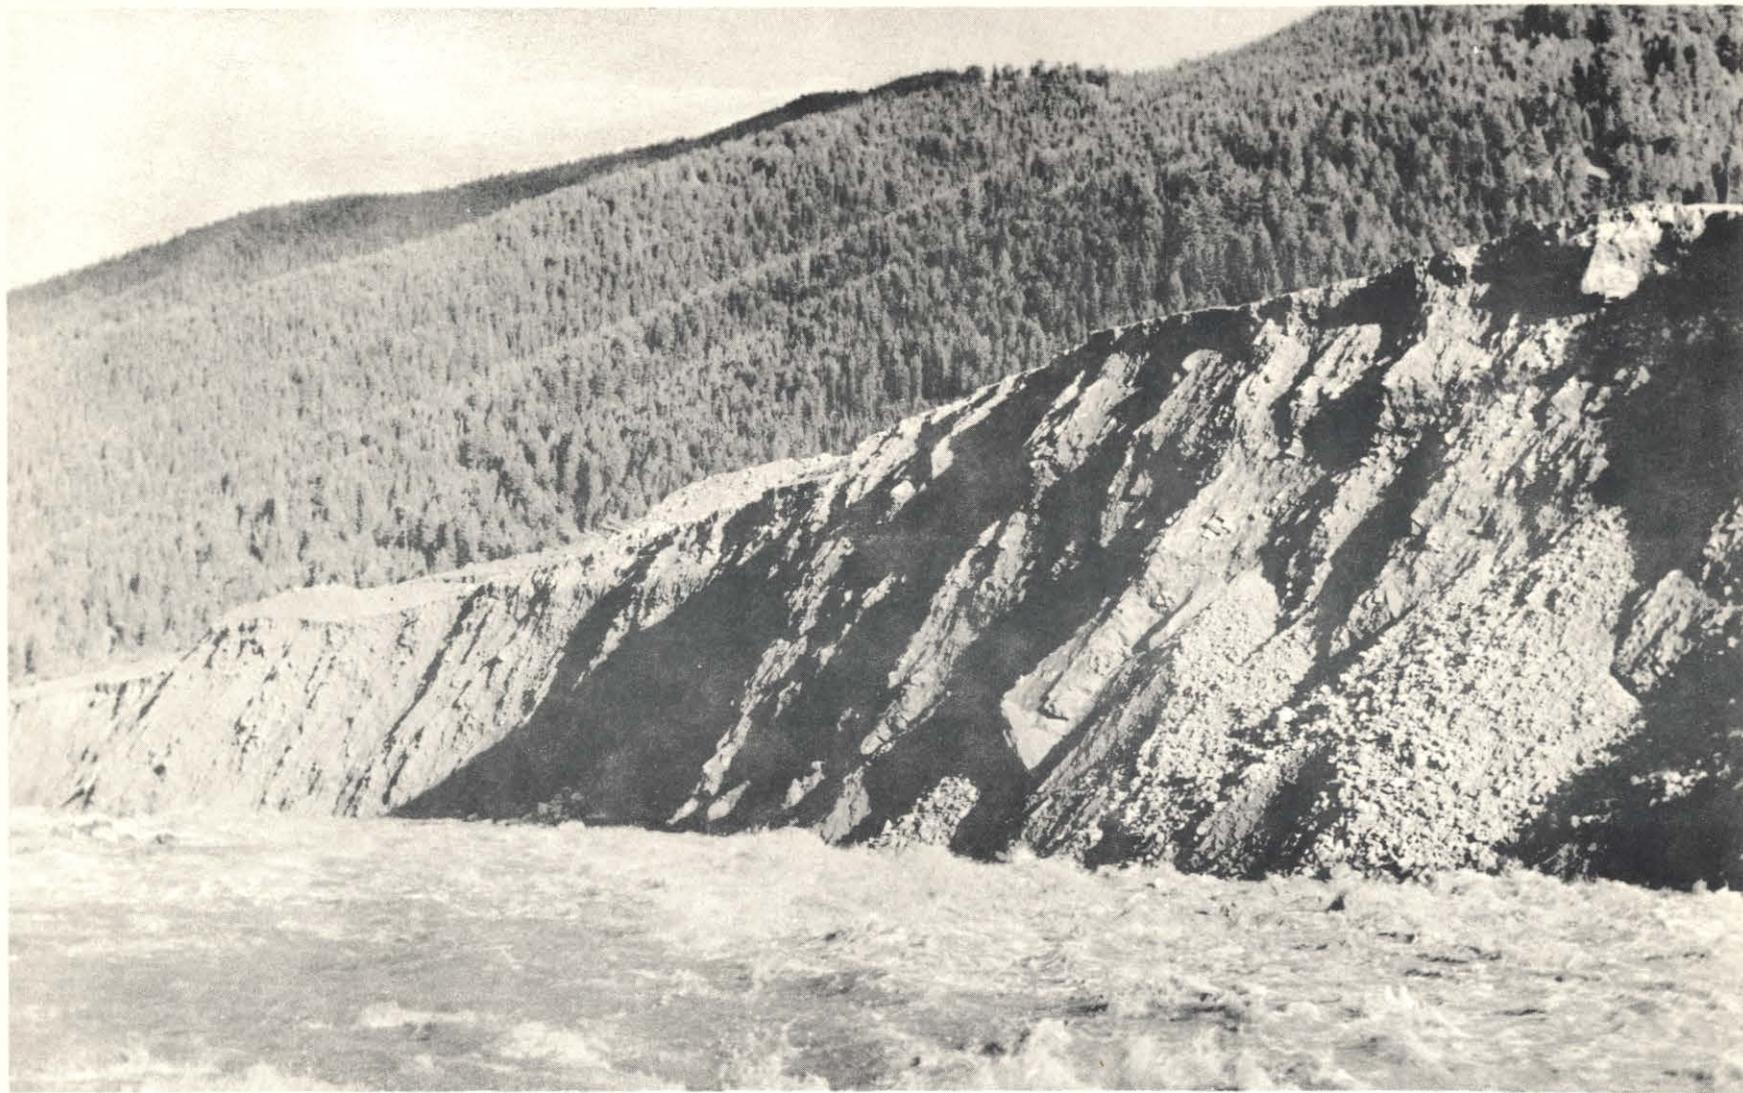
Oblique view of slide spillway taken from station 19 right bank looking upstream showing rock and soil conditions of left bank. Material "Earthy" with occasional boulders and very susceptible to erosion. Typical of downstream reach of spillway. Light bank at top the original 10 foot rock lining of spillway. Photo taken 23 October 1959. (Photo #12)
