**Observed Performance
of Dams
During Earthquakes
Volume II**

October 2000

Prepared by the USCOLD Committee on Earthquakes

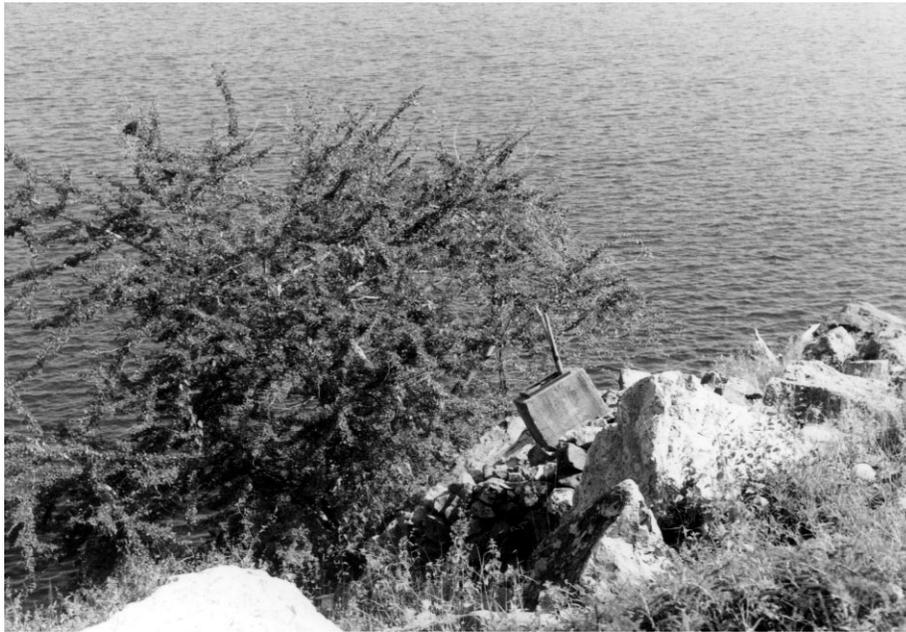
Figure 5
SETTLEMENT AT PIEZOMETER BOX
La Villita Dam

to deep within the embankment remained in place, while their protective concrete boxes settled along with the face of the dam (Figure 5).

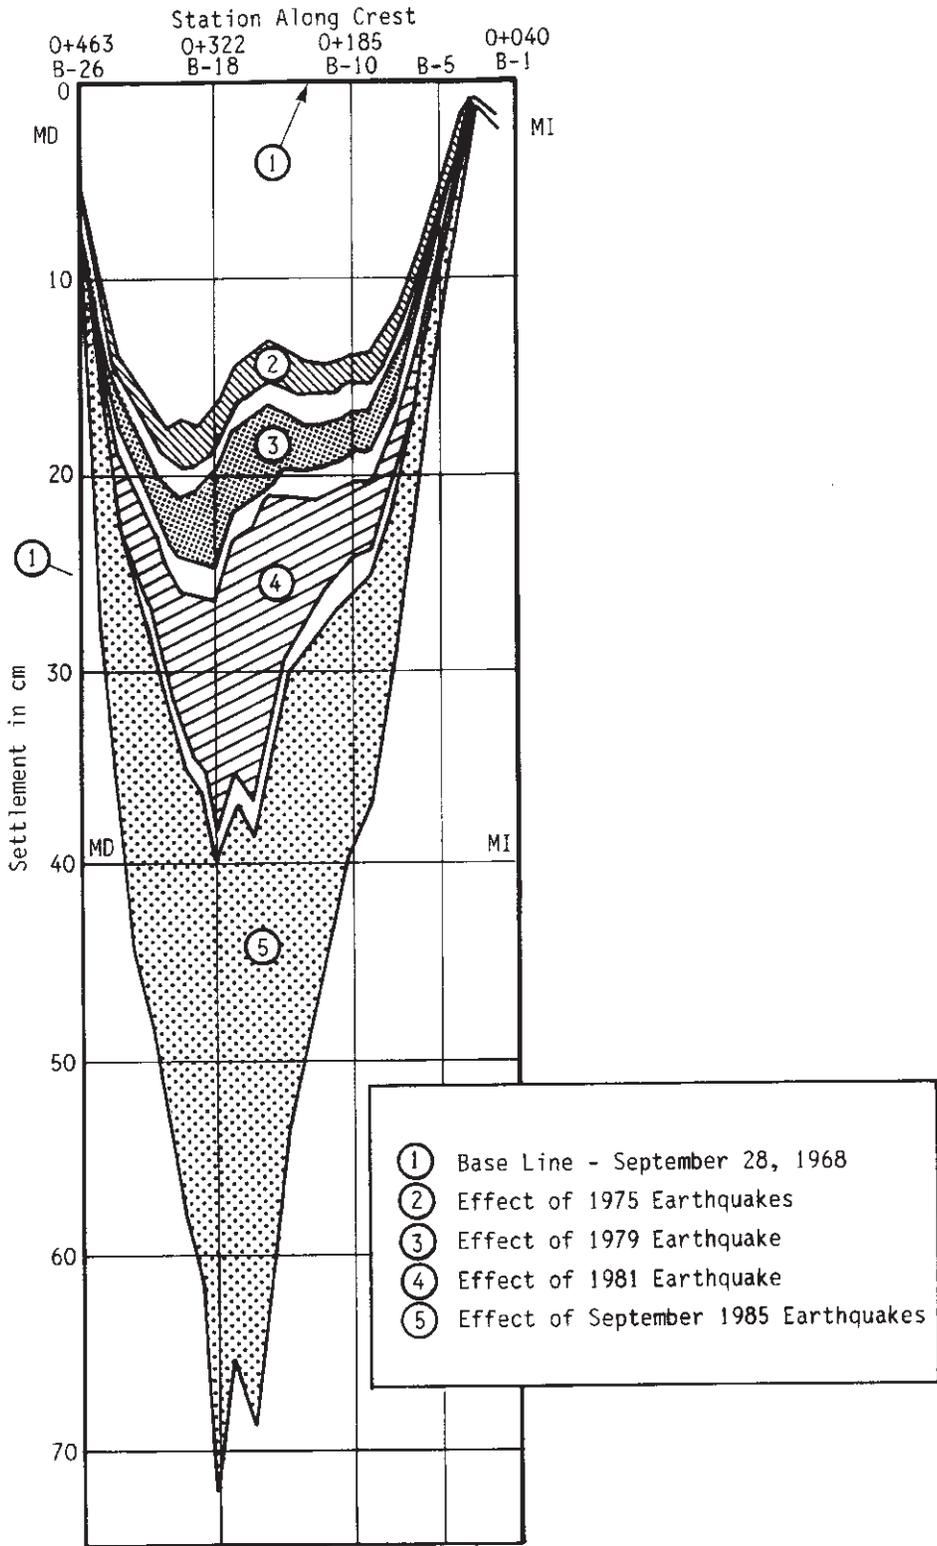
Figure 7
HISTORIC CREST SETTLEMENTS
 La Villita Dam

Survey monuments, inclinometers and extensometers were essential to provide detailed information on the earthquake-induced deformations of La Villita Dam. Of particular interest was the fact that the dam had previously been shaken by several significant earthquakes in the 12 years that preceded the 1985 event. Figure 7 shows a record of crest settlements from 1968 to 1985. Earthquake-induced settlements have been found to exceed static post-construction settlements and appear to increase in magnitude from one earthquake to the other, perhaps indicating a change in stiffness of the dam materials or a slow, cumulative, deterioration of part of the embankment. Inclinometer records confirmed that permanent deformations decreased in magnitude from crest to bottom of the embankment and did not involve the foundation materials.

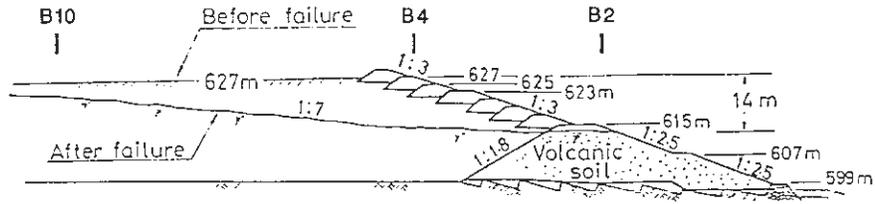
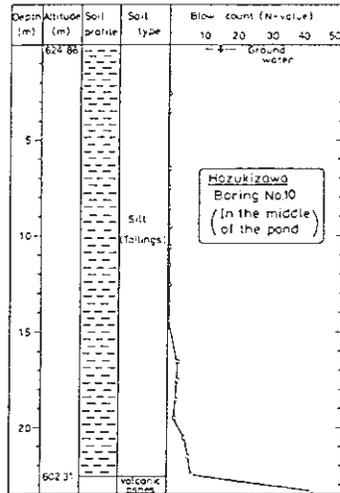
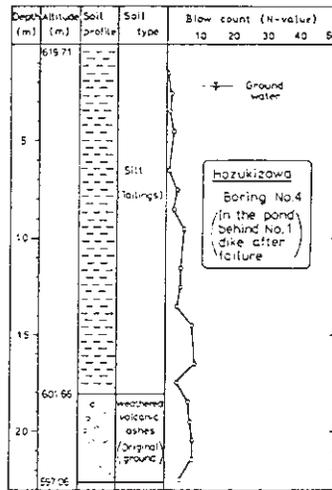
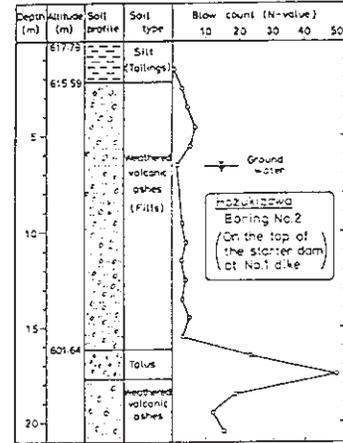
Figure 3
CROSS-SECTION THROUGH EMBANKMENT OF NO.1
DIKE AND BORING LOGS
 Mochikoshi Tailings Dam
 From Ishihara, 1984

Cross sections before and after the failures of dikes No. 1 and No. 2 are shown in Figures 3 and 4. These cross sections include the logs of borings drilled after the failures. Typical gradations of the dike and tailings materials are shown in Figures 5 and 6, respectively.

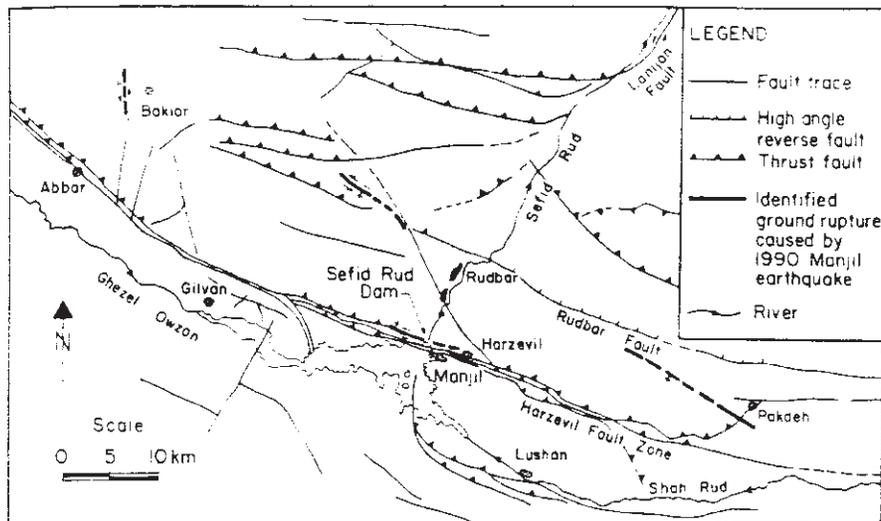
Figure 8
IDENTIFIED FAULT RUPTURE ZONES
 Sefid Rud Dam

Primary ground movements were interpreted to have occurred in the north-northwest direction, hence nearly parallel to the dam axis. Several faults, including the Rudbar and Harzevil fault zones, have been related to the occurrence of this earthquake. Immediately west of the dam, about 30 cm of strike-slip displacement and 50 cm of vertical thrust movement were observed (Figure 8), confirming the compressional nature of the tectonic process.

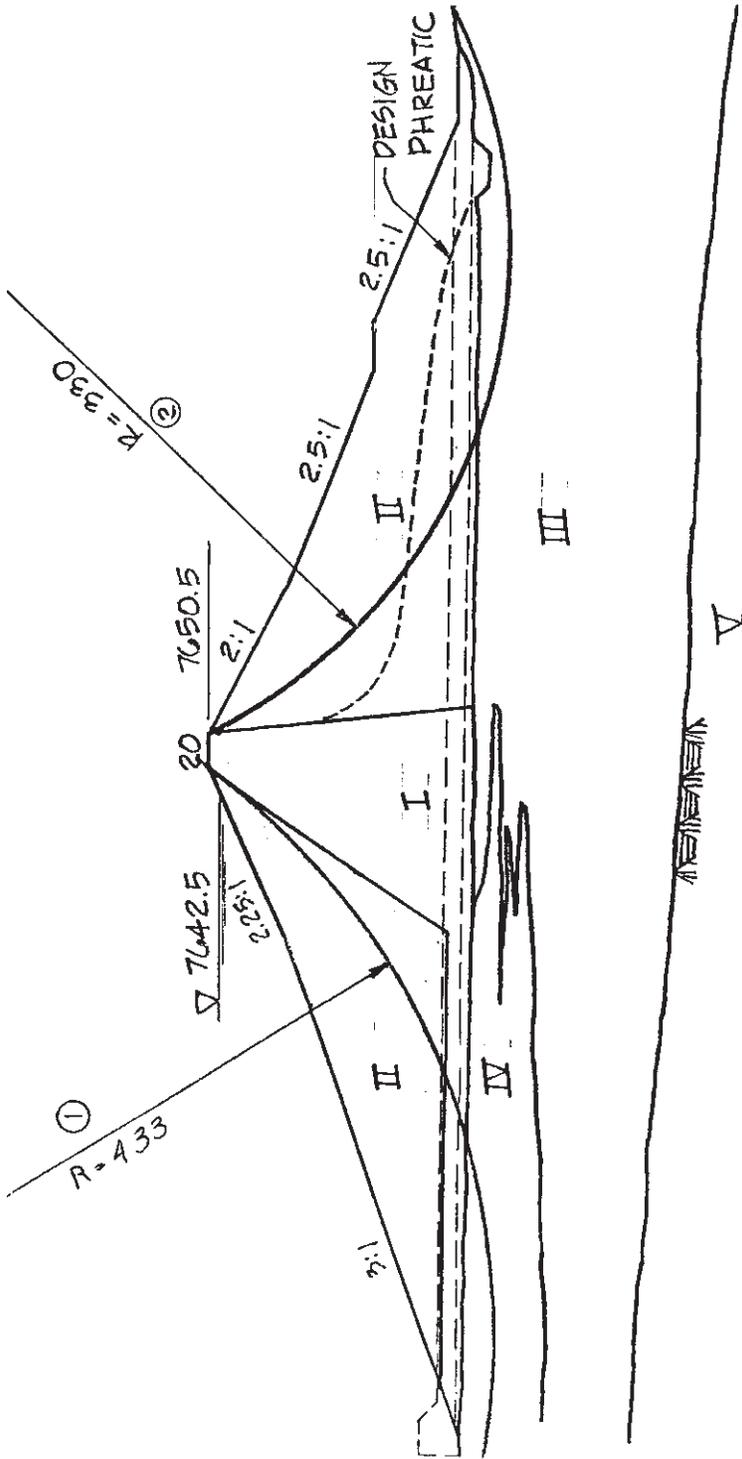
Figure 3
CROSS-SECTION
Vermilion Dam

PRINCIPAL RESULTS (RESERVOIR FULL)

CIRCLE	SAFE FACT. (STAT.)	SAFE FACT. $\alpha=0.10g$	SAFE FACT. $\alpha=0.17g$
1	2.5	1.9	1.6
2	2.4	1.8	1.6

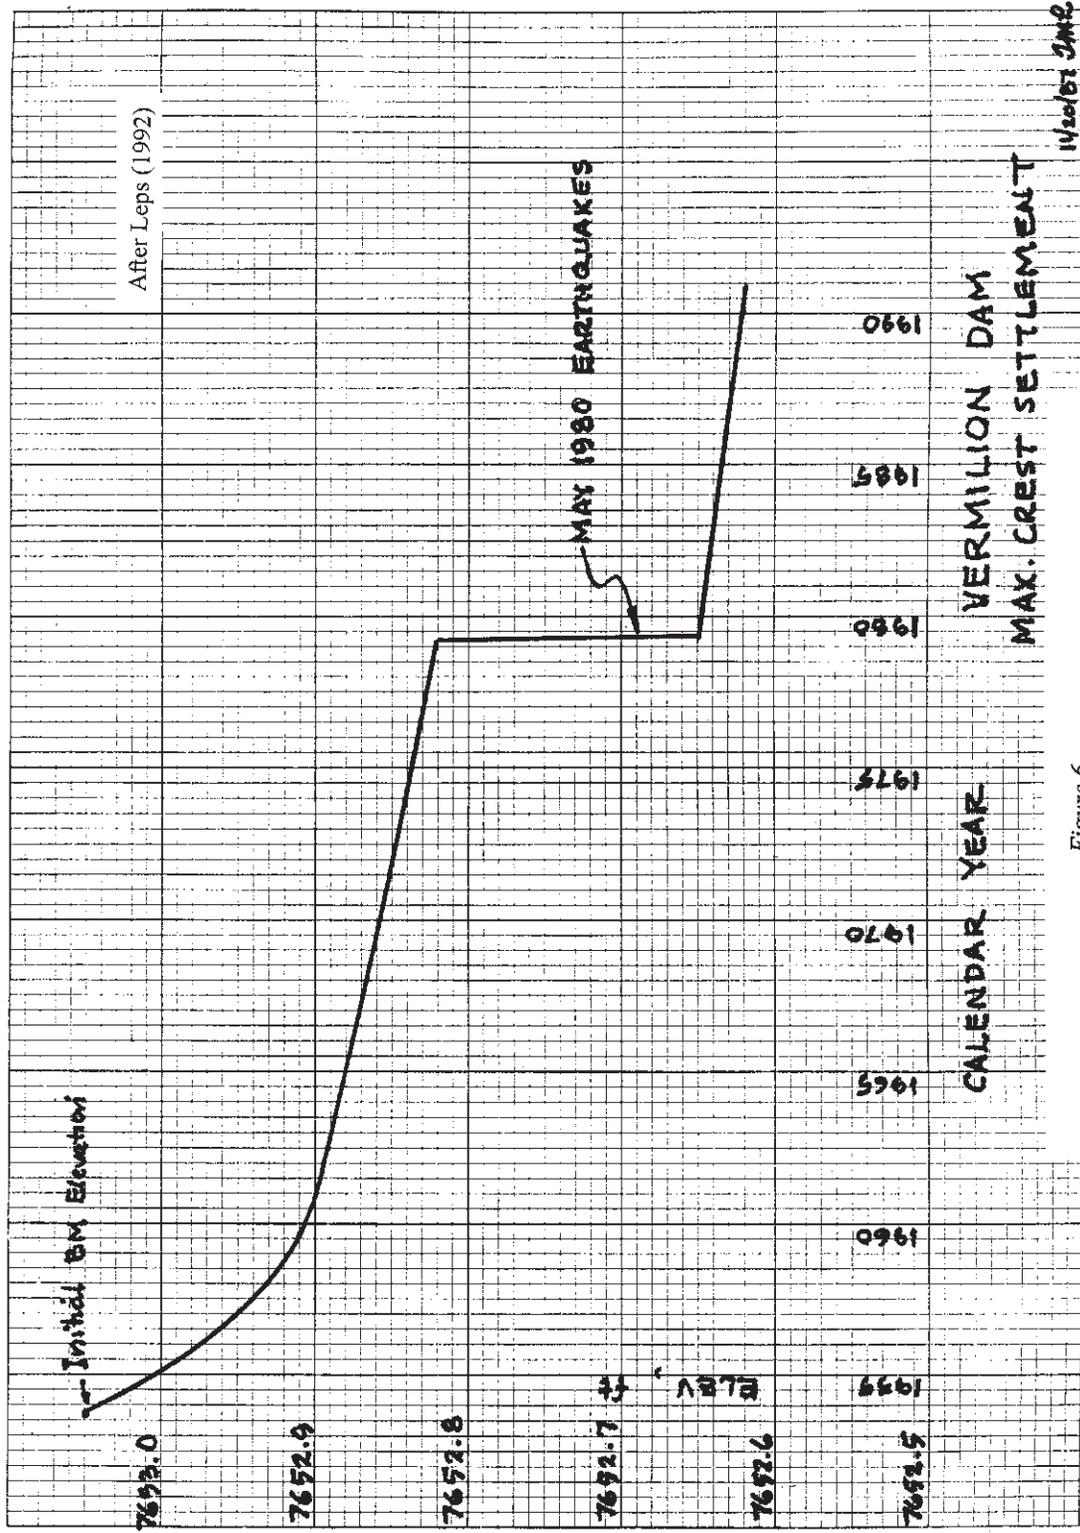
While a subsequent examination of the dam failed to find any visible damage, a resurvey of monuments on the surface of the dam was carried out and carefully reviewed. The survey data indicated that the maximum settlement, occurring at the maximum dam section, was about 0.17 ft. Figure 6 illustrates the chronology of maximum crest settlement since construction of the dam was completed in 1954.

CHRONOLOGICAL PLOT OF CREST SETTLEMENT
Vermillion Dam
