U. S. ARMY
CORPS OF ENGINEERS

REPORT
ON
INVESTIGATION OF FAILURE OF SHEFFIELD DAM
SANTA BARBARA, CALIFORNIA

OFFICE OF THE DISTRICT ENGINEER

JUNE 1949

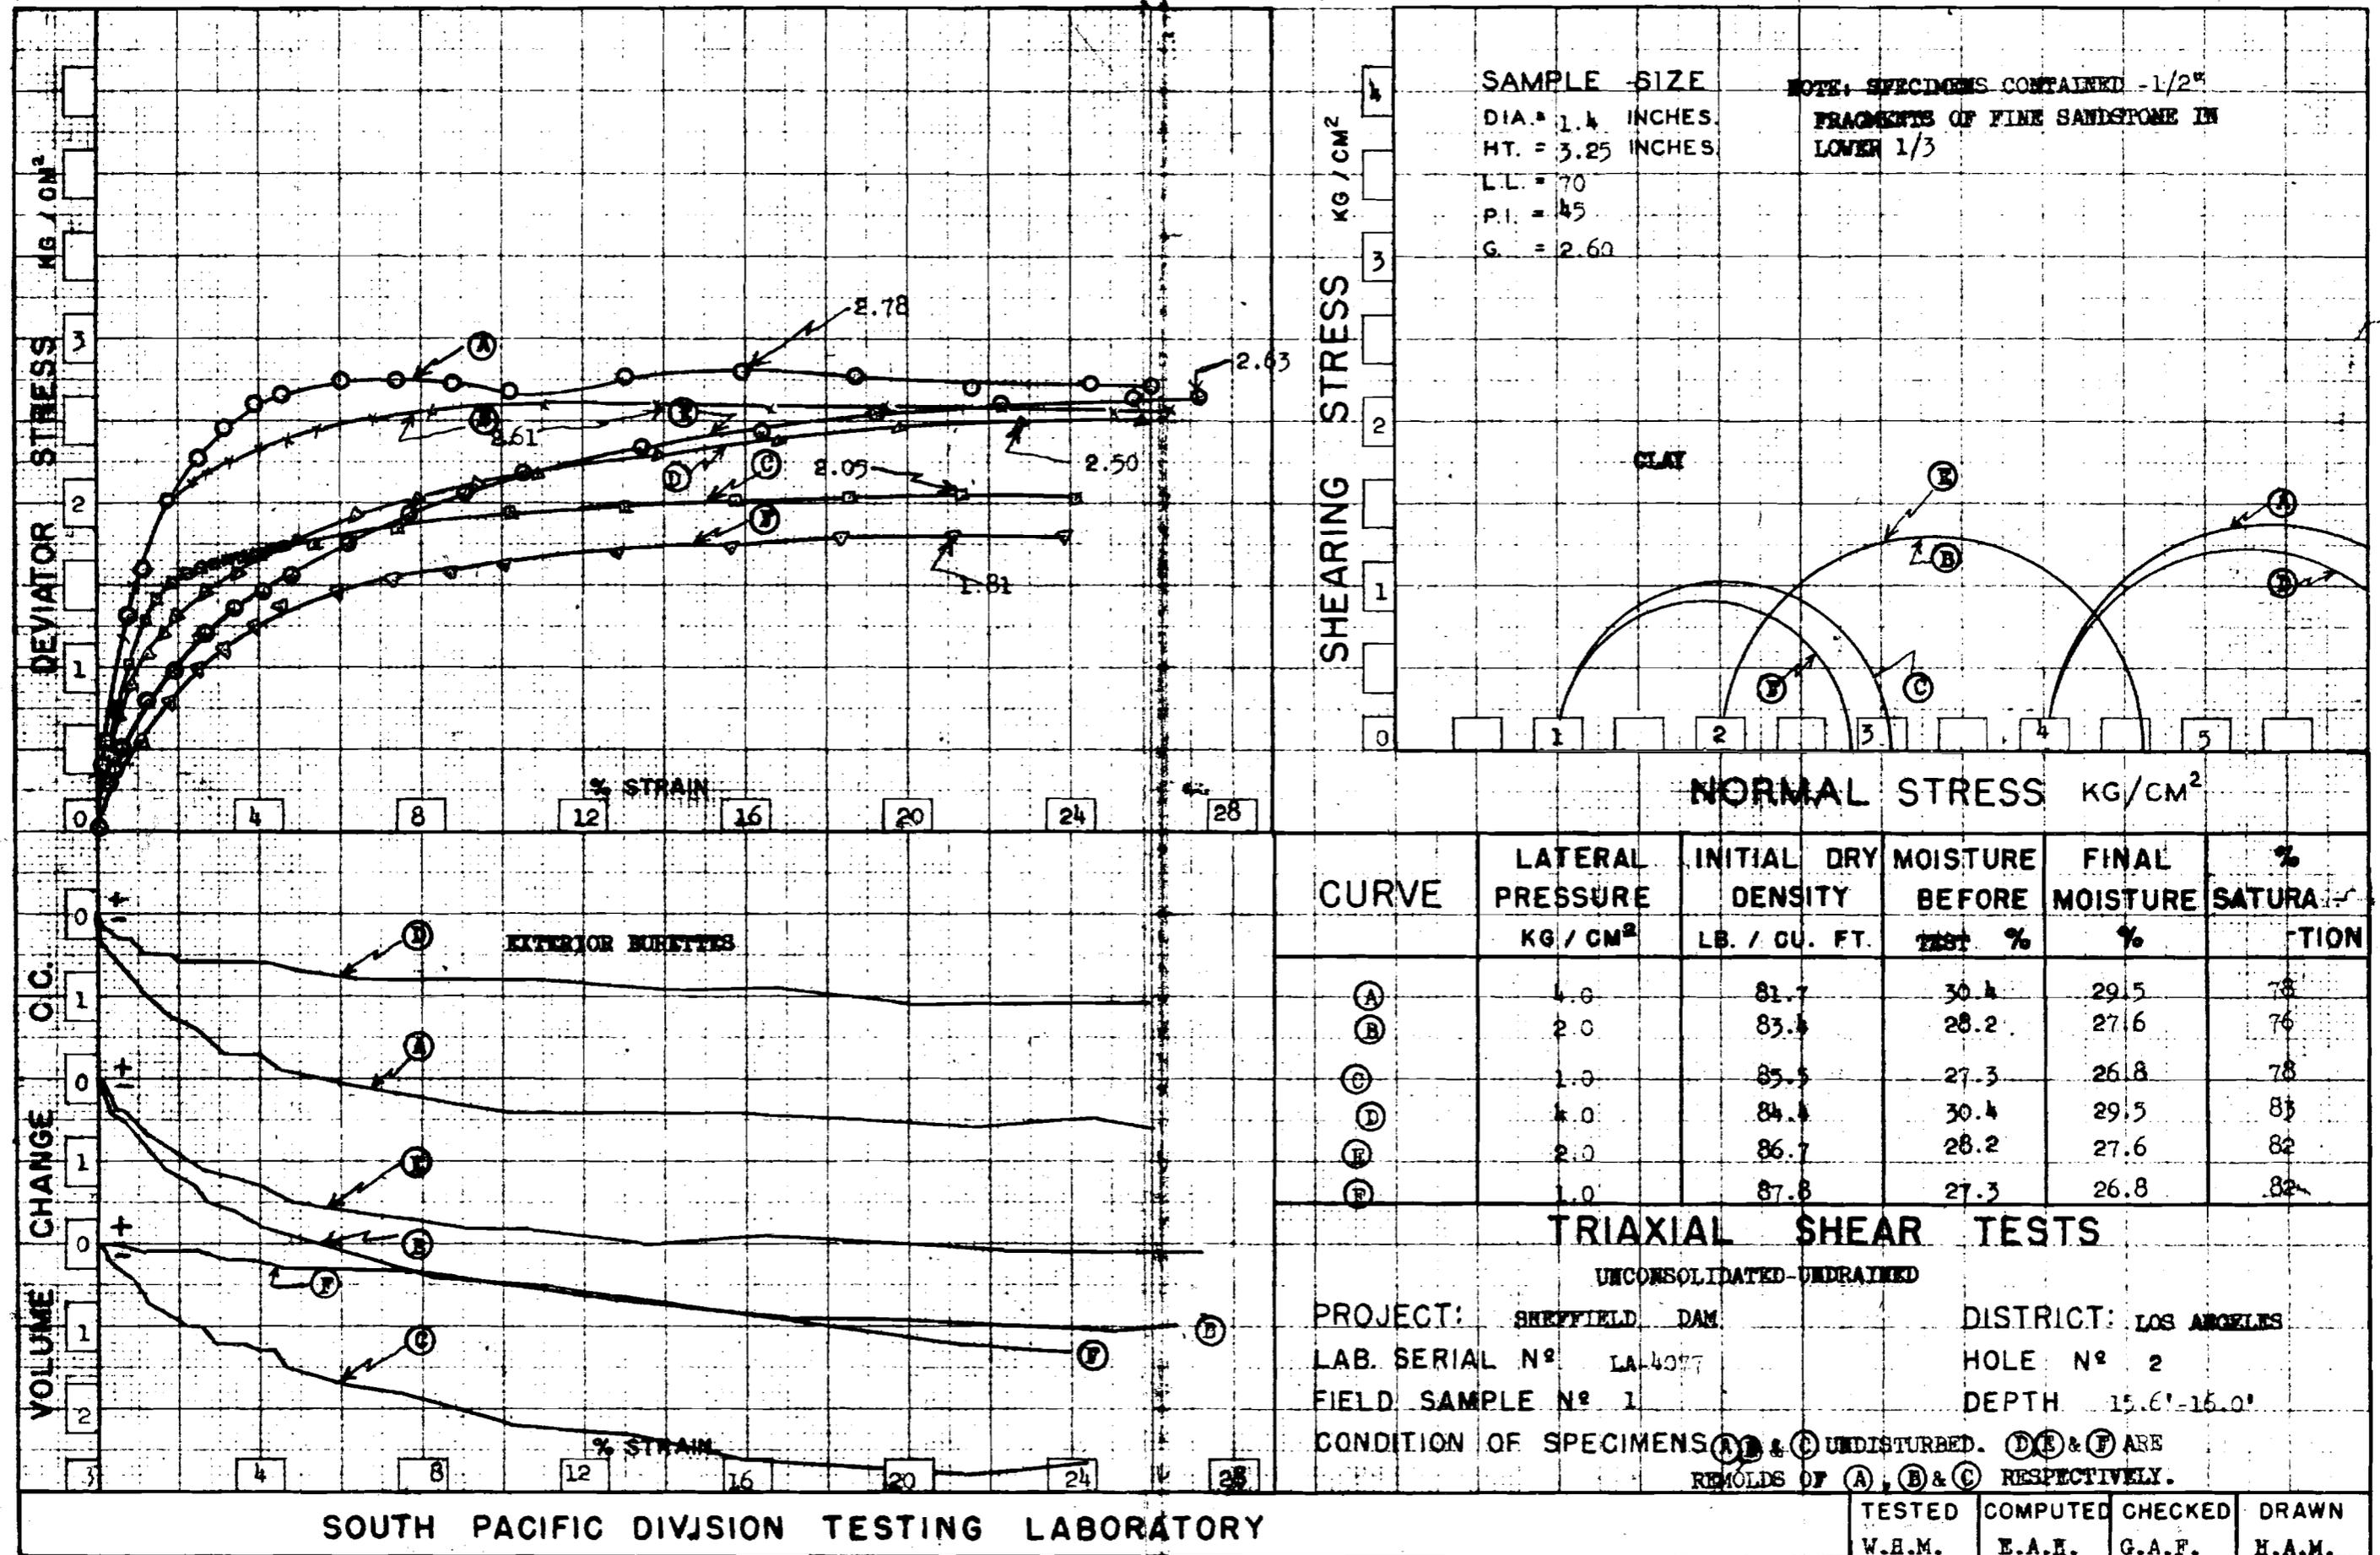
FIGURE 9

specimen was completed, the specimen was remolded in the apparatus and again tested under unconsolidated-undrained conditions. The detailed shear test data are given on figures 9, 10, and 11.

Based on the consolidation test data, the triaxial shear tests were performed for consolidated-undrained conditions. The results of these tests indicate that shear constants, varying between an angle of internal friction ϕ , equal to 16.5 degrees and zero cohesion, and ϕ equal to 21.5 degrees and zero cohesion, may represent the range in shear strength for the foundation material at the time of failure. A value of $\phi = 19^\circ$ was adopted for both the foundation and embankment. The sample of clay obtained from test hole 2, which conceivably might be representative of the original foundation material, was tested in an unconsolidated-undrained condition in both undisturbed and remolded states to determine the probable loss in strength due to remolding. The test results indicate little loss in strength.

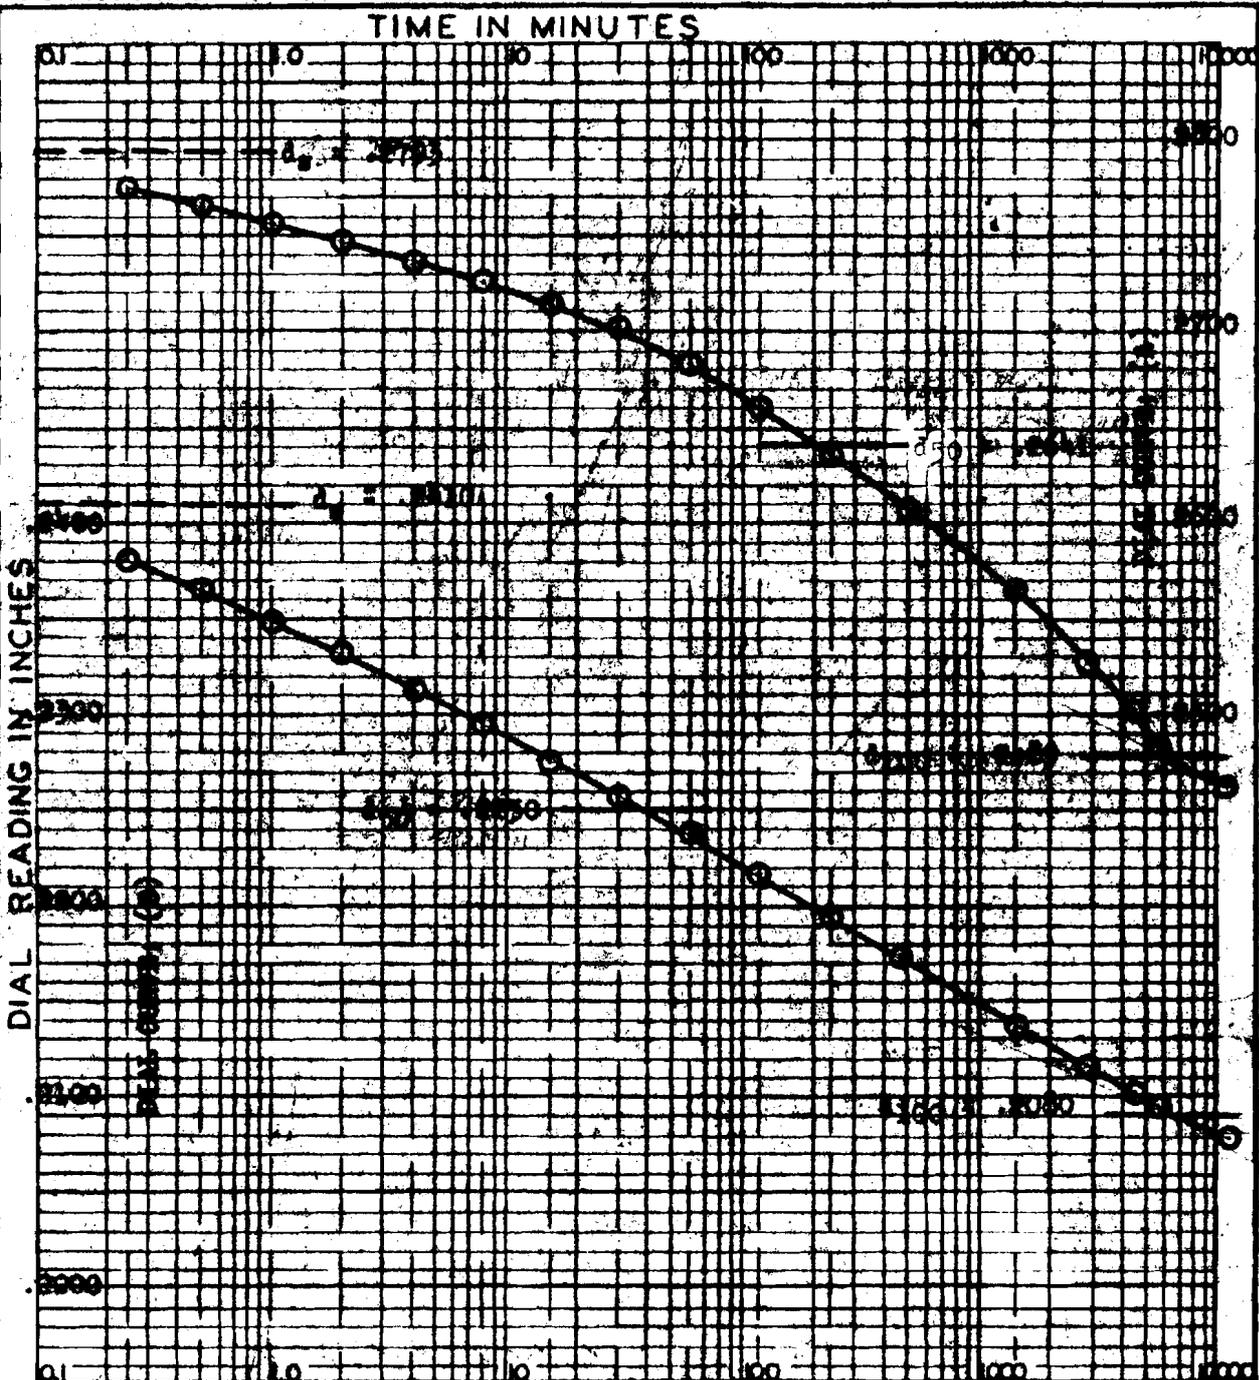
FIGURE 12

13. Consolidation.-A consolidation test was made on a sandy silt foundation material from hole 5, depth 0.4'-1.4'. The cylindrical specimen was about 4.4 inches in diameter and one inch in height. With moist cotton batting covering its exposed surface, the soil was allowed to consolidate under a seating load for 24 hours and then consolidated in increments of load starting with 0.1 kg./cm.². After final dial reading under a consolidating load of 0.2 kg./cm.², the moist cotton batting was removed and the specimen saturated. Loads were doubled until the characteristics under a load of 3.2 kg./cm.² were established. A vertical dial reading to 0.0001 inch, measured the settlement under each load. A reading of 0.3000 inch on the dial represents the height of one inch. The detailed consolidation test data are given on figures 12, 13, and 14.

is therefore doubtful if the consolidation theory is applicable for the prediction of the time-compression characteristics. However, it is evident that this type of soil undergoes fairly rapid consolidation, but it is not sufficiently free draining to consolidate during rapid application of shearing stress. The lack of any appreciable rebound, as noted on the void ratio-pressure curve, indicates that the natural structure of the material is considerably altered by loading past the preconsolidation pressure.
