2004 FAILURE OF BIG BAY DAM

Lamar County, Mississippi

Irfan A. Alvi, PE

February 2015

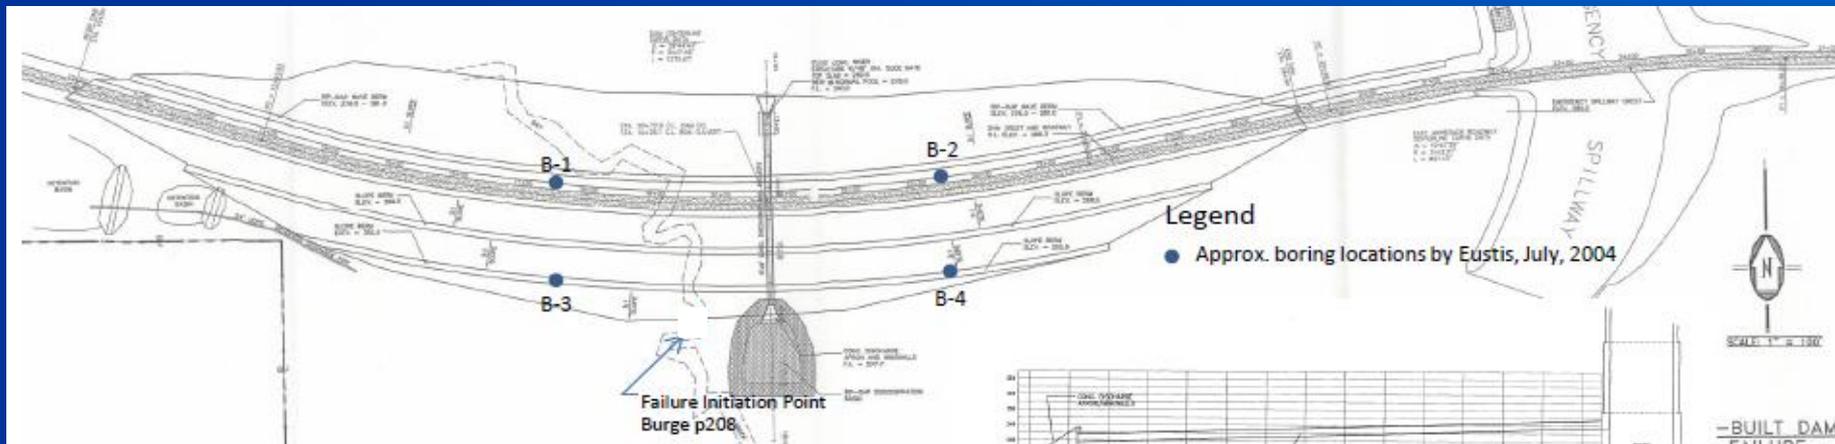
Plan View

- Privately owned
- East-west axis, 2000' long, downstream is to south
- Outlet: concrete riser, 8'x8' culvert, concrete apron, riprap basin
- Normal pool of 900 acres, over 11,000 acre-feet

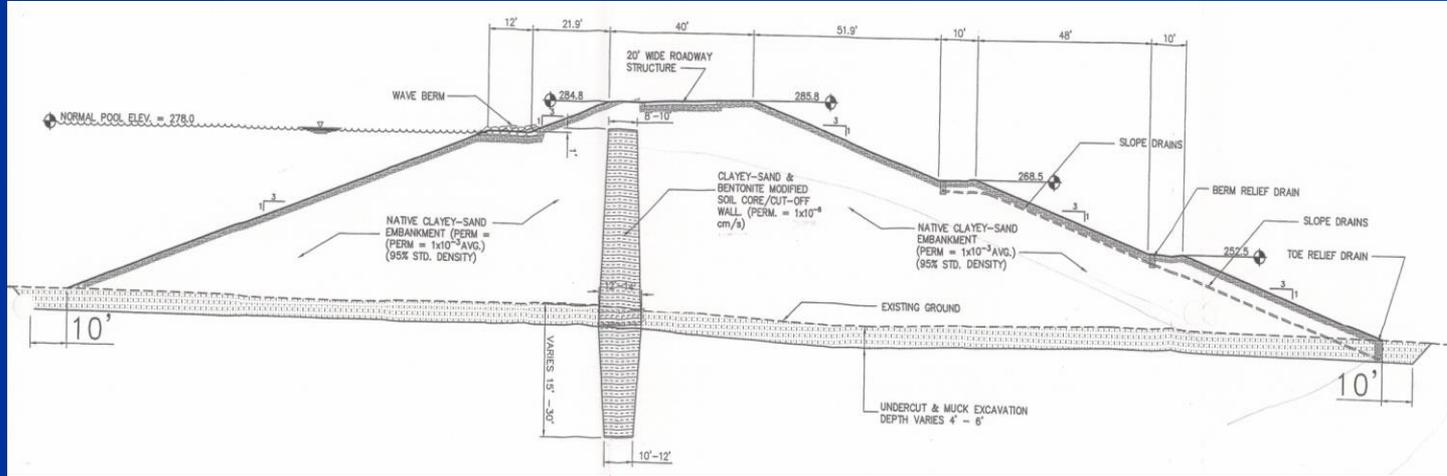
Embankment Section

- Over 50' high, 42' normal pool
- 360' wide, 3:1 slopes with berms
- Core/cutoff wall – soil mixed with bentonite clay

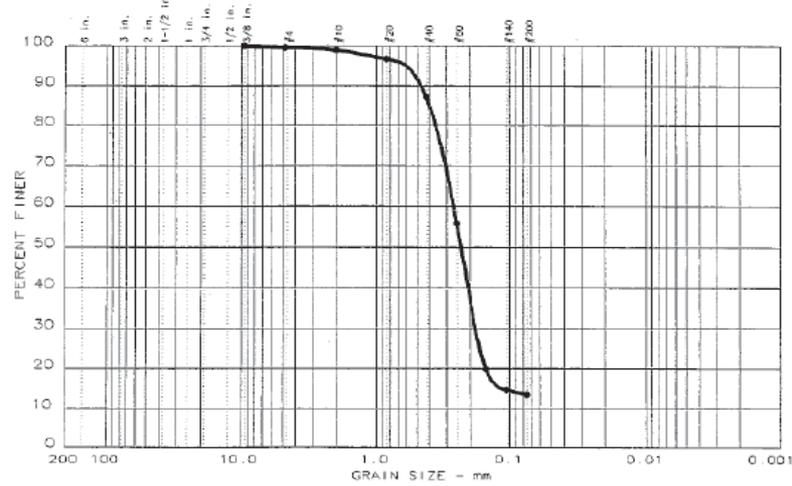
PARTICLE SIZE DISTRIBUTION TEST REPORT

Typical Gradation vs. Critical Velocity
(Foundation Soil)

Highly Erodible Embankment & Foundation Soils
