# SEEPAGE FAILURE, EVALUATION AND REMEDIATION OF PENN FOREST DAM

by W. B. Bingham, P.E.<sup>1</sup>  
R. E. Holderbaum, P.E.<sup>2</sup>  
W. S. Sherman, P.E.<sup>3</sup>

## ABSTRACT

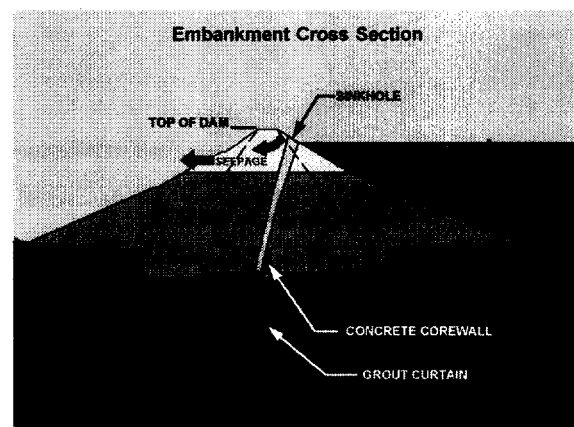
Penn Forest Dam was filled for the first time in 1959 and 1960. On May 18, 1960, with the reservoir at Elevation 995.5 (4.5 feet below the spillway crest), a sinkhole developed on the upstream slope of the embankment. Approximately one month prior to the development of the sinkhole, seepage had been observed exiting from a road cut in the downstream area and from weep holes in the spillway stilling basin. The leakage from the road cut was turbid and reported to be approximately 350 gpm. The sinkhole, which was reported to be on the order of 15 feet in diameter and 15 feet in depth, was filled with approximately 100 cubic yards of loosely placed silt and shale fragments. The fill placement had no measurable effect on the leakage, and the reservoir was subsequently lowered to Elevation 973.6, which is 26.4 feet below the spillway crest. Seepage reduced to approximately 90 gpm at that pool level.

Repairs to Penn Forest Dam were accomplished under the direction of D'Appolonia Associates between August and October 1960. The repairs consisted of grouting the embankment and the underlying rock foundation. During drilling, voids up to 18 inches in diameter were detected in the embankment. The embankment was grouted with surface-hydrated bentonite lumps and cellophane strips, and the rock was grouted with cement grout mixed in a ratio of 1:1 by volume. Upon completion of the grouting program, seepage from the road cut area was reported to be approximately 20 gpm with the reservoir at Elevation 985.5.

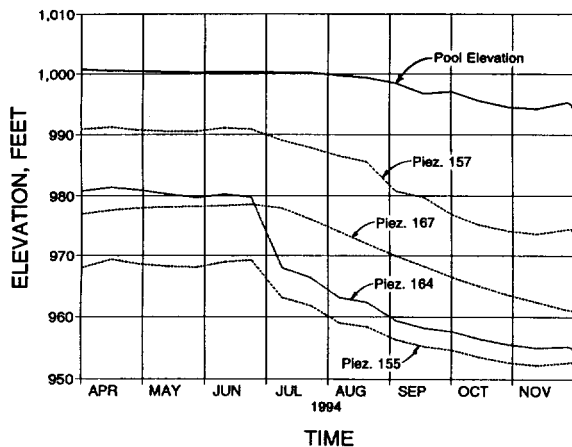
In July 1994, while the pool level was being maintained at spillway crest, piezometric levels in instruments located in the foundation rock in the sinkhole area began to decline. The decline was masked for a period of time because a drawdown of the reservoir started at approximately the same time. The pool level dropped to about Elevation 995 and was at that level for several months. Records show that piezometric levels in the foundation rock continued to gradually decline during that period. By November 1994, plotted piezometric records showed a sufficient decline in 7 instruments to warrant implementing precautionary measures. Overall, piezometric

levels in the foundation rock in the vicinity of the original sinkhole declined approximately 10 to 20 feet in the interval from July through November. The changes in the piezometric levels were interpreted as a possible early warning sign of recurrence of piping. Subsequently, it was determined that a total of approximately 15 instruments in the general vicinity of the sinkhole area were affected to varying degrees. The additional 8 instruments that were identified as being affected include those for which data plots were not initially available and those for which the declines are detectable but substantially smaller in magnitude.

In response to the observed conditions and the overall history of Penn Forest Dam, the City of Bethlehem implemented a series of emergency response measures recommended by Gannett Fleming. The emergency response measures, summarized below, remained in effect until January 1995, at which time the pool level had been drawn down to approximately Elevation 975. Following the emergency measures, the reservoir was further drawn down and held at Elevation 950 during subsequent investigations.
