Failure of Sella Zerbino Secondary Dam in Molare, Italy

Irfan A. Alvi, PE, President & Chief Engineer, Alvi Associates, Inc.

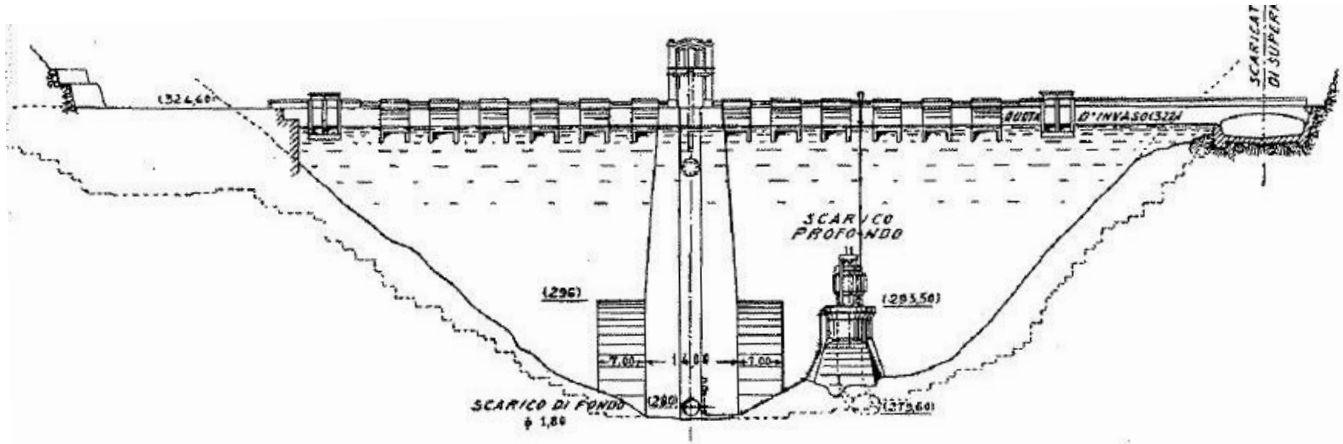
Figure 4. Upstream Face of Main Dam

The Bric Zerbino main dam was a curved concrete gravity dam about 154' high (Figure 4), located on the Orba River. Discharge from the dam was via a valved bottom outlet (Figure 5), a mid-level pressure outlet with inflow through a shaft with a valved intake (Figure 6), 12 siphon spillways (Figure 4), and a gated chute spillway (Figure 4), providing a total discharge capacity of about 31,000 cfs [6]. This discharge capacity represented an increase from the originally planned capacity, in response to the 1923 failure of Gleno dam in northern Italy after heavy rain [3], which had resulted in at least 356 fatalities.
