REEXAMINATION OF THE 2004 FAILURE OF BIG BAY DAM, MISSISSIPPI¹

Keith A. Ferguson, P.E., National Dam and Hydraulic Structures Practice Leader²
Scott Anderson, P.E., National Technology Leader for Numerical Modeling³
Elena Sossenkina, P.E., National Technology Leader for Risk⁴

ABSTRACT

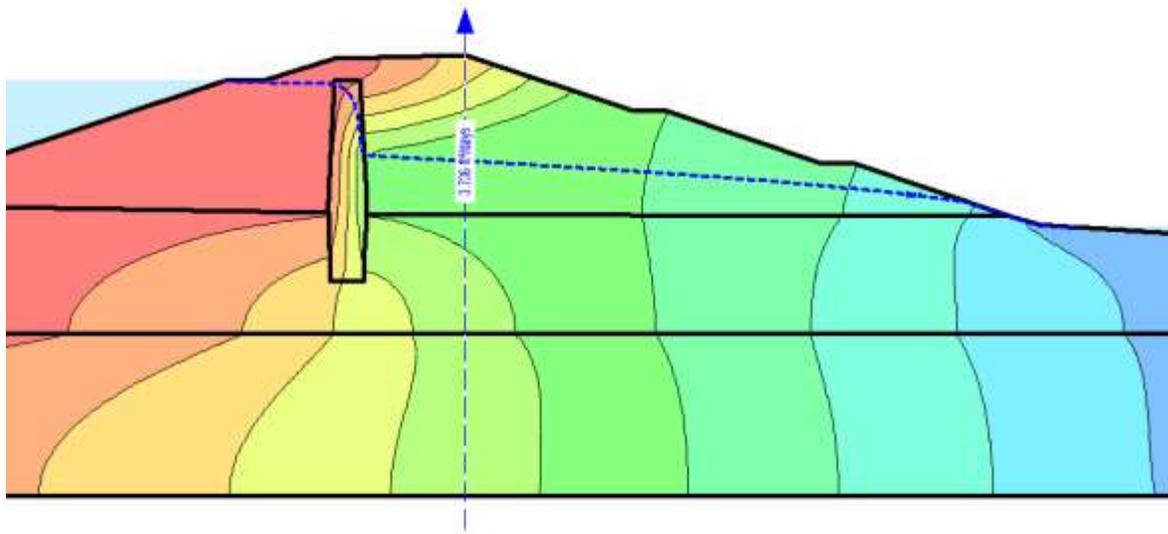
Figure 14. Equipotential Lines for Step 1, Base Case 1, Embankment Adjacent to Conduit

We begin by examining the results of the seepage modeling of Step 1 and Base Case 1 (with cutoff wall) at the cross-section of the embankment and foundation immediately adjacent to the conduit. These model results represent the seepage conditions that would have been expected for the as-designed condition without the influence of defects in either the cutoff wall or conduit and neglecting any consideration of the nominal toe drain system or the seepage remediation constructed around the downstream end of the conduit in 1999. Equipotential lines and seepage gradient contours for these conditions are shown on Figures 14 and 15. The equipotential lines on Figure 14 show the influence of foundation seepage through the “window” beneath the cutoff wall that would have occurred. If the cutoff wall had been extended into the low permeability older alluvium at the site, the phreatic surface within the embankment would be substantially lower than indicated on this Figure. The phreatic surface that is shown is the result of “mounding” of seepage from the foundation up into the embankment that is typical when incomplete or defective cutoffs are installed. The total estimated seepage through this cross-section is about 0.02 gpm per foot of embankment. This corresponds to about 2 gpm per 100 feet of embankment. Significant defects in the cutoff wall could impact several important aspects of seepage within the dam and foundation that are difficult to simulate in a 2D seepage model: 1) localized increases in the phreatic surface, 2) slightly increasing

seepage quantities, and 3) increasing seepage exit gradients at the toe of the embankment and from the foundation immediately below the toe of the dam.

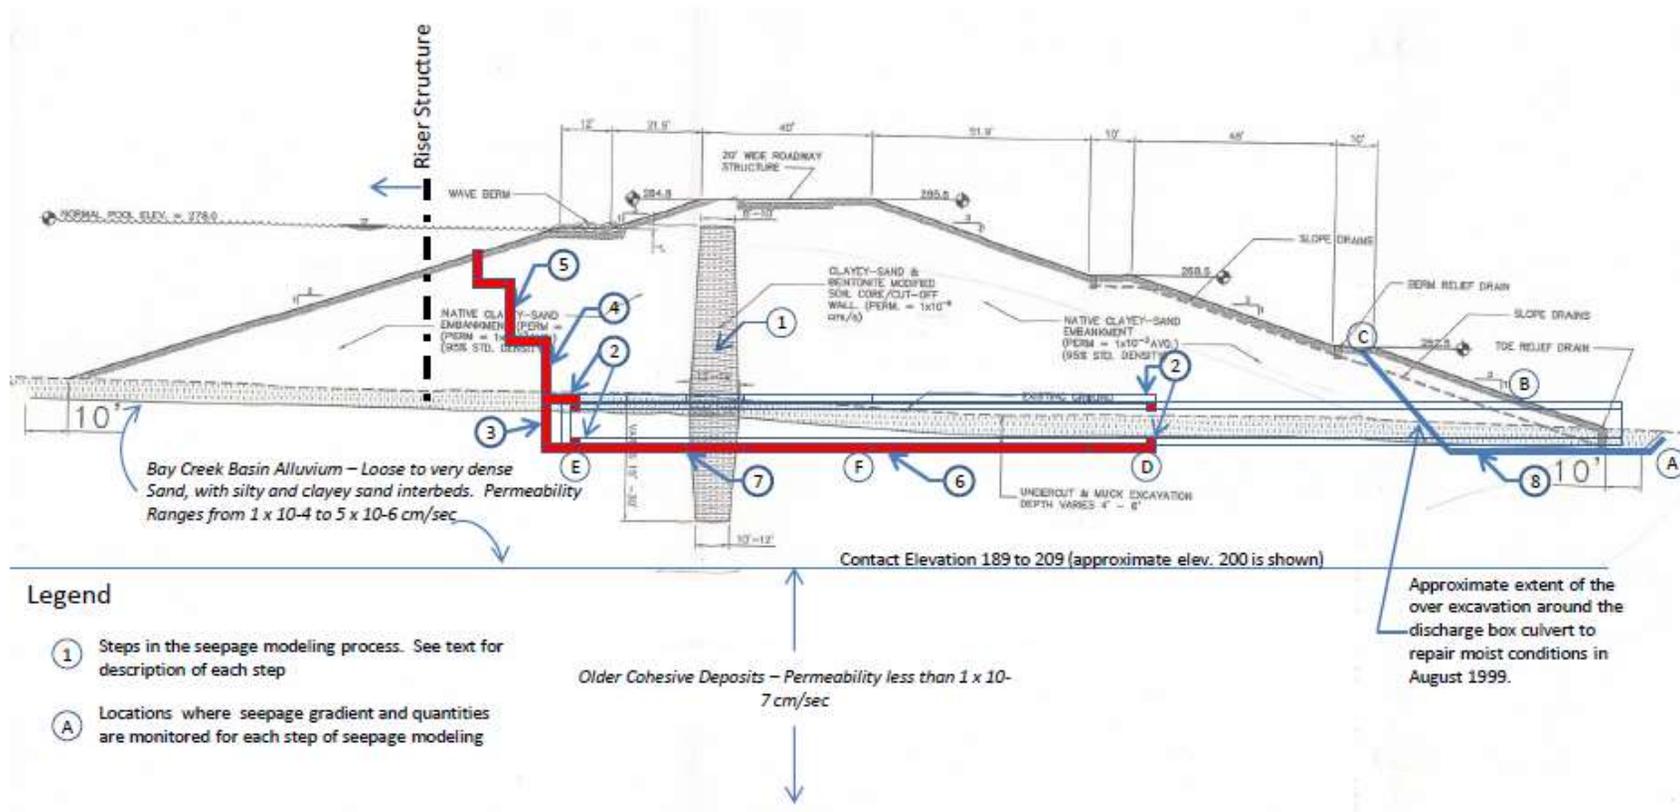
Figure 13. Cross-section of Dam and Outlet Conduit Showing Seepage Modeling Steps 1 through 8 and Model Result Evaluation Locations A through F

To help inform this assessment of the conditions and events leading to the failure of Big Bay Dam described above, a generalized 2-dimensional (2-D) seepage model was created and a series of stepwise models were run. The models were created with SEEPW (Geo-Slope International, Ltd, version 8.12). Each step in the modeling process represents one in the series of events that we believe describe the most likely failure mode development process described in the preceding section. A cross-section of the dam at the outlet works annotated to indicate the locations where each step was added to the model along with the locations where both seepage quantities and gradients were identified and assessed (assessment points A through F) is shown on Figure 13. A summary of the permeability values assumed in the model is provided in Table 2.

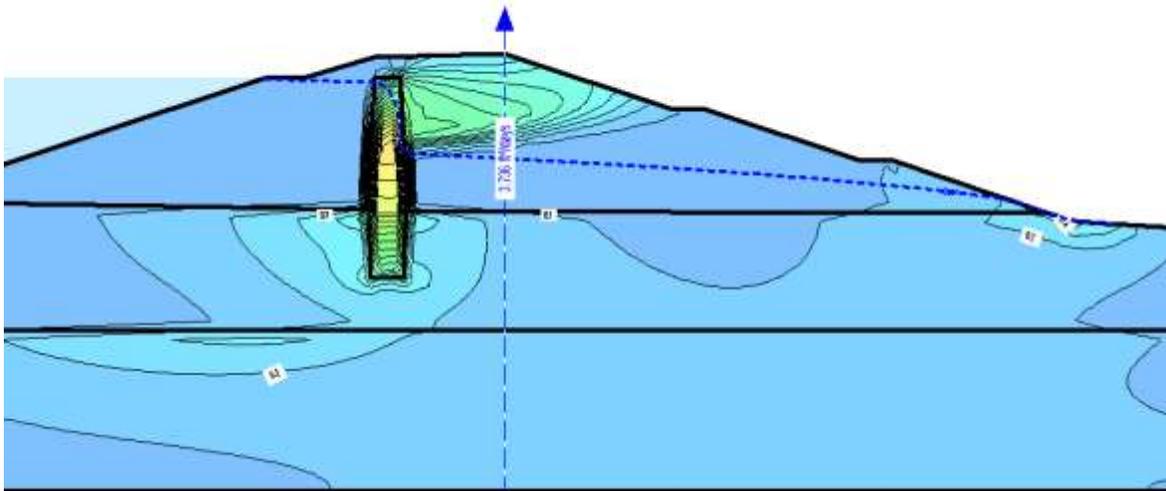
Figure 15. Seepage Gradients for Step 1, Base Case 1, Embankment Adjacent to Conduit

The seepage gradient contours along the cross-section including the downstream toe area are shown on Figure 15. The maximum seepage exit gradient occurs where seepage exits from the foundation immediately below the toe of the dam (location A). This would be the expected result from the partial foundation cutoff. The model suggests a maximum exit gradient that is about 0.4. This gradient is colored a cautionary yellow in the upper portion of Table 3. While it is lower than “critical” for these materials suggesting that general gradients would be less than necessary to initiate erosion along the toe of the dam, this gradient is high enough to indicate the need for a well designed and constructed embankment/foundation drainage system to account for potential geologic and construction defects, and produce an adequate level of seepage safety for the structure. When the cutoff wall is eliminated from the model, the estimate maximum seepage exit gradient at the surface of the foundation immediately below the downstream toe of the dam increases to 0.6. This high exit gradient has been colored red in the lower portion of Table 3 as it indicates inadequate margin of safety and a high likelihood of seepage distress area development associated with minor geologic or construction anomalies.

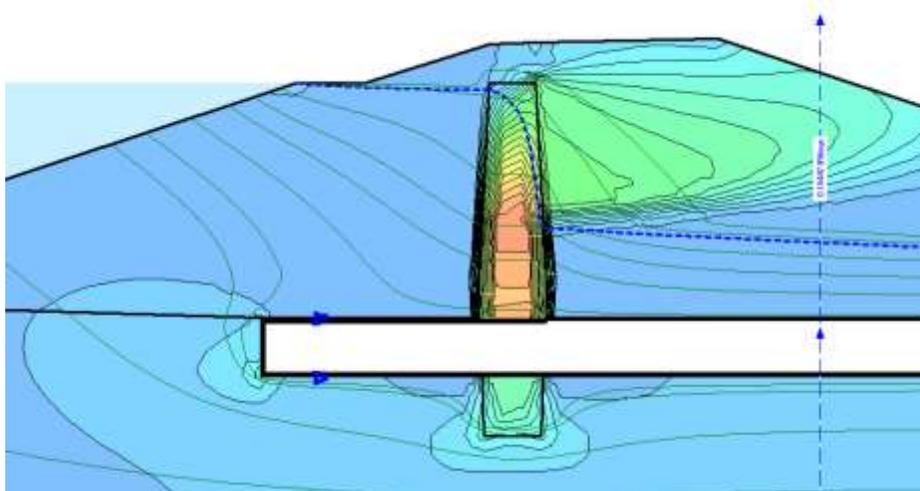
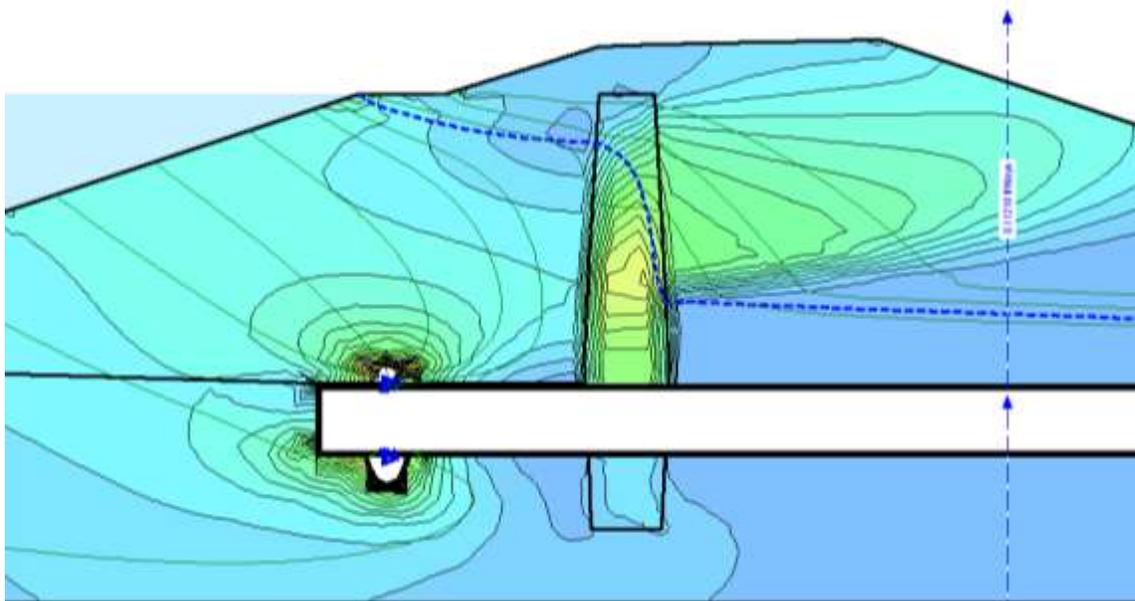
Figure 16 and 17 show estimated seepage gradients in the embankment and foundation along the model cross-section that includes the seepage conduit. Figure 16 shows gradients at the upstream end of the conduit at the end of Step 1, Base Case 1 without an open conduit defect, and Figure 17 shows the seepage gradients estimated at the end of model Step 2 when the defects at both the top and bottom of the conduit at the upstream defect are opened. As can be see by the gradients summarize at assessment point E in Table 3, the conduit defects have a significant influence on gradients and seepage conditions in both the embankment and foundation and are high enough to indicate initiation of erosion through the defects. In fact, considering 3-D effects, the model results summarized in Table 3 suggest that the exit gradients at the defects are sufficient to initiate and sustain embankment and foundation erosion at both the upstream and downstream defect locations.

Figure 16. Seepage Gradients, Step 1, Base Case 1, Conditions along Conduit Cross Section

Figure 17. Seepage Gradients, Step 2, Base Case 1, Conditions along Conduit Cross Section

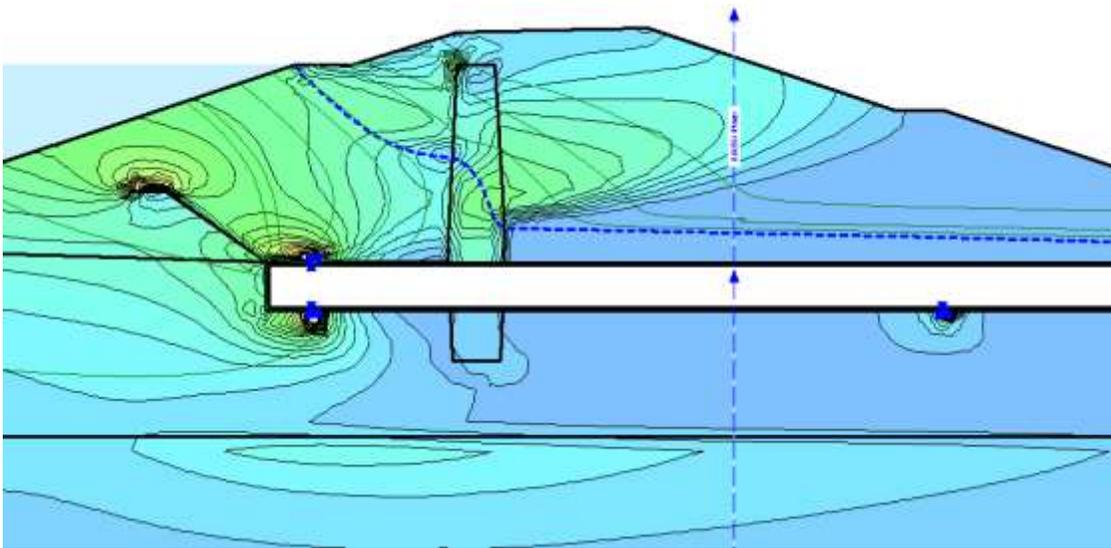
Figure 18. Seepage Gradients, Step 4b, Base Case 1 Conditions along Outlet Conduit Cross Section

Seepage gradients in the upstream portion of the embankment and foundation, and near the downstream conduit defect at the end of Step 4b are shown on Figure 18. These results indicate that once a “piping” defect extending from the conduit defect into the embankment is introduced into the model during Steps 3, 4a, and 4b, gradients at the opening of the conduit defects drop into a cautionary range. However, exit gradients in the embankment adjacent to the upstream conduit defects as well as the into active front (upstream end) of the “piping” defects in the embankment remain very high (substantially above 1) and indicate that the erosion process would continue and accelerate as the defect approaches the upstream face of the dam. The seepage exit gradients from the embankment into the area adjacent to the conduit defects further suggest that other erosion pathways could develop even if a primary “piping” pathway has continued a portion of the distance toward the upstream face of the dam. As expected, the seepage quantities predicted by the model are substantially lower (0.03 gpm at the upstream defect, and 0.002 gpm/foot at the downstream defect) than observed discharging from the defects (up to 5 to 6 gpm at each location) during later inspections. While the model results do not indicate sufficient seepage quantities, the observed conditions at the defects described in the preceding sections indicate ample flow to sustain a steady continuation of erosion through the developing erosion features.

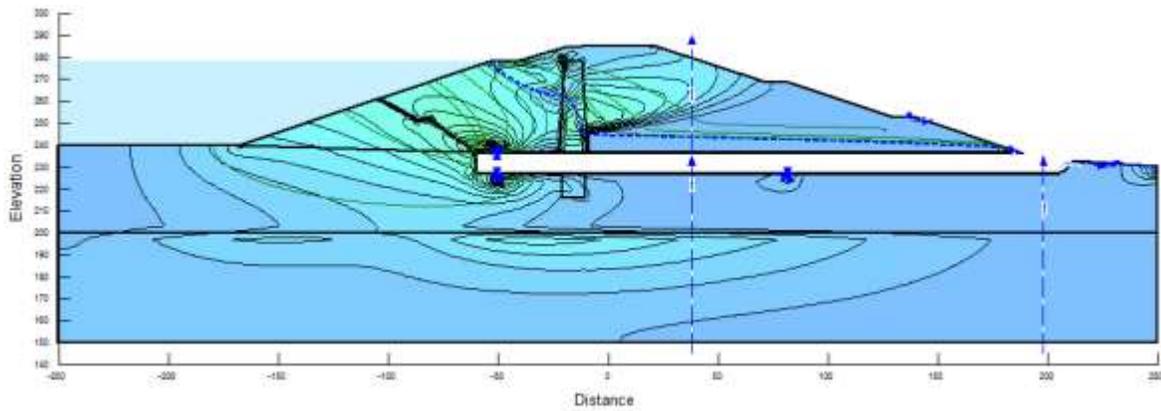
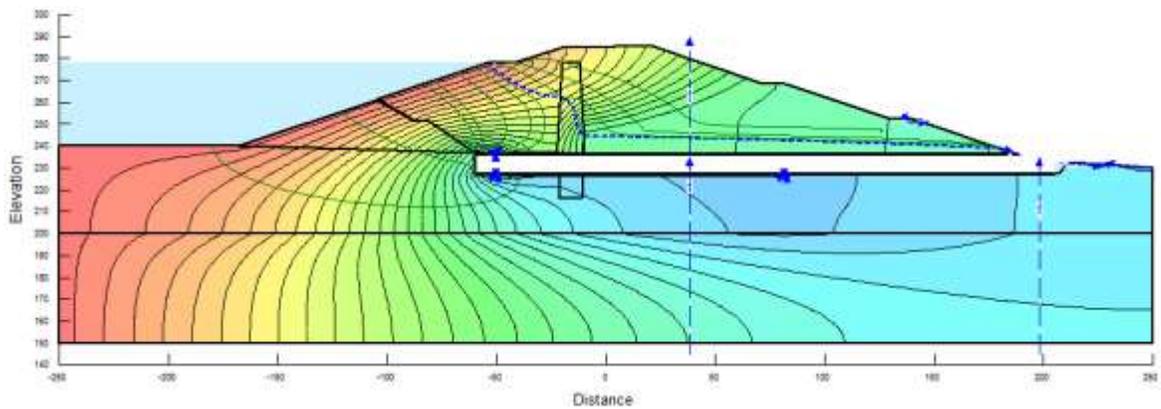
Seepage gradient contours, and equipotential lines within the model containing the outlet conduit at the end of Step 7 are shown on Figures 19 and 20. Estimated seepage gradients and flow quantities at each of the assessment points are presented for Steps 7 in Table 3.

Figure 19. Gradient Contours at end of Step 7, Base Case 1

Figure 20. Equipotential Lines at end of Step 7, Base Case 1
