INVESTIGATION AND EVALUATION OF SEEPAGE CONDITIONS AND POTENTIAL FAILURE MODES AROUND OUTLET CONDUITS

Keith A. Ferguson, P.E.¹

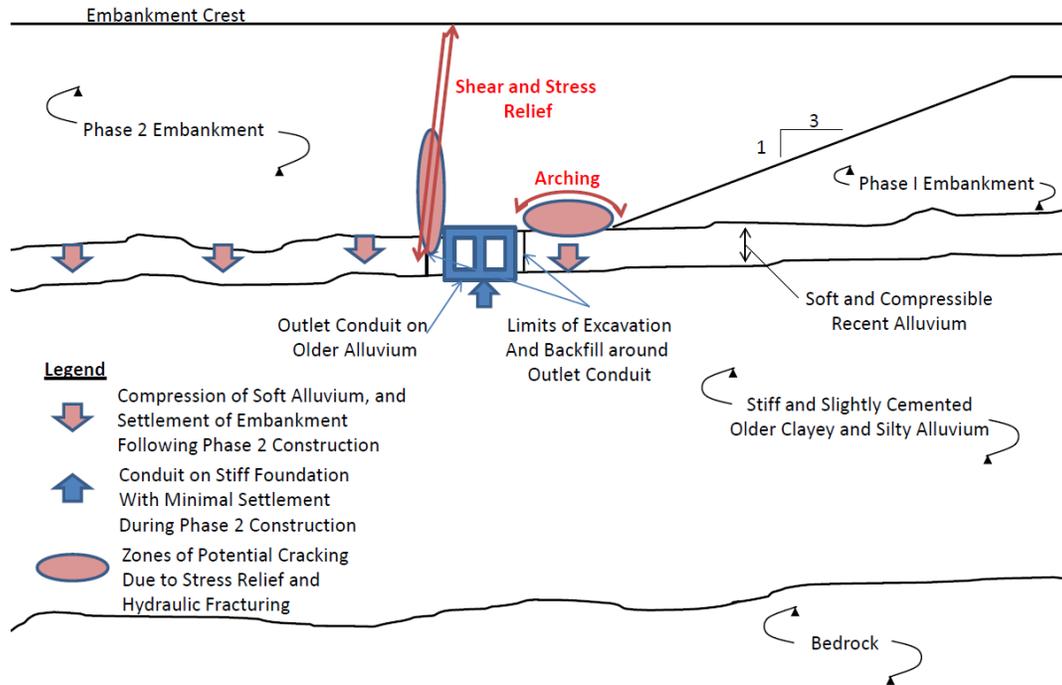
An example where this can occur relative to an outlet conduit is illustrated on Figure 4.

Hydraulic fracturing can occur even in dams without unusually large or concentrated differential settlement. Case histories as well and finite element studies indicate that hydraulic fractures may develop on near vertical transverse planes caused by the longitudinal stretching of the embankment and/or foundation materials in the region of differential settlement, near horizontal planes caused by arching of self weight forces. This phenomenon can occur

- across the core as a result of the differential settlement between the central core and shells of the dam,
- across a relatively narrow but deep cutoff trench,
- around localized foundation defects that traverse the foundation under the low permeability cutoff,
- other orientations due to a more complex combination of actions

Figure 4 – Locations where Cracking and Hydraulic Fracturing Could Develop Around an Outlet Conduit

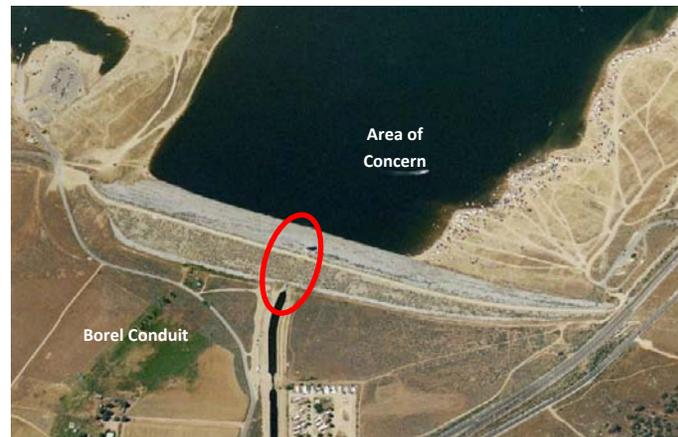
Figure 6. Isabella Auxiliary Dam

The configuration of the Auxiliary Dam and the location of the Borel Canal conduit are shown on Figure 6. The Auxiliary Dam is a homogeneous, rolled earthfill structure with a crest length of 3,257 feet, a top width of 20 feet, a crest elevation of 2633.5 feet and also has 6.5 feet of freeboard above the original Spillway Design Flood elevation. The foundation of the Auxiliary Dam consists of heterogeneous valley fill alluvium with a maximum depth of about 130 feet over highly and deeply weathered granitic bedrock.

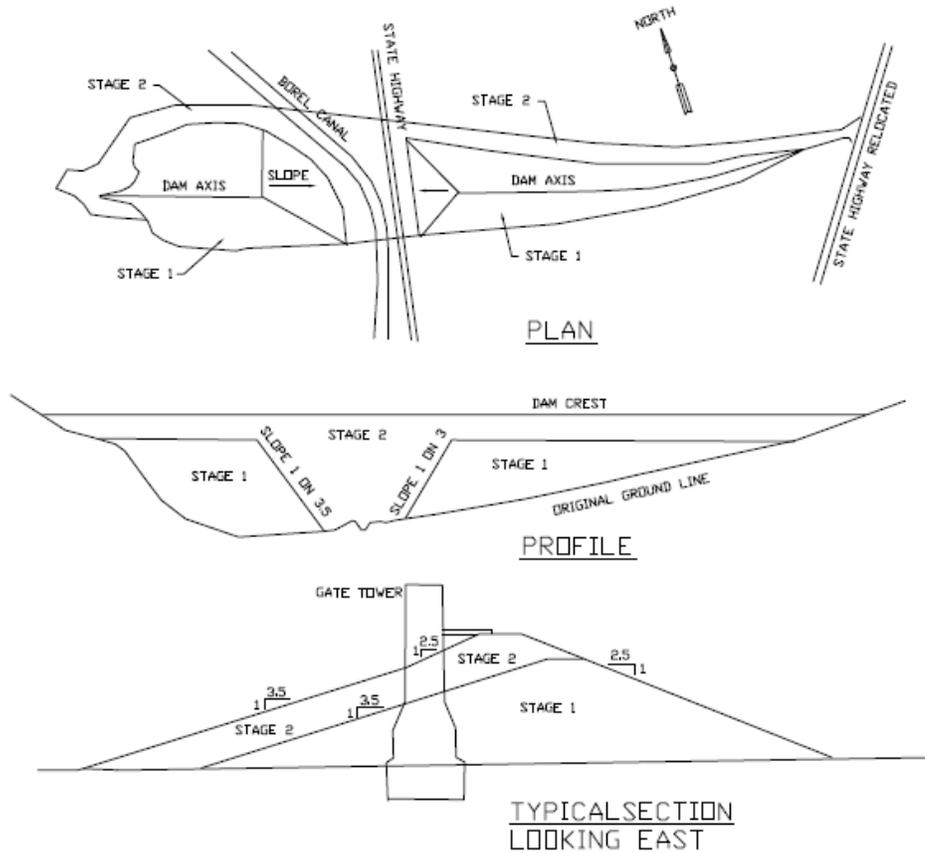
The Auxiliary Dam was built in two phases and the typical plan view showing the two phases along with a simplified profile and cross-section of the embankment at the conduit is shown on Figure 7.

Figure 7. Plan View and Typical Cross Section of the Isabella Auxiliary Dam

The Borel Canal conduit is a relatively smaller conduit in relation to the height and cross section of the embankment when compared to the Lake Darling Dam outlet described in the preceding section. The conduit itself was founded on a relatively stiff material (lower foundation layer), and the adjacent embankment was founded on an upper foundation layer having a thickness of about 10 to 15 feet and a compression index, C_c of around 0.1 to 0.2. As noted above, the embankment was built in two phases with the closure section and dam raise being the second

phase. The left side of the conduit (looking downstream) was located near the end of the eastern Phase 1 embankment. The Phase 1 embankment was constructed and the foundation beneath the embankment was allowed to consolidate for over 6 months before the Phase 2 embankment and closure section was completed.

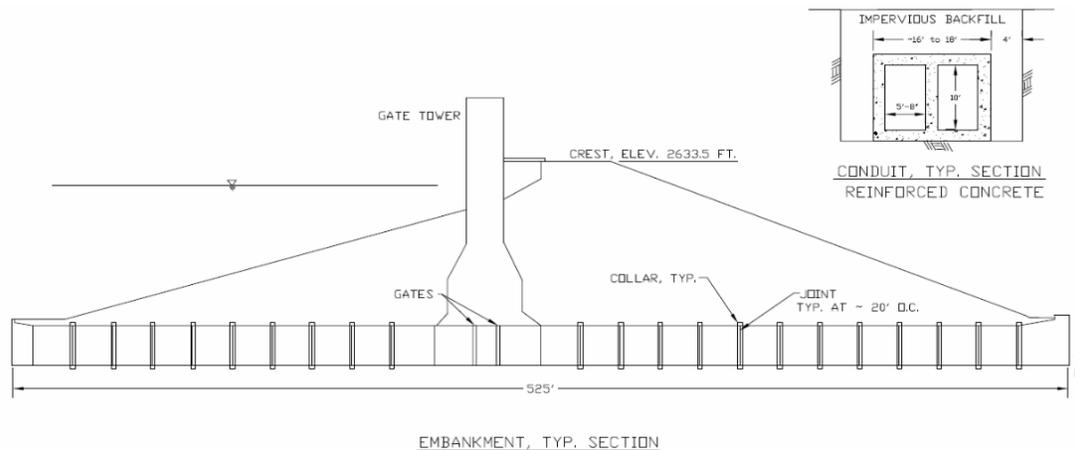
barrel cast-in-place reinforced-concrete structure. The two rectangular gate chambers have opening dimensions of 5 feet - 8 inches x 10 feet separated by a 1 foot - 8 inch thick reinforced concrete wall. A vertical control tower was constructed on top of the conduit's gate chamber 55 feet upstream of the centerline of the dam. A profile and cross-section of the conduit is shown on Figure 8.

Figure 8. Profile and Cross-section View of the Borel Canal Conduit

The configuration and sequence of construction of the conduit and Auxiliary dam embankment created a complex settlement and related stress history in the area in and around the conduit. Differential settlement would have occurred and would have been a complicated three-dimensional influence on stresses in the embankment. In addition to the issues associated with differential settlement, a number of other important considerations in each of the categories summarized in Section 2, above were identified as potentially influencing seepage conditions around the outlet conduit. These considerations included:
