A DAM INCIDENT AT SUGAR CREEK L44

*D. Wade Anderson, P.E. U.S. Army Corps of Engineers, Tulsa District. (918) 669-7654
(formerly with USDA-NRCS, Fort Worth, Texas)*

*Arvil Bass, P.E. USDA-NRCS, Stillwater, Oklahoma. (405)742-1270,
Arvil.Bass@ok.usda.gov.*

Abstract

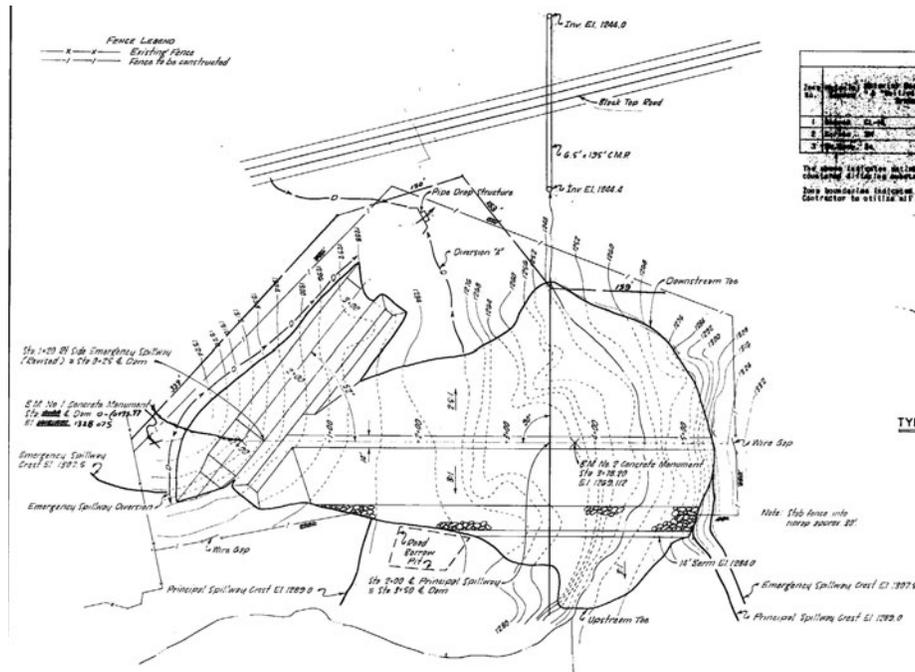
Figure 1 – Plan of Embankment and Spillway

Sugar Creek L44 Dam is an earthfill embankment dam providing flood control located in Caddo County, Oklahoma. The drainage area above the dam is 1,709 acres. The maximum fill height is 64 feet and the length of the embankment is 550 feet. An as-built plan view of the dam is shown in Figure 1. The auxiliary spillway had a width of 40 feet and is located in the left abutment.

The as-built drawings indicate the core of the dam was to be constructed of silty clay materials and both the upstream and downstream zones of sand or silty sand. The vegetated auxiliary spillway consisted of silty sand surface soils underlain by sandstone.
