RCEM – Reclamation Consequence Estimating Methodology

Dam Failure and Flood Event Case History Compilation

**U.S. Department of the Interior
Bureau of Reclamation**

February 2014

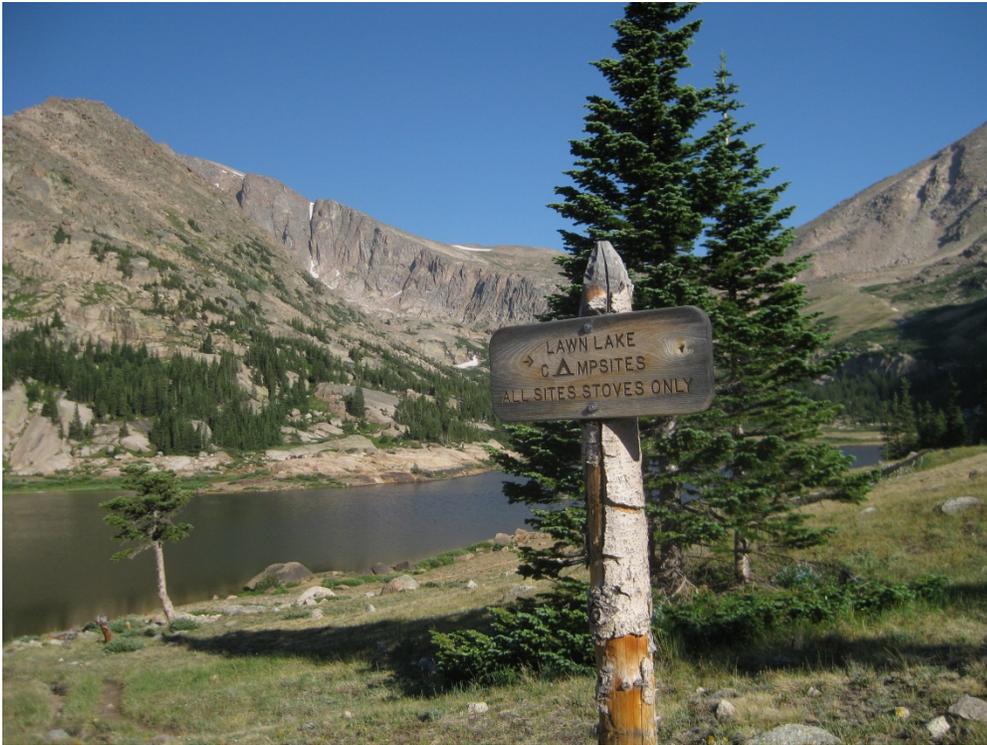
Lawn Lake, taken July 2012

Lawn Lake Dam was located at about an 11,000 foot elevation, in Rocky Mountain National Park, Colorado, just west of the town of Estes Park. Access to the dam was by way of a 6.3 mile hiking trail. The dam was an embankment structure which raised a natural lake, and stored water for irrigation. The twenty-six-foot-high dam held a reported 674 acre-feet of storage and was 79 years old at the time of its failure. Breaching of the dam was due to piping which was initiated along the outlet works conduit that ran through the embankment. Lawn Lake Dam failed at about 5:30 am, Thursday July 15, 1982.
