THE WILLIAMSBURG RESERVOIR DAM FAILURE OF 1874

R. Lee Wooten, P.E.¹, Peter L. Spangenberg, P.E.², William C. Salomaa³,
and Michael Misslin⁴

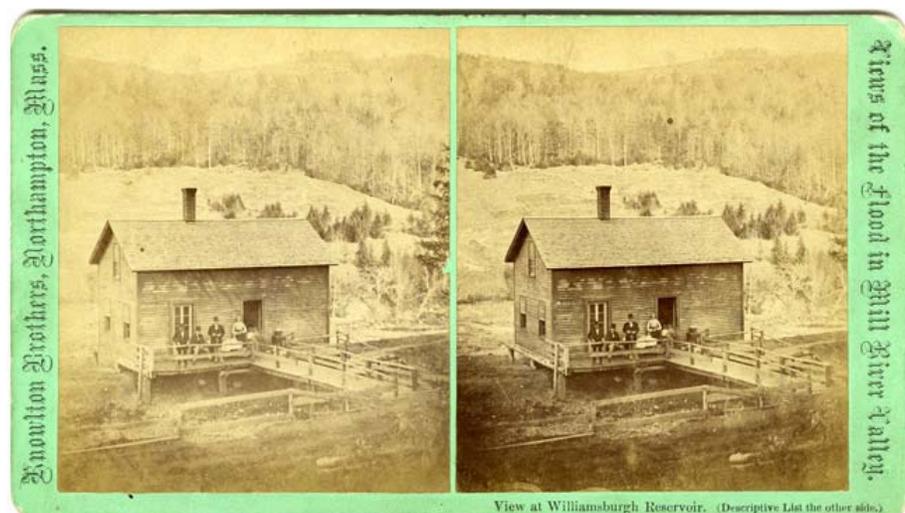
Figure 6. Caretaker's Cabin and the Cheney family.

Cheney returned for breakfast to the caretaker's cabin (Fig. 6) overlooking the downstream slope. The small cabin housed Cheney, his wife, their five children, and his parents. Cheney's father, upon getting up from their meal, called out to his son "For God's sake, George, look there," as the east side of the dam sloughed. A section of the embankment slope, about 40 feet wide by 25 feet high, moved downstream off of the dam. George Cheney raced to the downstream gatehouse to open the valve. Seepage from the east slope exposed by the slide accelerated, and Cheney feared that dam would not hold. He left the gatehouse, bridled his horse (Fig. 7), a cheap mare, and rode bareback the three miles down the valley to Williamsburg to contact Spelman. His father ran to warn the downstream farmer of the peril to his cows.

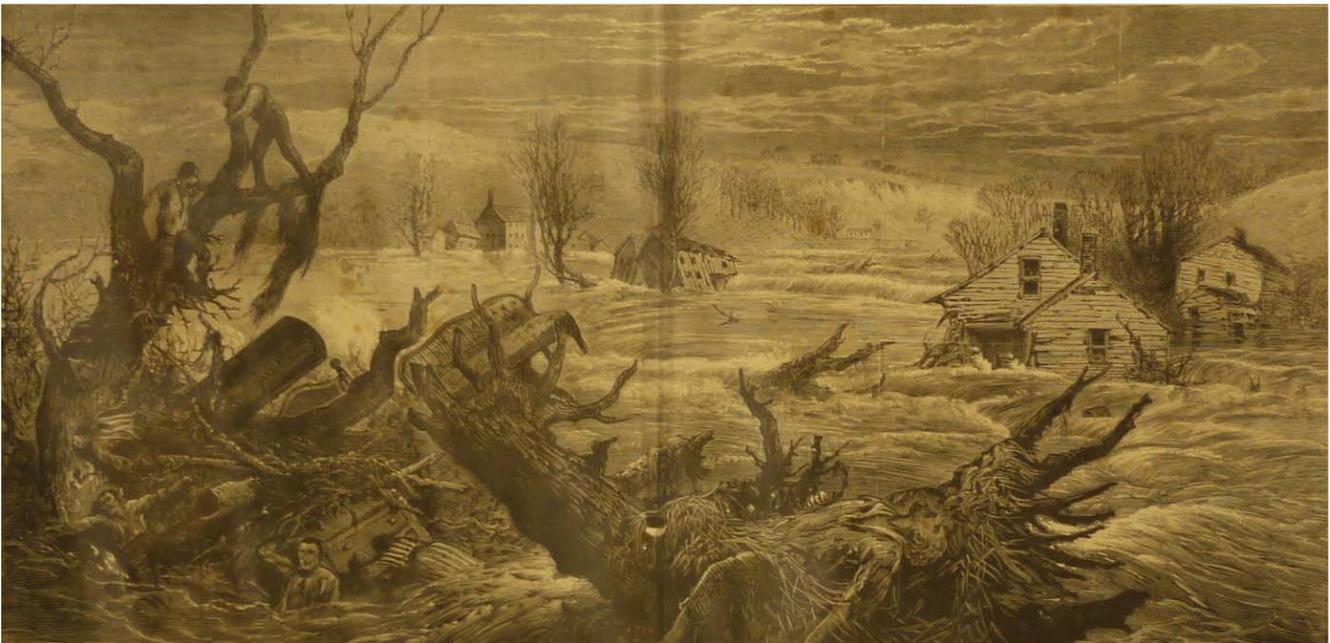
Figure 9. Newspaper Interpretive Sketch of the Flood

The floodwave ripped through Williamsburg, Skinnerville, Haydenville, and Leeds and was described as "a great wall about 40 feet high," probably an exaggeration. Photos of scarred trees suggest a height of 10 to 20 feet for the floodwave. The current, aided by the steepness of the river grade and confined by the narrow valley hills wrecked the river-hugging villages (Fig. 9). The warnings of Cheney, Graves, Hillman, and Day saved hundreds of lives, but not all. The flood killed those who did not hear the warnings, those who could not flee fast enough, those who lingered or tried to save either friends or family in the face of the floodwave, and those unlucky enough to pick the wrong escape route. The stories told by survivors were fascinating and are recounted by Sharpe with clarity and detail.

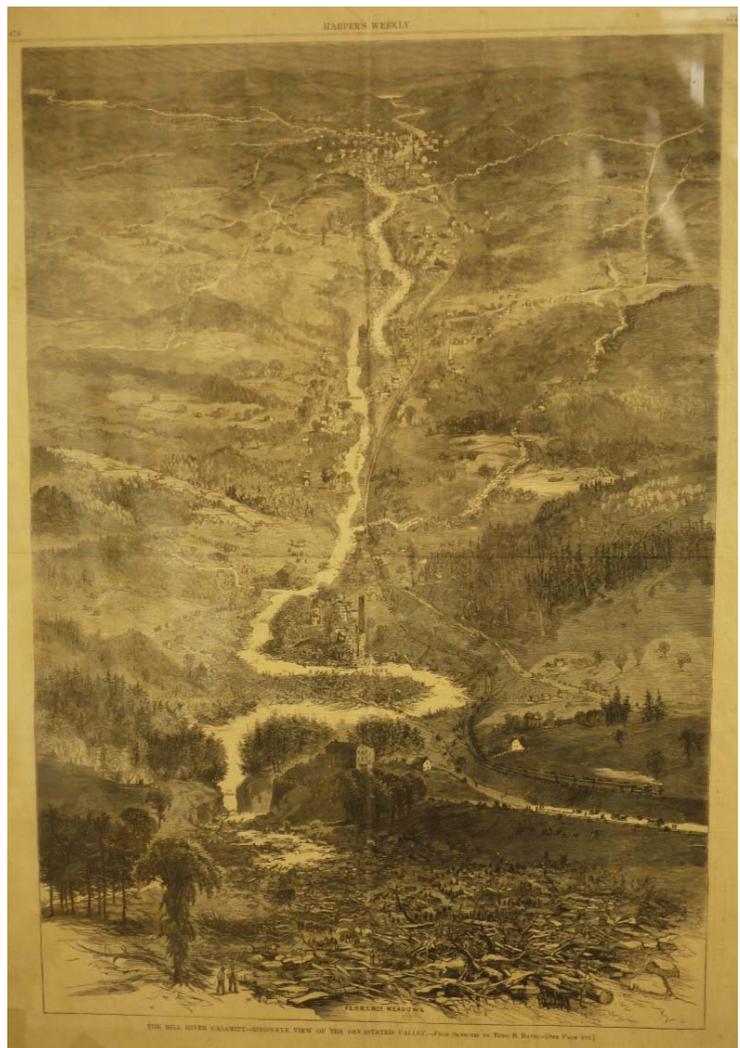
Figure 10. Newspaper Sketch (Artist's Concept) of the Valley after the Flood.
