# The 1911 Bayless Dam Failure: Physical and Human Factors

Robert A. Kline, Jr., P.E., Gannett Fleming, Inc.  
Irfan A. Alvi, P.E., Alvi Associates, Inc.  
Greg Richards, P.E., CFM, Gannett Fleming, Inc.

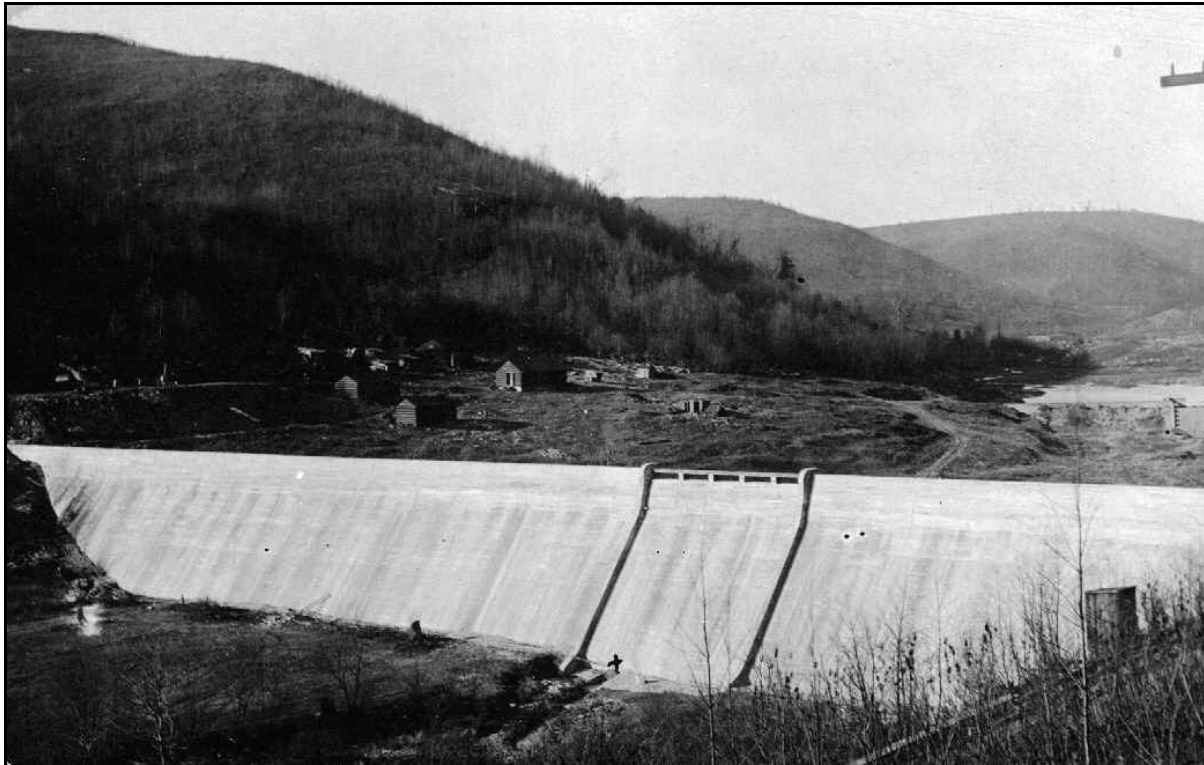
Figure 2. Bayless Dam, December 1909 (Source: Potter County Historical Society).

The dam was ready to be put into service on December 1, 1909. Before water was impounded behind the dam, two transverse vertical cracks developed at locations left and right of the spillway section. Each crack had about a 1/16-inch width opening. Hatton attributed these cracks to thermal contraction since there was no evidence of structural settlement.

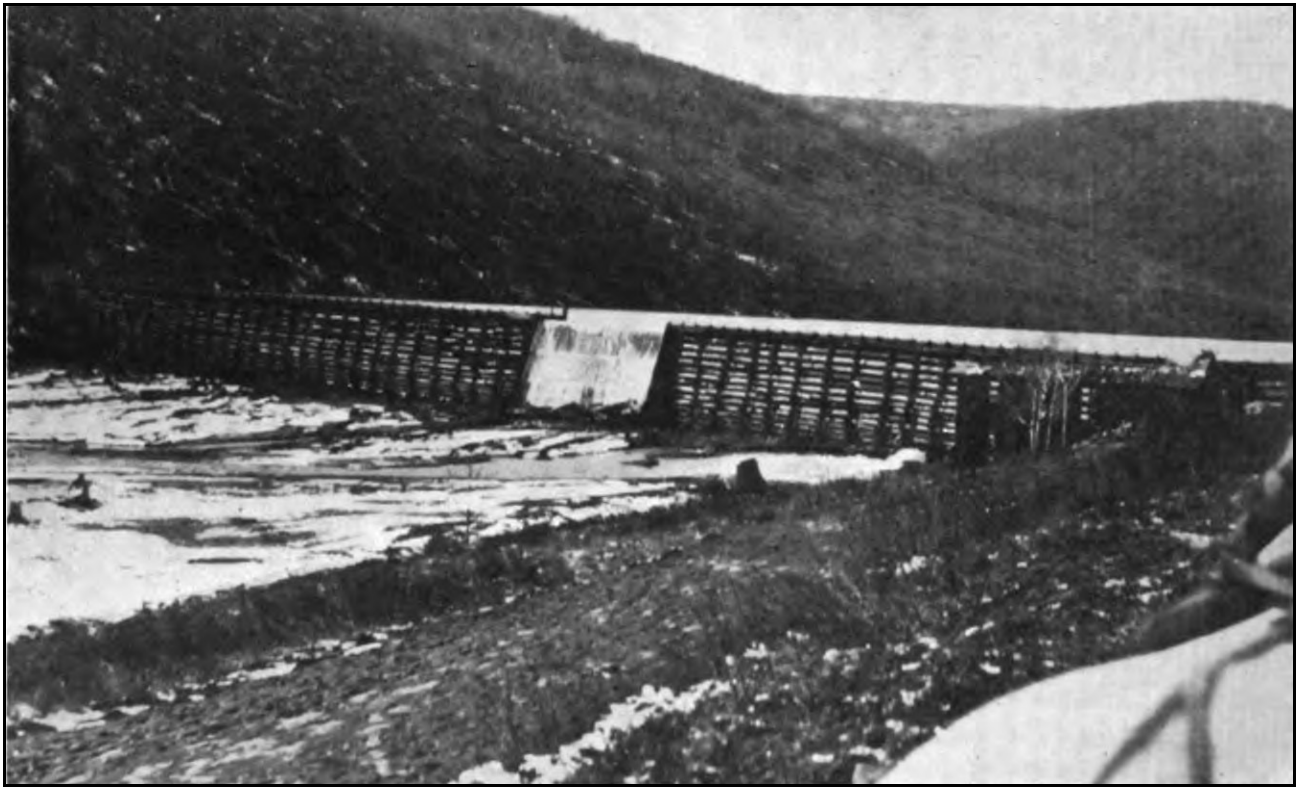
Figure 4. Timber-Crib Dam, Completed June 1910 [10].

In the first five months of operation, the timber-crib dam experienced seepage at the base along its entire length as well as up the right abutment. By December 1910, ten inches of settlement was observed along the entire length of the dam crest. Upon this news, Bayless directed the mill superintendent to empty the reservoir behind the timber-crib dam to investigate its condition and implement repairs. Later accounts indicate that strengthening this dam with timber, earth, and rock required a constant effort.
