Toddbrook Reservoir Independent Review Report By Professor David Balmforth

10 February 2020

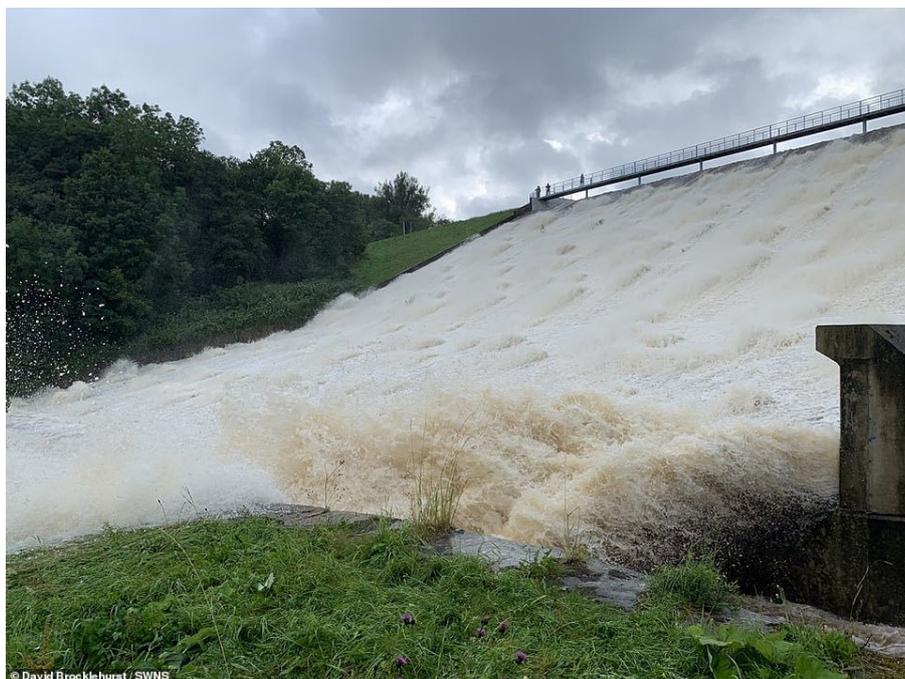
Figure 4. The Spill at its height on the 31 July 2019

The photographic and video evidence from the 31 July shows a substantial discharge down the spillway, with high velocity flow, and aeration caused by the impact of the flow with the “plums” embedded into the surface of the chute. There is a large roller wave along the left-hand flank wall and the flow lifts away from the spillway at the lower left-hand side to jump over the primary spillway channel into the grassed area beyond. A distinct brown staining of the flow to the left-hand side of the spillway can be observed at this time, which is consistent with the transportation of silt and fines (fig. 4).

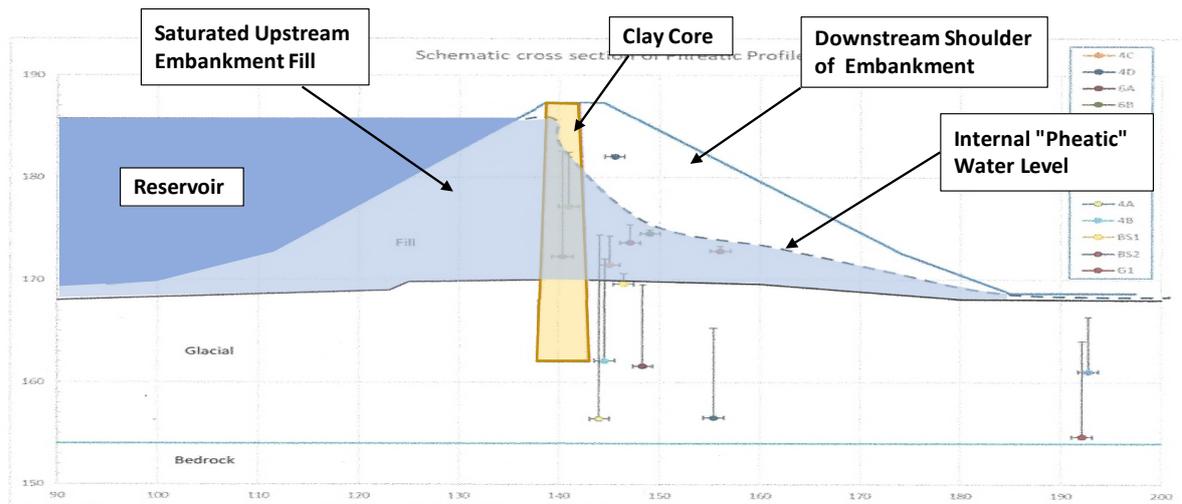
It is clear then that there were routes for water to pass through and/or under the auxiliary weir crest slab. However, it is not necessarily the case that these would have continued under the downstream chute slabs, nor that such crest seepages would have led to any significant migration of material. The downstream shoulder material is essentially permeable and well graded, albeit with zones of variability. It would not therefore be prone to internal fines migration through suffusion (the ability of fine material to pass into and through voids in a coarse matrix, such as gravel). It is also likely that gravity would take any seepages coming beneath or through the auxiliary spillway crest downwards through the fill material rather than them continuing under the chute slabs. Figure B6 shows the phreatic water surface within the embankment recreated in the recent Mott MacDonald study based on measured piezometer levels. It illustrates the very low phreatic (pore water pressure) levels in the downstream shoulder, indicating a free draining material.

Figure. B6 Measured phreatic water levels within the embankment

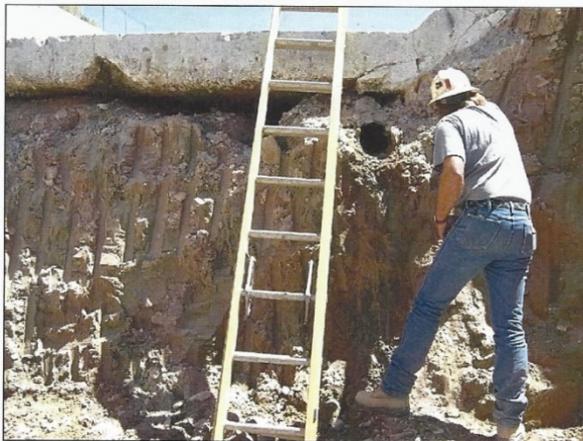
Figure 3.—Undermining of the chute slab has occurred due to flow entering at joints and cracks and transporting foundation material through unfiltered drains.

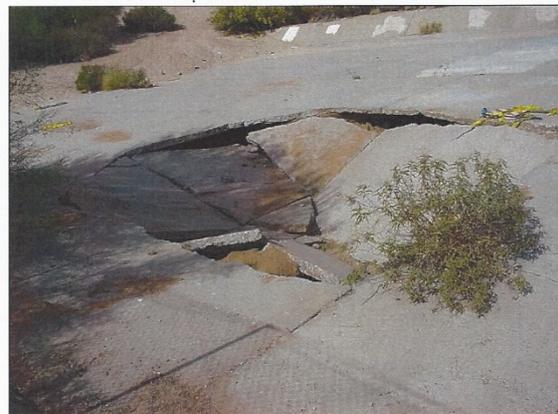
Figure 4.—Structural collapse of the slab system occurs when enough undermining has occurred to cause loss of support. This damage is typical of slabs placed on soil foundations (note: this slab is not reinforced so failure is more evident).

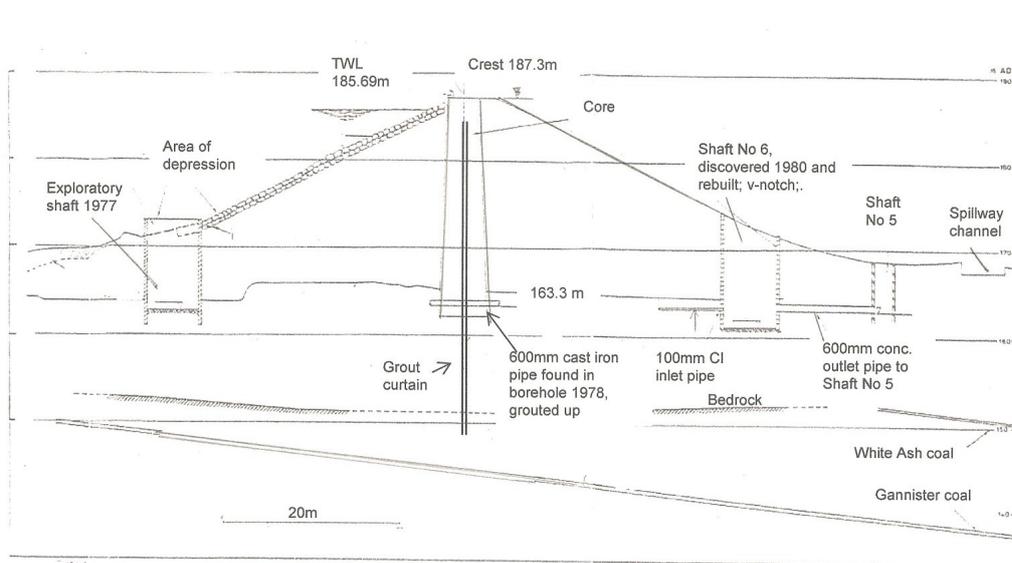
Concerns and uncertainty that leakage and possibly internal erosion could take place through the core and foundation, led to a grout curtain being installed in 1983. Grout takes (a "take" is the amount used) varied significantly. One large grout take, some 1400kg of cement (approximately 5 cubic metres of grout), occurred between 15m and 25m below crest level, and was injected below the auxiliary spillway crest slab at the level of the original stream bed, where the masonry culvert was built, just upstream of the core. Elsewhere grout takes of up to 3400kg of cement (approximately 11 cubic metres of grout) were recorded. A cement/bentonite/water grout mix was used, typically 10/1/30 but varying depending on its use. Apart from reducing leakage through and under the core, the grout would have strengthened the core, increasing its shear strength against potential deep-seated slope instability.

Figure C2. Section showing location of grout curtain various investigation and monitoring shafts (Based on British Waterways Drawing HH /BWB /02/03, 1984)
