REVIEW OF THE
TESTALINDEN DAM
FAILURE

JULY 2010

This report is an independent review of the context leading up the failure of the Testalinden Dam, the circumstances of the event itself, the response and recovery efforts, and a review of dam safety oversight in British Columbia.

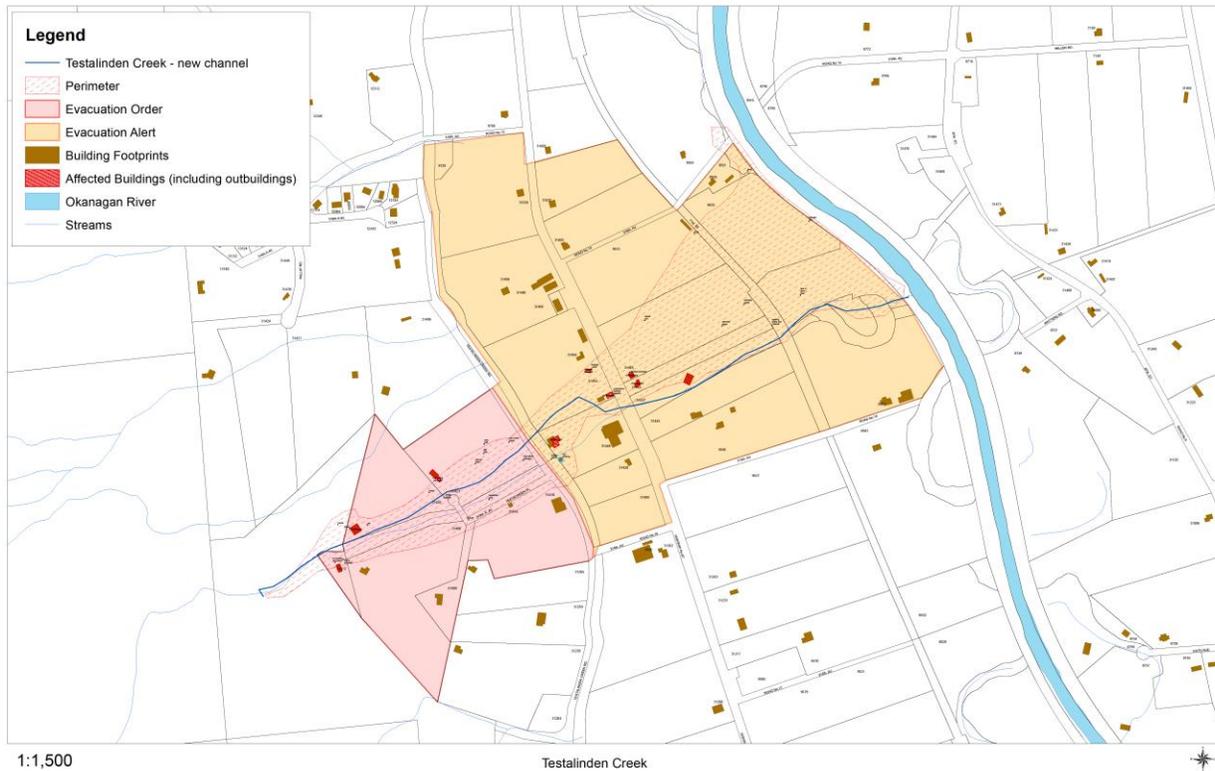
At approximately 2:15pm on June 13, 2010, the Testalinden Dam breached, causing a debris torrent that travelled five kilometers downstream. The mudslide destroyed or badly damaged five homes and caused significant damage to crops and farm equipment, covering 200 meters of Highway 97 and blocking several secondary roads. The technical reasons for the dam failure are still being investigated by hydrological and geophysical engineers, but it is likely that the combination of heavy water load (due to recent heavy rains and clear cuts in the area), over-topping of the roadway and dam, and blockage of the spillway and drainage sluices were all contributing factors.
