Report of Findings on the Overtopping and Embankment
Breach of the Upper Dam - Taum Sauk Pumped Storage
Project, FERC No. 2277

FERC Taum Sauk Investigation Team

April 28 2006

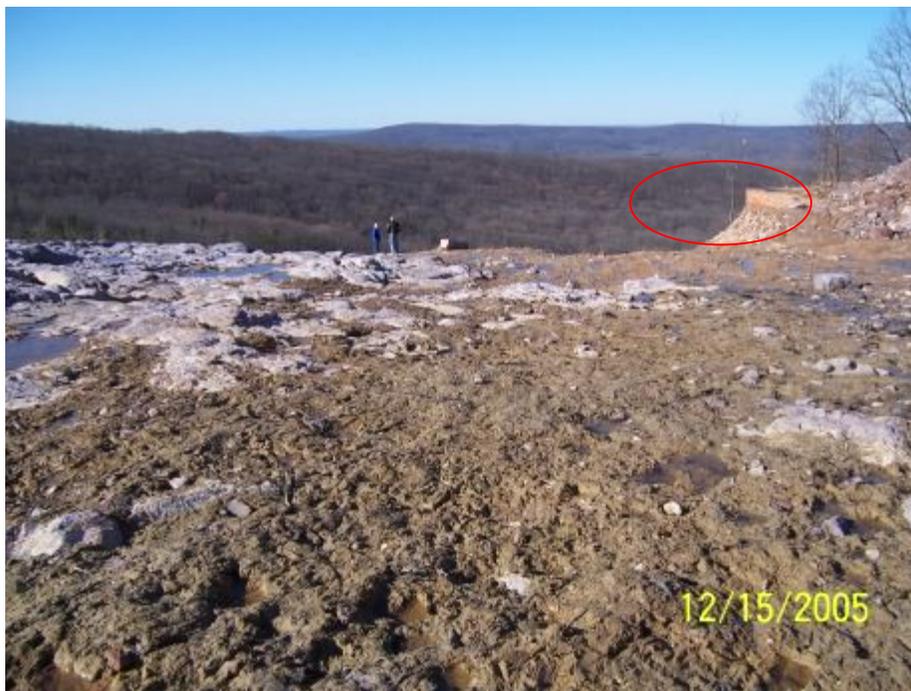
Figure 2.8 - Overview of area shown in previous photograph. Note washed out access road (circled).

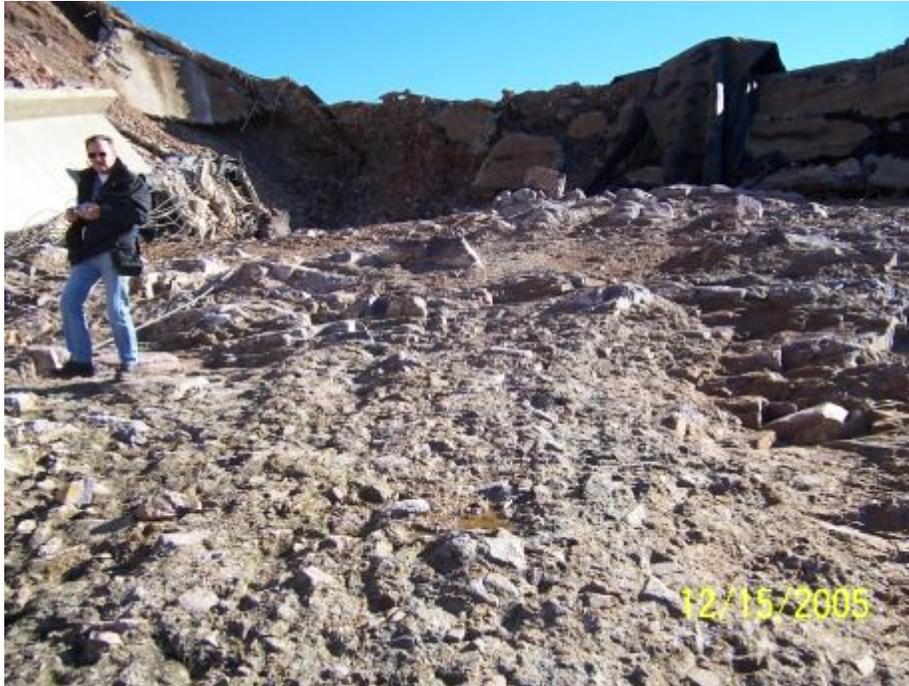
Figure 2.9 - Overview of area to the right of that shown in previous photograph. (See also Figure 2.4.) Note breach in background and toe of breach slope on left edge of photograph.

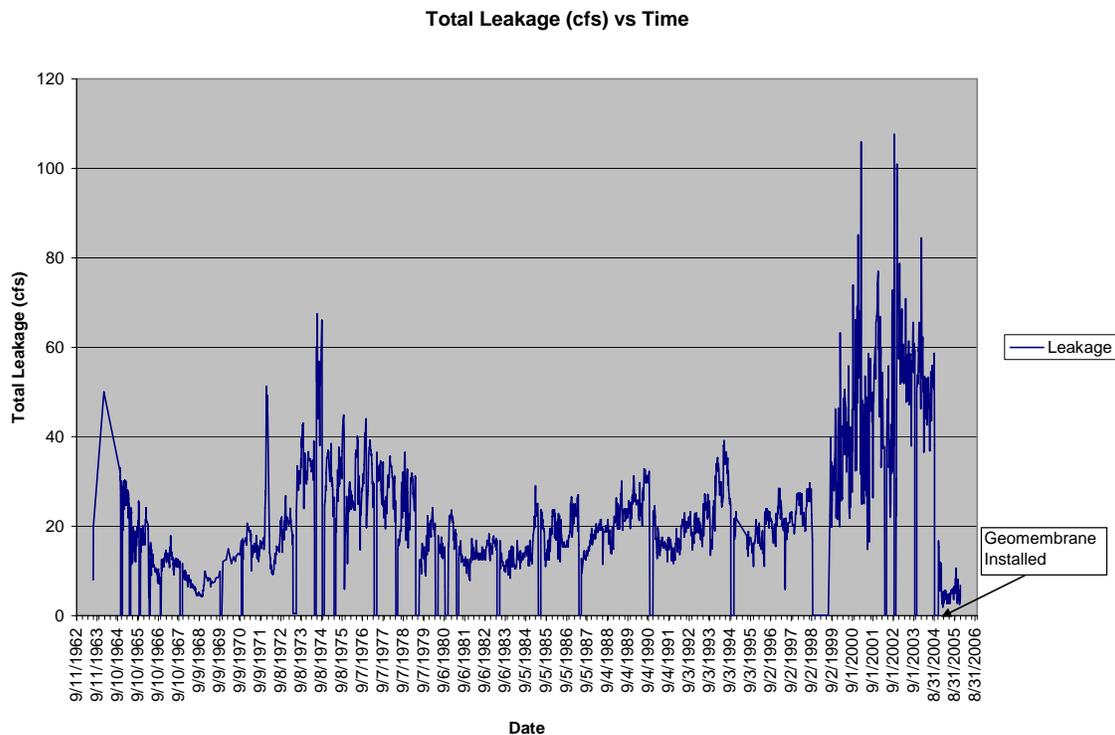
Higher rates of leakage began in 1999 following an extended outage. A geomembrane liner was subsequently installed in 2004, which significantly reduced the leakage for the 12 months prior to the breach. Figure 3.5 shows the history of leakage and the periods of repairs (illustrated by periods of zero leakage).

Figure 3.5- Historical leakage Rates

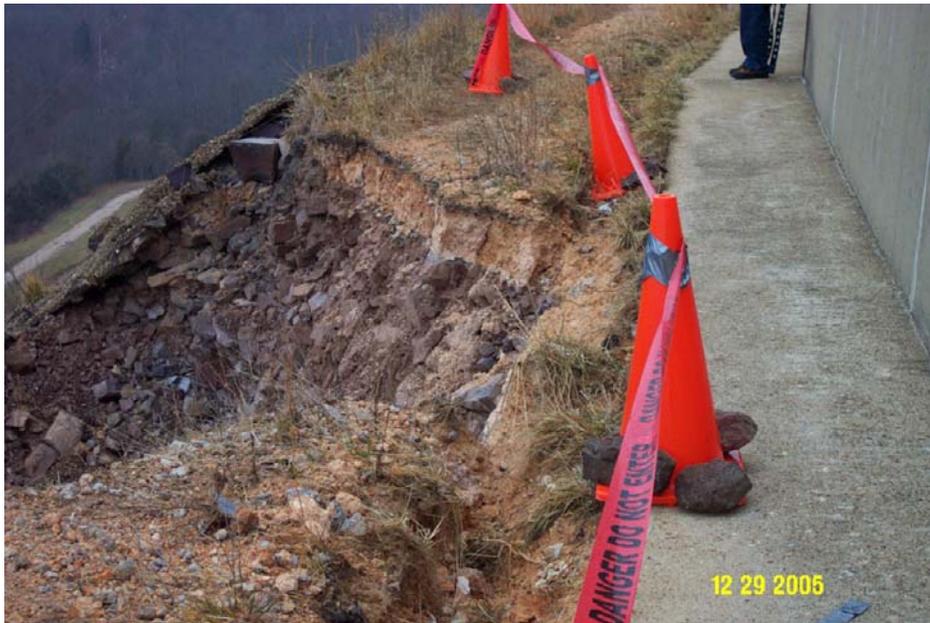
**Figure 4.6 - Panels 48 and 49
Scarp near toe of parapet wall footing
Note erosion rut adjacent to the footing**

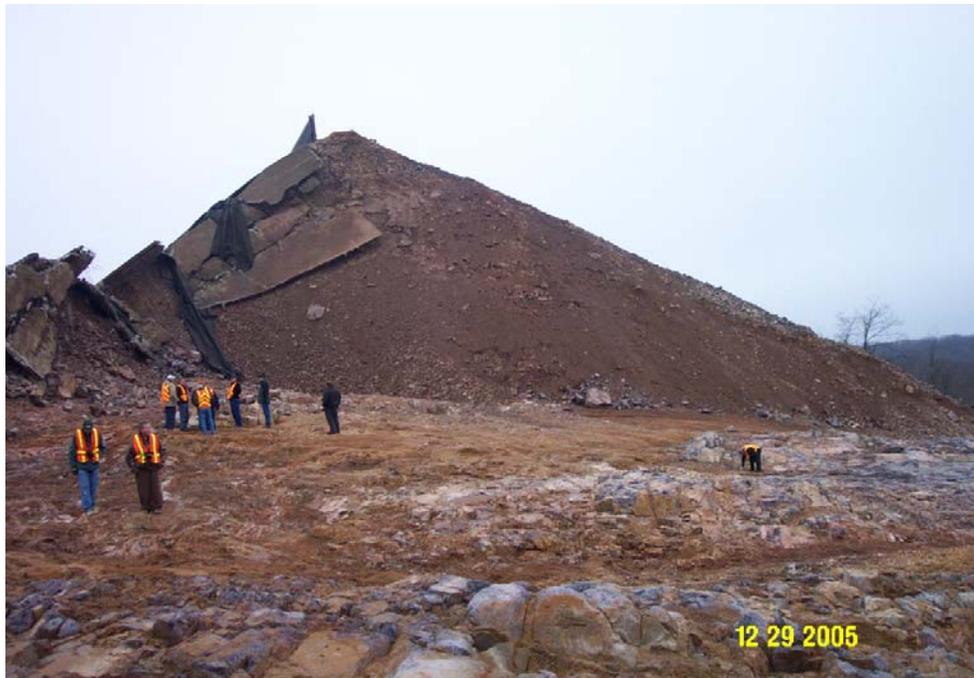
Figure 4.11 - Left side of breach

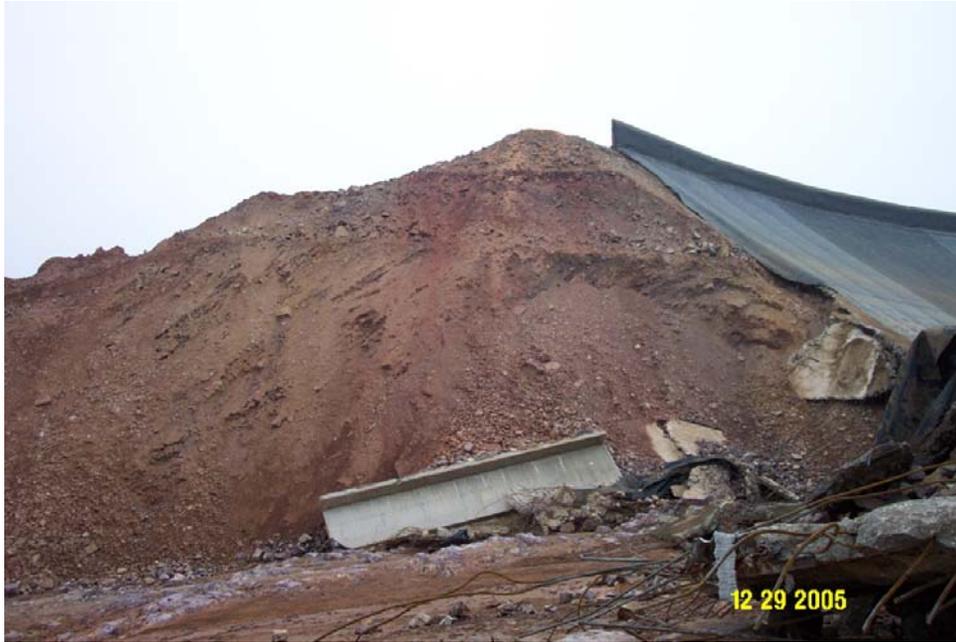
**Figure 4.12 - Right side of breach
Note layering of embankment**

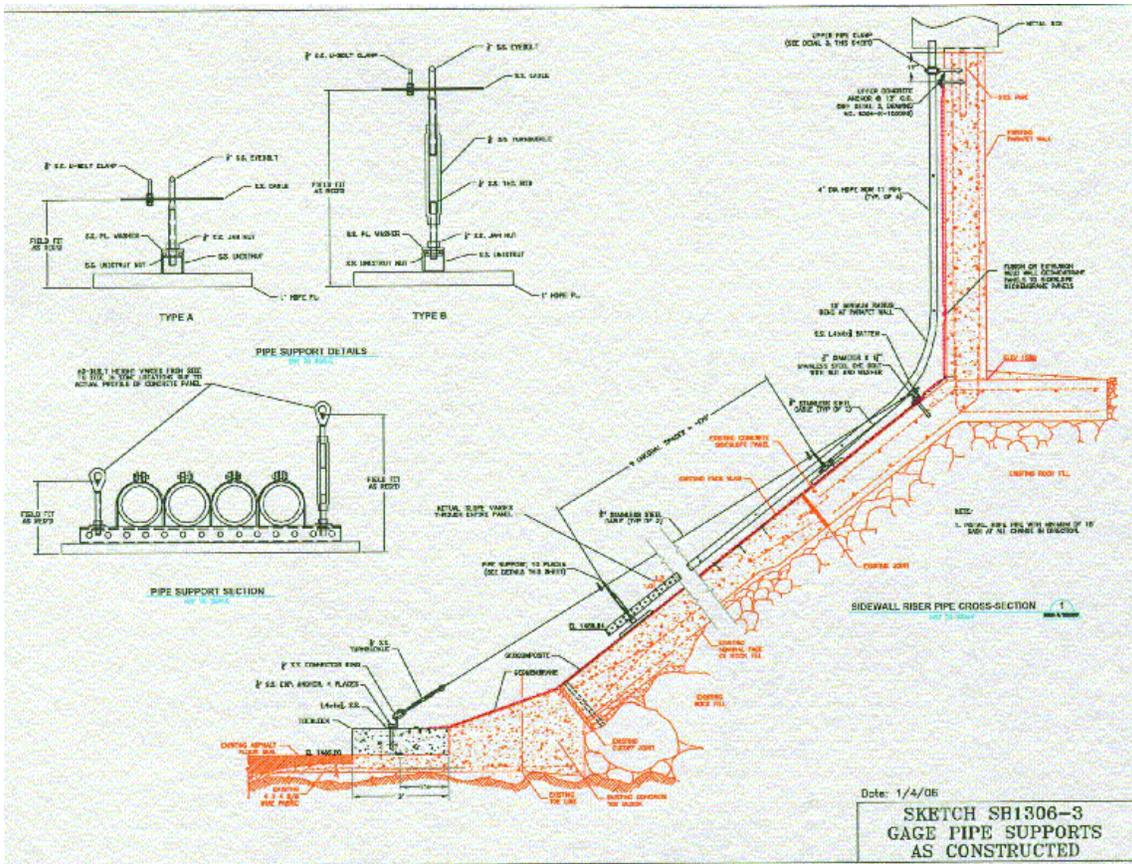
The HDPE pipes were tied to 1 inch by 48 inch by 12 inch HDPE flat stock which was set on, but not connected to a HDPE rub pad which was glued to the geomembrane liner. These pipes were not firmly attached to the face of the dam. Instead, stability was intended to be provided by a configuration of stainless steel unistrut section, steel bolts, turnbuckles, jam nuts, eyebolts and U-shaped cable lock bolts tied to two stainless steel cables. The cables were anchored only at the toe block at the base of the slope and at the interior base of the parapet wall (Figure 5.1). Down slope movement of the HDPE pipe assembly was limited by clamps placed on the cabled just down slope of the eyebolt connection to the pipe assembly. A similar restriction to movement upslope was not included.

**Figure 5.1 - Structural Design of the Upper Reservoir Control System
December 2004**

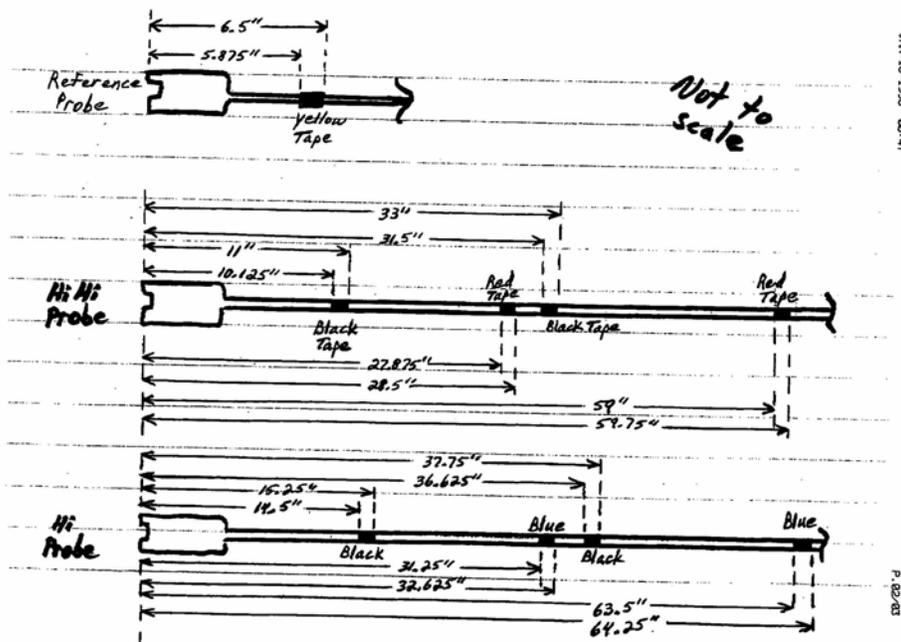
Figures 5.2 show the configuration of the sensors within the instrument cabinet. The cabinet is located on the dam crest at the southwest end of the reservoir. Figure 5.3 shows distances from the Warrick Conductivity sensor tips to reference tapes placed on the wiring by AmerenUE staff. The tapes were used to place the sensors at the original design elevation (November 2004) and the as-found elevation on December 14, 2005.

Figure 5.3 - Tape reference points on leads to the HIGH and HIGH-HIGH Warrick Conductivity Sensors (as Provided by AmerenUE)

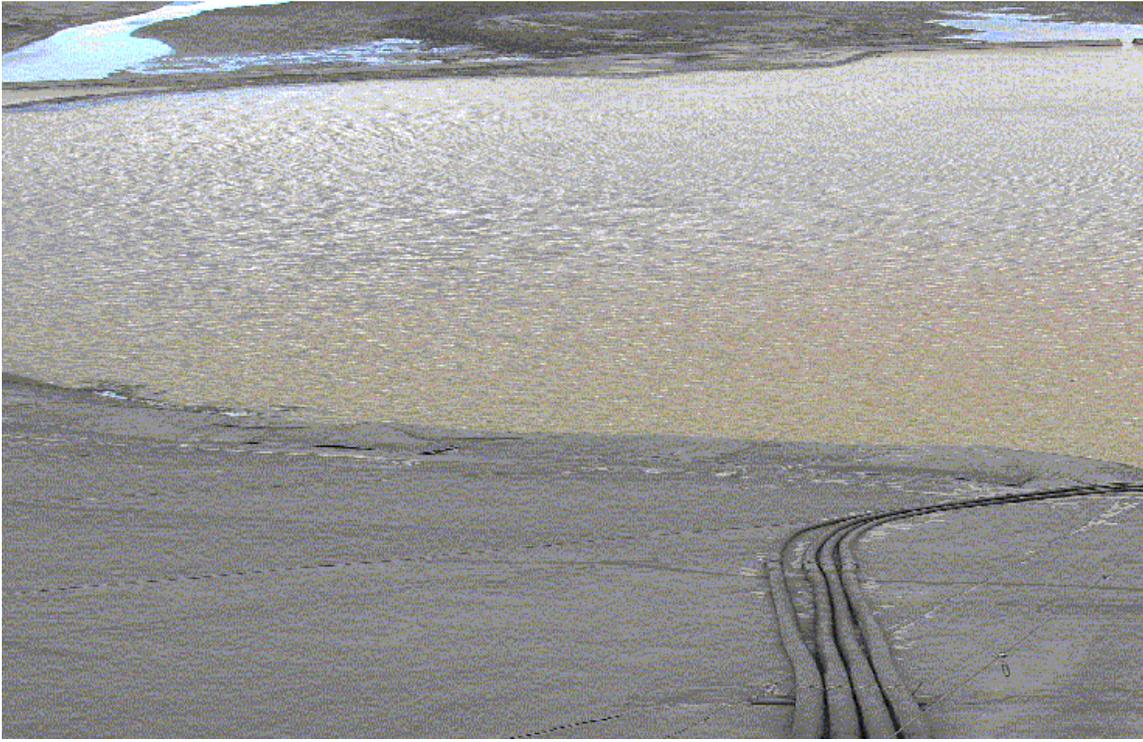
An October 3, 2005 inspection by AmerenUE of the reservoir monitoring system revealed the HDPE pipes were bowed out to one side an estimated 3 feet. (Figure 5.4 shows bowing after the breach) The bowing of the instrumentation pipes coincided with the failure of the fasteners holding the pipes to the stainless steel cables. The intake in the upper reservoir is about 125 ft from the location of the HDPE pipe and instrumentation.

**Figure 5.4 - Bowing of HDPE Tube position on December 15, 2005
(Courtesy of Missouri DNR)**

The licensee reported that the offset and length of the arc of the HDPE pipes measured after the breach were 14 ft and 119 ft, respectively (see Figure 5.4). This was estimated to raise the reservoir control sensors approximately 2.5 feet. Due to the fact that the pipes have a tendency to straighten after the water is drawn down, it is not known what the maximum deflection was at the time of the breach. The estimate of peak pool level of about 1597.7 ft verses the Druck pressure transducer reading of 1593.72 indicates the transducers were about 4 feet higher in elevation than the original design. The following table presents the results of a geometric analysis of the bowing in the HDPE pipes showing several variations of offset and arc lengths and the resulting increase in elevation. Chord lengths were limited due to a cut in the rock outcrop where the pipes tended not to move laterally (see Figure 5.5).

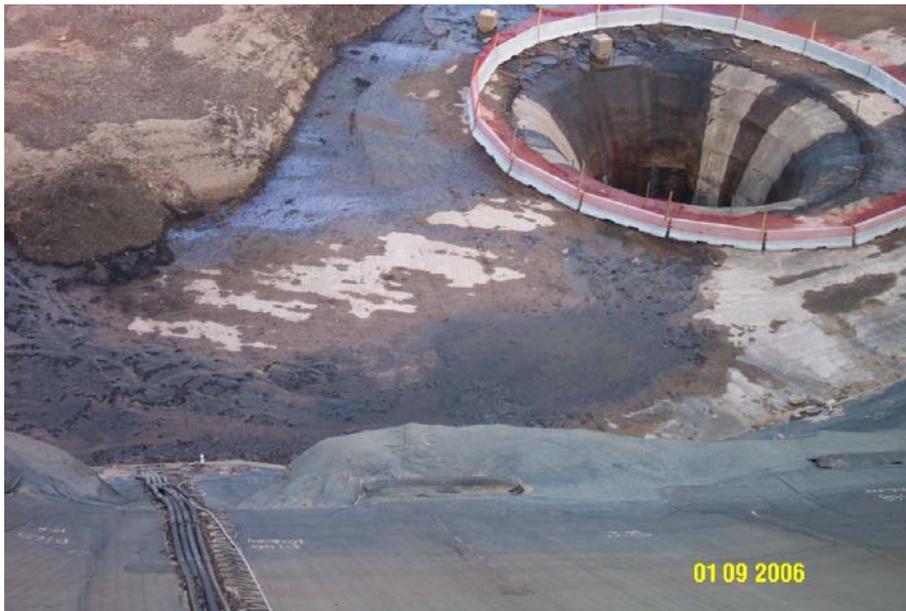
Figure 5.5 - Instrumentation location relative to the water conveyance shaft

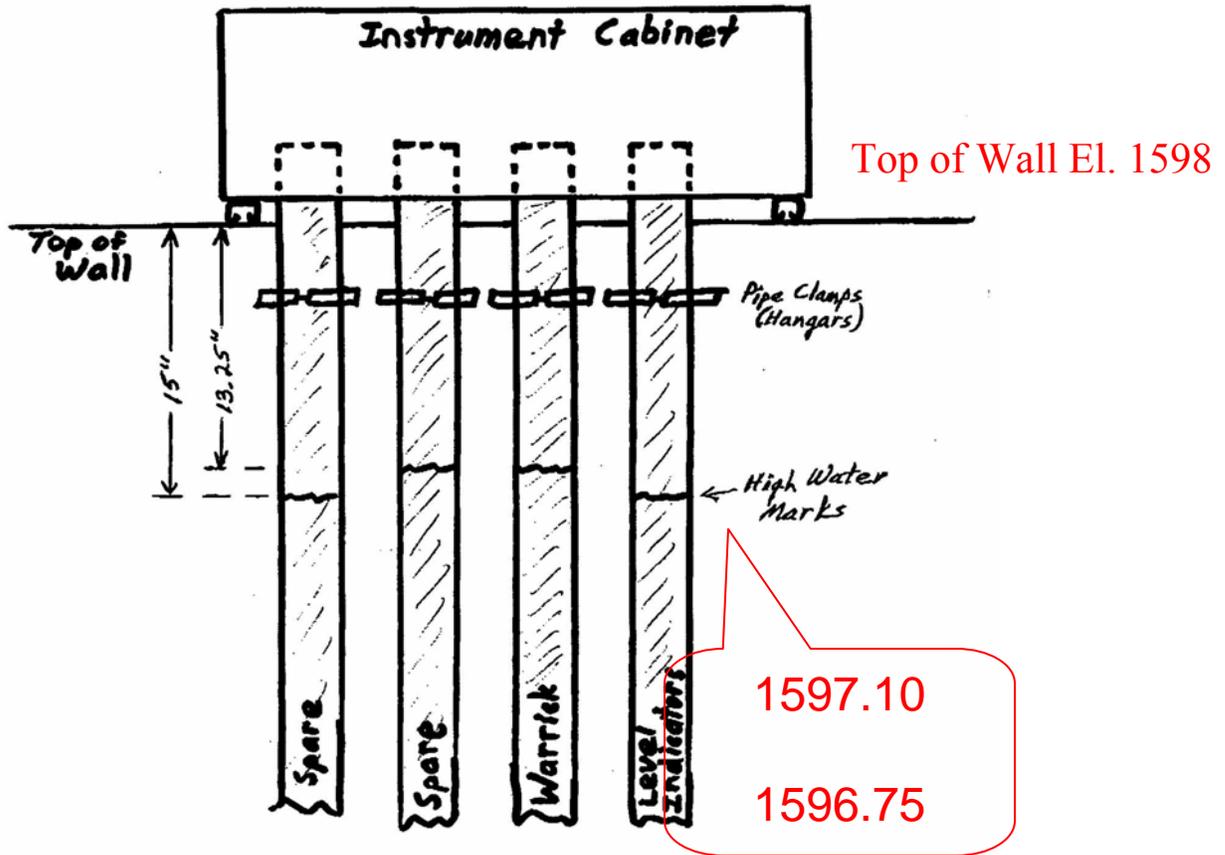
Evidence of the monitoring system not operating as designed was found at the gage house with water marks noted on the HDPE pipes. The elevation of the watermarks indicates the peak reservoir level may have been routinely above elevation 1596 ft. Figures 5.6 and 5.7 are a photograph and schematic of the high water marks, respectively.

Figure 5.7 - Elevation of high water marks

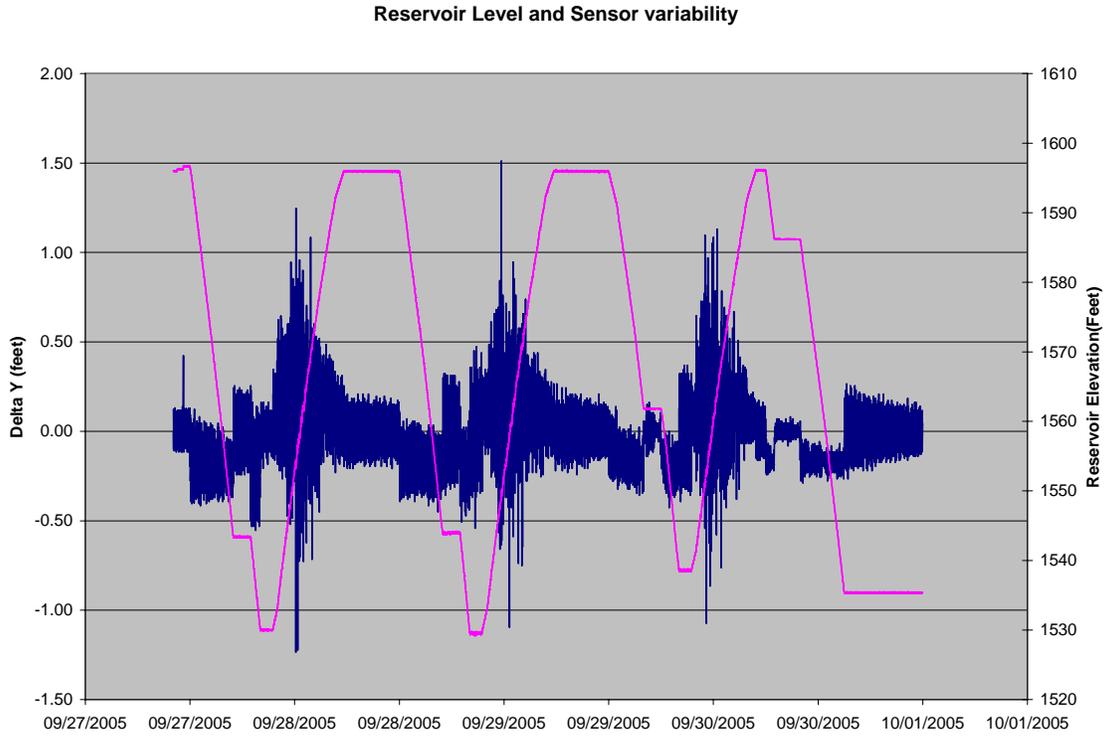
1. The variability in the system output when the reservoir was in pump mode appeared to be within the specification after initial installation.
2. Increases in variability of the Druck pressure transducer signals and output appear to increase from September 2005 through December 2005.
3. Variability appears to be greater than the sum of the electronic error and the rate of reservoir rise. Variability up to +/- 1.75 feet occurred December 13, 2005.
4. The greatest fluctuation in the output occurs during the pump cycle when the reservoir elevation is between 1545 ft and 1565 ft.
5. It is possible there is a relationship between the movement of the instrumentation pipes and the turbulence caused by the pumping cycle (Figure 5.16 – shows turbulence on first filling. Figure 5.5 shows proximity of pipes to the intake shaft.)

Figure 5.12 - System Variability November 2004 - After Installation

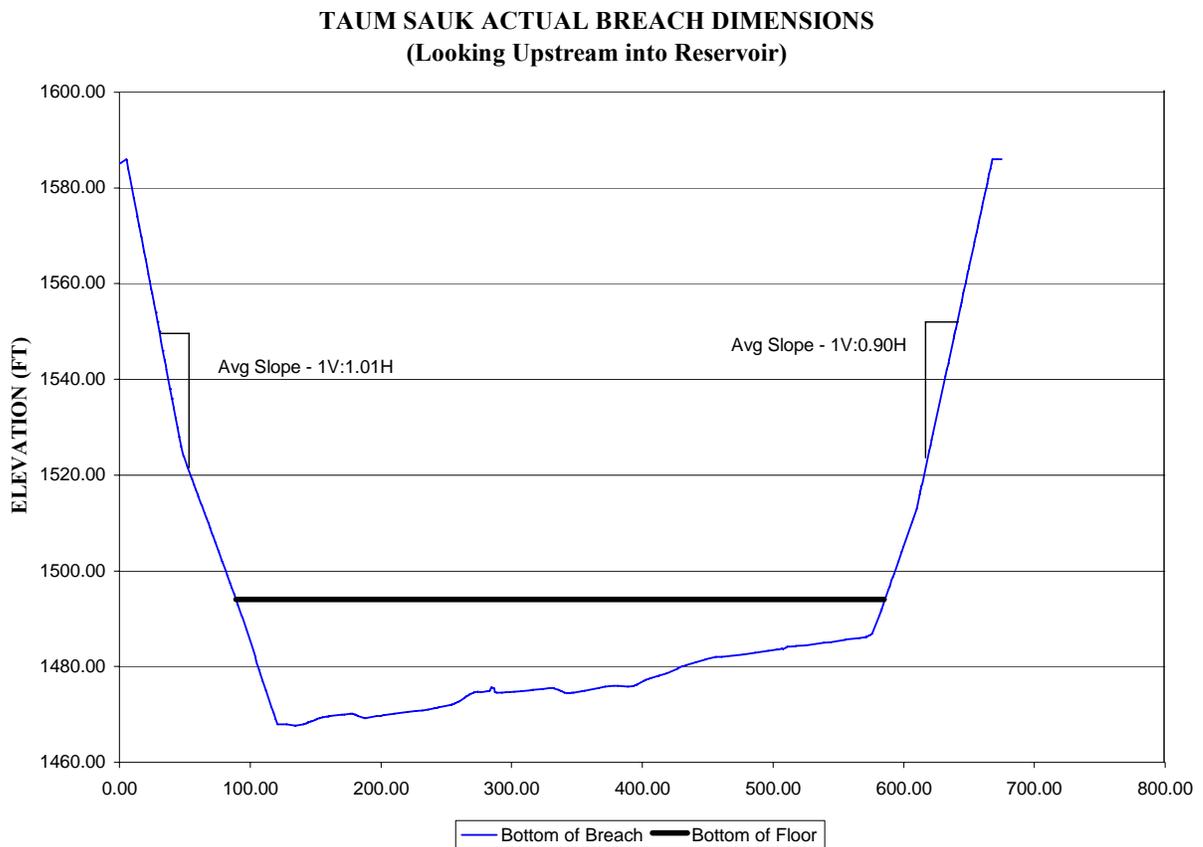
Breach depth = 103 feet. This is based on the floor of the reservoir at elevation 1494 ft and the low point of the parapet wall at about elevation 1597 ft.

An elevation view of the breach based on the aerial survey is in Figure 8.3.

Figure 8.3– Breach Cross Section

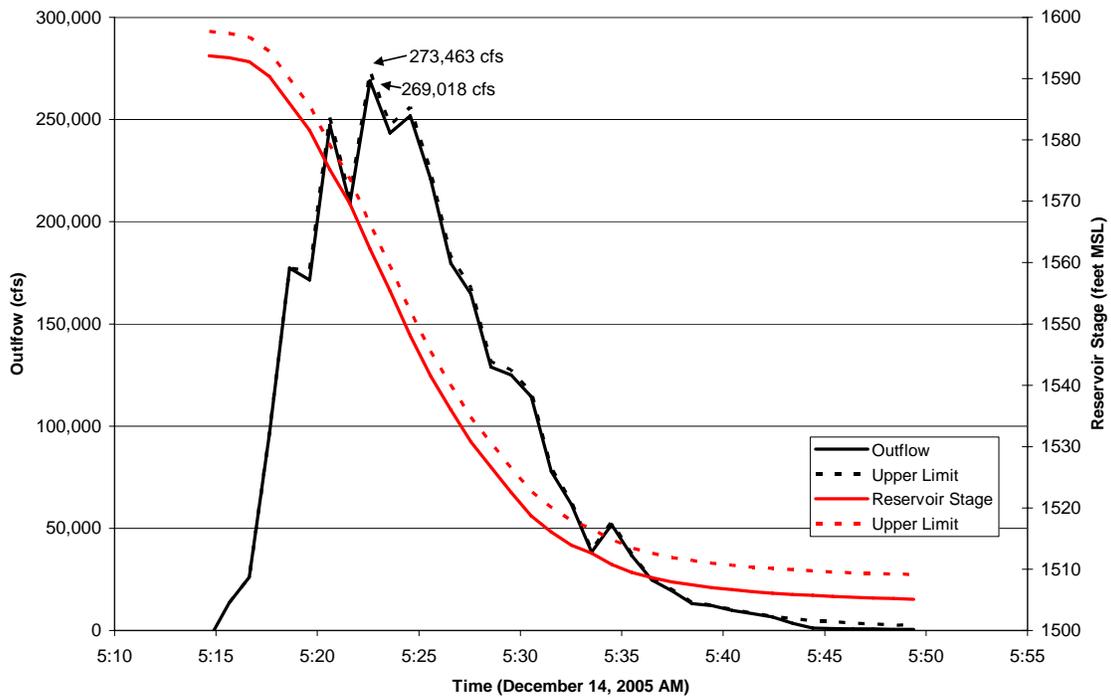
Assuming that the pressure transducer readings were off by 4 feet, the calculated peak flow out of the breach was about 273,450 cfs. If the actual pressure transducer readings are used, the resulting peak outflow from the reservoir was about 269,000 cfs. Time to peak for the outflow hydrograph was approximately 8 minutes after the breach initiated.

Figure 8.6 - Calculated Outflow Hydrograph for Taum Sauk Breach

The outflow hydrograph indicates initial flows may have been due to the loss of one and then two sections of the parapet wall. At 5:16 and 5:17 AM outflows were about 10,000 and 25,000 cfs, respectively. This corresponds with the outflow expected from the loss of one and then two sections of the parapet wall (see Section 8.1.9). After 5:17 AM flows increased rapidly peaking at 273,000 cfs at about 5:23 AM. This zig-zag shape of the outflow resembles somewhat the shape of the outflow estimated in the Emergency Action Plan (EAP), see Figure 8.2.

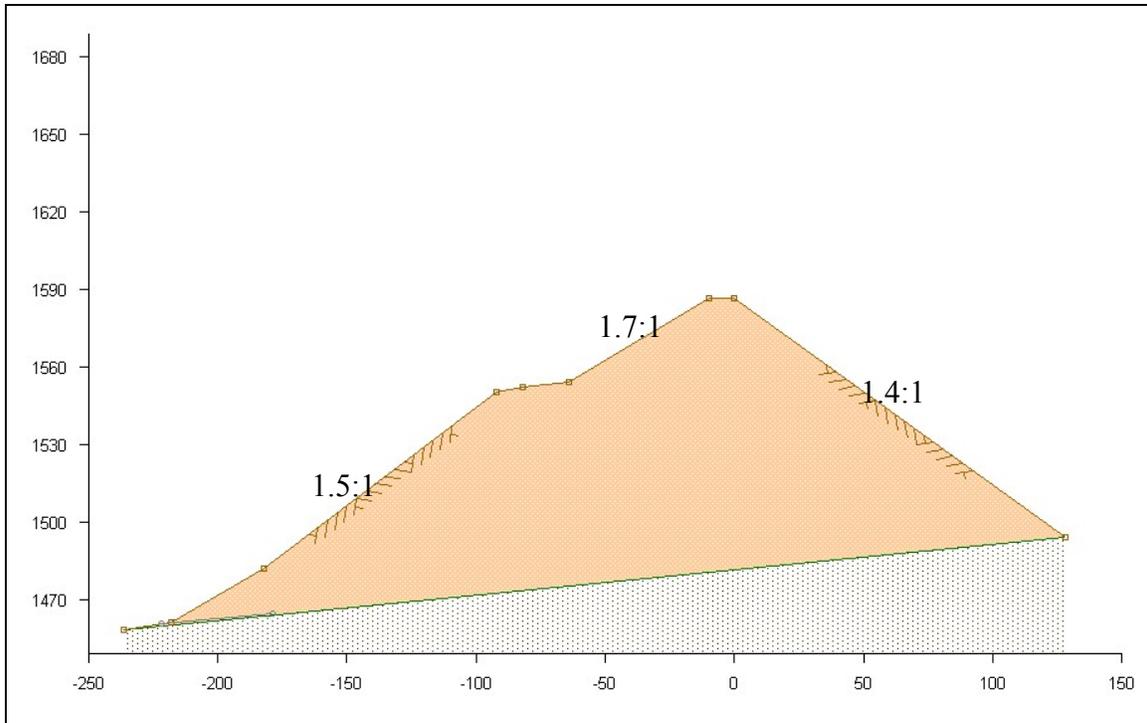
Questions were raised about the steepness of the downstream slope in the area of the breach. A second topographic section was made at the north end of the breach to assess the steepness of the slope in that area. Due to slope failures immediately adjacent to the breach, the section was taken 80 feet northeast of the breach edge (refer to Line 2 in Appendix D – Figure D.1). Figure 9.1 shows the cross section which represents the as-built configuration of the breach section.

Figure 9.1– Embankment Cross Section

The upstream slope (right side of above drawing) is 1.4H:1.0V. The portion of the downstream slope that is above the access road is 1.7H:1.0V, and the portion of the downstream slope below the access road is 1.5H:1.0V. The downstream slope used in the stability analyses for the section taken at the center of the breach was 1.5H:1.0V. Rather than cutting into the original embankment to construct the access road, it appears the access road was placed with material dumped on top of the original embankment. The slope of the road fill material is slightly steeper than the original downstream embankment slope (1.5H:1.0V versus 1.7H:1.0V, respectively). The steeper slope of 1.5H:1.0V was used to represent of the downstream slope in the area of the breach.

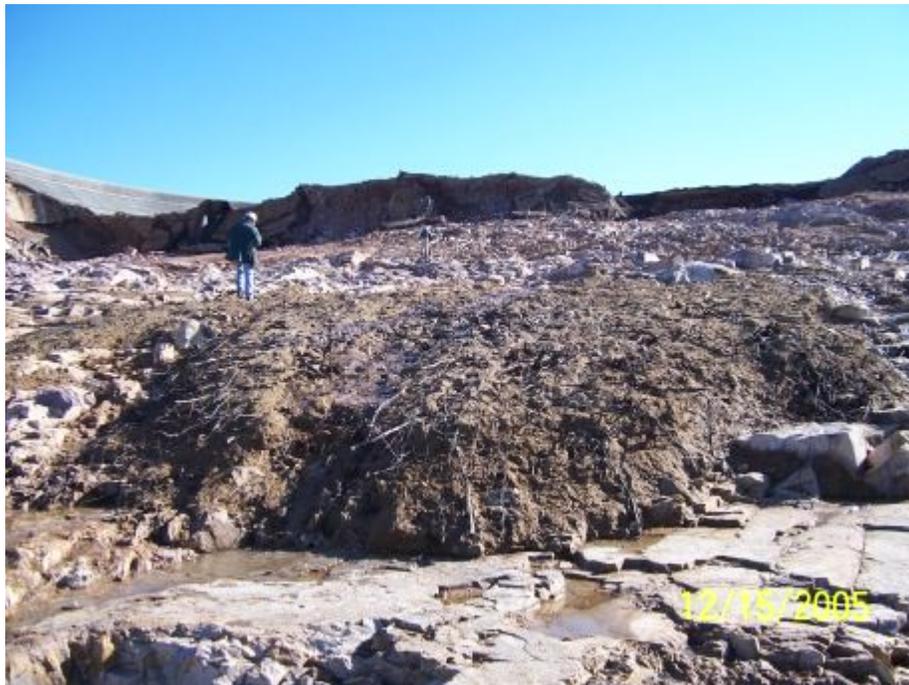
Figure 9.3 - Residual topsoil on top of fresh rhyolite.

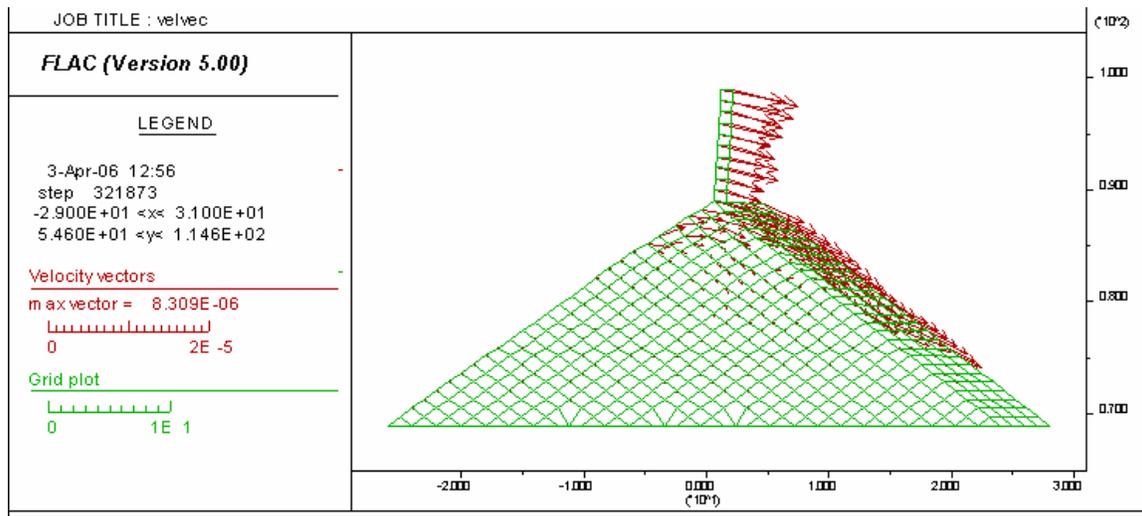
The analysis was stopped when the top of the parapet wall deflected more than 1 foot, which occurred when embankment erosion approached the toe of the wall. This deflection would cause significantly more overtopping to occur, further undermining the wall. Also, it is possible the geomembrane and concrete liner would have ruptured due to the significant wall movement allowing substantial leakage through the open joint, accelerating the loss of embankment material beneath the wall. (See Figures 9.5 and 9.6)

Figure 9.5 – FLAC Analysis

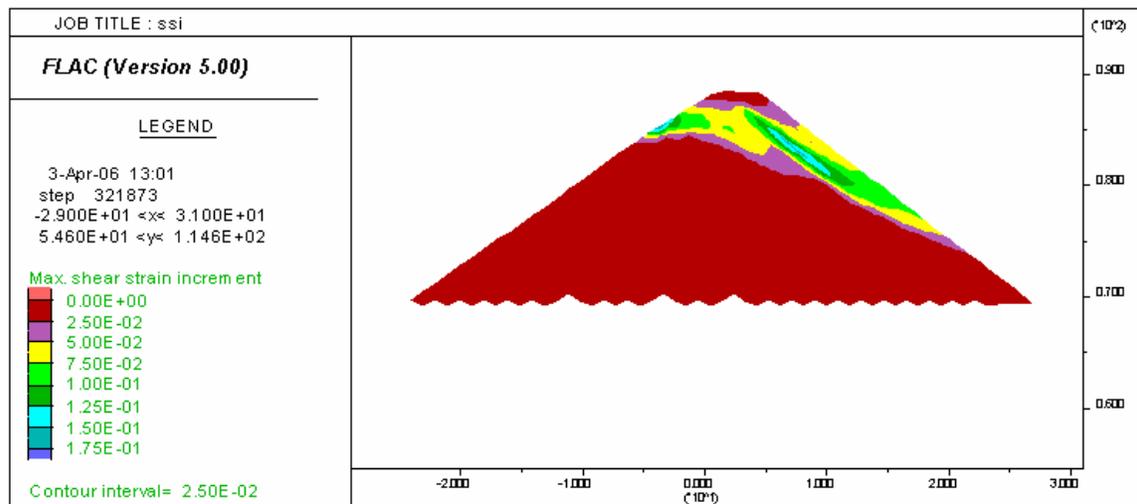
Figure 9.6 - Shear strain from the final FLAC iteration.

Note the band of high shear strain parallel to the slope

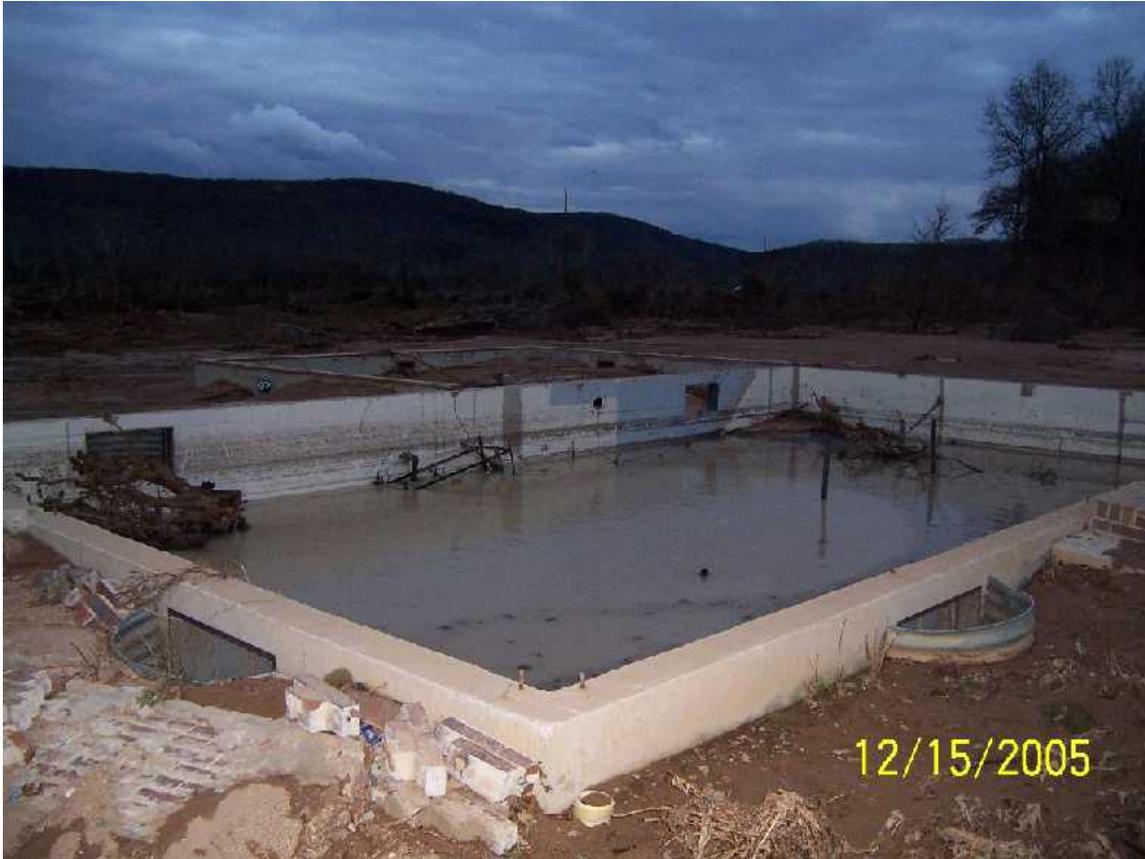
The upper reservoir, atop Proffit Mountain, breached at approximately at 5:15 a.m., releasing a wall of water that rushed down the mountain to the valley floor. There it crashed into the state park superintendent's home shattering it from its foundation while the superintendent and his family were still inside (Figure 11.1). Reports of the event indicate that first responders quickly found the superintendent clinging to a tree; however, it took another hour and half to locate his wife and three small children (ages 5, 3 and 7 months) who were swept up to quarter mile for their home. The family members suffered various contusions and abrasions and were covered in mud. The children were hospitalized in St. Louis, MO and listed in critical condition with hypothermia and breathing problems

Figure 11.1 - State park superintendent's former home. (Source: Staff)

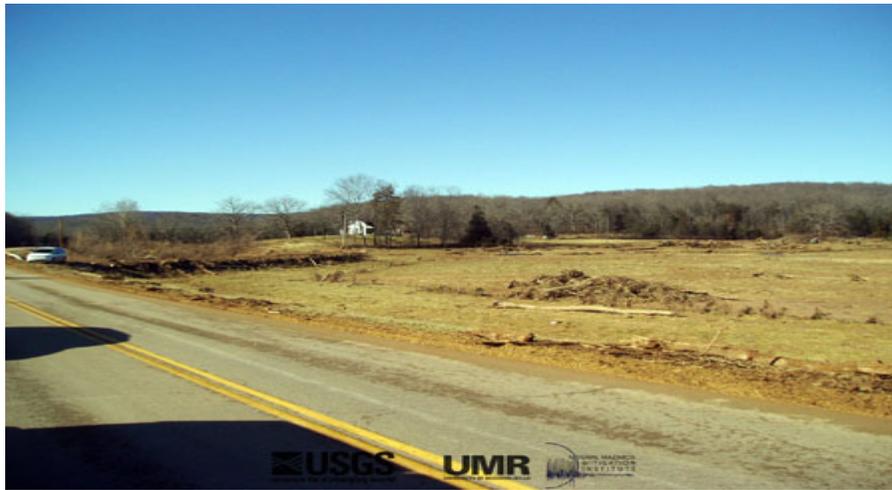
One home approximately 200 hundred yards from the Superintendent's residence (located off Route N) was surrounded by flood waters but, because it is located on a small hill, the flood waters encircled the residence but did not flood it. The surrounding farmland however, was flooded and debris and sediment was deposited in the fields. Additionally, some of the farmland fencing was destroyed (Figure 11.2).

Figure 11.2 - Farmland with debris on north side of Route N. Note home on small hill. (Source: U.S. Geological Survey)

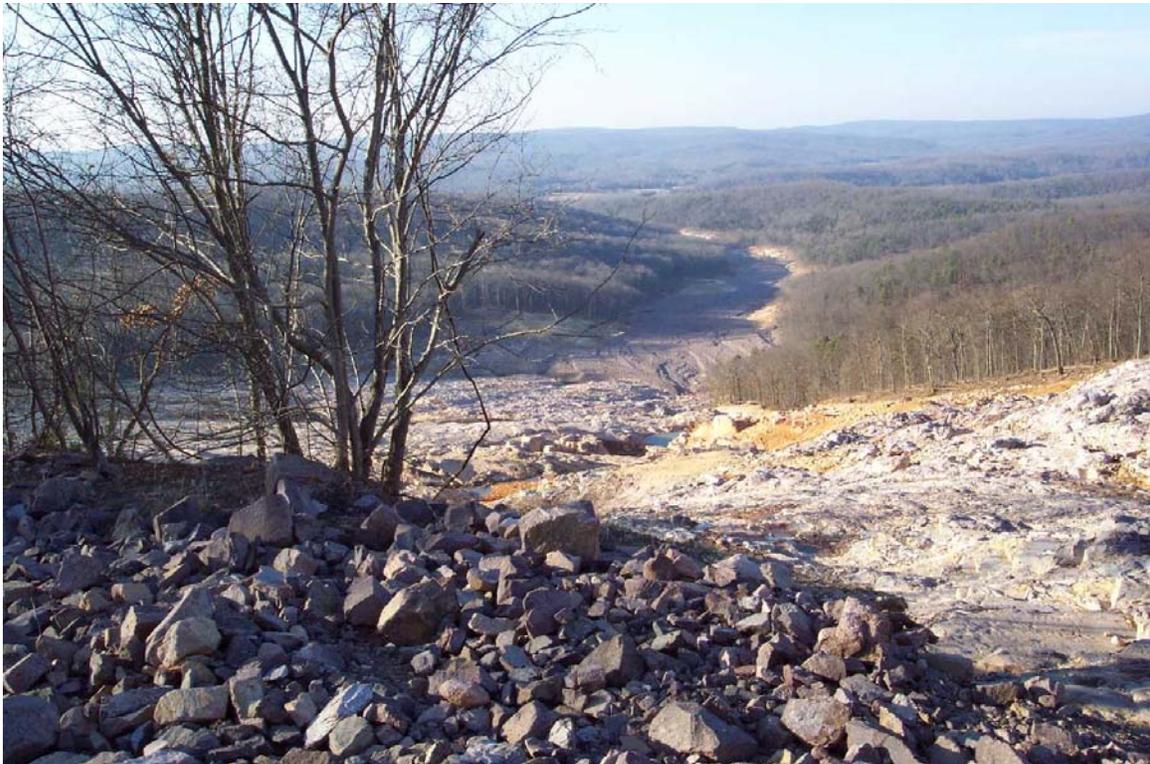
Approximately 317 acres, between the upper and lower reservoir, were directly impacted by the release of water immediately following the dam breach. A map and description of the land uses and soils of this impacted area can be found in Appendix E in the back of this report. The erosive force of the water from the breach removed all topsoil to bedrock in an approximate 200-yard swath, down the face of the Proffit Mountain (Figure 11.3) along the course of an intermittent unnamed tributary. Also, seen in Figure 11.3 is the shallowness of the topsoil along the tree line.

Figure 11.3– Downstream view from breach (Source: Staff, 12/22/05)

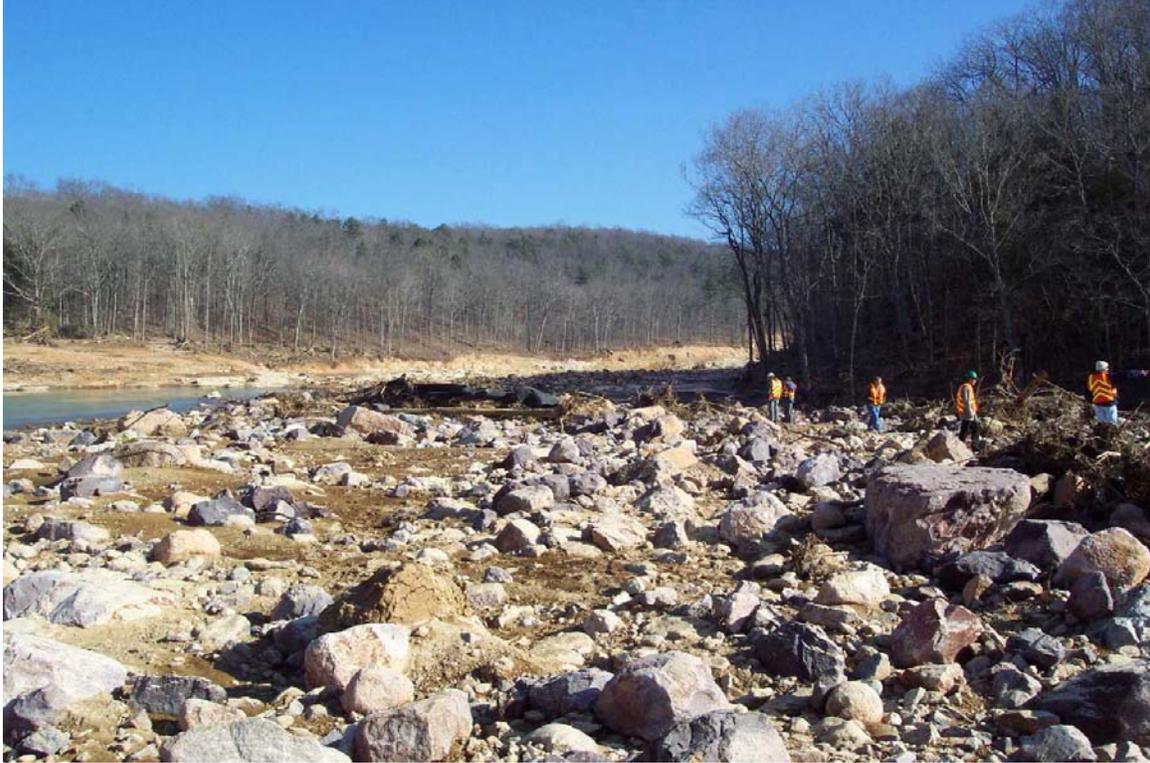
A break in the slope of the terrain is located where the unnamed tributary joins the East Fork Black River at the lower portion of the mountain. Most of the deposition of eroded sediments and rock fill from the dam embankment occurred at this point, forming a debris dam (Figure 11.4) and pond at the approximate location of U.S. Geological Survey gage station (No. 070661270) which was severely damaged during the event. The material deposited at this point ranged from boulders several feet in diameter to sand and fine silts. Concrete, rebar, and

sections of the geomembrane lining from the Upper reservoir were also present in the debris field.

Figure 11.4 – Looking upstream from debris dam (Source: Staff, 12/22/05)

It is expected that there will be continued soil erosion and transport of material of varying sizes from the slope of Proffit Mountain and the associated debris field. The licensee has proposed a series of temporary sediment retention structures along the affected area to prevent further transport of the sediments, until they can be stabilized.

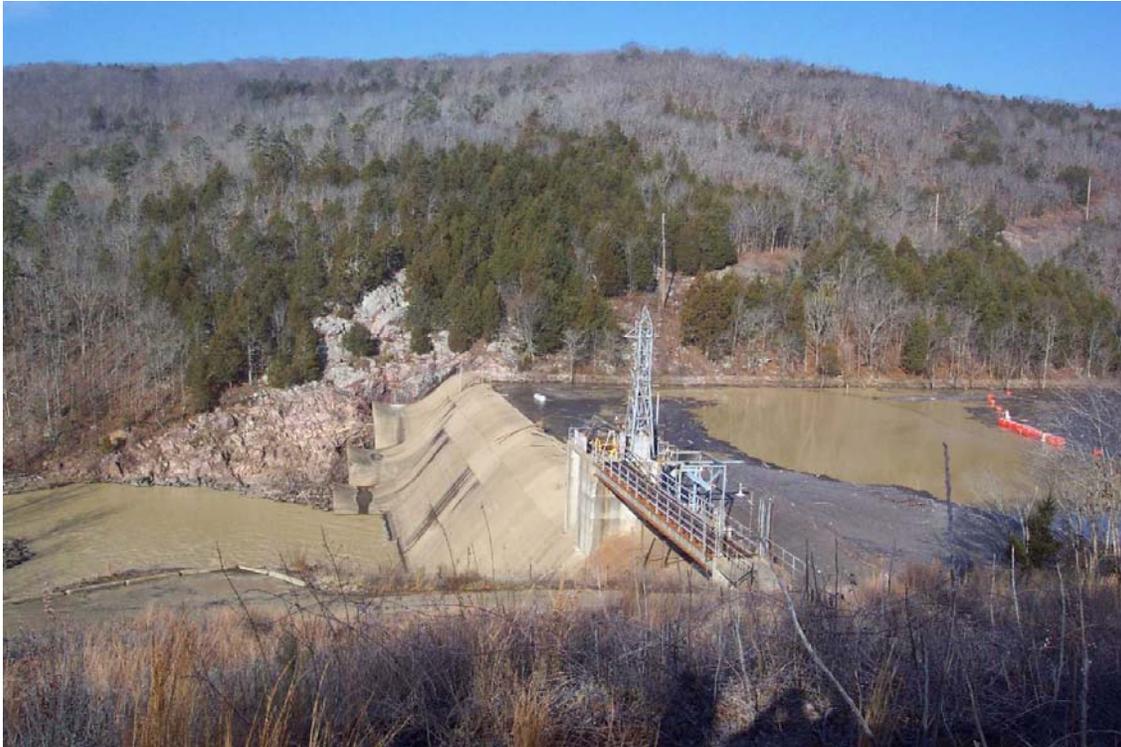
Figure 11.6 – Turbidity at Lower Dam (Source: Staff, 12/22/05)

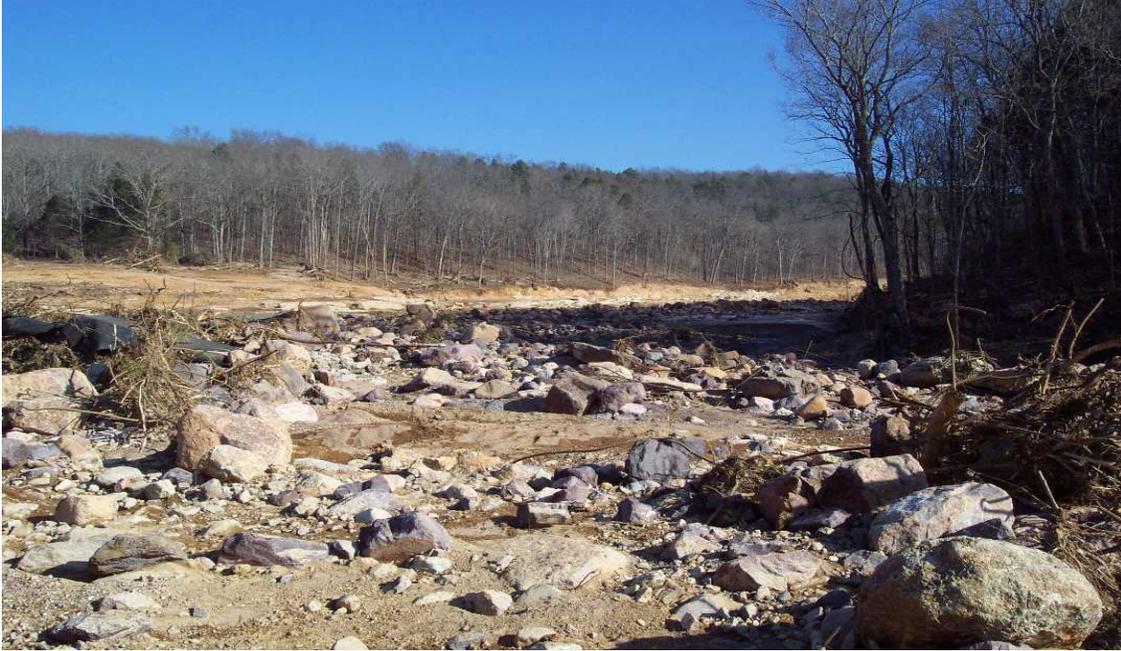
The high flows immediately following the rim dike breach, carried a tremendous amount of sediment and boulders into the river from the upper dam's embankment, in addition to the scour created down the side of the mountain. Vegetative debris and earthen sediment was deposited on the valley floor and in the East Fork Black River (Figure 11.7). The volume of the debris and sediment altered the configuration of the river from the point of entry to the Shut-Ins area of the park and destroyed riparian habitat (Figure 11.8). It also reduced aquatic habitat and adversely affected the river channel by creating pools, barrier dams and disjoining habitats.

Figure 11.7 - Modified channel of the East Fork Black River (Source: Staff)

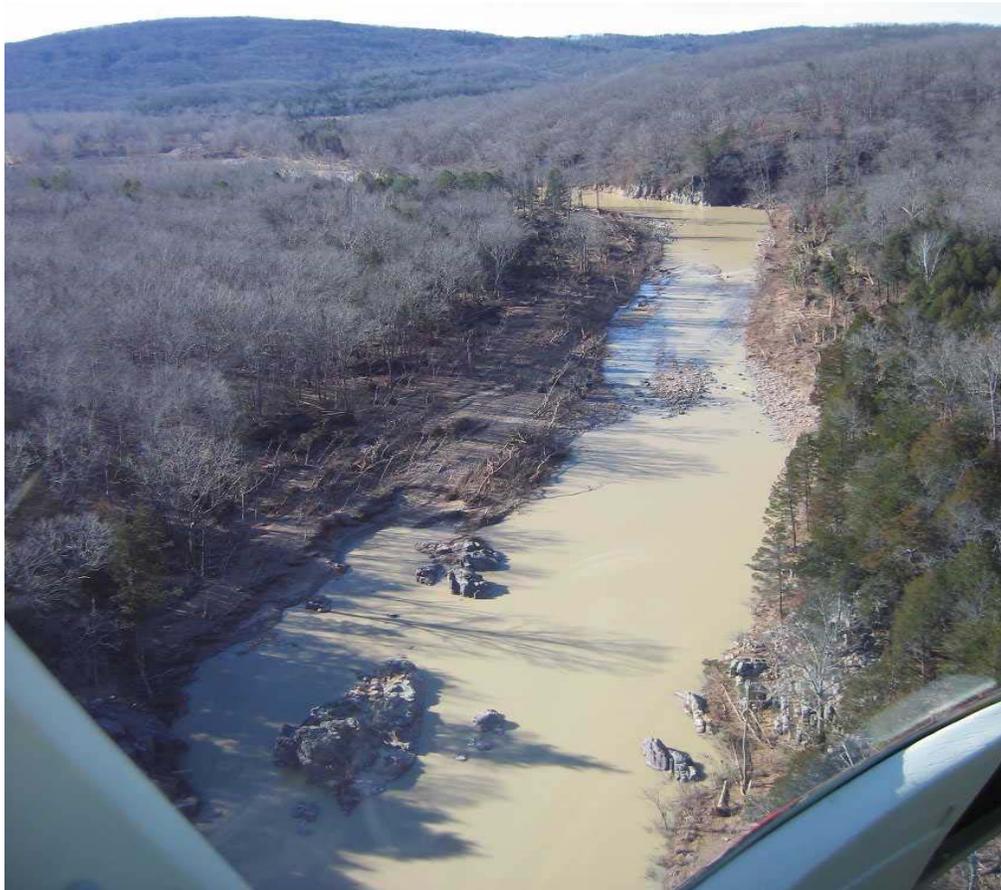
The channel modification was most extensive upstream from the Shut-Ins at the entrance to the State Park. The natural boulder and bedrock area of the Shut-Ins helped prevent excessive scour and the reconfiguration of the channel in that area; however, below the Shut-Ins area and upstream of the lower reservoir, significant loss of riparian habitat, flooding, scour, and turbidity were sustained (Figure 11.9).

Figure 11.9 - Scour and loss of riparian habitat below the Shut-Ins. (Source: Missouri Department of Conservation)
