Report of Findings on the Overtopping and Embankment
Breach of the Upper Dam - Taum Sauk Pumped Storage
Project, FERC No. 2277

FERC Taum Sauk Investigation Team

April 28 2006

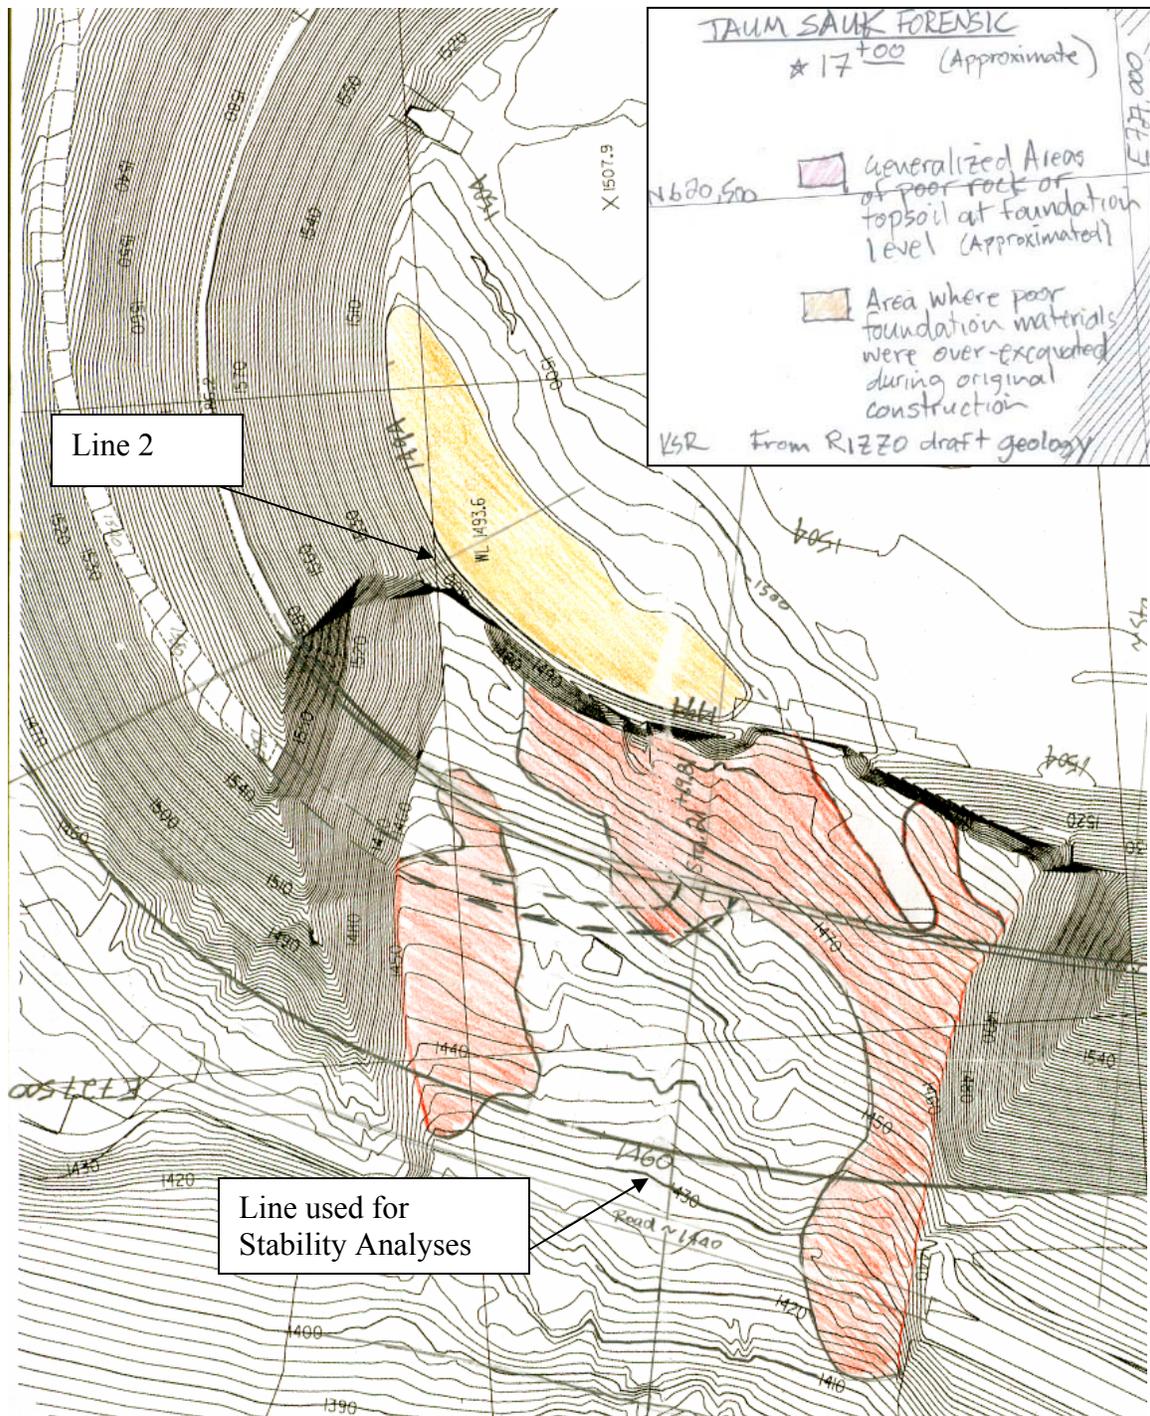
Figure D.1- Taum Sauk Forensic Reconstruction

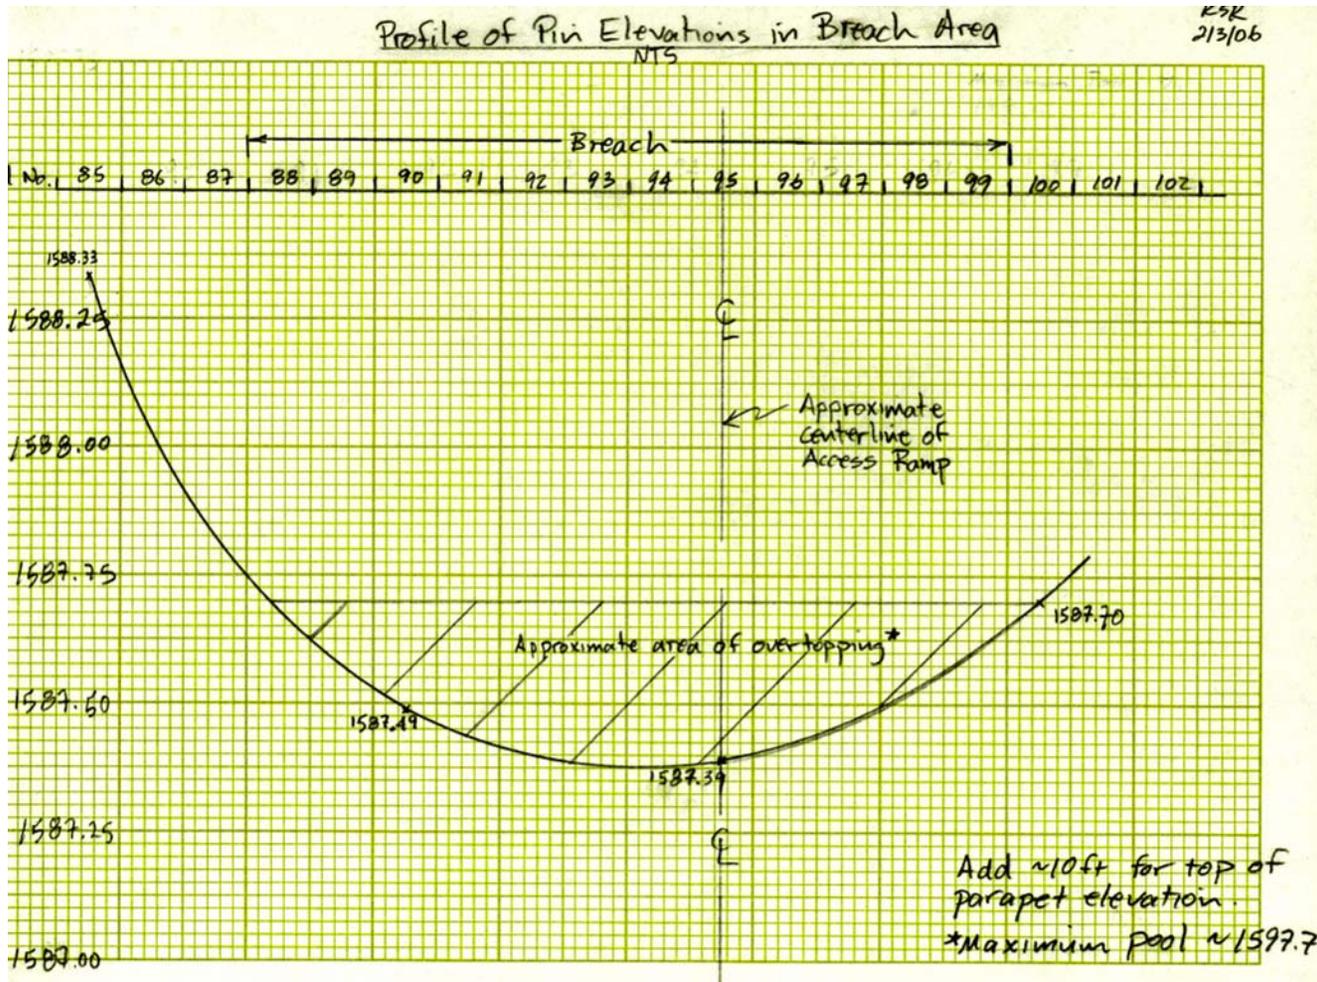
Figure D.2 - Vertical curve in the area of the breach. Approximate extent of overtopping is hatched.

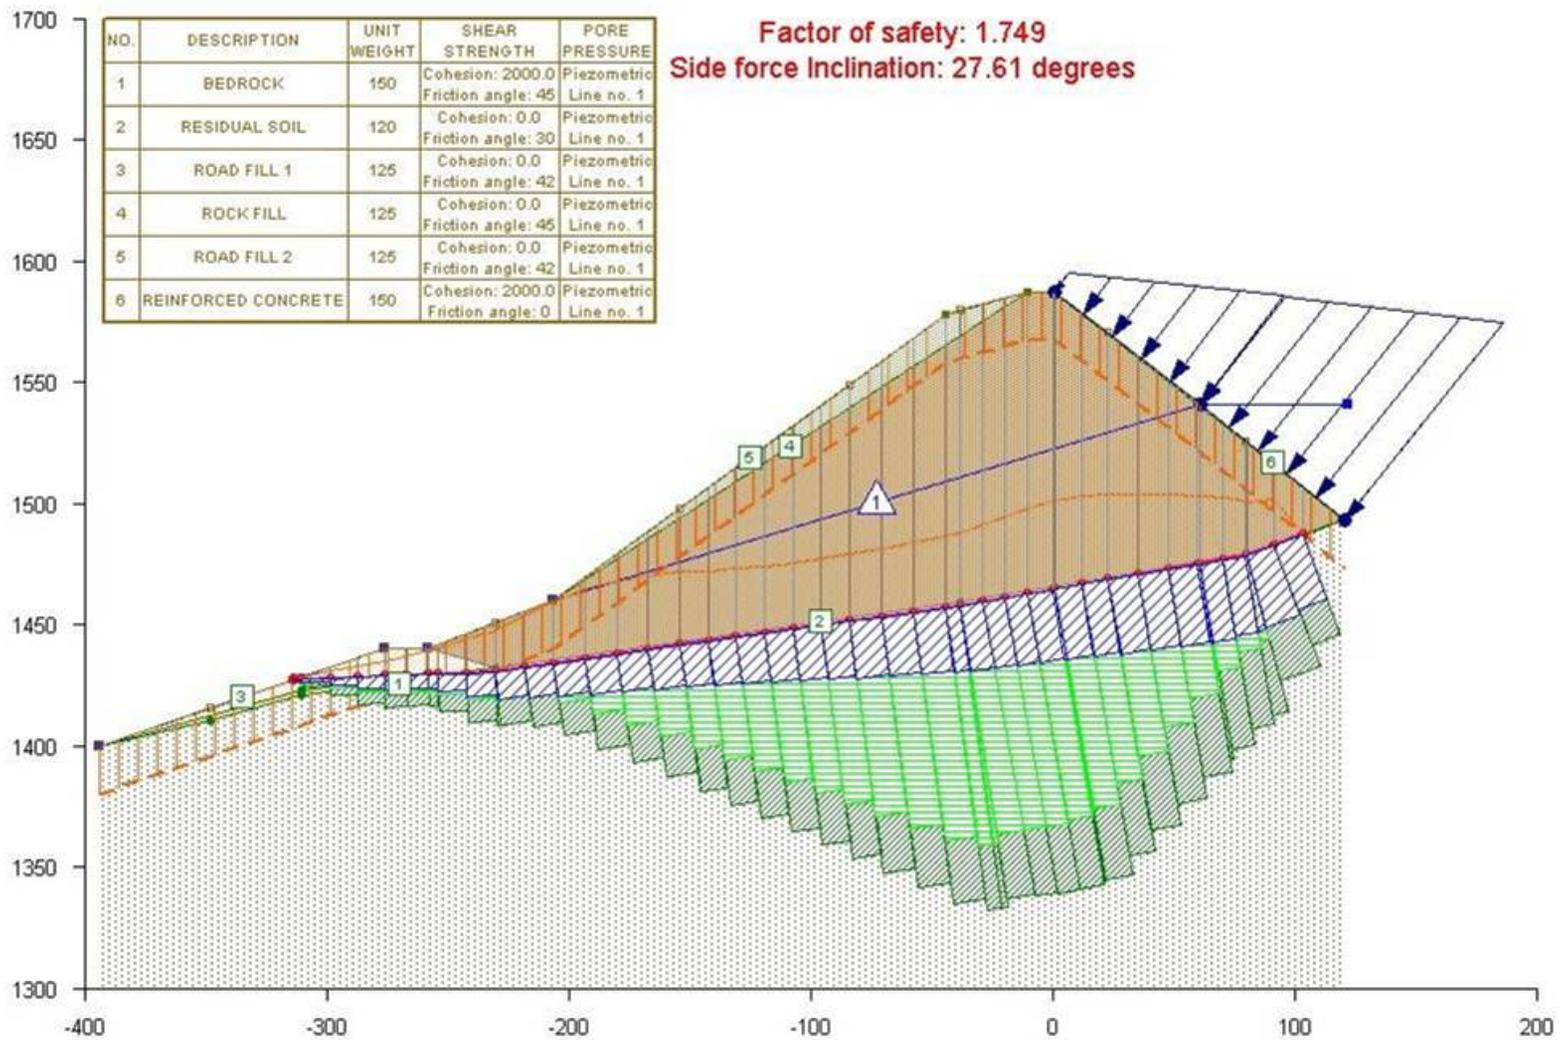
Figure D.14 - Trial 3c

NO.	DESCRIPTION	UNIT WEIGHT	SHEAR STRENGTH	PORE PRESSURE
1	BEDROCK	150	Cohesion: 2000.0 Friction angle: 45	Piezometric Line no. 1
2	RESIDUAL SOIL	120	Cohesion: 0.0 Friction angle: 30	Piezometric Line no. 1
3	ROAD FILL 1	125	Cohesion: 0.0 Friction angle: 42	Piezometric Line no. 1
4	ROCK FILL	125	Cohesion: 0.0 Friction angle: 45	Piezometric Line no. 1
5	ROAD FILL 2	125	Cohesion: 0.0 Friction angle: 42	Piezometric Line no. 2
6	REINFORCED CONCRETE	150	Cohesion: 2000.0 Friction angle: 0	Piezometric Line no. 1
7	SATURATED ROCK FILL	125	Cohesion: 0.0 Friction angle: 45	Piezometric Line no. 2

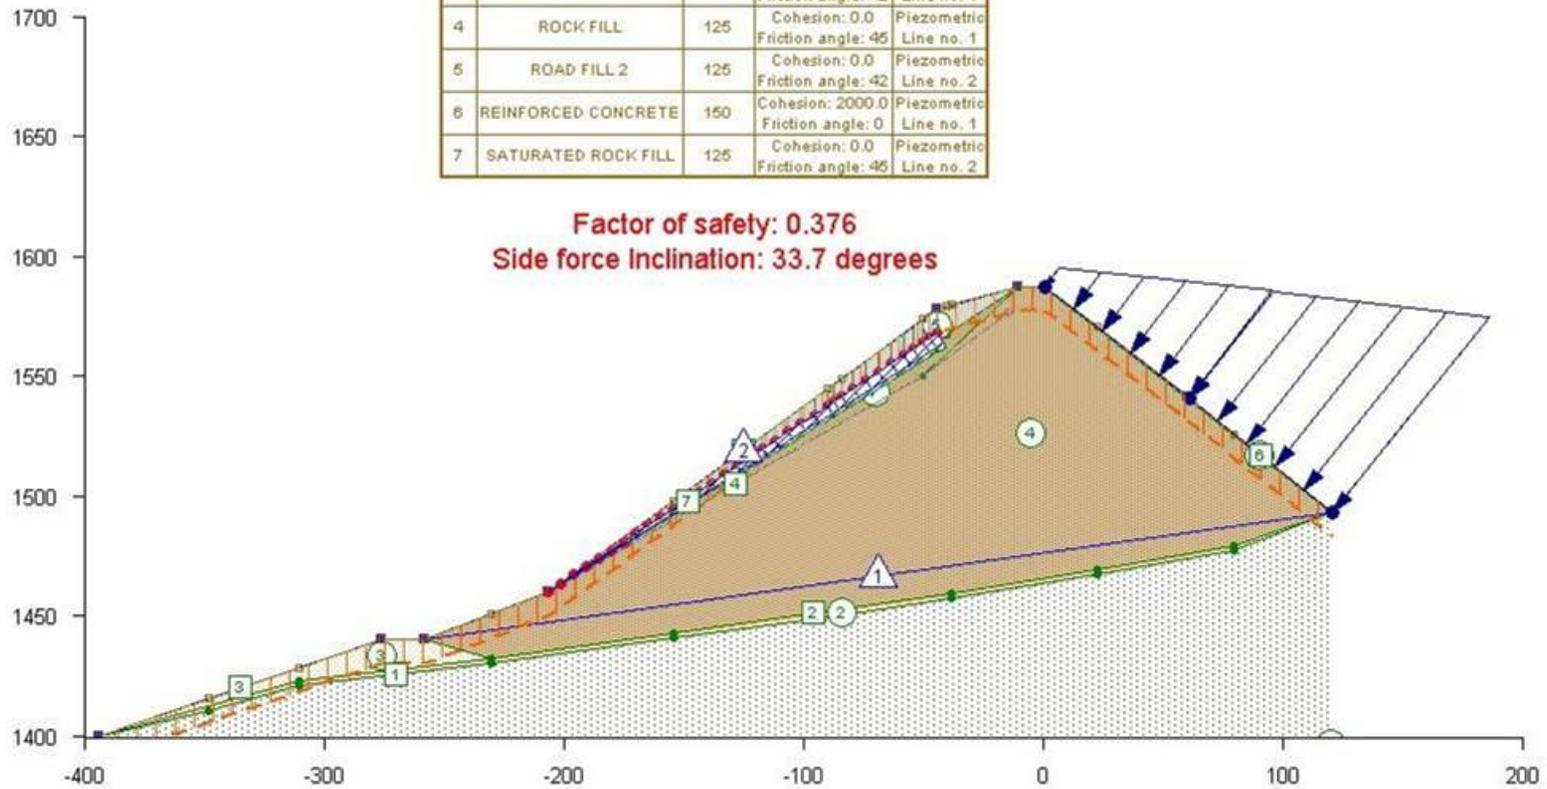
Figure D.15 - Trial 3d

NO.	DESCRIPTION	UNIT WEIGHT	SHEAR STRENGTH	PORE PRESSURE
1	BEDROCK	150	Cohesion: 2000.0 Friction angle: 45	Piezometric Line no. 1
2	RESIDUAL SOIL	120	Cohesion: 0.0 Friction angle: 20	Piezometric Line no. 1
3	ROAD FILL 1	125	Cohesion: 0.0 Friction angle: 40	Piezometric Line no. 1
4	ROCK FILL	125	Cohesion: 0.0 Friction angle: 43	Piezometric Line no. 1
5	ROAD FILL 2	125	Cohesion: 0.0 Friction angle: 40	Piezometric Line no. 1
6	REINFORCED CONCRETE	150	Cohesion: 2000.0 Friction angle: 0	Piezometric Line no. 1
7	SATURATED ROCK FILL	125	Cohesion: 0.0 Friction angle: 43	Piezometric Line no. 1
